DEPARTMENT OF THE AIR FORCE
HEADQUARTERS AIR FORCE CIVIL ENGINEER SUPPORT AGENCY

19 DEC 2007

SUBJECT: **Engineering Technical Letter (ETL) 07-10: Evaluation and Restoration of Folded Fiberglass Mats (FFM)**

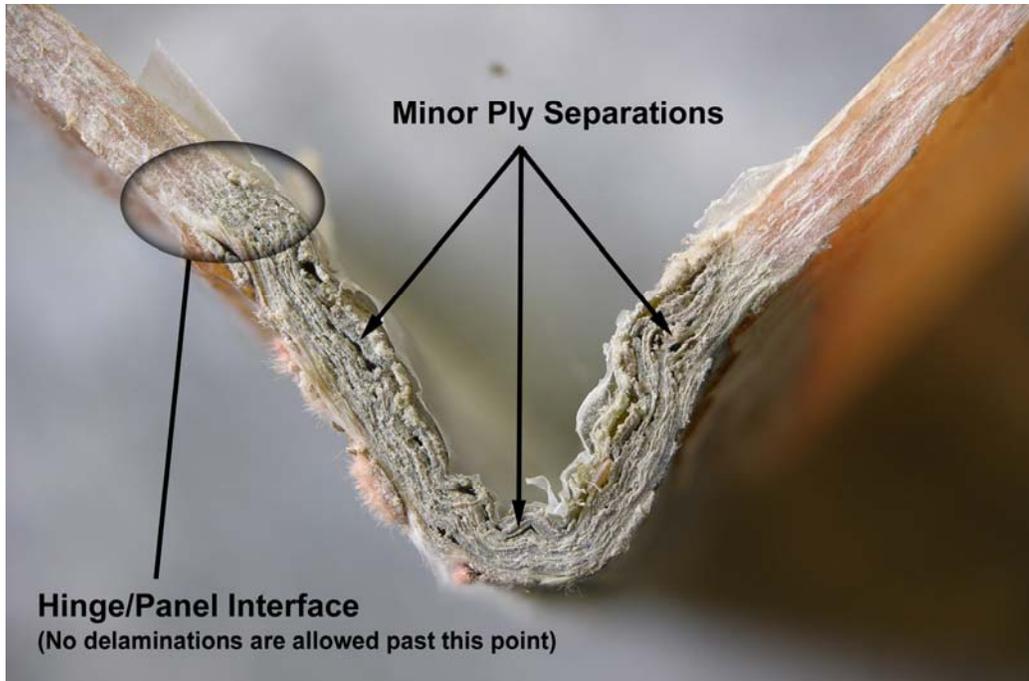
6.2.2. Delaminations (Ply Separations). During inspection, FFM will be examined for the presence of ply separations, commonly called delaminations. It may be difficult to discern between internal dry spots and delaminations at times, so the evaluator should examine such damage closely. Delaminations, if present, may propagate very quickly under large flexural loads, leading to FFM failure. For this reason, it is recommended that no delaminations be present on rigid panel sections of FFM used in airfield repair. The most common location for delaminations to form is throughout the hinge-panel interface area. An occurrence of such a delamination is shown in Figure 1. Delaminations in this area should not be of significant concern unless they extend out into the FFM rigid panel area.

Figure 1. Minor Delaminations in Elastomer Hinge

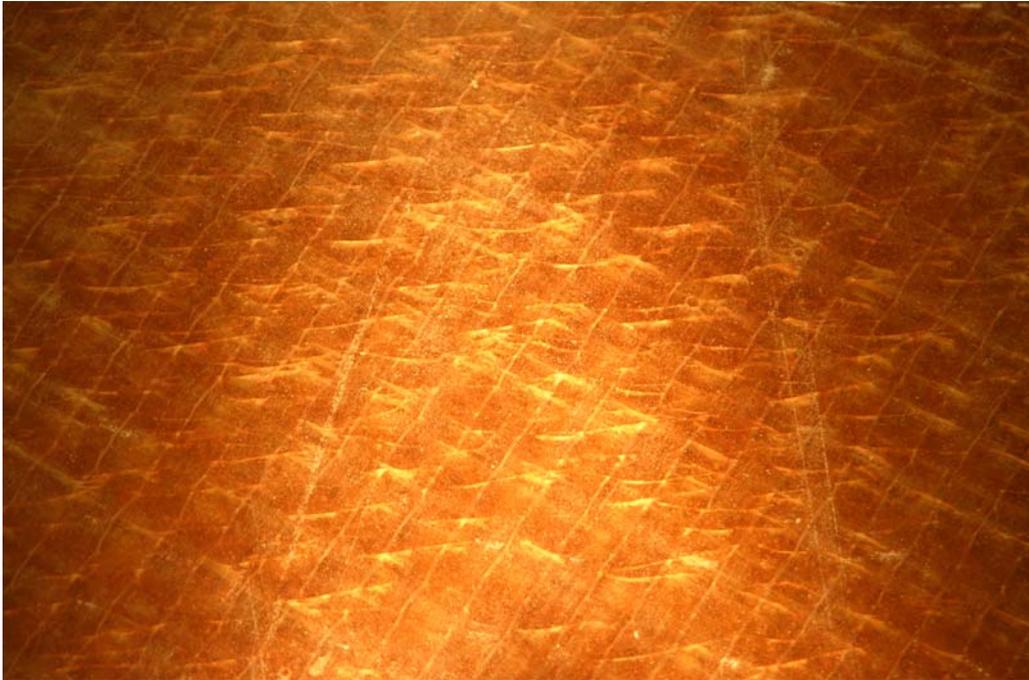
6.2.4. Directional Cracks. Two significantly different types of cracking have been observed on rigid panel sections of FFM. The less severe is a unidirectional cracking commonly created by large flexural loads. All cracks appear to be near the surface and do not penetrate into the fiberglass reinforcement, thus keeping fiber-matrix interfacial bonds intact. When this type of damage is discovered, the inspector should carefully examine the depth of such cracks and verify that they have not propagated into the fiberglass reinforcement area. One practical method of examining crack depths requires a fairly directional light source such as a focused flashlight or sunlight. When the light source is pointed at an angle to the FFM surface, cracks will reflect light at a different angle than light refracting off the FFM surface. This makes the cracks stand out by either making them lighter or darker than the surface depending on where the observer is located, as seen in Figure 2. Essentially, the light source is one method of increasing the visual contrast between cracks and the rest of the mat. Upon inspection, the rigid panel should be deemed acceptable if the directional cracking is localized to

the resin surface. If cracks have propagated into the fiberglass reinforcement, the rigid panel must be replaced or patched as its strength has likely deteriorated to an unacceptable level.

Figure 2. Unidirectional Cracking Seen with Angled Flashlight

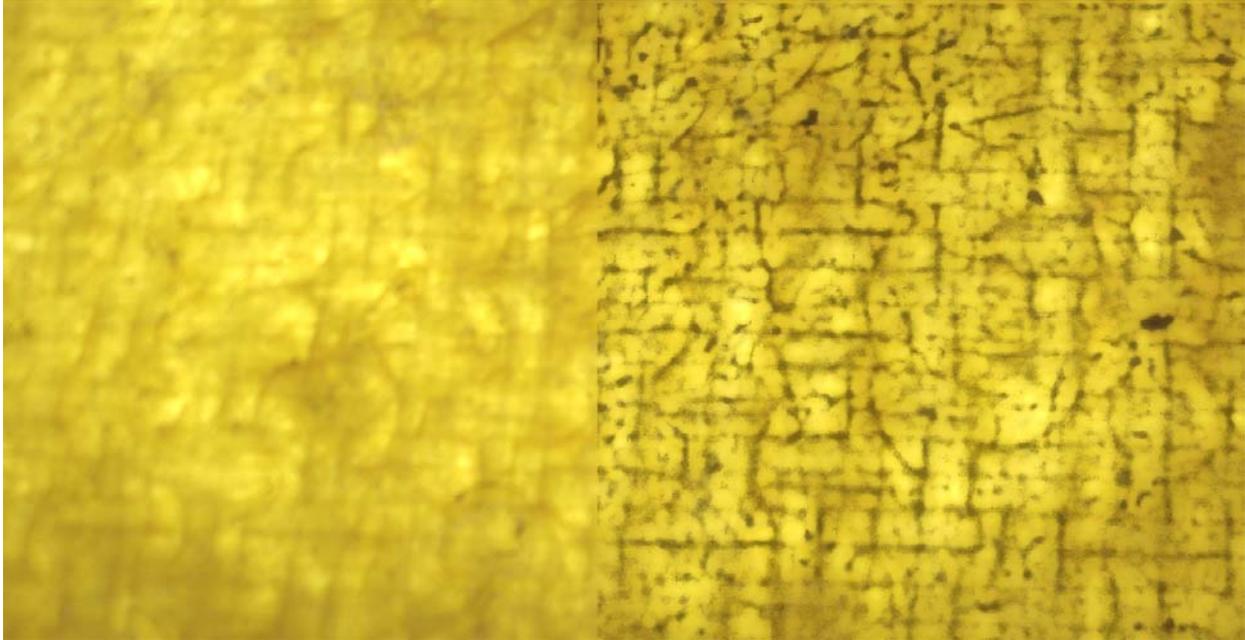
6.2.5. Randomly Oriented Surface Cracks. The second type of cracking occurs in random patterns displaying connectivity and is often called “map” or “alligator” cracking. This damage can be seen in Figures 3 and 4. Although not common, this cracking has been determined in multiple tests to be more serious than unidirectional cracking. The severity of damage is likely a function of crack connectivity which creates a “network” of weak sections bonded onto fiberglass. During the FFM evaluation process, it is important that inspectors are meticulous enough to locate this type of surface cracking as it is not an extremely apparent type of damage. In trial inspections, this type of cracking has been observed to occur over large sections of rigid panels. Under such circumstances it is important that whole panel sections are replaced due to the likelihood of crack propagation under load.

Figure 3. Randomly Oriented Surface Cracking Visualized with Image Processing

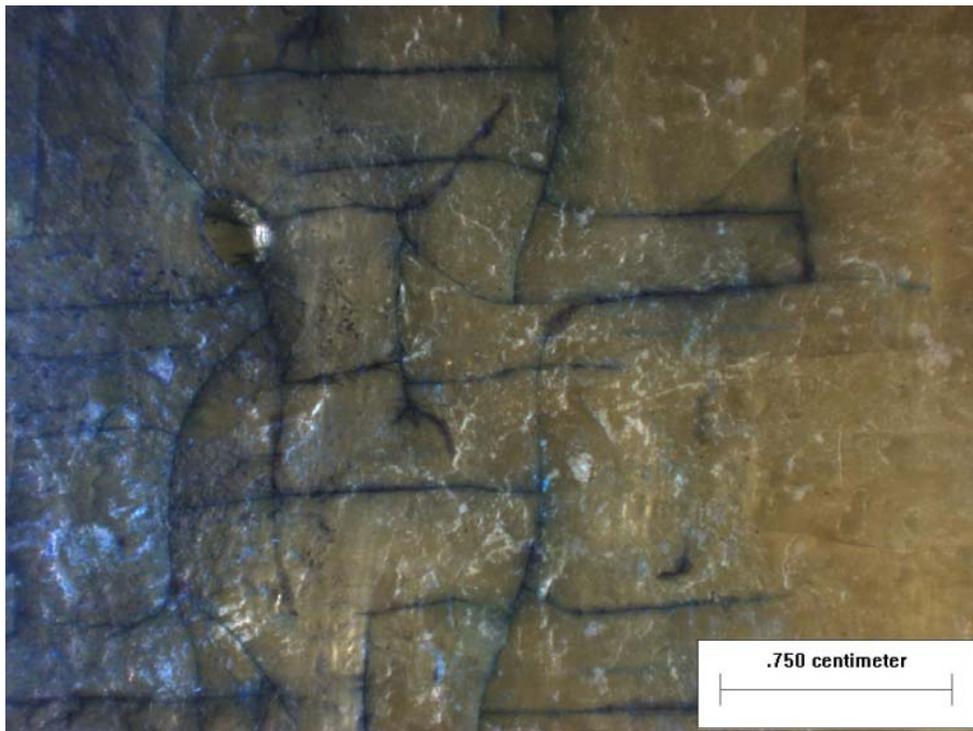
Figure 4. Randomly Oriented Surface Cracking with Methyl Blue Dye

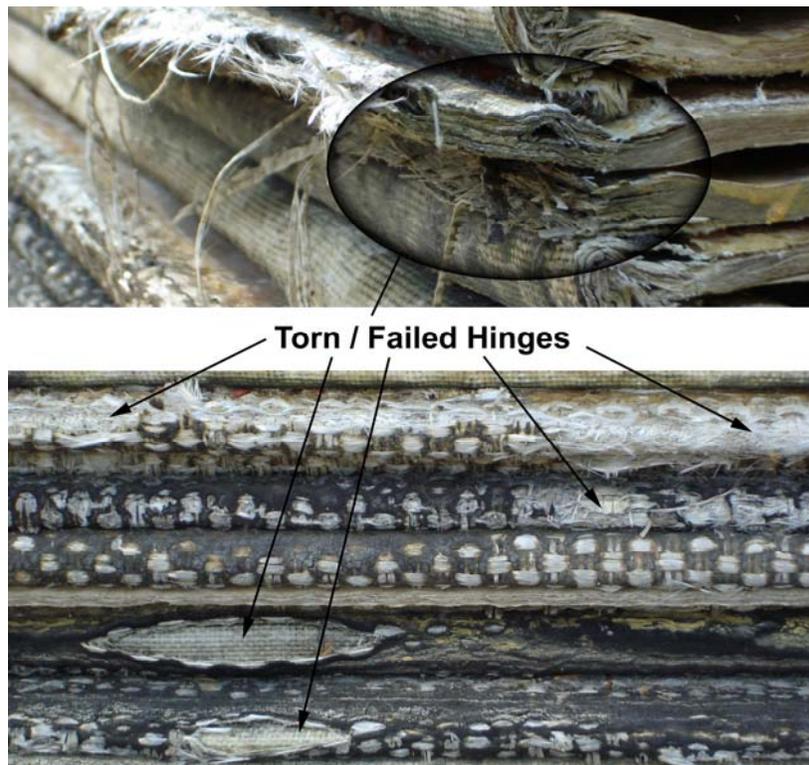
6.2.6. Tears. Hinges that have experienced significant tensile loads may begin to exhibit failure in the form of tears or broken fiberglass. In some cases, mats

which have only been exposed to storage environments have also exhibited this type of damage, as seen in Figure 5. These cases are likely caused by elastomer shrinkage, folding strains, ultraviolet radiation damage, and/or thermal stresses. Any hinge areas that are torn, regardless of tear length, are not suitable for use. Such hinges must be replaced as allowed in approved repair methods. Some FFM manufacturers have attempted to address the occurrence of hinge tears by controlling the location of bending, in turn stress concentrations, in new elastomer hinges as seen in Figure 6. Such procedures may decrease the occurrences of tears and delaminations near hinges. At this time these hinges have not undergone proper testing or usage to validate such beneficial claims.

Figure 5. Critical Damage to FFM Hinges

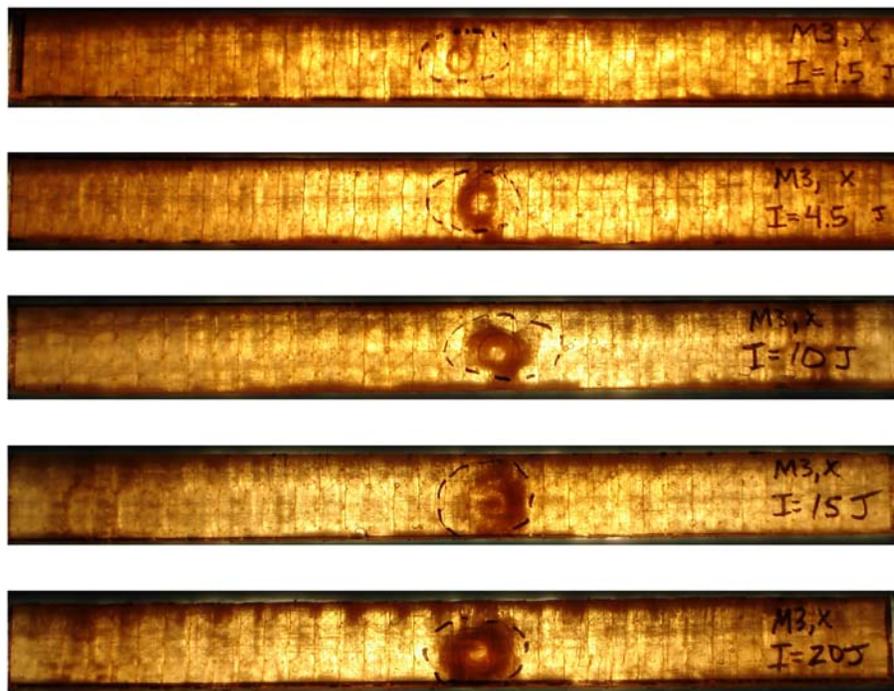
6.2.7. Localized Impact. During FFM use, it is likely that impact damage will occur from FOD and/or aggregate underneath the FFM. Under most circumstances, impact damage will affect FFM strength in negligible amounts because it is localized to small areas. However, when impact damage is measured to be 1 inch (25 millimeters) or more in diameter, it should become a concern in the evaluation process. Locations of impact areas this size should not occur in a frequency greater than five per square foot. Also, any occurrences greater than 4 inches (100 millimeters) in diameter are not allowed. It may be necessary at times to reject panel sections due to impact damage that have less than five locations per square foot due to crack propagation. If cracks run outside of the impact (discolored) area, they should be examined as described in paragraph 6.2.4. Cracks deep enough to penetrate into the fiberglass reinforcement area are a cause for panel rejection. Such areas should be marked using a permanent marker for further evaluation in the repair process. Panel replacement may not be necessary, as damaged areas can be cut out and patched. Figure 7 shows examples of impact damage at varying intensities.

Figure 7. Localized Impact Damage Visualized with Backlighting

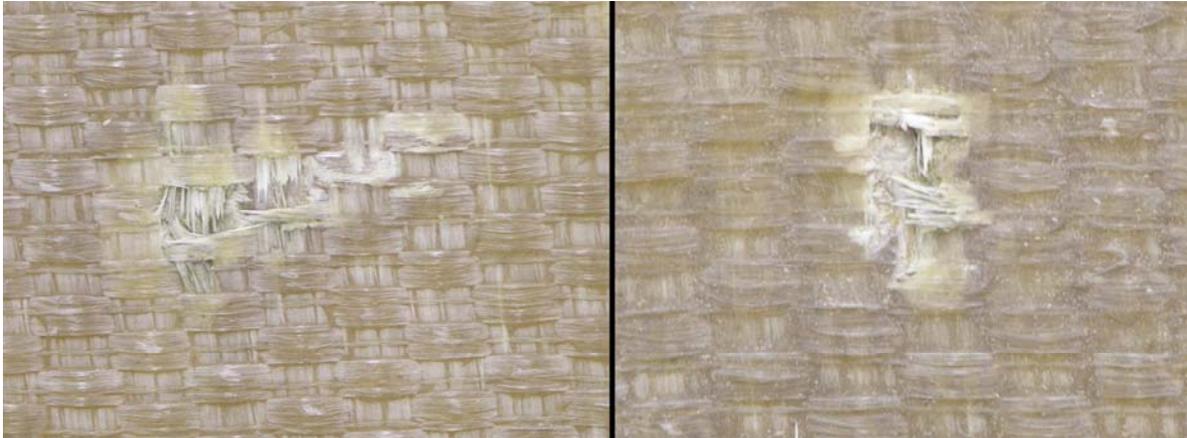
6.2.8. Unclassified Damage. There will undoubtedly be types of damage found during FFM evaluations that have not been covered in this ETL or seem to blur the lines of classification. The significance of such damage will require the judgment of an evaluator. An example of questionable damage is shown in Figure 8. Either caused by a “dry spot” or “impact damage,” this damaged area has worsened to the point where reinforcing fibers have failed. If larger than 1 inch (25 millimeters) in diameter, such areas should be cut out and replaced as

specified by acceptable repair methods. When dealing with unclassified damage, an evaluator should use their best judgment, keeping in mind the relative severity of previously described damage.

Figure 8. Examples of Unclassified Damage

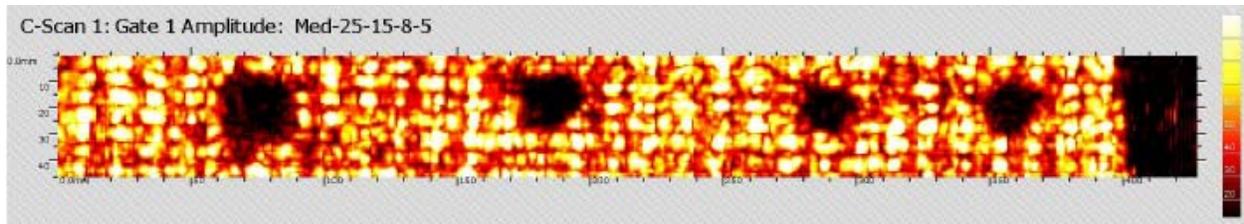
Figure 12. Example of C-Scan Plot Showing Localized Impact Damage

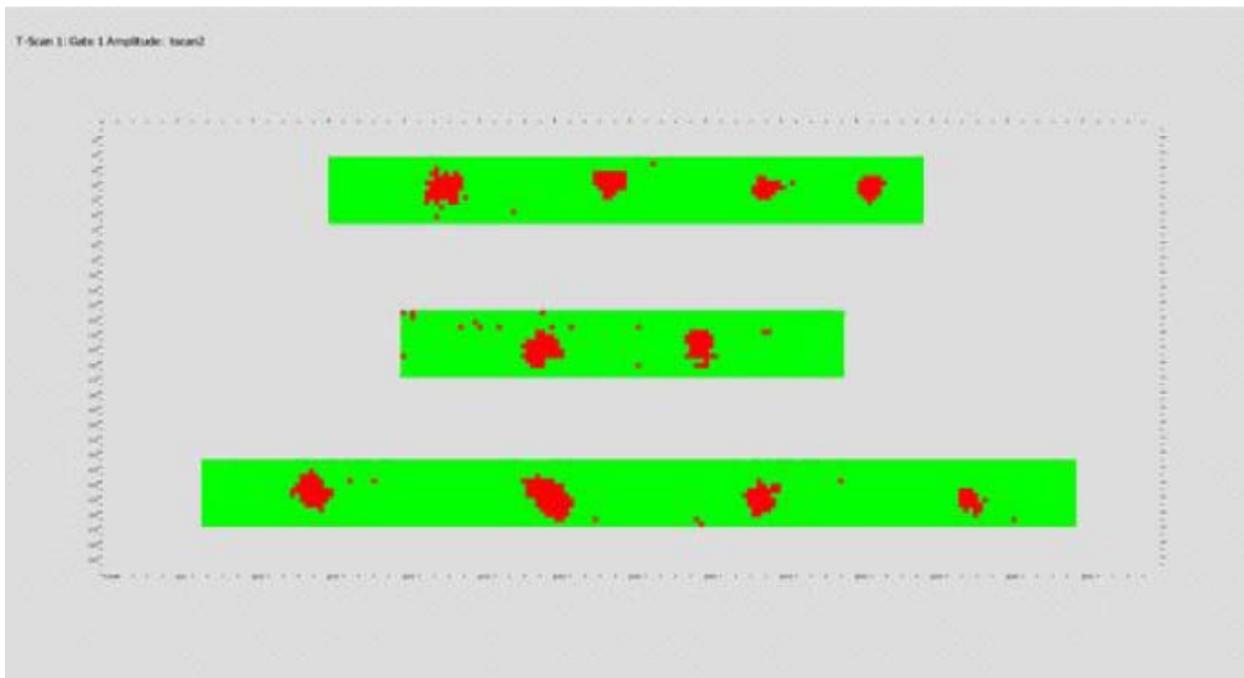
Figure 13. Example of C-Scan Plot Showing Pass-Fail Results Using Binary Colors

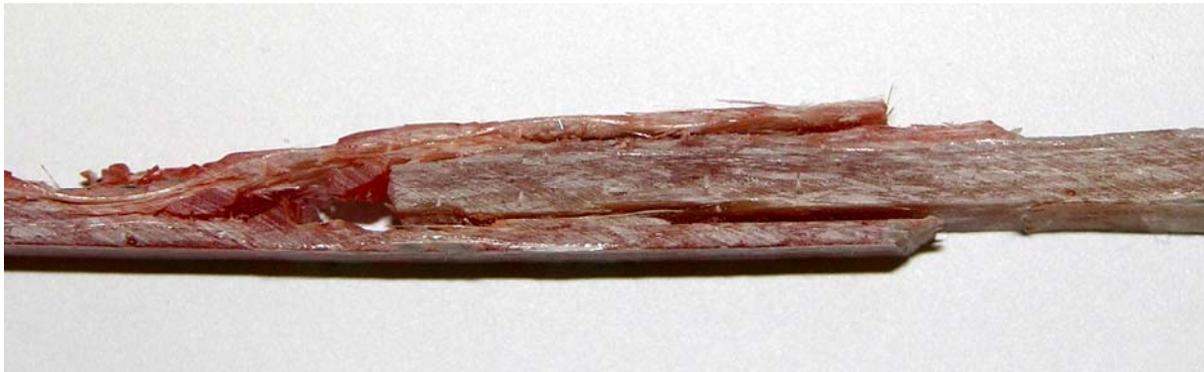
Figure 15. Cross-Section of Failed Secondary Bond Test Specimen

7.5. Panel Patches. When small areas of damage are found, it is possible to repair them with a “patch” instead of replacing the entire rigid panel. The damaged section can be cut out, prepared, and a secondary bond can be made between the patch and existing panel. The patch must be physically equivalent to the panel in material composition, including the type of resin used as the secondary bonding agent. Testing was completed to determine an optimal secondary bond size for patches in the rigid panel area. It has been determined that a secondary bond width of

3.5 inches (90 millimeters) is sufficient relative to the required specifications. This means that all new patches applied to FFM must overlap the existing mat by 3.5 inches (90 millimeters) on the top and bottom surfaces. At this size, the bond strength exceeds that of a mat's tensile strength. The cross-section of a failed test specimen with a secondary bond is shown in Figure 15 for reference. Certified vendors are listed in Attachment 1. An updated list of certified vendors is available upon request from the certification officials listed in paragraph 7.1.1.
