DEPARTMENT OF THE AIR FORCE
HEADQUARTERS AIR FORCE CIVIL ENGINEER SUPPORT AGENCY

19 DEC 2007

SUBJECT: Engineering Technical Letter (ETL) 07-10: Evaluation and Restoration of Folded Fiberglass Mats (FFM)

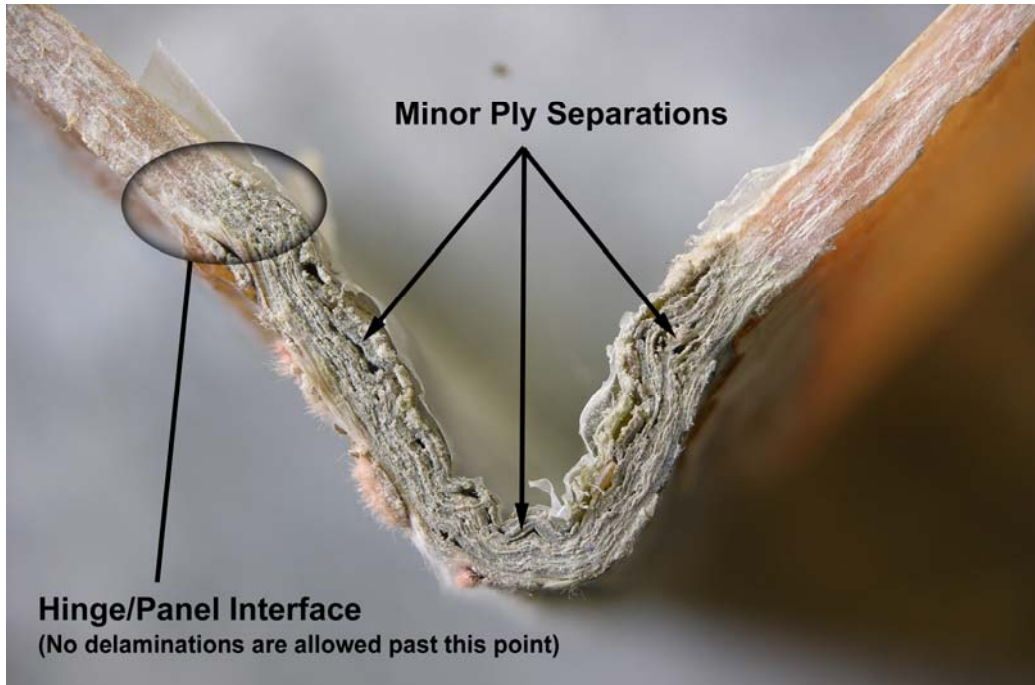
6.2.2. Delaminations (Ply Separations). During inspection, FFM will be examined for the presence of ply separations, commonly called delaminations. It may be difficult to discern between internal dry spots and delaminations at times, so the evaluator should examine such damage closely. Delaminations, if present, may propagate very quickly under large flexural loads, leading to FFM failure. For this reason, it is recommended that no delaminations be present on rigid panel sections of FFM used in airfield repair. The most common location for delaminations to form is throughout the hinge-panel interface area. An occurrence of such a delamination is shown in Figure 1. Delaminations in this area should not be of significant concern unless they extend out into the FFM rigid panel area.

Figure 1. Minor Delaminations in Elastomer Hinge

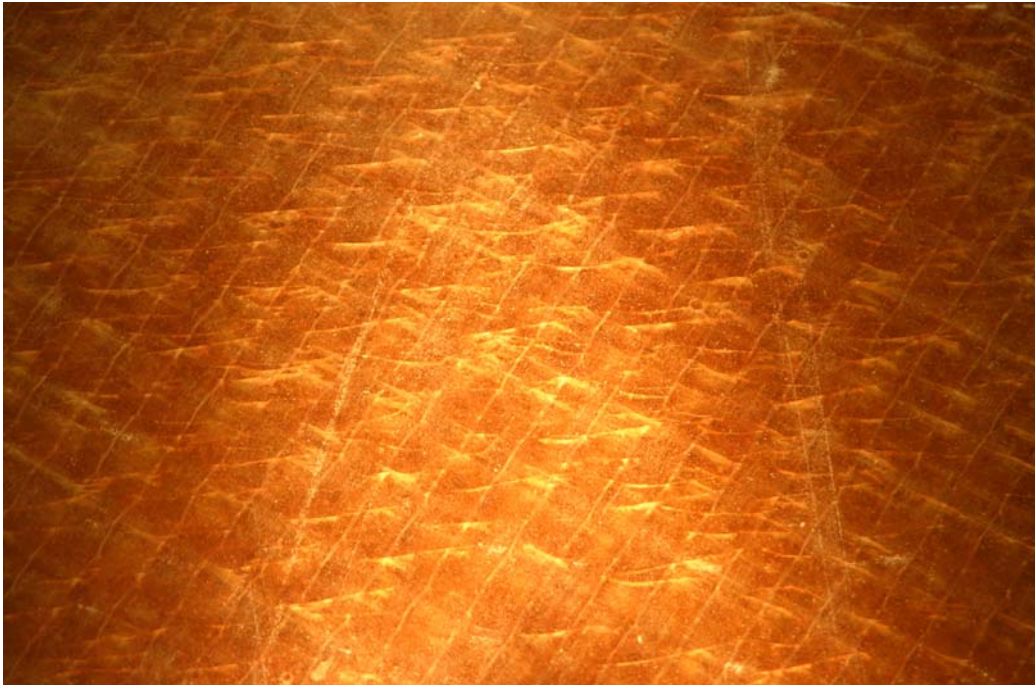
6.2.4. Directional Cracks. Two significantly different types of cracking have been observed on rigid panel sections of FFM. The less severe is a unidirectional cracking commonly created by large flexural loads. All cracks appear to be near the surface and do not penetrate into the fiberglass reinforcement, thus keeping fiber-matrix interfacial bonds intact. When this type of damage is discovered, the inspector should carefully examine the depth of such cracks and verify that they have not propagated into the fiberglass reinforcement area. One practical method of examining crack depths requires a fairly directional light source such as a focused flashlight or sunlight. When the light source is pointed at an angle to the FFM surface, cracks will reflect light at a different angle than light refracting off the FFM surface. This makes the cracks stand out by either making them lighter or darker than the surface depending on where the observer is located, as seen in Figure 2. Essentially, the light source is one method of increasing the visual contrast between cracks and the rest of the mat. Upon inspection, the rigid panel should be deemed acceptable if the directional cracking is localized to

the resin surface. If cracks have propagated into the fiberglass reinforcement, the rigid panel must be replaced or patched as its strength has likely deteriorated to an unacceptable level.

Figure 2. Unidirectional Cracking Seen with Angled Flashlight

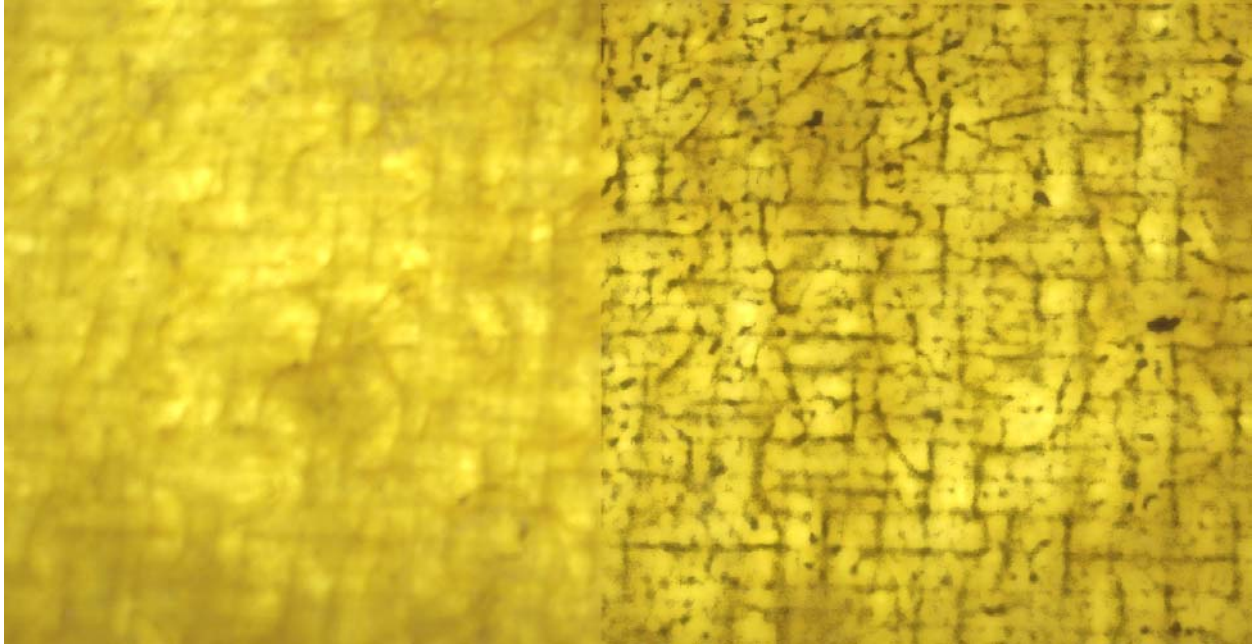
6.2.5. Randomly Oriented Surface Cracks. The second type of cracking occurs in random patterns displaying connectivity and is often called “map” or “alligator” cracking. This damage can be seen in Figures 3 and 4. Although not common, this cracking has been determined in multiple tests to be more serious than unidirectional cracking. The severity of damage is likely a function of crack connectivity which creates a “network” of weak sections bonded onto fiberglass. During the FFM evaluation process, it is important that inspectors are meticulous enough to locate this type of surface cracking as it is not an extremely apparent type of damage. In trial inspections, this type of cracking has been observed to occur over large sections of rigid panels. Under such circumstances it is important that whole panel sections are replaced due to the likelihood of crack propagation under load.

Figure 3. Randomly Oriented Surface Cracking Visualized with Image Processing

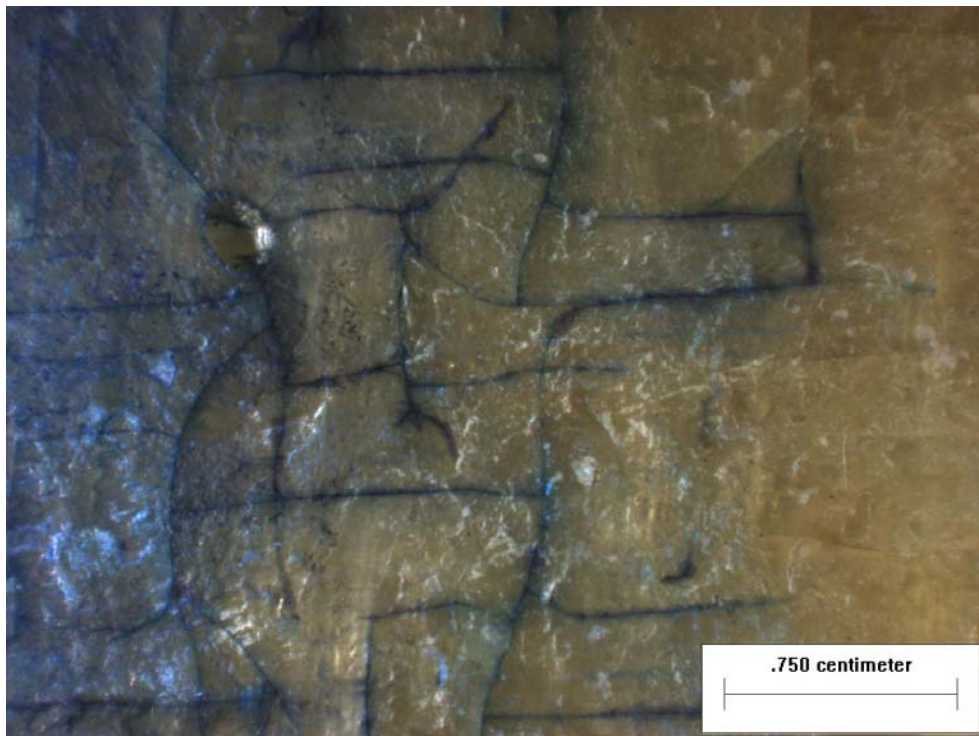
Figure 4. Randomly Oriented Surface Cracking with Methyl Blue Dye

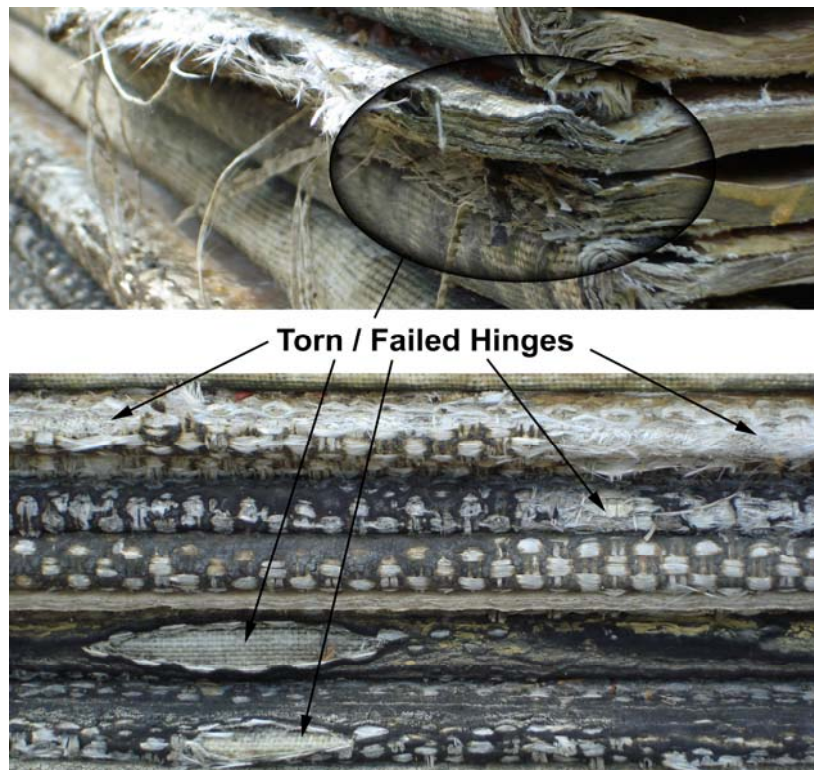
6.2.6. Tears. Hinges that have experienced significant tensile loads may begin to exhibit failure in the form of tears or broken fiberglass. In some cases, mats

which have only been exposed to storage environments have also exhibited this type of damage, as seen in Figure 5. These cases are likely caused by elastomer shrinkage, folding strains, ultraviolet radiation damage, and/or thermal stresses. Any hinge areas that are torn, regardless of tear length, are not suitable for use. Such hinges must be replaced as allowed in approved repair methods. Some FFM manufacturers have attempted to address the occurrence of hinge tears by controlling the location of bending, in turn stress concentrations, in new elastomer hinges as seen in Figure 6. Such procedures may decrease the occurrences of tears and delaminations near hinges. At this time these hinges have not undergone proper testing or usage to validate such beneficial claims.

Figure 5. Critical Damage to FFM Hinges

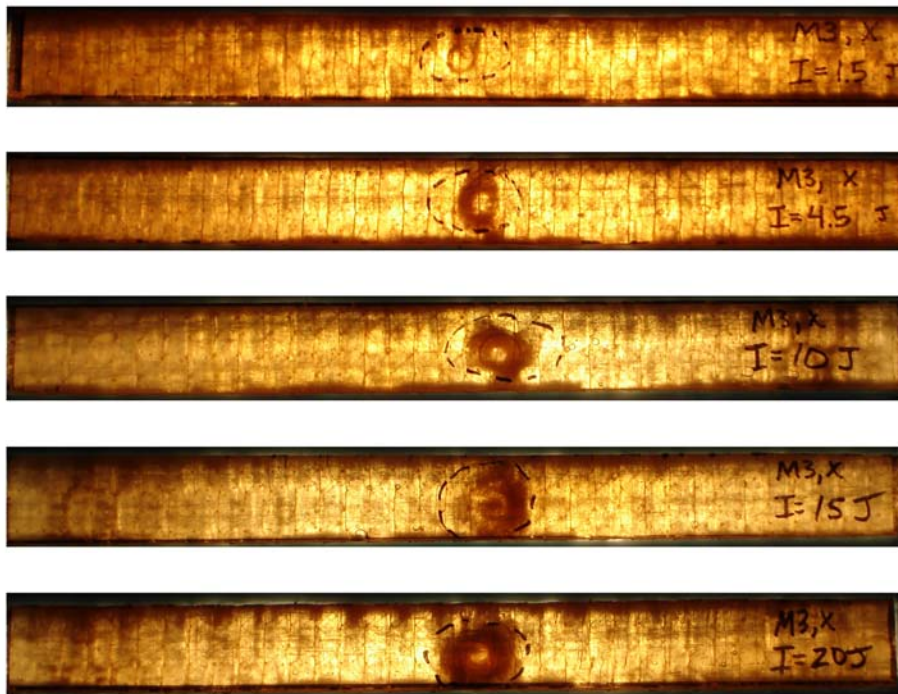
6.2.7. Localized Impact. During FFM use, it is likely that impact damage will occur from FOD and/or aggregate underneath the FFM. Under most circumstances, impact damage will affect FFM strength in negligible amounts because it is localized to small areas. However, when impact damage is measured to be 1 inch (25 millimeters) or more in diameter, it should become a concern in the evaluation process. Locations of impact areas this size should not occur in a frequency greater than five per square foot. Also, any occurrences greater than 4 inches (100 millimeters) in diameter are not allowed. It may be necessary at times to reject panel sections due to impact damage that have less than five locations per square foot due to crack propagation. If cracks run outside of the impact (discolored) area, they should be examined as described in paragraph 6.2.4. Cracks deep enough to penetrate into the fiberglass reinforcement area are a cause for panel rejection. Such areas should be marked using a permanent marker for further evaluation in the repair process. Panel replacement may not be necessary, as damaged areas can be cut out and patched. Figure 7 shows examples of impact damage at varying intensities.

Figure 7. Localized Impact Damage Visualized with Backlighting

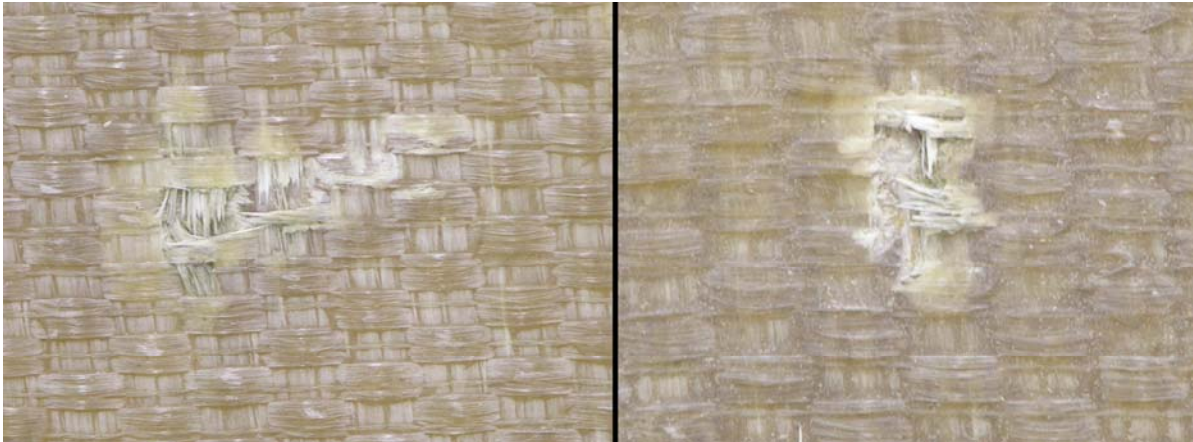
6.2.8. Unclassified Damage. There will undoubtedly be types of damage found during FFM evaluations that have not been covered in this ETL or seem to blur the lines of classification. The significance of such damage will require the judgment of an evaluator. An example of questionable damage is shown in Figure 8. Either caused by a “dry spot” or “impact damage,” this damaged area has worsened to the point where reinforcing fibers have failed. If larger than 1 inch (25 millimeters) in diameter, such areas should be cut out and replaced as

specified by acceptable repair methods. When dealing with unclassified damage, an evaluator should use their best judgment, keeping in mind the relative severity of previously described damage.

Figure 8. Examples of Unclassified Damage

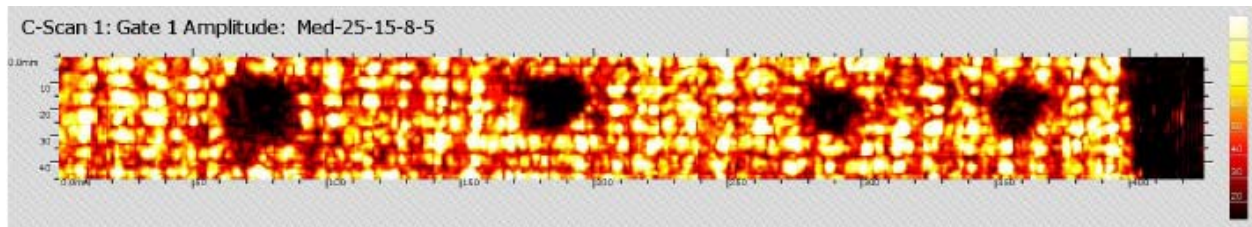
Figure 12. Example of C-Scan Plot Showing Localized Impact Damage

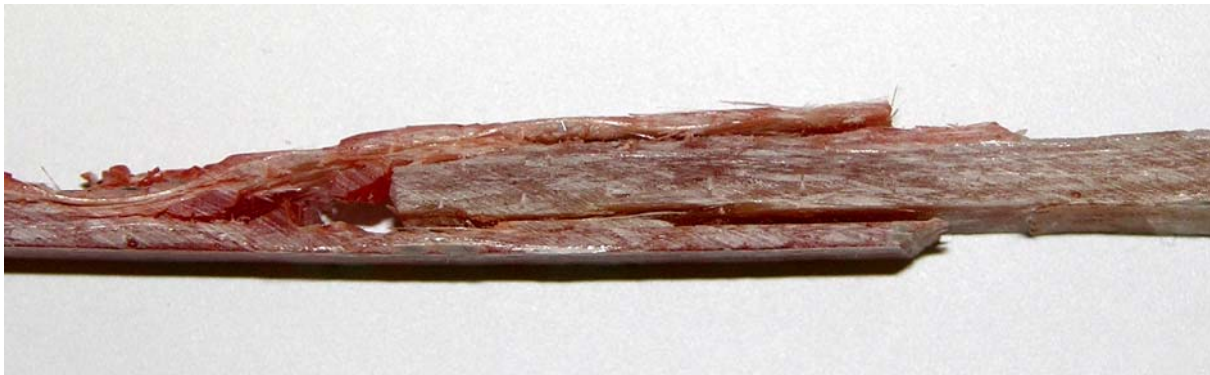
Figure 15. Cross-Section of Failed Secondary Bond Test Specimen

7.5. Panel Patches. When small areas of damage are found, it is possible to repair them with a “patch” instead of replacing the entire rigid panel. The damaged section can be cut out, prepared, and a secondary bond can be made between the patch and existing panel. The patch must be physically equivalent to the panel in material composition, including the type of resin used as the secondary bonding agent. Testing was completed to determine an optimal secondary bond size for patches in the rigid panel area. It has been determined that a secondary bond width of

3.5 inches (90 millimeters) is sufficient relative to the required specifications. This means that all new patches applied to FFM must overlap the existing mat by 3.5 inches (90 millimeters) on the top and bottom surfaces. At this size, the bond strength exceeds that of a mat's tensile strength. The cross-section of a failed test specimen with a secondary bond is shown in Figure 15 for reference. Certified vendors are listed in Attachment 1. An updated list of certified vendors is available upon request from the certification officials listed in paragraph 7.1.1.
