**PUBLIC WORKS TECHNICAL BULLETIN 420-49-6  
31 MAY 1996**

**THE USE OF PLASTIC PLUMBING MATERIALS:  
LESSONS LEARNED**

Public Works Technical Bulletin  
No. 420-49-6

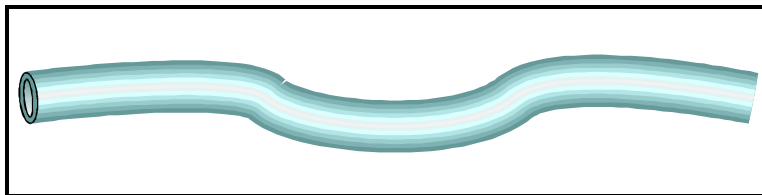
3. Another installation installed a hot water heat pump system in a headquarters-type building. The contractor who installed the heat pump used a PVC pipe rated for cold water rather than the CPVC pipe required for hot water. When the system was turned on, the pipe sagged and soon broke (Figure 1). The contractor replaced the PVC pipe with CPVC pipe.

**Figure 1** Cold water PVC pipe sags when used to carry hot water.

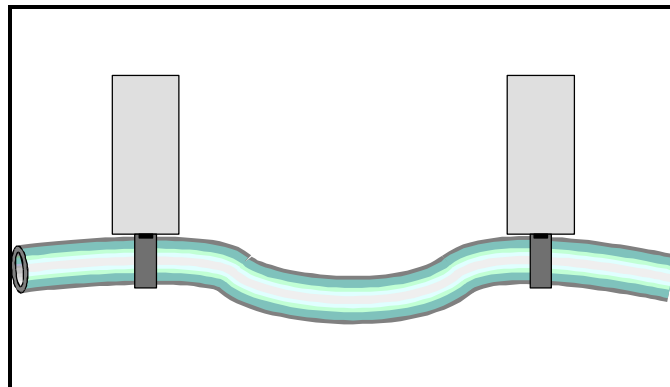
2. Polybutylene plumbing was used in a motor pool tactical equipment maintenance facility to prevent pipes from bursting. A positive attribute of polybutylene piping is its ability to withstand the forces caused by water freezing inside it. However, to accommodate the thermal expansion and contraction, the pipe was installed so it sagged between pipe hangers. The weight of the water in the pipes combined with thermal expansion during hot weather caused the pipes to sag to the point that, over time, they began pulling out of the compression fittings (Figure 2).

**Figure 2** Water weight and thermal expansion may cause polybutylene piping to pull out of compression fittings.

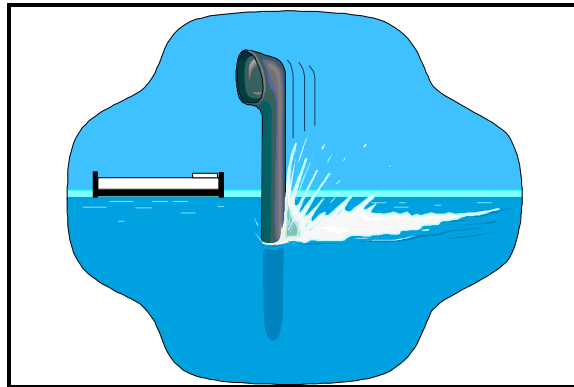
3. Another installation built some barracks with all PVC plumbing in the winter of 1987. After the pipe was placed, the builders cemented it tightly against the barracks floor. The cement did not allow thermal expansion or contraction in the pipe, so the pipe burst and flooded the barracks soon after it was placed in use (Figure 3). Installation personnel took out the cemented plumbing and replaced it using brackets to hold the PVC pipe in place. A barracks built three or four years ago, however, has not had the same problem even though the plumbing was cemented in place. The area was heated when the pipe was laid and cemented in place.

**Figure 3** Not allowing for thermal expansion or contraction may cause pipes to burst.

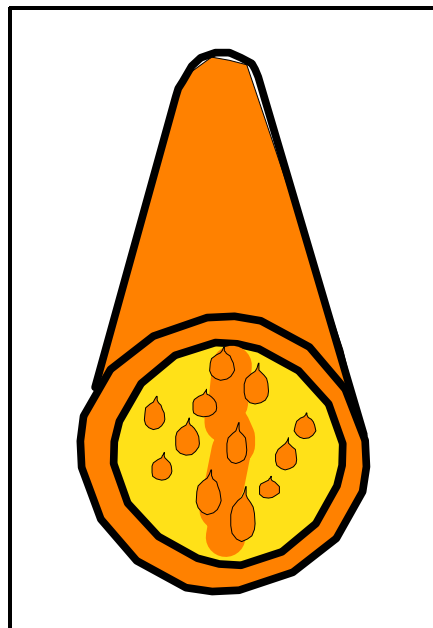
2. Several installations have tried using FRP condensate return lines with little success. The major problem with FRP lines is that if a steam trap should fail and allow steam into the pipeline, the pipes do not hold up (Figure 5). Steam destroys the polymer matrix of the pipe resin, leaving just the reinforcement in place. Army Corps of Engineers guidance requires the installation of a relief tank at each steam trap for FRP condensate return lines. Where the relief tank has been installed, no failures have been reported. Draft guidance (AR 420-consolidated)

**Figure 5**FRP condensate return lines do not hold up if a steam trap fails and allows steam in the pipeline.

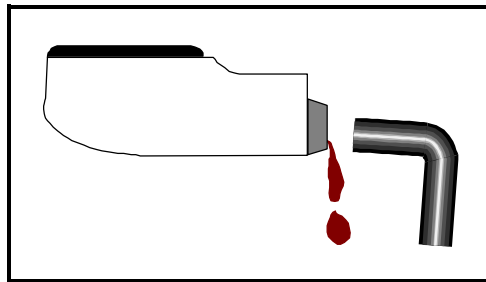
rear-discharge commodes installed during the renovations. The PVC drain lines sagged and pulled out from the commode flanges (Figure 6). Examples of poor workmanship identified in the renovations include no primer used during assembly, some pipe fittings not pushed on the pipes to their bottom, some joints dry with no cement in them, and insufficient pipe hangers used to secure the PVC drains in the walls. The installation replaced the PVC drains with cast iron pipe to avoid further problems in the upper stories. The contractor either had no knowledge of the basics of joining PVC pipe or was negligent in performing the work. Had the joints been properly assembled, they would not have failed, and the problem would never have occurred.

**Figure 6** Improperly joined PVC drain pipes pull away from wall flanges.

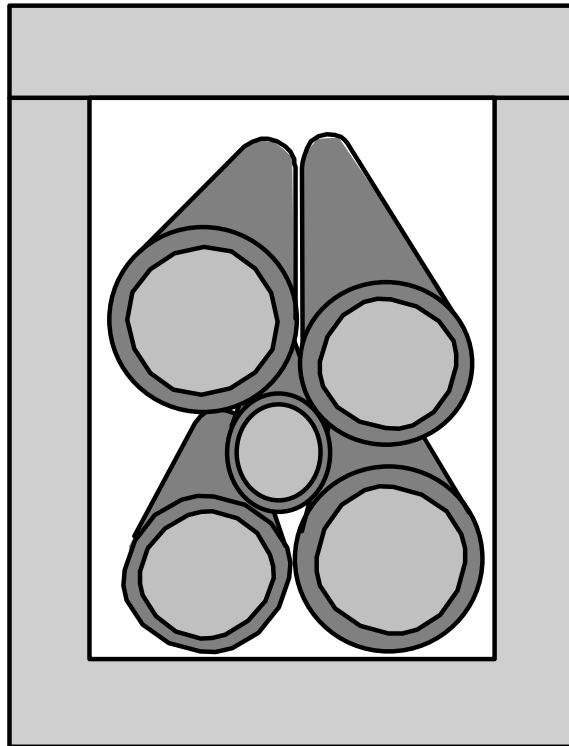
1. A common complaint about engineers by maintenance workers is that engineers do not design things so that they can be easily maintained. At one installation, several locations have the gas, water, electrical, and sewer lines all stacked on top of one another. If maintenance is required for one, the other pipelines are in danger of being damaged by the maintenance crew (Figure 7).

**Figure 7** Pipes stacked around each other are difficult to maintain without risk to other pipes.
