Naval Facilities Engineering Command

Lessons Learned from Design & Engineering of Naval Facilities

NAVFAC P-1010
October 1985

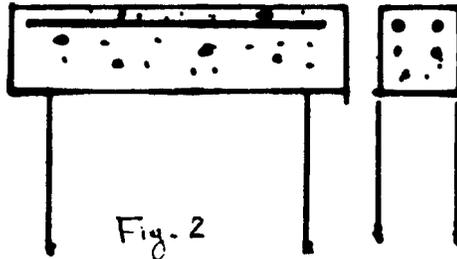
Fig. 2

Collection of Facts: This project involved a complex of multi-story apartment buildings with brick bearing walls, steel columns, beam and joists. A structural evaluation of the precast reinforced concrete lintels was made from the design drawings and they were found adequate to carry the design loads. During the investigation, it became obvious that the location of the reinforcement was unknown after the fabrication of the lintels. Therefore, a great number of lintels were placed over the openings with the reinforcement on the compression side of the lintel (The top of the lintel. See Fig.2). This was verified by removing a number of lintels and exposing their reinforcement. Removing the cracked lintels and replacing them with new lintels was a costly process since it was necessary to remove and replace part of the already constructed brick wall over the lintels.

Solution: Use top and bottom reinforcement in precast concrete lintels to eliminate the possibility of misplacement. See Figure 3.

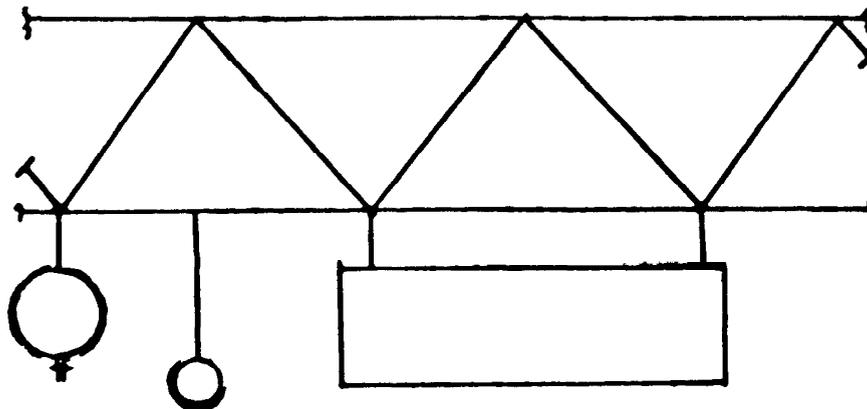
Fig. 4

Symptoms: A visual inspection showed excessive deflection of the roof trusses with indications of cracks and torsion at the bottom elements of the trusses. Measurements taken indicated deflections in excess of 2 inches.

Collection of Facts: A storage building located at NAS Patuxent River was designed with steel columns and roof trusses. A structural analysis was performed based on the original loading conditions. Stresses and deflections were found to be within allowable limits. Results of a material survey indicated that the trusses were maintained properly without evidence of corrosion or any other type of material deterioration. During the site survey it was found that various sizes of piping from 1 inch to 6 inches in diameter and heavy air conditioning units were supported by bottom elements of the truss (see Fig. 4). This additional loading was imposed on the trusses in various times after the original construction. A new structural analysis which included the additional loading substantiated the cause of distress.

Solution: To correct this situation, it was recommended that the additional loading be immediately removed from the bottom of the trusses. Secondly, a repair procedure was initiated to eliminate the imposed deflection and repair the damaged members. A very useful lesson to be learned from this case is to compare the original loading conditions with the existing conditions during the structural investigation. In many projects, alterations are made during the initial stages of construction which are not followed by preparation of as-built drawings. In these cases, a structural analysis based on original drawings and loading conditions will result in erroneous findings.

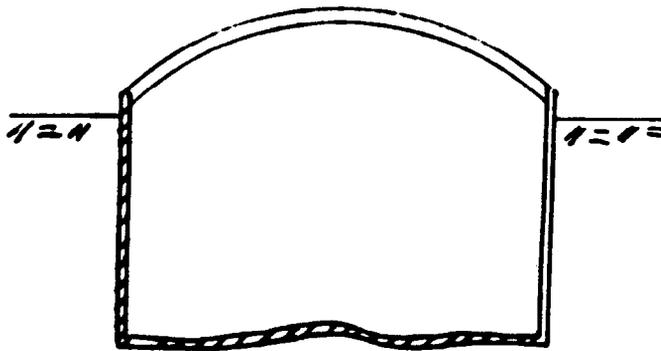
Fig. 1

Symptoms: Upon completion of the project and before filling with fuel, the steel bottom plates buckled and warped (See Fig. 1). Cracking also occurred in several areas of the steel plates.

Collection of Facts: Upon inspection of the site, it was apparent that an upwards force had caused the failure. A geotechnical evaluation revealed a water table close to the ground elevation. However, the tank was designed without consideration of the uplift force due to hydrostatic head. Therefore, no provisions for anchorage of the bottom were made.

Solution: One of the most critical loading conditions of any structure below the water line is hydrostatic pressure. This pressure is applied on the side of the structure as well as upwards on the bottom. Various solutions were taken into consideration. The basic elements included gravity weight and an anchoring system to counteract the uplift and a method to repair the buckled plate. The most cost effective and reasonable solution was to provide a concrete slab anchored to the bottom of the tank (See Fig. 2).

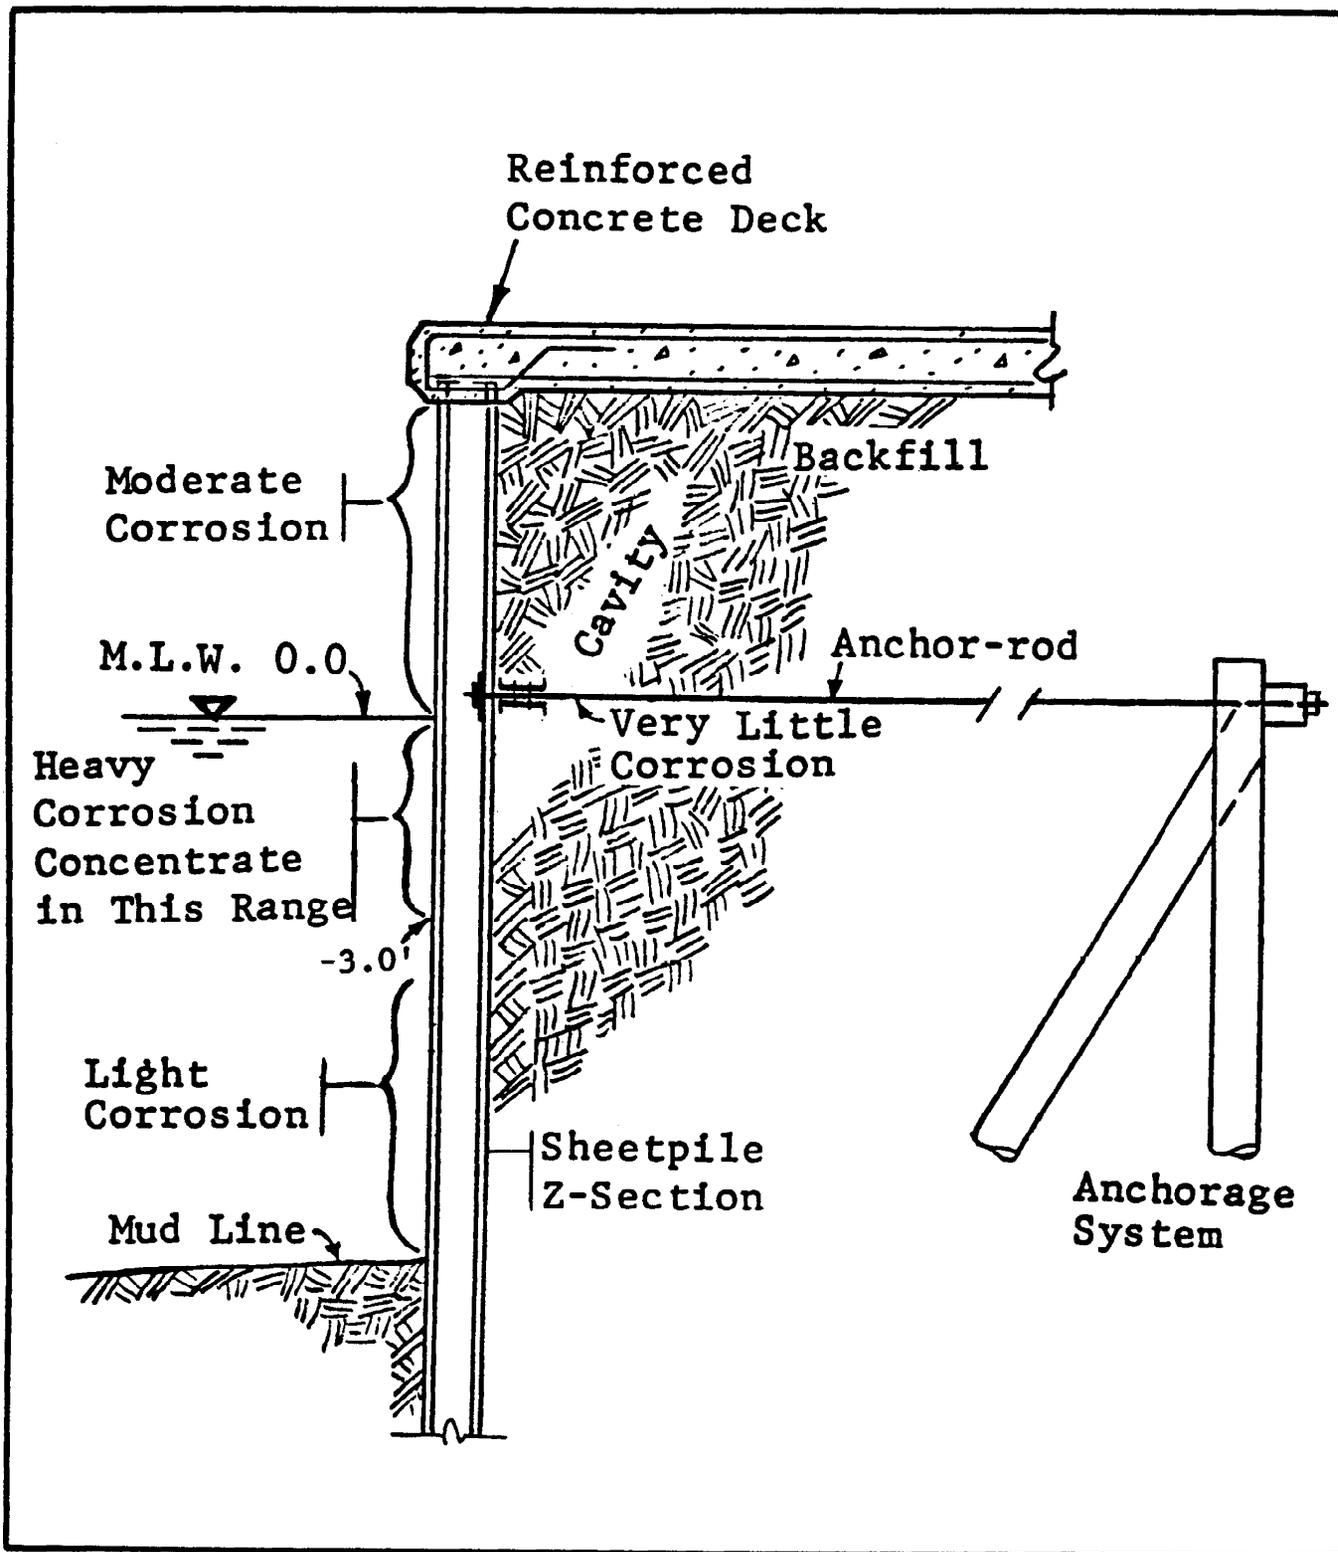
Fig. 2. Anchored Bulkhead After 25 Years in Service (Ref. 3)

If an anchored bulkhead has corroded after many years of service, but is structurally stable and field inspection revealed that the anchorage system is in good condition, then a cost effective replacement method may be adopted using the above method. The new sheetpile need not be installed deeper than the existing sheetpile unless dredging in front of the new wall is needed.

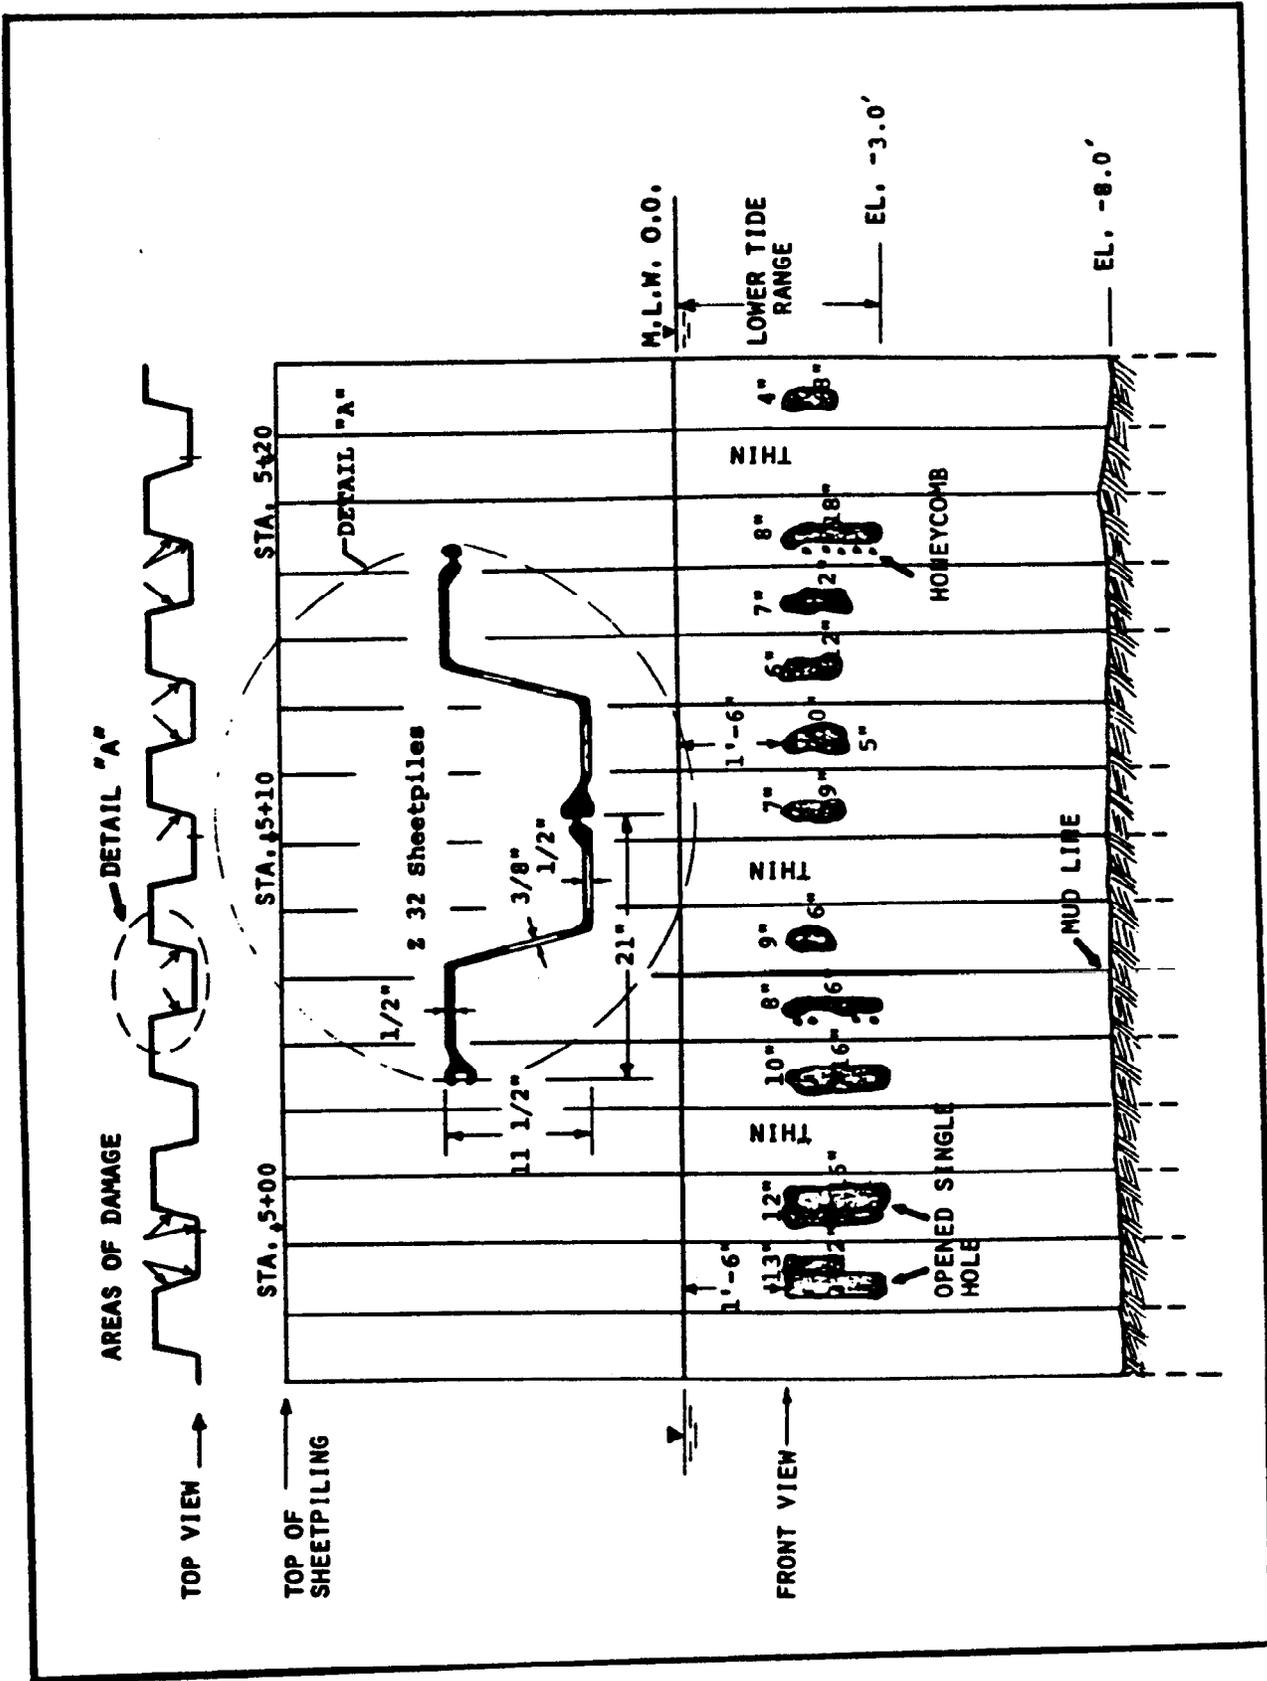
Fig. 3. Sheetpile Corrosion After 28 Years in Service (Ref. 3)

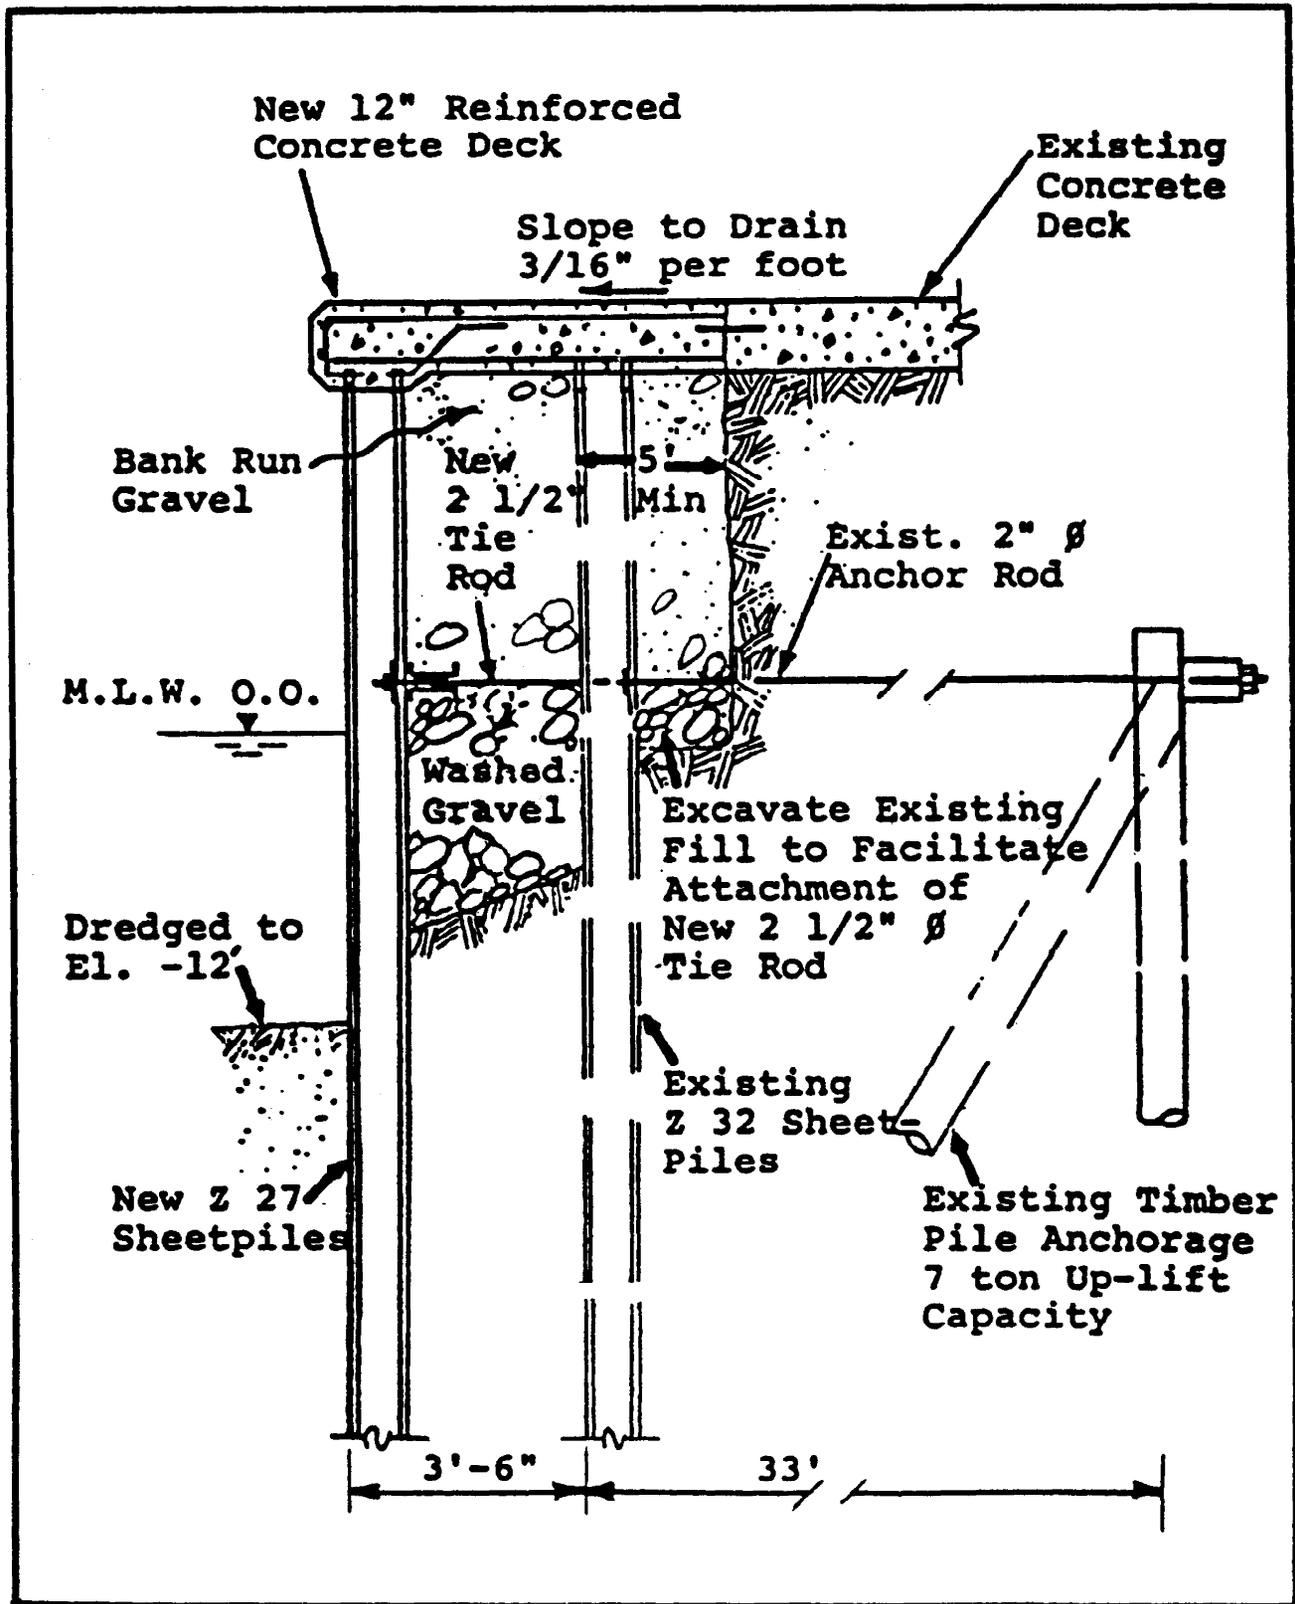
Fig. 4. Bulkhead Replacement, U. S. Naval Station Annapolis, Maryland (Ref. 3)

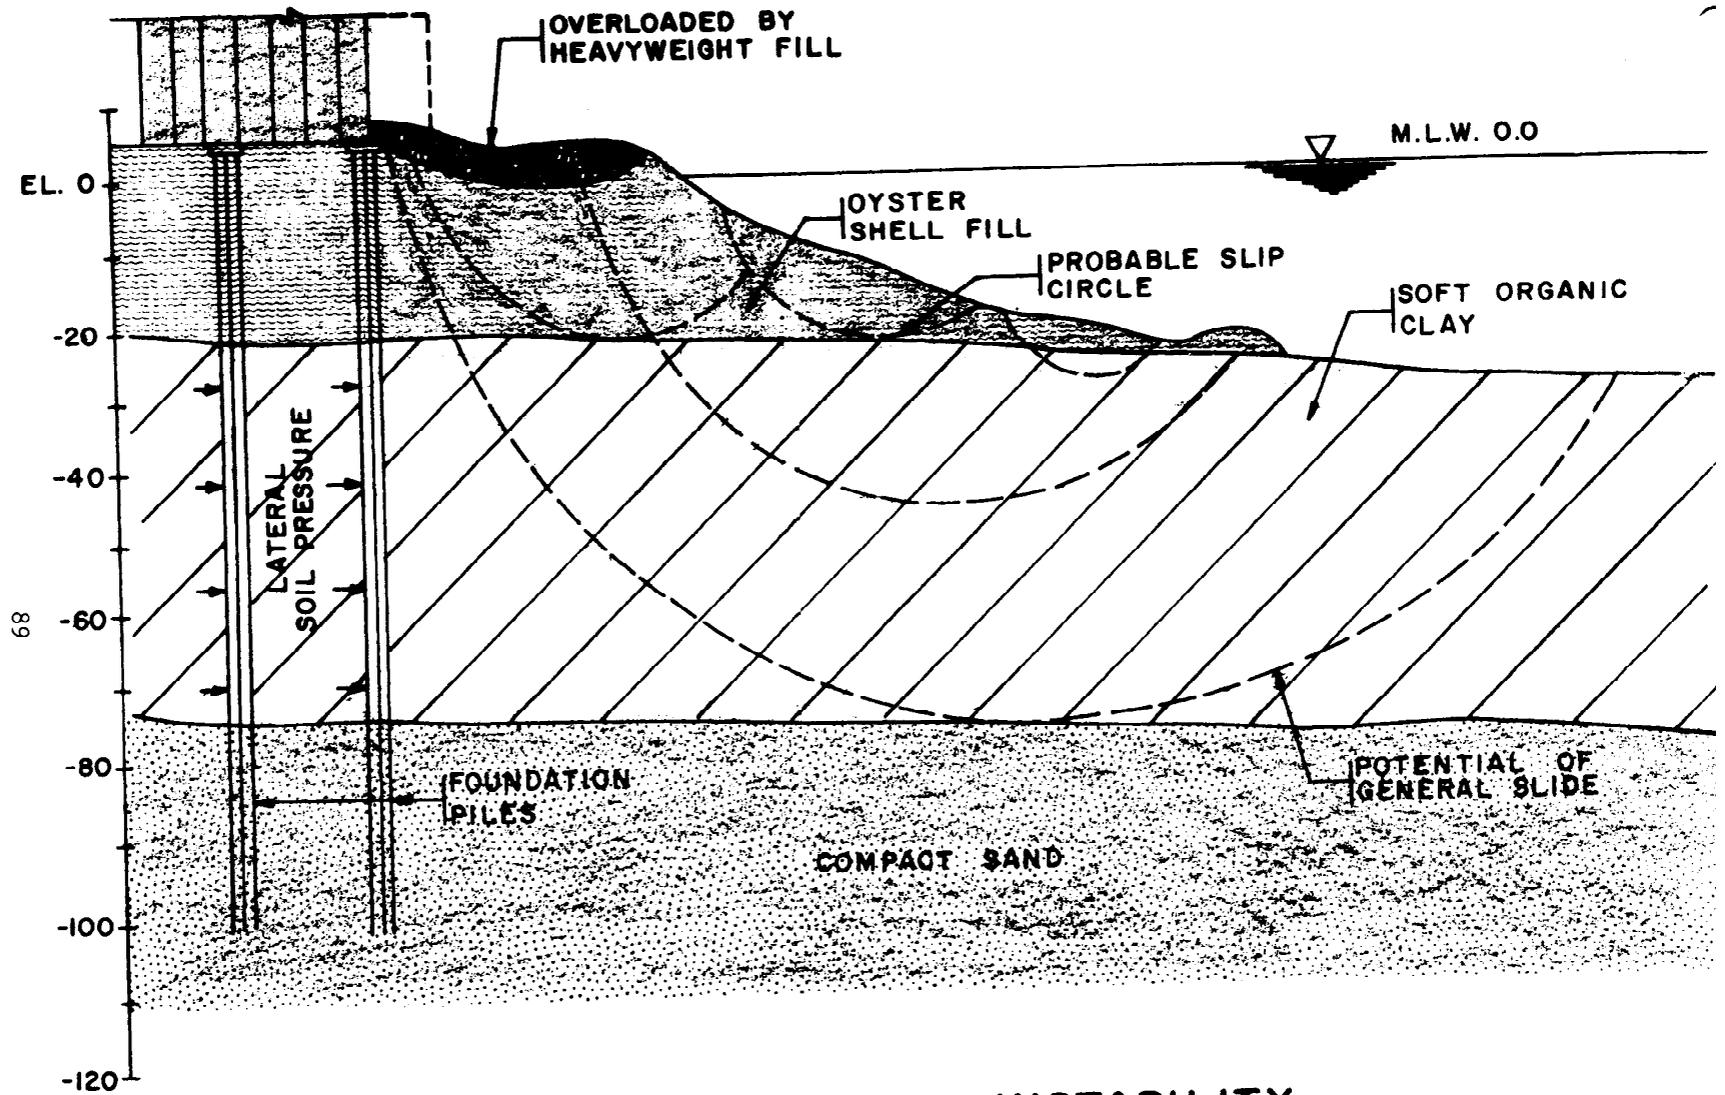
Fig. 1

**POTENTIAL OF INSTABILITY
WITH EXISTING SITE CONDITIONS**

The main landfill stabilization work was essentially complete in March 1977. The stabilization method used in this project has, so far, proven successful. The progressive lateral movement of the fill toward the creek has been arrested. The danger of such movement, which occurred particularly to the library building, has been eliminated. The landfill area has been restored as a fire vehicle access route and as an aesthetically pleasant site conforming to the surroundings of the Naval Academy environment.

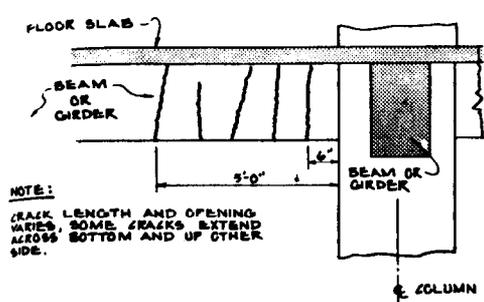
Fig. 1

Collection of Facts: Observation of the cracks indicated that the cracks on the beams were generated by reversal of stress - Fig. 1. The cracks in columns were caused by lack of pile support which resulted in the adjacent framing supporting the column instead of the column supporting the structure with the lower column and pile caps creating a tension load - Fig. 2.

Exploratory pits were opened to check the timber piles and concrete pile caps. The timber piles under the structural members which had experienced cracks were found deteriorated and in some cases the upper portion was completely decayed. After an extensive exploration at various locations of the piles, the problem area was isolated. A large diameter sewer pipe runs along the deteriorated piles. The leakage from and infiltration to the pipe was the apparent cause of the deterioration.

Solution: Possible causes of reinforced concrete beam and column cracking are overloading, underdesign, material deterioration and poor quality of materials. In addition, such in the above case, investigators should check for foundation settlement, pile deterioration and failure in caps.

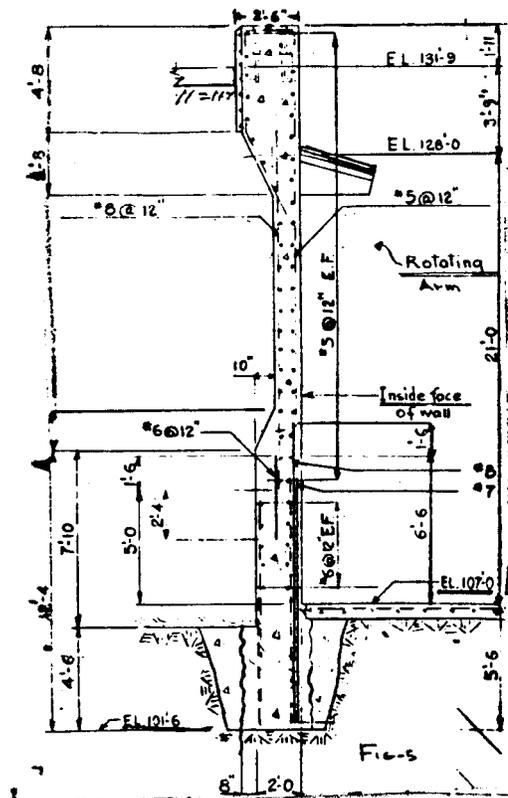
Collection of Facts: The experts review of the collapse concluded that the contractor had selected forms based on experience and intuition rather than on structural computations. The concrete was completely disintegrated and the reinforcing steel misplaced. The cost of replacement of the damaged part of the wall was approximately \$500K.

Solution: Forms are very important elements of a structural system. As such, they must be analyzed and designed appropriately to withstand to predetermined loads and carry the stresses given by various codes. Therefore, they must be approved by a professional engineer as the rest of the structural system.
