ENTRY CONTROL FACILITY /ACCESS CONTROL POINT

LIGHTING ANALYSIS

INTRODUCTION

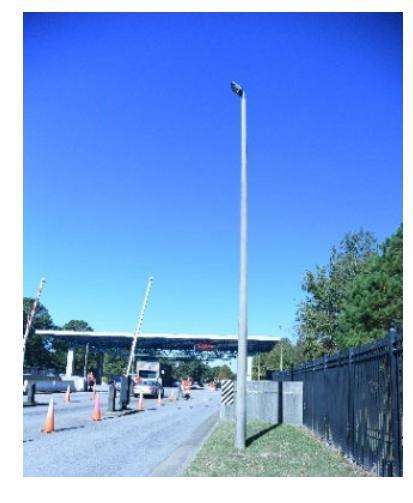
Figure 2 – Approach Zone Lighting

The Oceana Main Gate approach zone is lighted with tilted LED roadway luminaires positioned like floodlights, see Figure 2. This tilting does not meet the UFC 3-530-01 criteria for "no uplight (U0 rating)". The UFC 3-530-01 criteria requires fully shielded luminaires mounted in the horizontal plane to reduce glare. These tilted roadway luminaires will produce glare to the surrounding areas and potentially to approaching drivers and Security Personnel. Each luminaire has a motion sensor mounted at the bottom of each light. Their operational effectiveness is unknown.

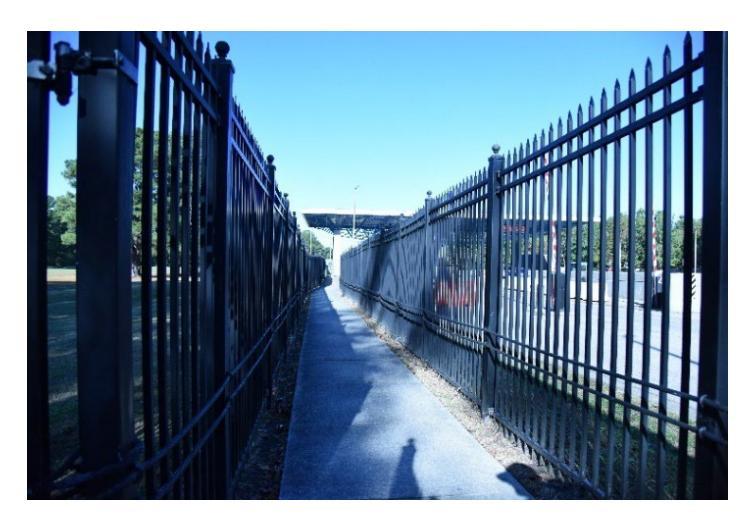
Figure 3 – Narrow and Unlit Pedestrian Path

There is a narrow pedestrian path leading to the Main Gate that is not lighted, see Figure 3. The boundary fences are dark having very low contrast between a possible intruder and background.

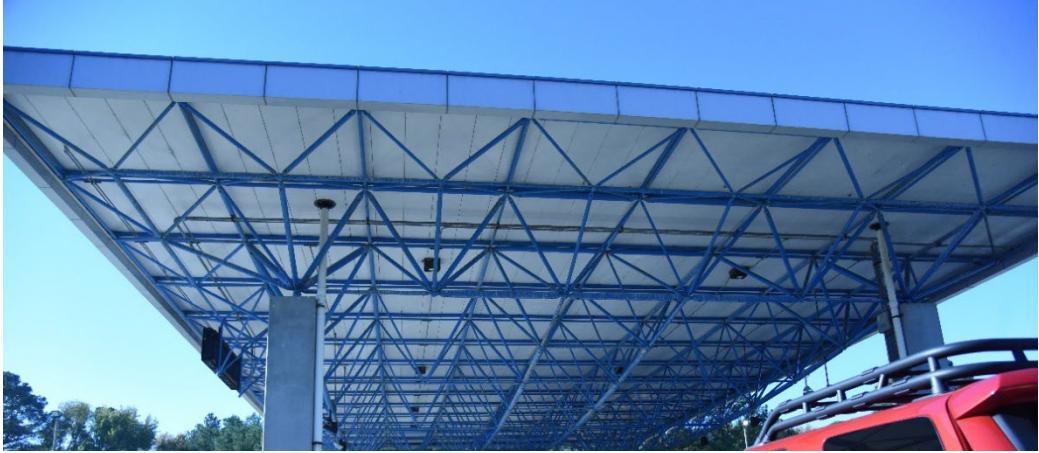
Figure 4 - Under Canopy Lighting

Underneath the canopy, there appears to be too few luminaires, see Figure 4. There are a few ceiling wash floodlights around the perimeter, and sparsely located retrofit downlights. Since all the luminaires are retrofit, lighting levels and uniformity should be verified.

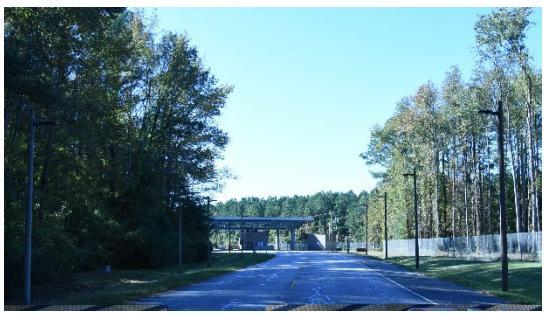
Figure 5 – Approach Lighting

The approach lighting is utilizing standard roadway luminaires with no uplight, which meets the UFC 3-530-01 criteria, see Figure 5.

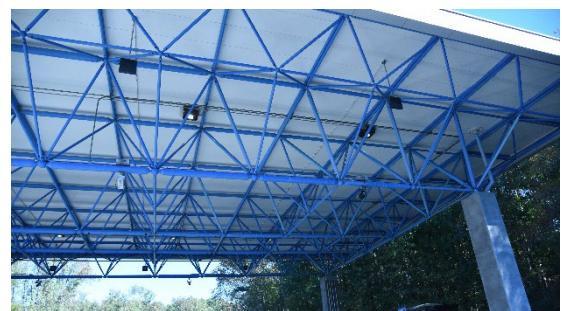
Figure 6 – Under canopy lighting

Underneath the canopy, there may not be enough luminaires to meet the under-canopy lighting UFC 3-530-01 criteria of 10 footcandle (fc) minimum, see Figure 6. All the luminaires are retrofitted so lighting levels and uniformity should be verified. The canopy luminaires are illuminated during the day, indicating photocell failure.

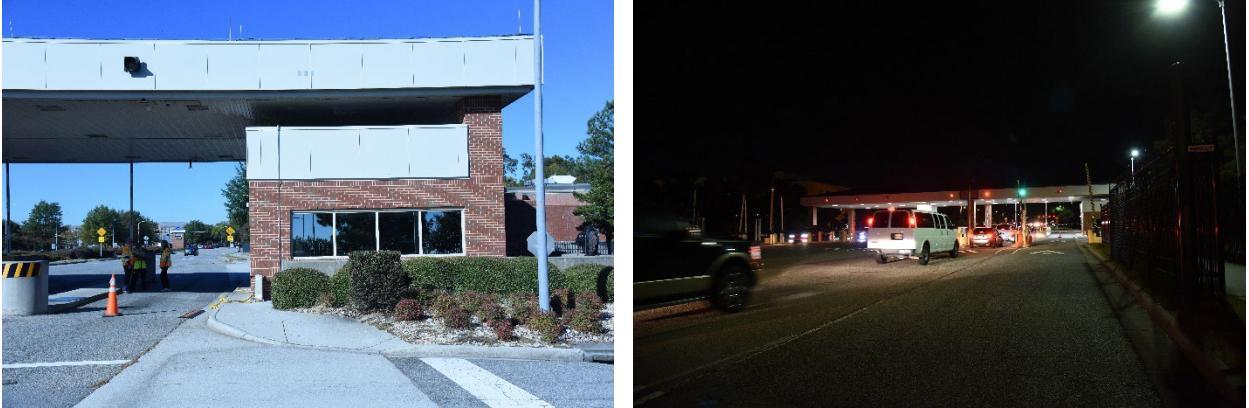
Figure 7 – Gate 2, Day and Night* *Actual conditions appeared brighter than shown in image

NAVSTA Gate 2 has a short approach and a nearby traffic signal. See Figure 7 for day and nighttime photos. There are four light poles with 4000K and 5000K CCT LED luminaire heads in the Approach Zone. The LED luminaires appeared to have been replaced several years ago because they were an older style LED luminaire. The exact date of installation is unknown. One of the four light poles was not operational at night.

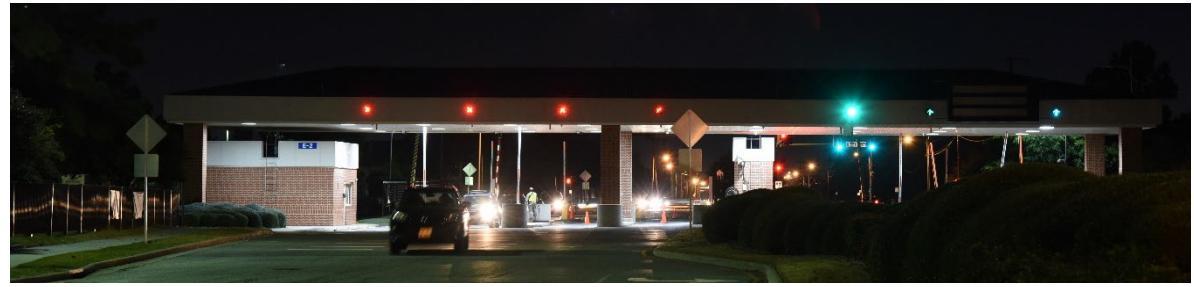
The Canopy has recessed, flat lensed, downlights retrofitted with LED replacement lamps. Current UFC 3-530-01 guidelines prohibit LED replacement lamps; therefore, the lighting in the canopy does not meet current criteria. These luminaires only provide downward-directed light and provide very little light on the underside of the canopy, see Figure 8.

Figure 8* - View of Gate 2 canopy *Actual conditions appeared brighter than shown in image

- Canopy luminaires were upgraded to LED light sources by direct bulb replacement instead of luminaire replacement, which is not allowed per current UFC 3-530-01 criteria.

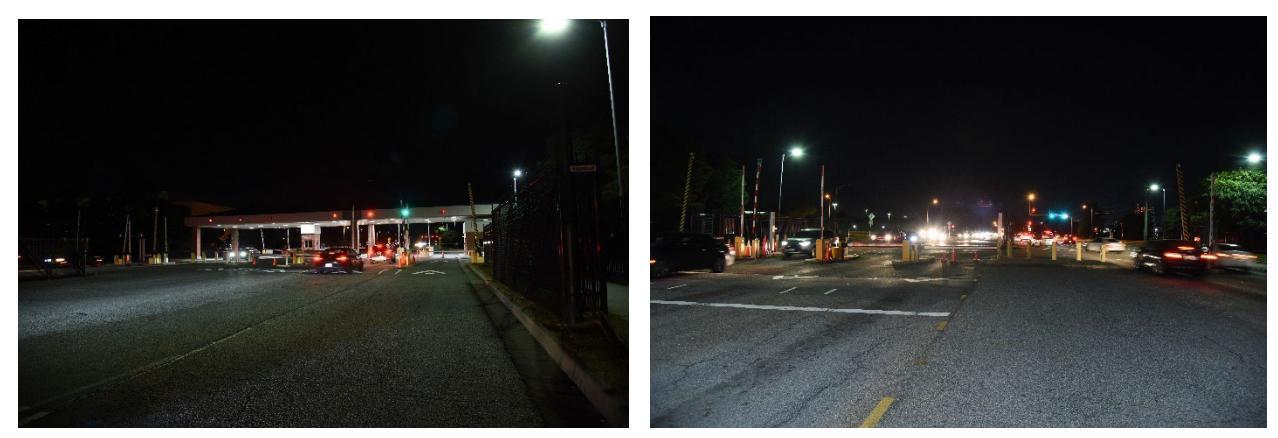
Figure 9* – Gate 2 Approach at night as viewed from approaching vehicles (left) and as viewed from the canopy (right) *Actual conditions appeared brighter than shown in image

- Approach Zone lighting does not meet current UFC 3-530-01 criteria of 1 fc minimum and is insufficient for both drivers and Security Personnel. See Table 2 for list of measured illuminance levels in Approach Zones.

- Due to the low light levels in the Approach Zone, headlights appear particularly glary, further reducing visibility and Security Personnel's capability to assess threats in Approach Zone.

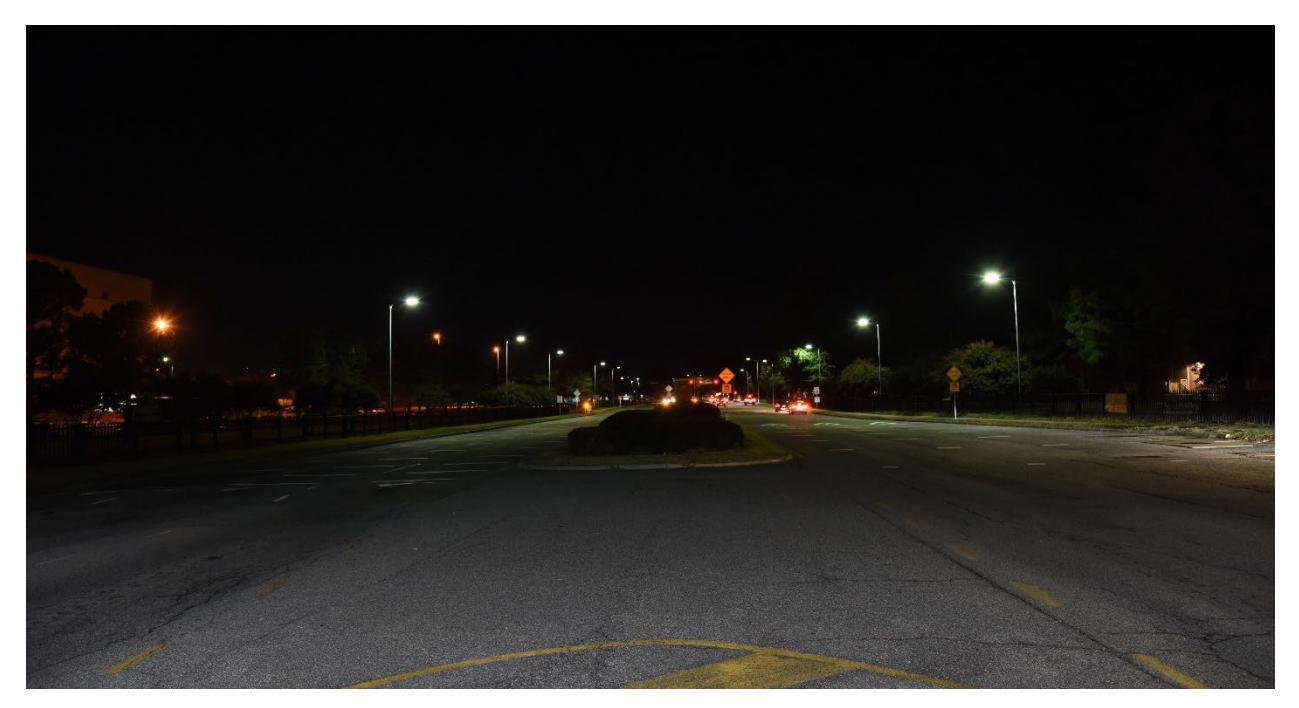
Gate 2 lighting design does not consider transitional lighting. Light levels directly outside of the canopy quickly drop off, which do not allow for the Security Personnel to visually adapt to darker surrounding conditions. The Response Zone at Gate 2 is an example of this condition, see Figure 10.

Figure 10* – View of Gate 2 Response Zone *Actual conditions appeared brighter than shown in image

- Response Zone lighting is insufficient and does not meet current UFC 3-530-01 criteria of 1 fc minimum, see Table 2 for measured illuminance levels in Response Zone.

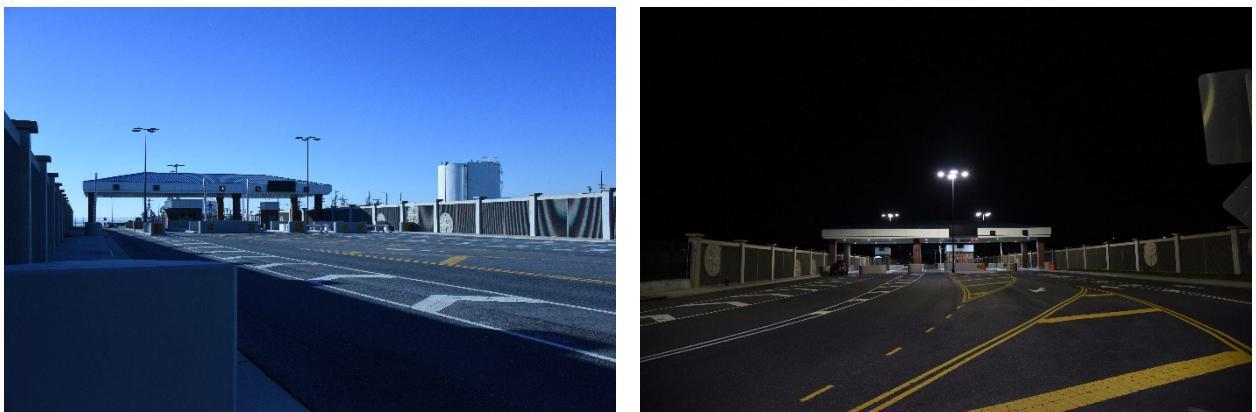
Figure 11 - Approach to Gate 6, Day and Night

NAVSTA Gate 6 has a long approach with median-mounted luminaires on mid-mast poles, see Figure 11. Each pole has four luminaires, 4100K CCT LED, with a very high lumen output of 38,000 lumens per luminaire.

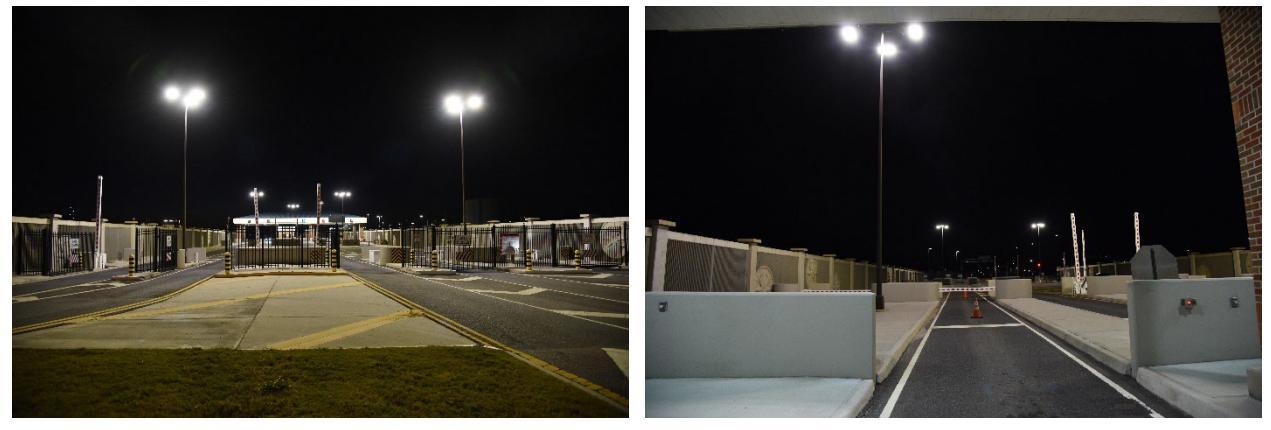
There are also several mid-mast poles in the Response Zone, see Figure 12. As the Response Zone continues away from the Access Control Zone, the quantity of luminaires on each pole transitions from four luminaires per pole to two luminaires per pole.

Figure 12 - Gate 6 Approach at night as viewed from approaching vehicles (left) and as viewed from the canopy (right)

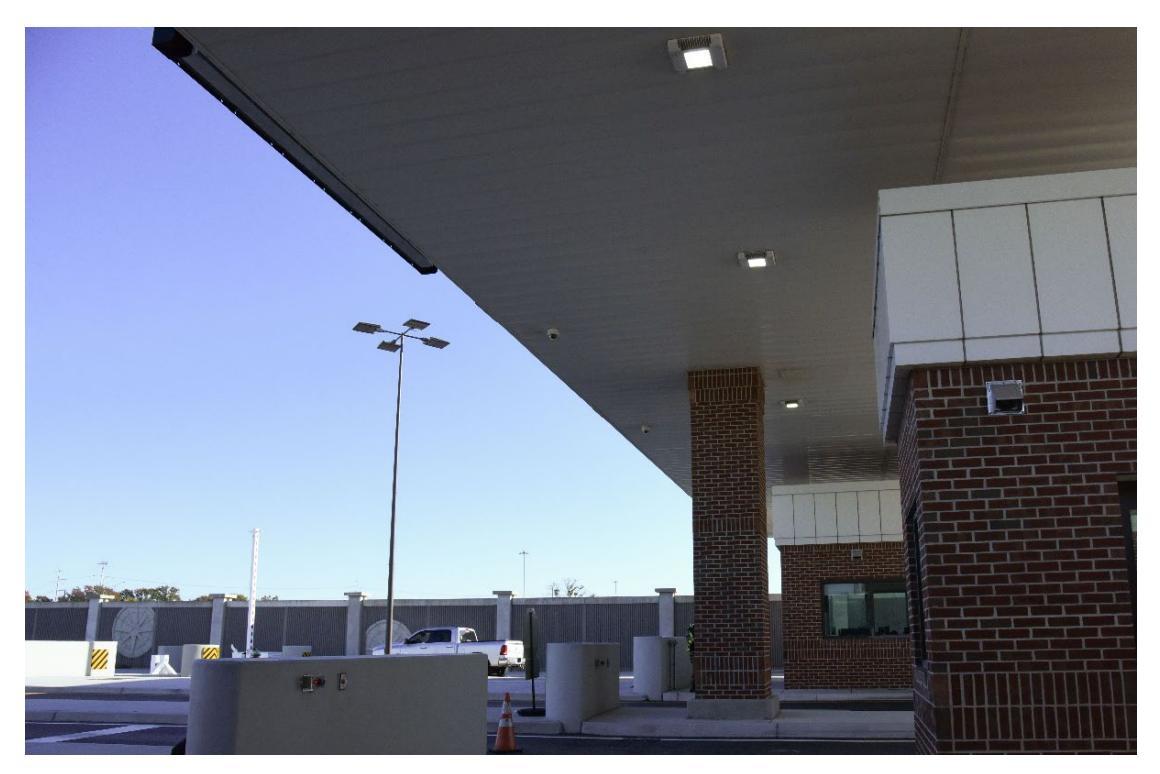
Underneath the canopy, there are 16 semi-recessed LED luminaires, see Figure 13. In addition, the photocells have failed, and the lights are on 24/7. These luminaires only provide downward-directed light and provide very little light on the underside of the canopy.

Figure 13 - Canopy luminaires do not provide any indirect light on underside of canopy

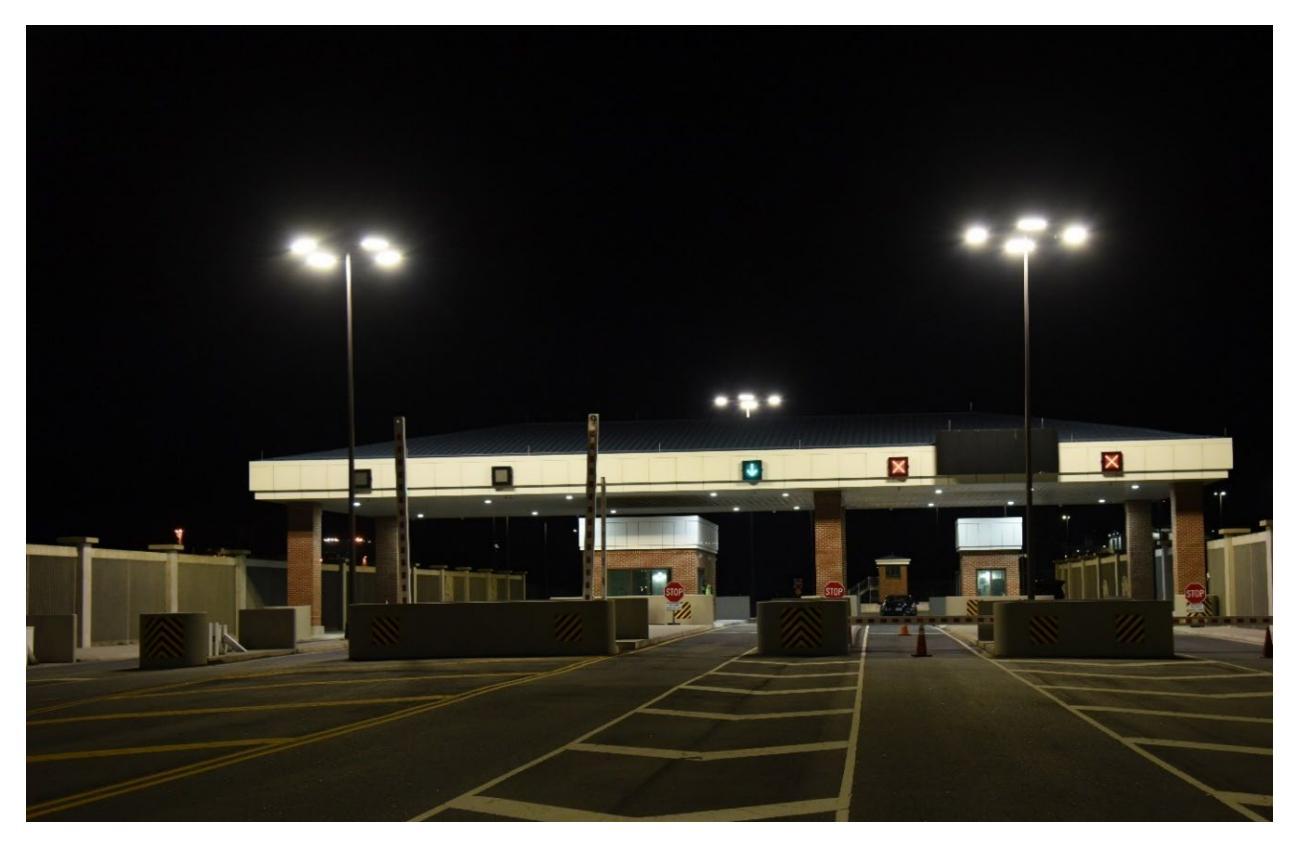
Light levels underneath the canopy are sufficient for ID check, but too high in adjacent areas, such as the Access Control Zone, see Table 3. The result is wasted energy and adaptation concerns. Placement of luminaires contributes to the problem since they are not placed in relationship with the tasks below. The canopy luminaires are downlight only, which makes the underside of the canopy appear dark. This effect creates a stark contrast between the canopy surface and the luminaires, causing eye adaptation issues and discomfort glare.

Figure 14 – Gate 6 canopy as viewed from the Approach Zone

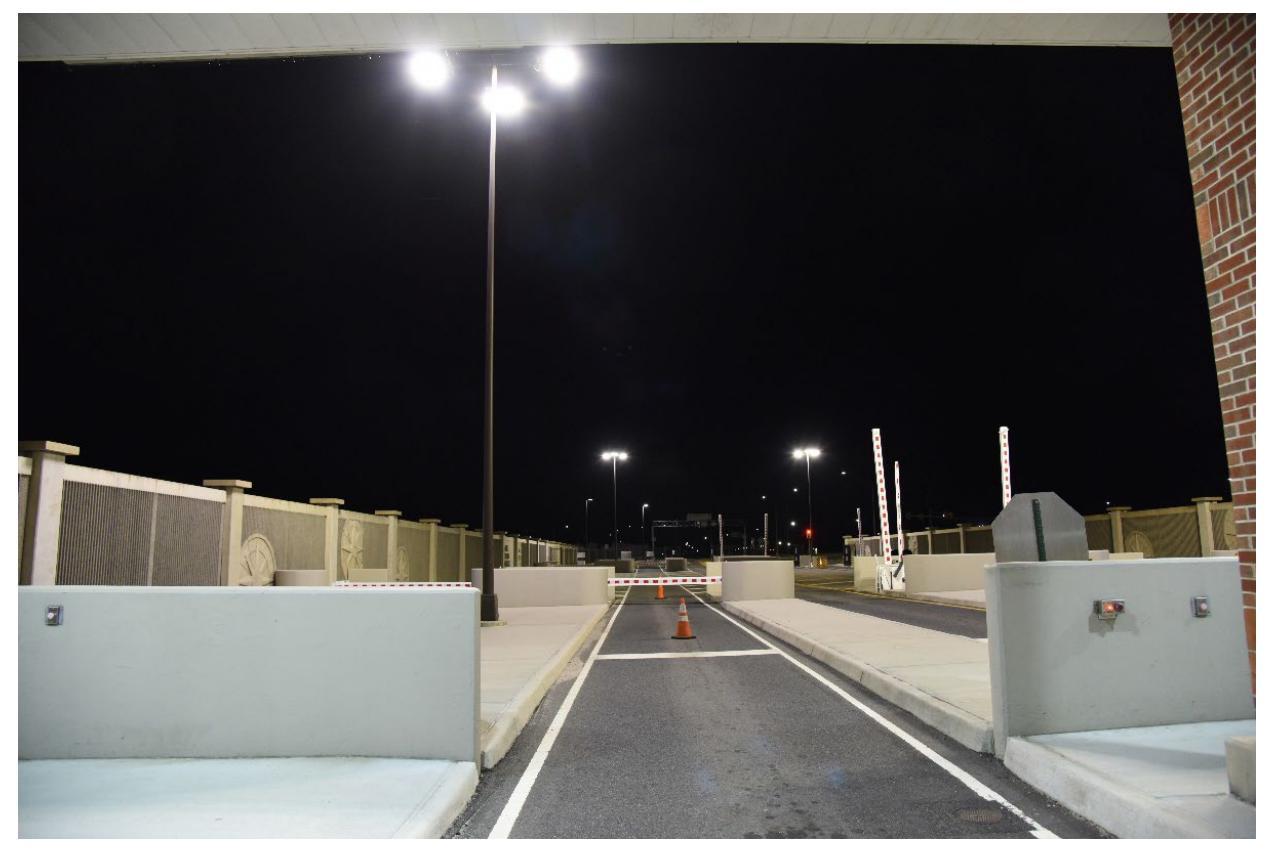
There is discomfort and disability glare among the Security Personnel on duty at the time of evaluation. The disability glare is due to a few factors. First, placement of high mast lighting is too close to the canopy, see Figures 14 and 15. Second, the high lumen output luminaire appears to have a high glare rating, which is not recommended for this type of lighting installation. The maximum glare rating is G2, according to the current UFC 3-530-01 criteria. Last, the pole height of the high mast luminaires is too low. The pole height used for a high glare, high lumen output luminaire should be greater than 40' in height to avoid visual discomfort.

Figure 15 – High glare luminaires directly in front of Security Personnel location in Access Control Zone

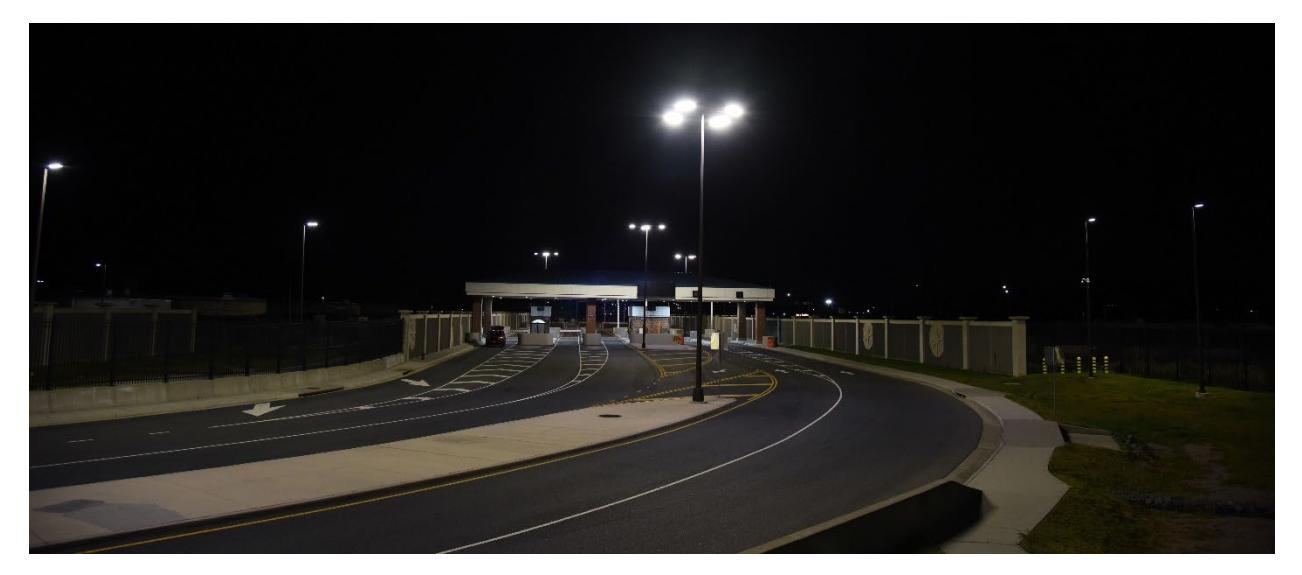
Gate 6 was designed using the most recently published UFC 3-530-01, but the resulting design has much higher light levels in most locations, see Figure 16. If calculations were performed using a low Light Loss Factor (LLF), such as 0.7 or lower, the design will be well above criteria for the first several years of operation. Additionally, the canopy was designed with a minimum of 10 fc, which results in a maximum illuminance of 40 fc. This requires a higher light level outside of the canopy to provide sufficient visual adaptation.

Figure 16 – Gate 6 Response Zone as viewed from the Overwatch Position

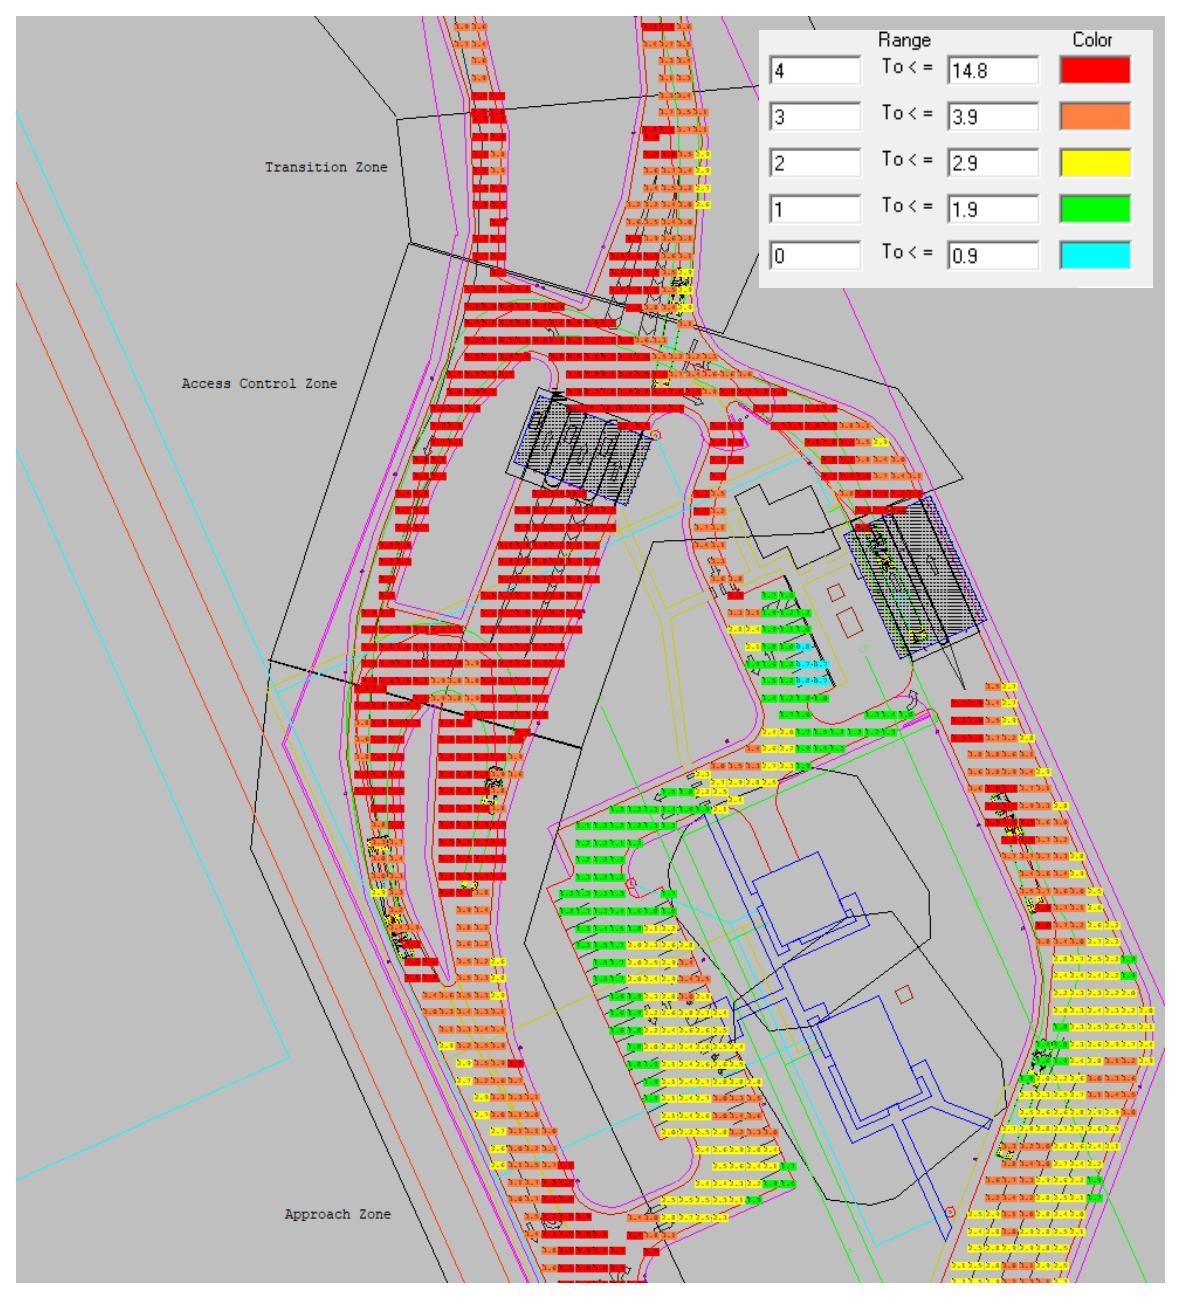
This design uses an LLF of 0.7, see Table 4. In the practice of lighting design, using an LLF of 0.7 for LEDs will result in an installation that is too bright with too much glare compared to the surrounding context. While LED's dim over time, designing to 70% of lumen output does not make sense for LED technology. For example, the metal halide lamp is rated at a 0.83 LLF, and their lamp life degrades at a much faster pace than an LED.

The Backlight, Uplight, and Glare (BUG) ratings for each luminaire are listed in Table 4. This design uses a high lumen output luminaire for the roadway and area lights with a high Glare rating of G5. UFC 3-530-01 limits the Glare rating to be a G2, meaning this design does not meet criteria. The high G rating will cause discomfort or even disability glare for both drivers and Security Personnel. The result will impede visibility because the visual environment will appear

Figure 17 – Gate A Overall Photometric Plan. Values shown in footcandles

However, the glare rating of the luminaires is a G5, which does not meet current UFC 3-530-01 criteria. The luminaire will cause disability glare and the Security Personnel may have difficulties viewing vehicles entering the Access Control Zone. Coupled with a 0.7 LLF, the lighting in the ECF area may be initially too bright compared to the adjacent roadway, which can produce vision impairment in the Approach Zone for drivers.

It is common design practice to use an LLF of 0.8 for LEDs. This LLF captures a Luminaire Dirt Depreciation (LDD) of 0.9 – 0.95 based off an average LDD given in the IES Handbook, 10th Edition. This value also includes a Lamp Lumen Depreciation (LLD) factor of 0.9, which for many LED light sources, will capture the first 10 years of use. While LED technology is often touted to last for 20+ years, it is not realistic to assume that luminaires will remain untouched for that long. Driver failure, individual diode failure, and changes in space use, etc. are all very likely to occur within a 20-year window.
