SUBJECT: **Engineering Technical Letter (ETL) 02-7: Preventing Concrete Deterioration Under B-1 and F/A-18 Aircraft**

1. Purpose. This ETL details the results of several strategies to mitigate concrete deterioration under B-1 Lancer and F/A-18 Hornet aircraft auxiliary power unit (APU) exhaust ports.

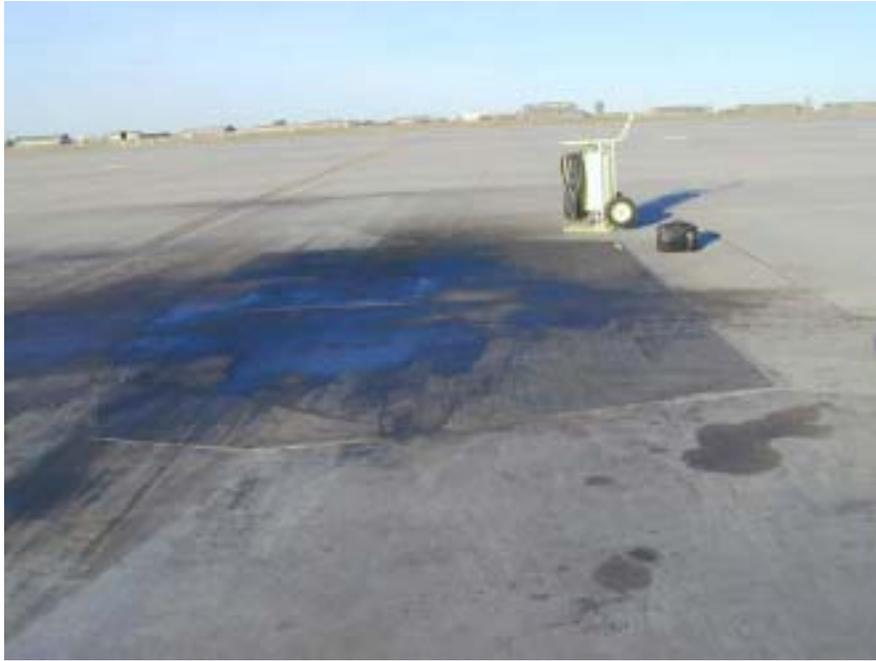
Figure A1.1. Pad B11 Soaked with Hydraulic and Turbine Fluid

A1.1.3. A detailed inspection of the pads was conducted In November 2000. The overall condition of the E-Krete™ was described as “fair.” Approximately 10 to 15 percent of the E-Krete™ surface had delaminated, with severe staining from aircraft fluid. In pads B10 and B12 the E-Krete™ had turned rubbery. This rubbery condition is due to swelling of the polymer within E-Krete™ by JTF. The condition of the E-Krete™ on pad B11 (Figure A1.1) was better than on pads B10 (Figure A1.2) and B12, but some rubbery areas were noted. Despite this condition, the E-Krete™ prevented the aircraft fluids from causing serious damage to the underlying concrete substrate. Given that concrete replacement under the B-1 aircraft generally occurs every two years, the performance of the E-Krete™ coating was considered successful. Delamination of the E-Krete™ occurred from poor adhesion due to existing aircraft fluids already present on

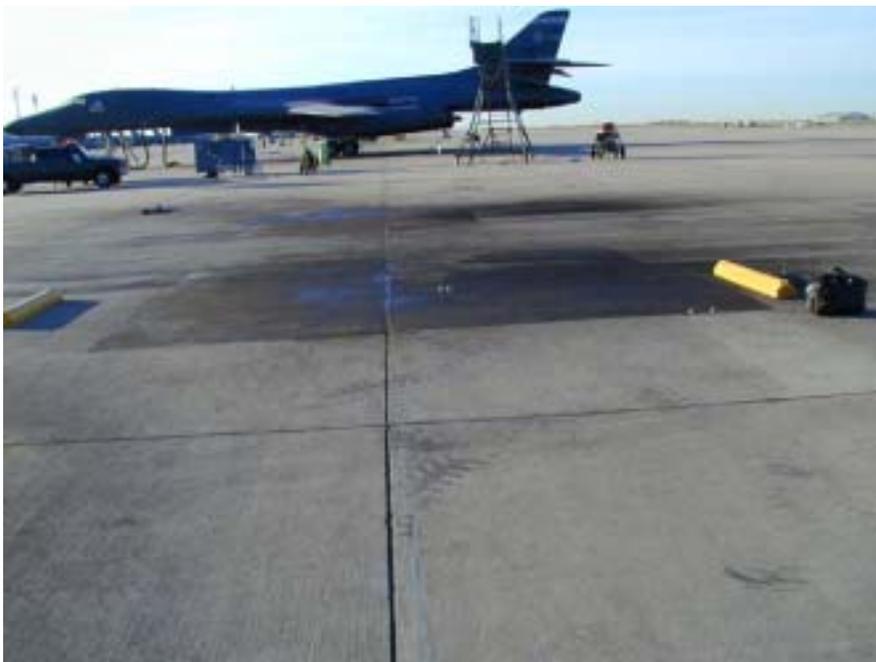
Figure A1.2. Pad B10 Soaked with Hydraulic and Turbine Fluid

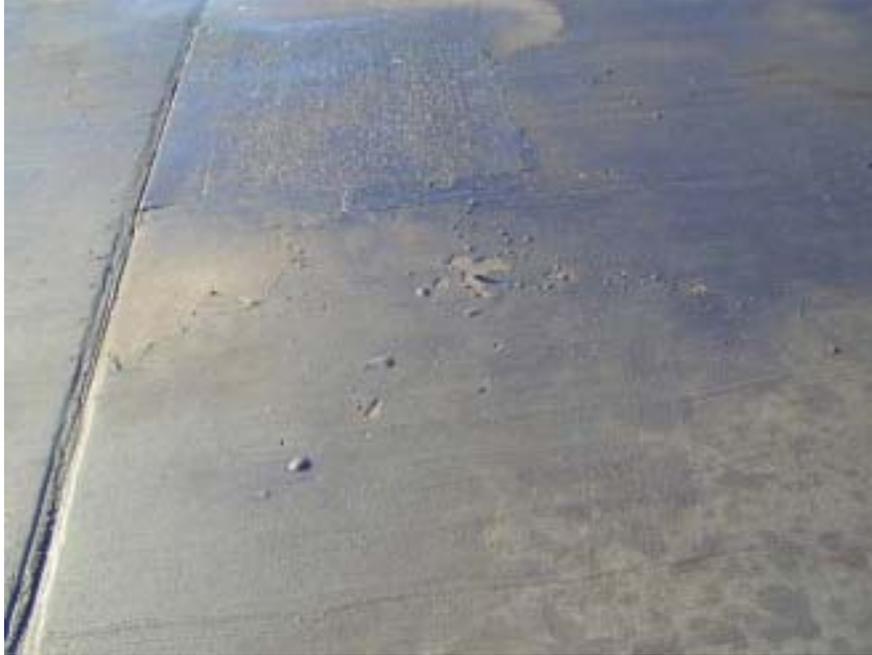
Figure A1.3. Pad B11 Joint, Showing Delamination and Blistering

the concrete and proceeded from the joints towards the center of the concrete slab (Figure A1.3). Further use of the E-Krete™ product is planned at McConnell AFB in 2002.

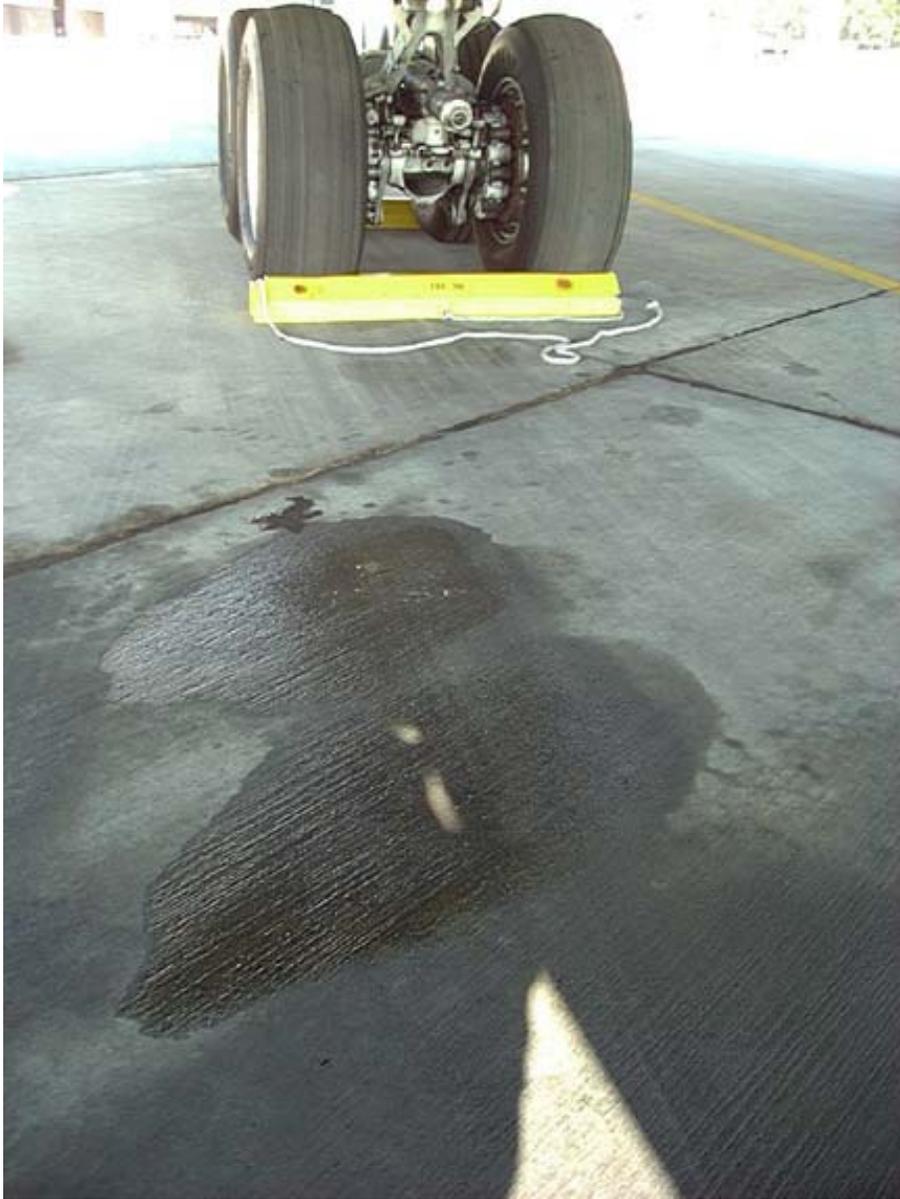
Figure A1.4. Typical Spot Staining

A1.2.1. B-1 Spots. The B-1 aircraft had been parked on this area for eleven months (since September 2000). Most “spots,” as they are referred to at Robins AFB, were in excellent condition; very little cracking was observed. The joint sealants were swollen but appeared to be holding up well, and was reported to be Federal Specification (FS) SS-S-1614, *Sealants, Joint, Jet-Fuel Resistant, Hot-Applied*. Hydraulic fluid was easily spotted due to its red color; JTF and lubricating oils appeared as amber-gold or brown. Leaking JTF under the engines/APU was also apparent (Figure A1.4). There were two different types of concrete in use and one concrete surface treatment: PCC with Georgia limestone aggregate; PCC with Iron Mountain traprock from Missouri; and PCC with Georgia limestone aggregate with Surtreat[®] concrete sealer. No deterioration was noted other than some minor shrinkage cracking (Figure A1.5).

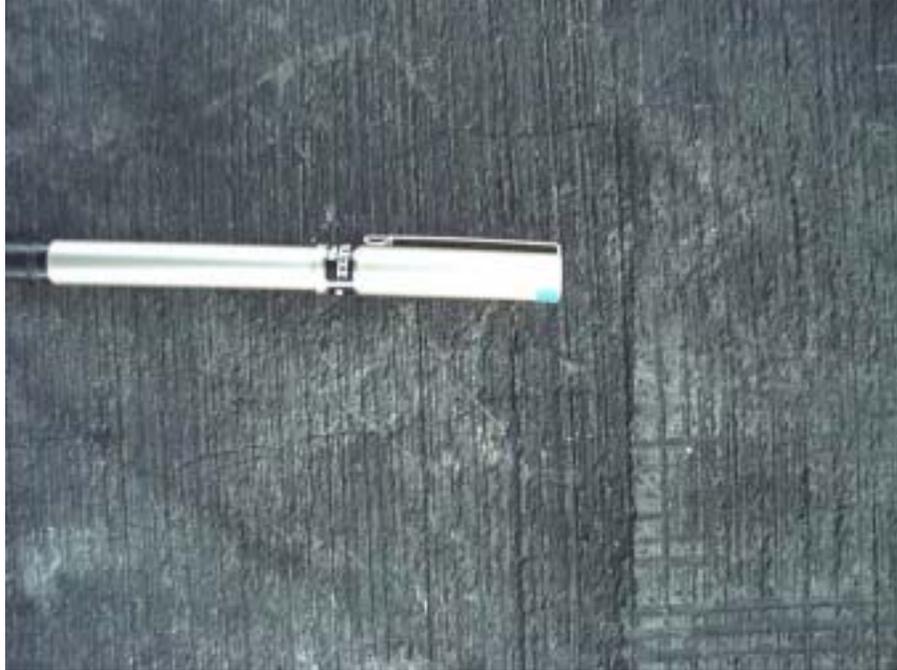
Figure A1.5. Spot 2 Shrinkage Cracks

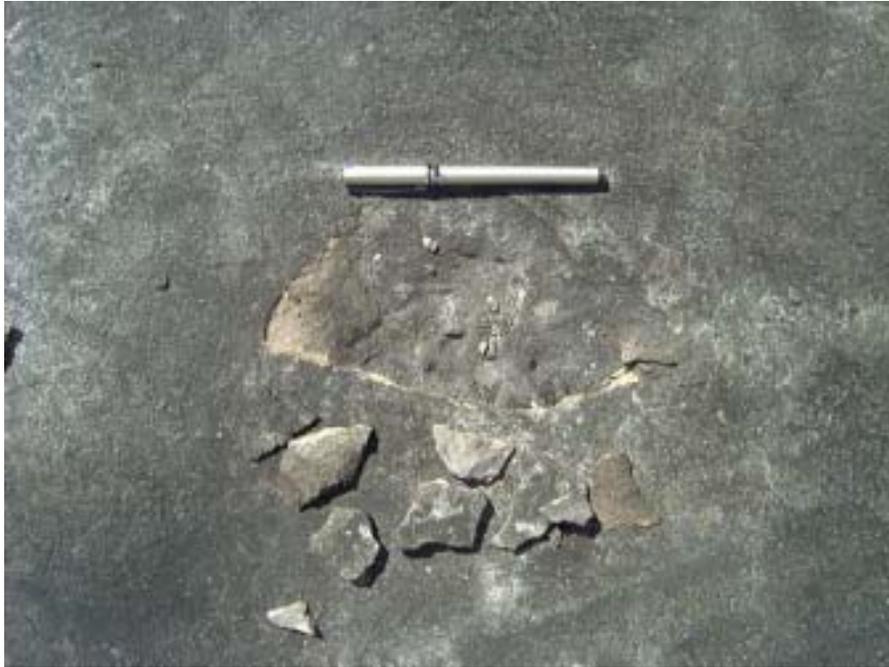
Figure A1.6. Close-up View of Scaling at Old Alert Apron

A1.2.2. Christmas Tree (Old Alert Apron). B-1 aircraft were parked on this apron, composed of 50-year-old concrete, for approximately two years. Some surface cracking in the old concrete was observed but most of the concrete slabs appeared structurally sound. The old concrete had a mottled, moldy surface. Some slabs had obviously been replaced and those showed more damage. The damage was typical of that observed under B-1 aircraft. The damaged concrete exhibited severe scaling and surface concrete paste was delaminating in sheets (Figures A1.6 and A1.7).

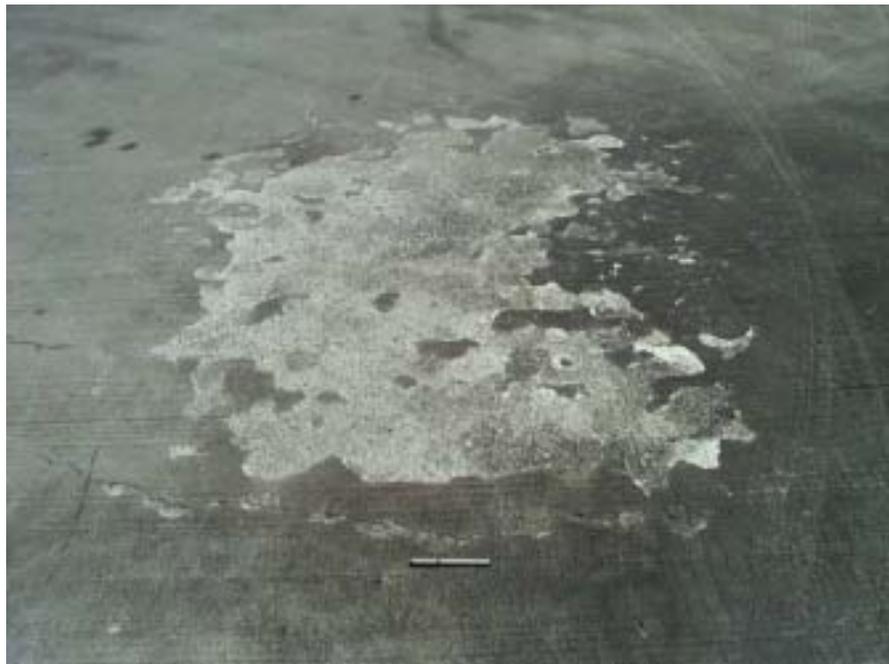
Figure A1.7. Scaling at Old Alert Apron

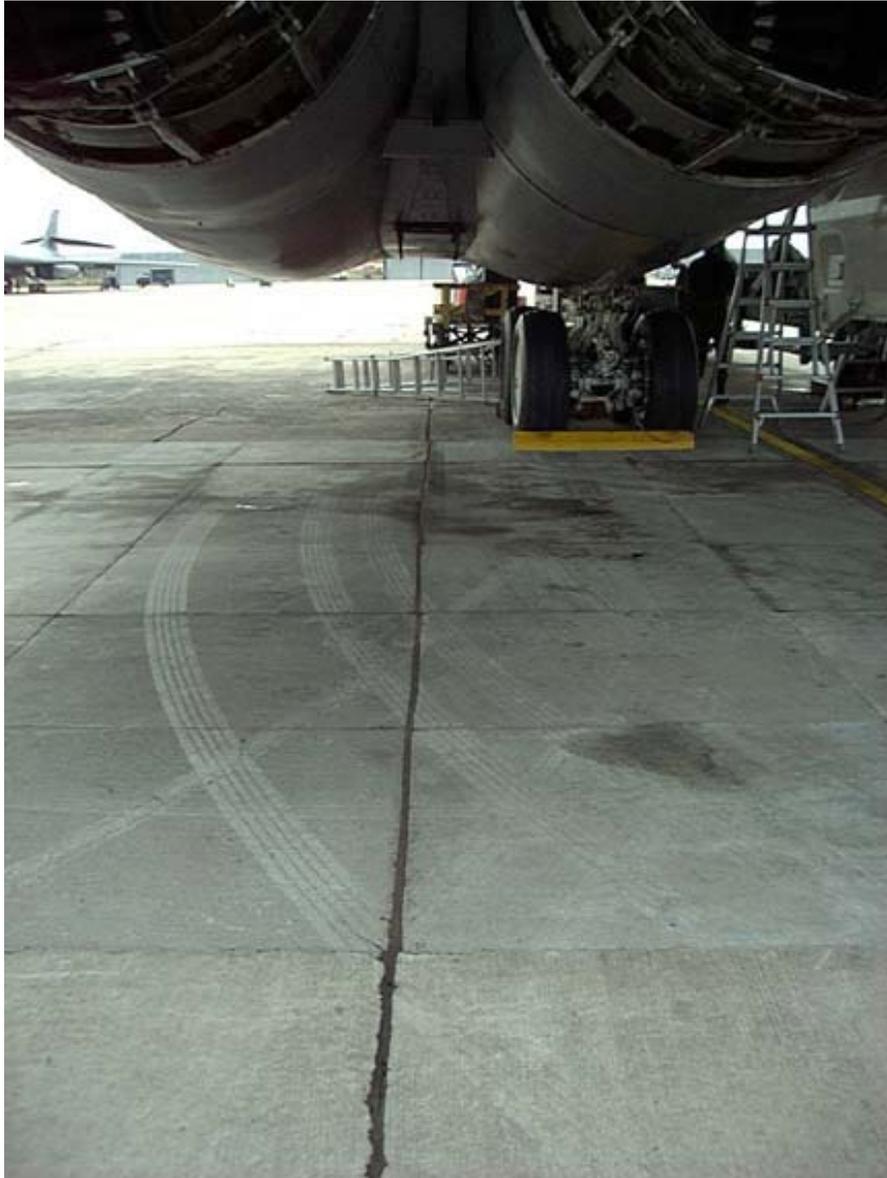
Figure A1.8. MPC “Checkerboard” Repair Area

A1.3.4. The construction of the Set 45™ pads was completed in a checkerboard fashion using slabs no larger than 1.5 meters by 1.5 meters (5 feet by 5 feet) (Figure A1.8). An area approximately 12 meters by 7.5 meters (40 feet by 25 feet) was replaced. The existing concrete was sawcut (where necessary) to a depth of 76 millimeters (3 inches) and the concrete removed with a jackhammer. The prepared surface was then drilled to provide anchors for the forms and the forms were placed. The Set 45™ was then placed in a checkerboard fashion where the “red” squares were filled, the forms removed, and the “black” squares filled using the new Set 45™ slabs and the old concrete as the forms for the second round of Set 45™ placements. A small concrete mixer was employed to mix the Set 45™/basalt mixture. Each form was filled and the surface finished before proceeding to the next form. Some shrinkage cracking

of the Set 45™ slabs was noted but it was not severe.
