— GUIDE FOR —
**RESILIENT THERMAL
ENERGY SYSTEMS DESIGN
IN COLD AND ARCTIC CLIMATES**

Guide for Resilient Thermal Energy Systems Design in Cold and Arctic Climates

Editor: Dr. Alexander Zhivov, U.S. Army Engineer R&D Center, Champaign, IL

January 2021

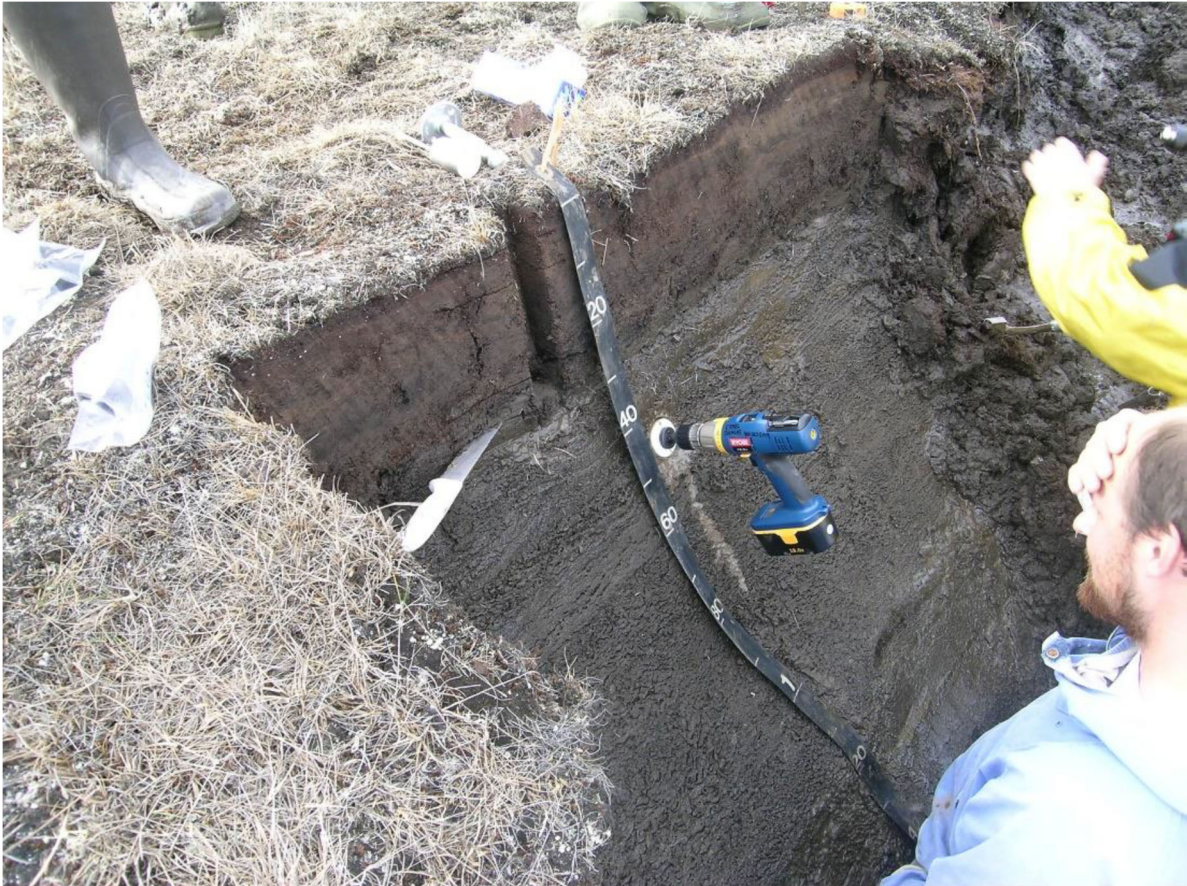
Figure 1-4. The seasonally thawed “active layer” (dark brown surface soil) and underlying permafrost along a coastal bluff near Utqiagvik, Alaska.

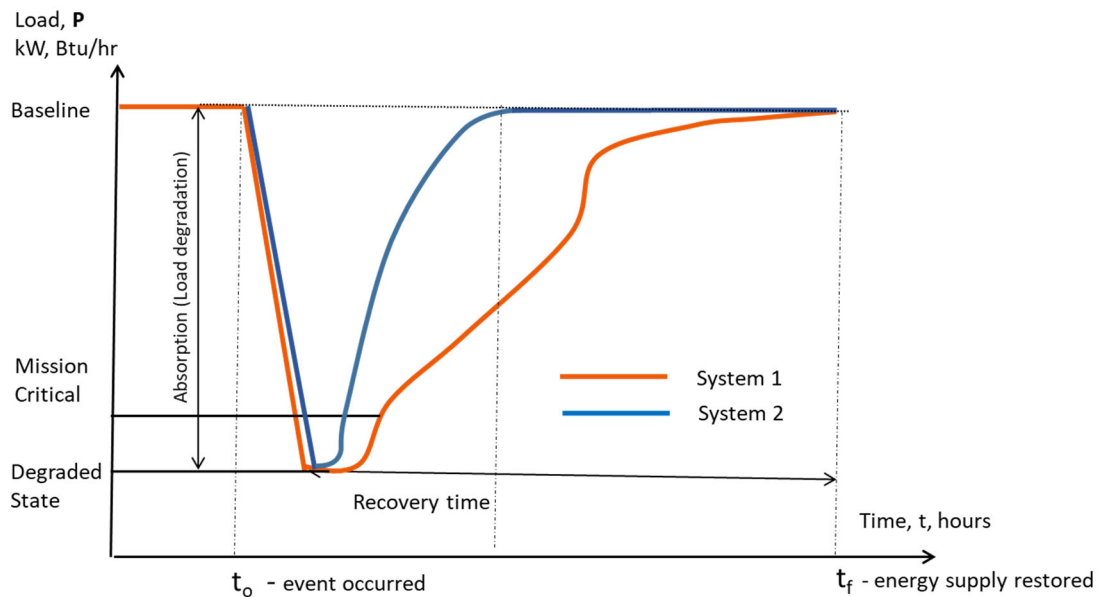
In other cases, it may be more important to prioritize recovery from an event as opposed to absorption. Figure 3-3 shows two systems with similar absorption to an event, but different recovery times. Though both systems have the same ability to absorb the shock from the event, the shorter recovery time for System 2 yields a larger area under the curve. Accordingly, System 2 can be said to be more resilient than System 1.

Figure 3-3. Two systems with different recovery time.

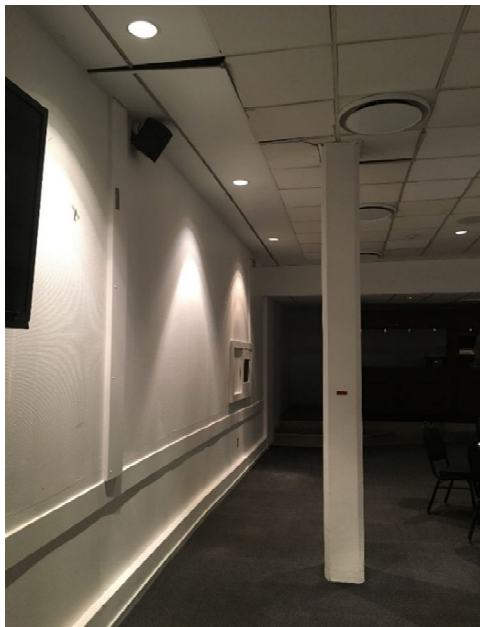
Figure 5-2. Left: A photo of a meeting room at a site in Thule, Greenland, where differential settling has led to wall and ceiling cracking. Photo by T. Douglas, CRREL.

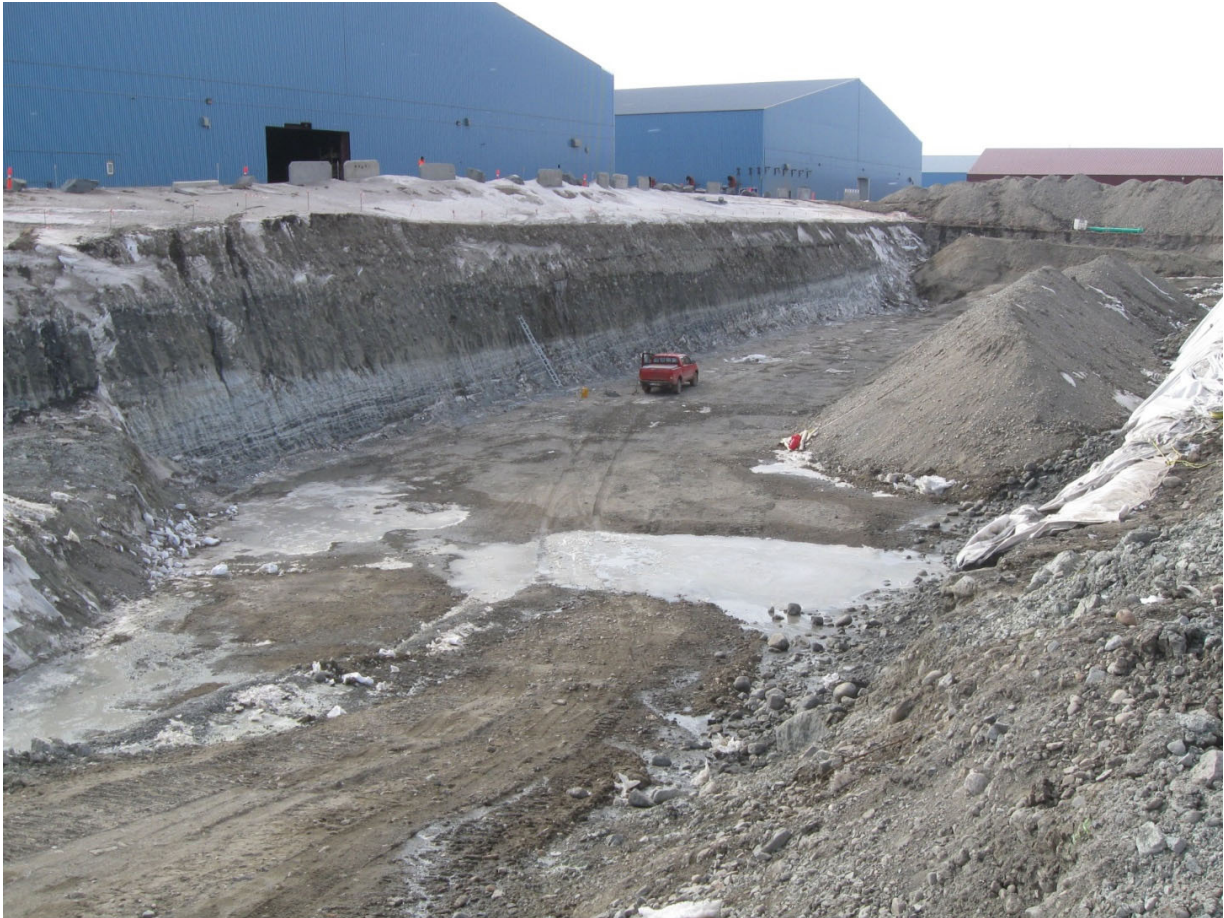
Figure 5-4. Removal of surface ice-rich permafrost and backfilling with thaw-stable materials allows for large slab on-grade construction. Photo by K. Bjella, CRREL.

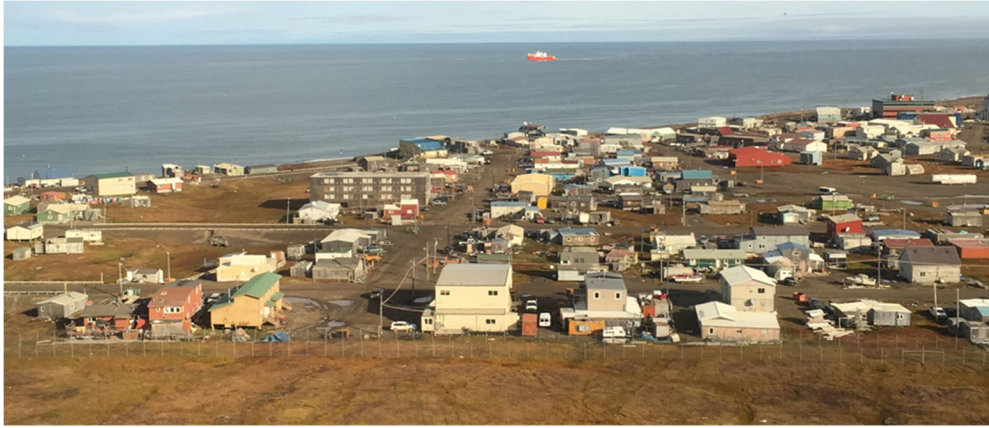
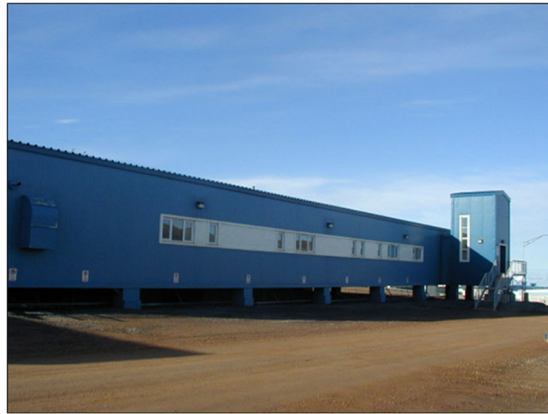
Figure 5-5. Examples of elevated structures on permafrost. Upper photo: An image of downtown Utqiagvik, Alaska where single-story and multi-story buildings, as well as all utilidors, are constructed above ground. Lower left: a large facility at Prudhoe Bay, Alaska. Lower right: a single-story structure at Thule, Greenland. Photos by Kevin Bjella, CRREL.

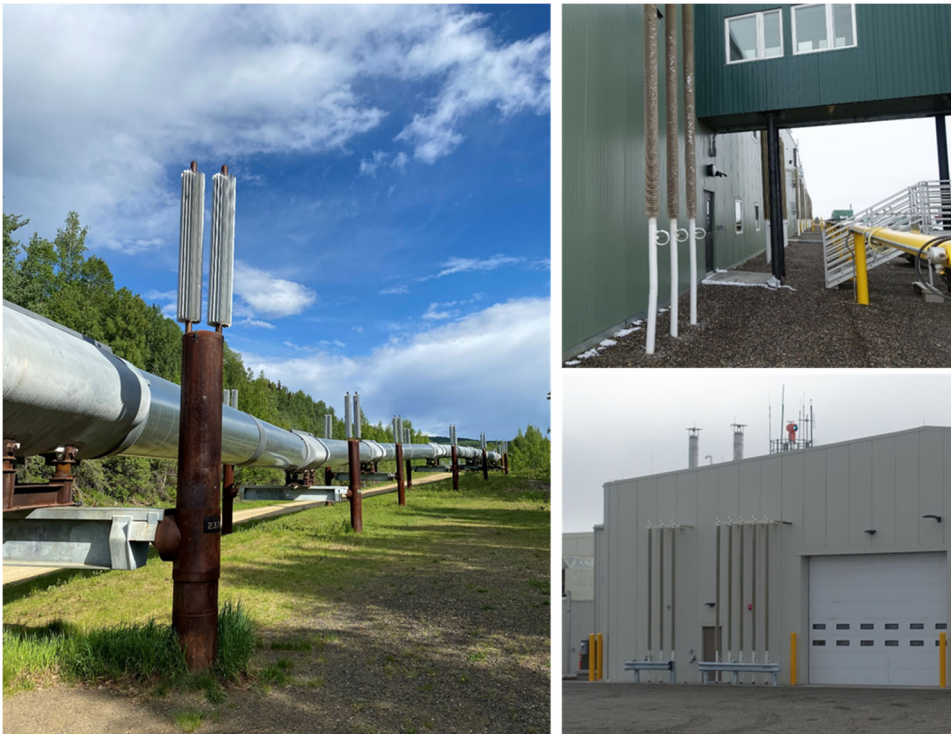
Figure 5-7. Images of thermosyphon installations. Left: on the Trans-Alaska Pipeline near Fairbanks, Alaska. Upper and lower right: along foundation edges of structures in Prudhoe Bay, Alaska. Images by T. Douglas, CRREL.

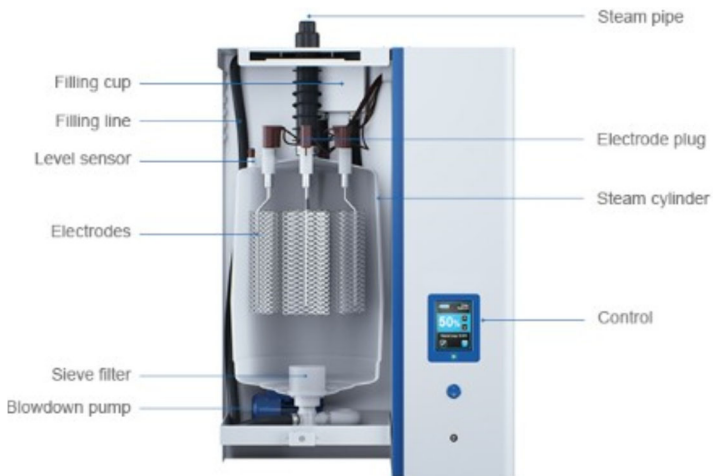
Figure 6-4. Electrode humidifier (www.condairgroup.com/know-how/electrode-steam-humidifier).

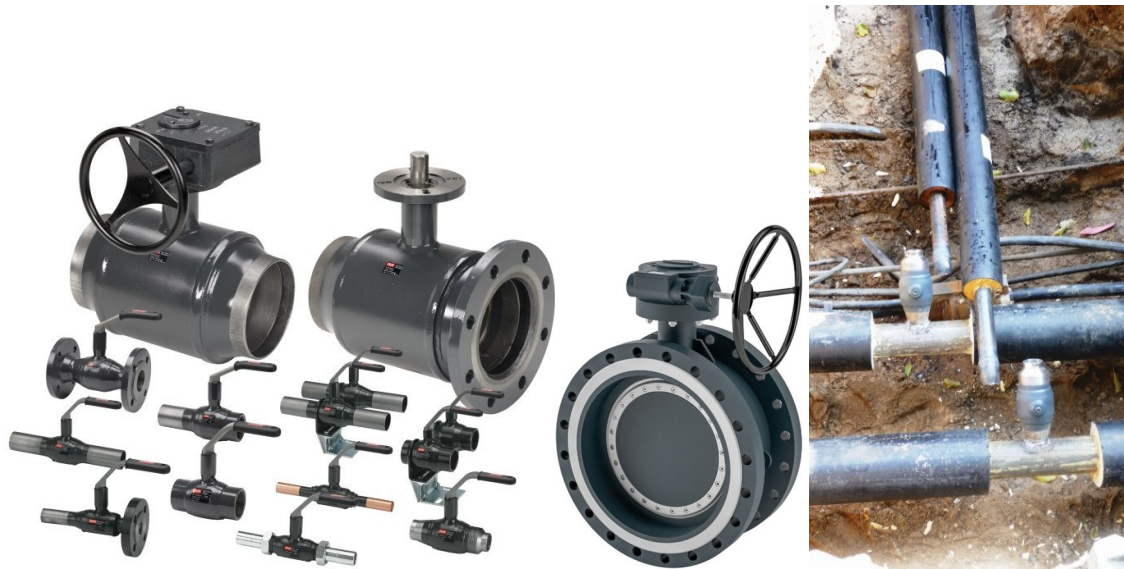
Figure 7-6. Left: Example of ball valves in various sizes. Middle: Butterfly valve. Right: Shutoff valves installed in a pipeline. Source: Danfoss A/S.

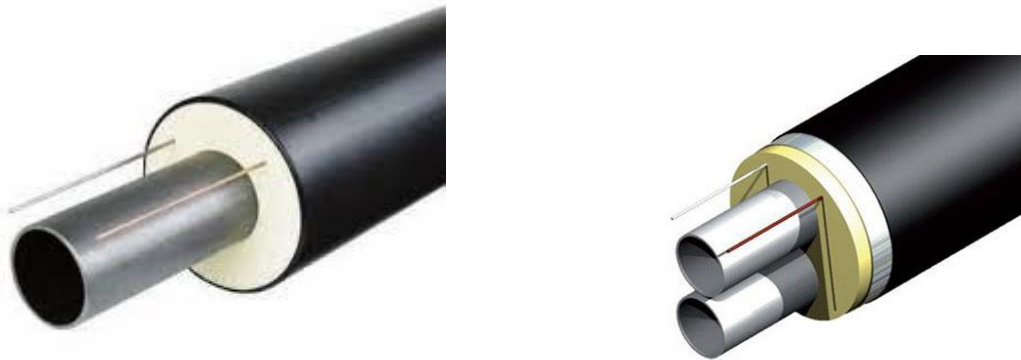
Figure 7-7. Leakage detection wires in a pre-insulated single and twin pipe. Source: Løgstør A/S.

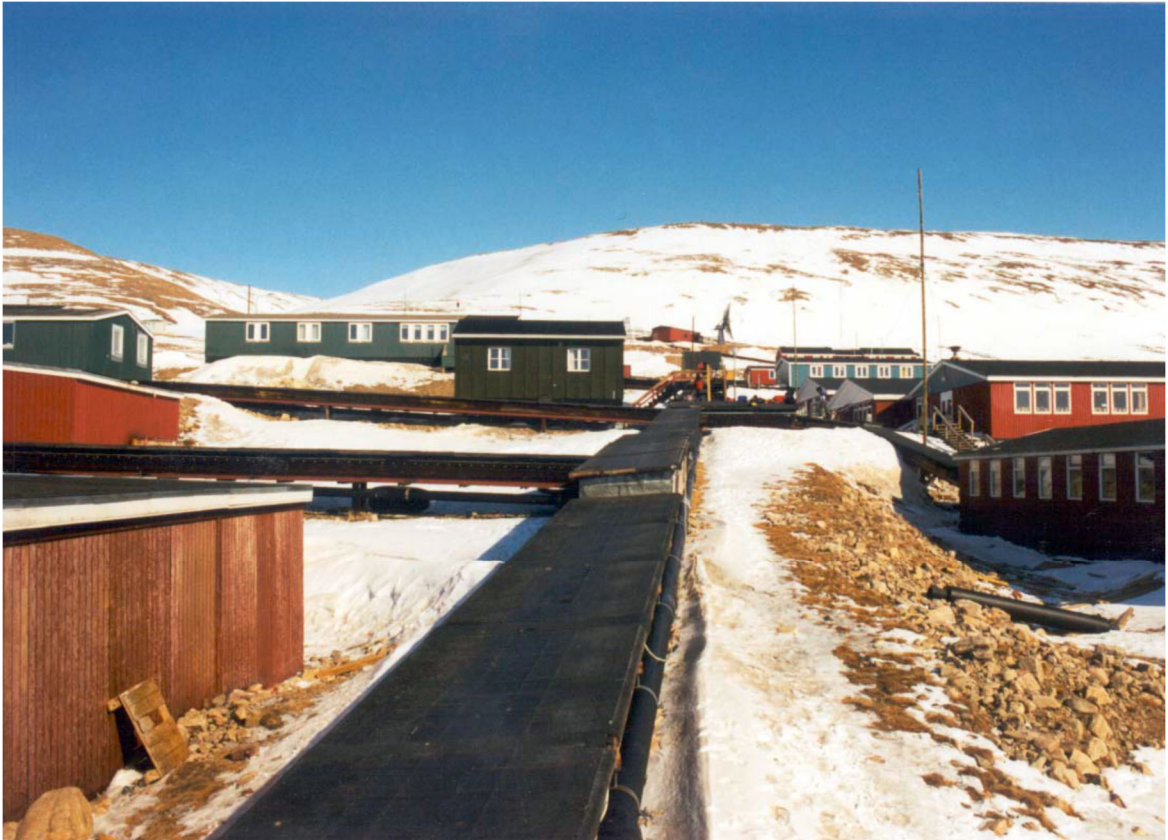
Figure 7-13. Above-ground supply infrastructure. Source: Ramboll A/S.

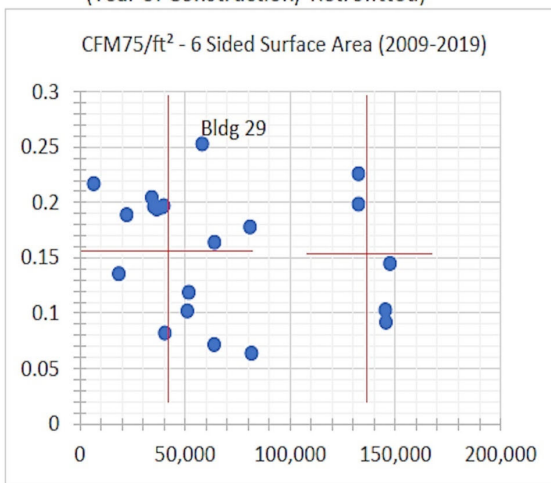
Graph 1-2. Leakage (cfm75/ft²) to Size, w/ Avg. Show

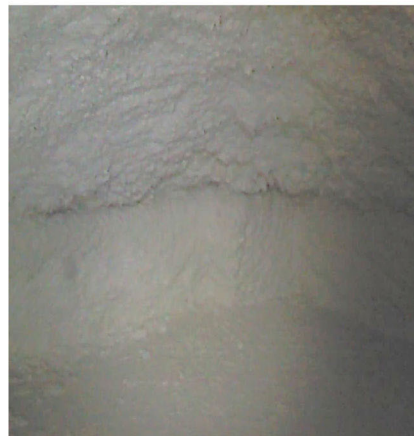
Image 8-4. Building 2 Roof to Wall Joint Dig.

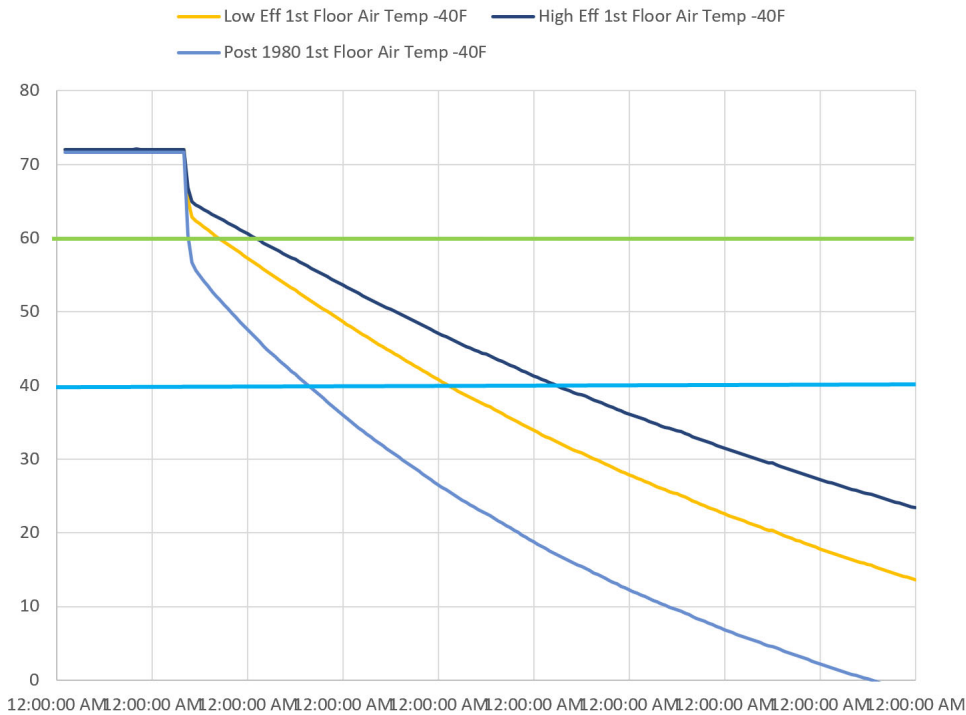
Figure B-15. Mass building comparison of high-efficiency, low-efficiency, and typical 1980 parameters for building heating failure results with -40 °F (-40.0 °C) Weather
