PUBLIC WORKS TECHNICAL BULLETIN 200-1-141
10 JUNE 2014

**IMPLEMENTING STORMWATER AND
EROSION CONTROL TECHNOLOGIES IN
URBAN-TYPE MILITARY RANGE DESIGNS**

No. 200-1-141

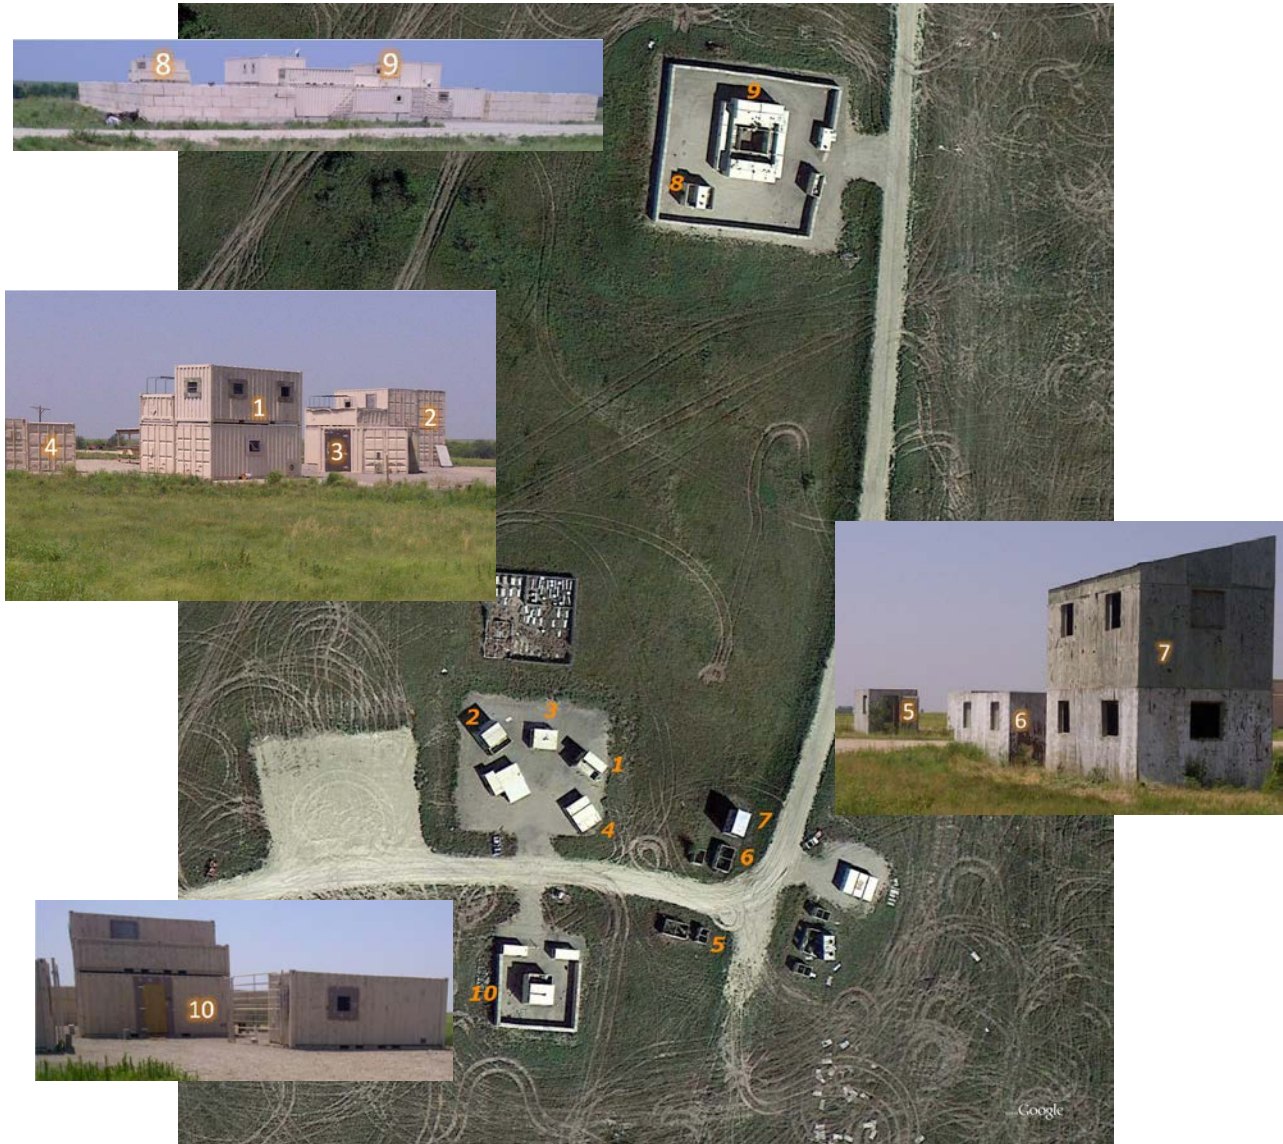
Figure A-1. Aerial view of temporary UTA site example, with the site's buildings shown in photo insets (source: Google Maps for aerial view; ERDC-CERL for photos, 2013).

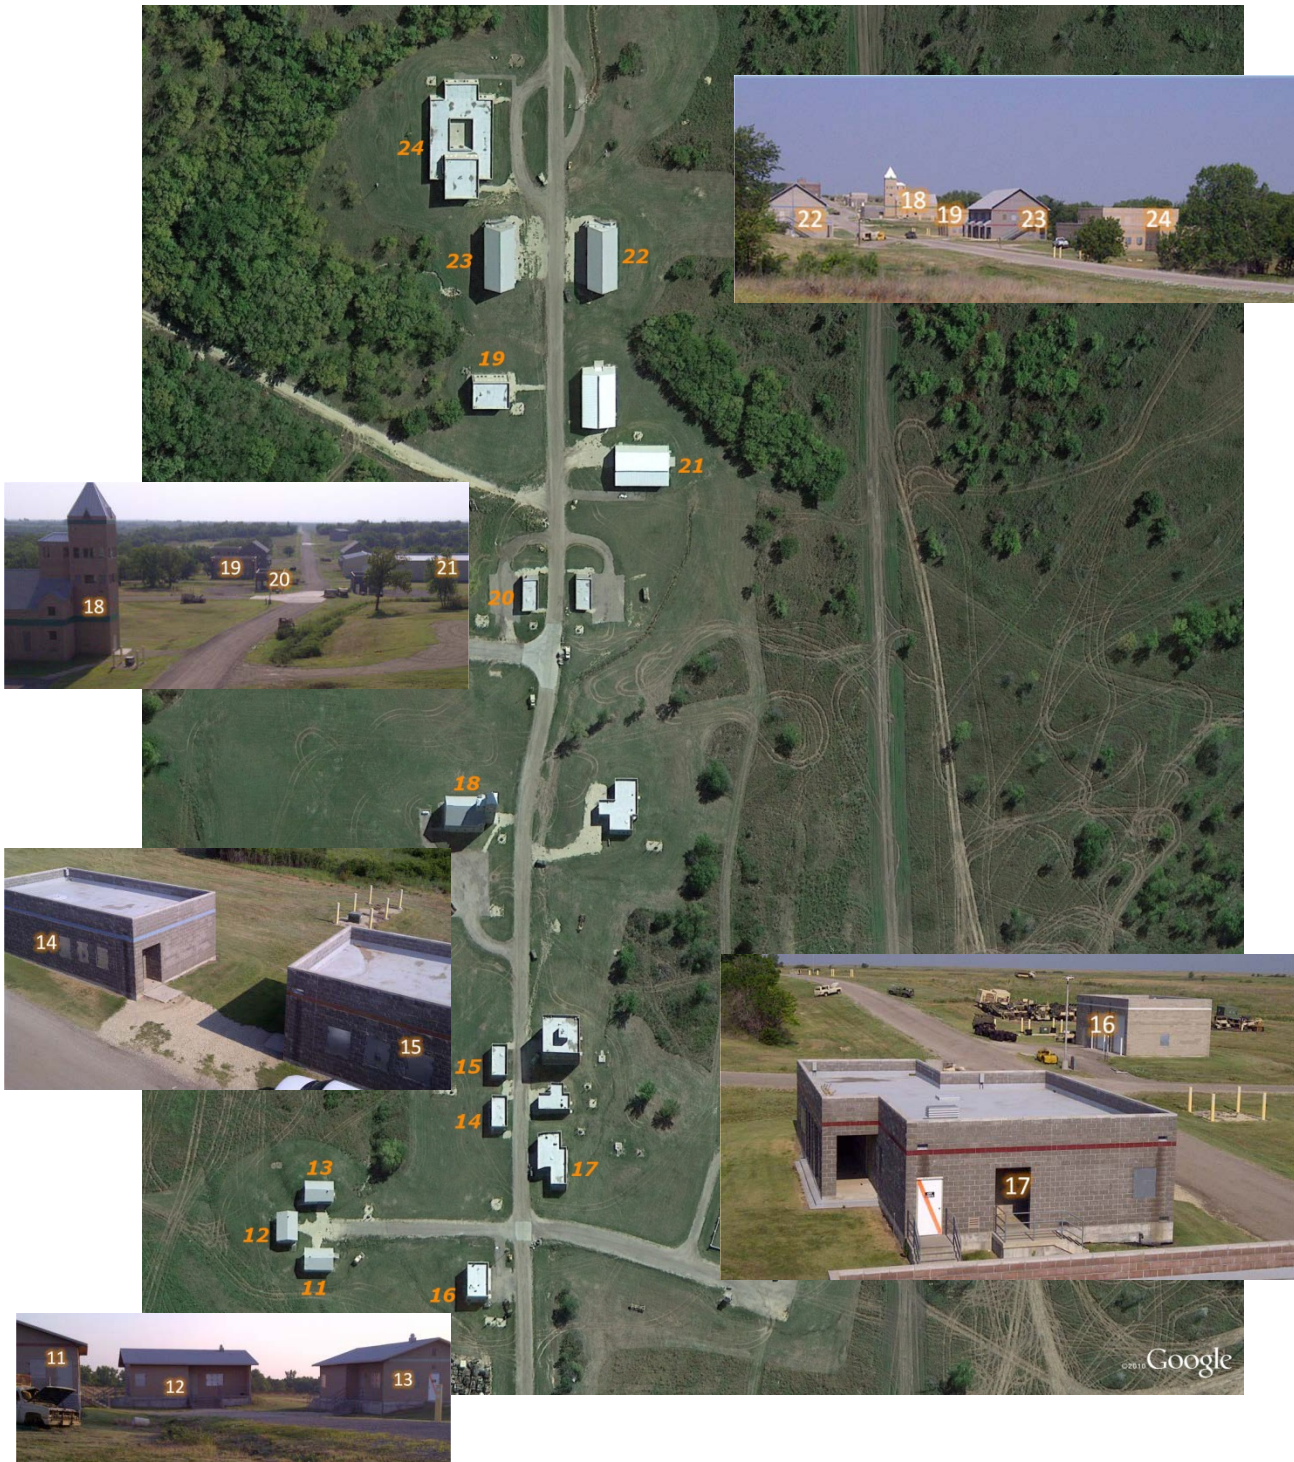
Figure A-2. Aerial view of permanent UTA site example, with the site's buildings shown in photo insets (source: Google Maps for aerial view; ERDC-CERL for photos).

Permanent UTAs consist of robust structures constructed with concrete or cinder-block foundations and paved roads; extensive earth work can be involved. In general, permanent UTAs are modeled after urban environments in developed nations, have a long life expectancy, are funded as permanent structures, and carry with them long-term maintenance schedules. The buildings are generally weatherproof and secure so that they can be outfitted with audio and visual technologies to assist trainers in providing After Action Reviews (AARs) of training exercises. Permanent UTAs also experience high volumes of training activities by many different units and elements of the military. The permanent UTA chosen for this study is shown in Figure A-2 via an aerial view of the site and photo insets of the site's buildings.

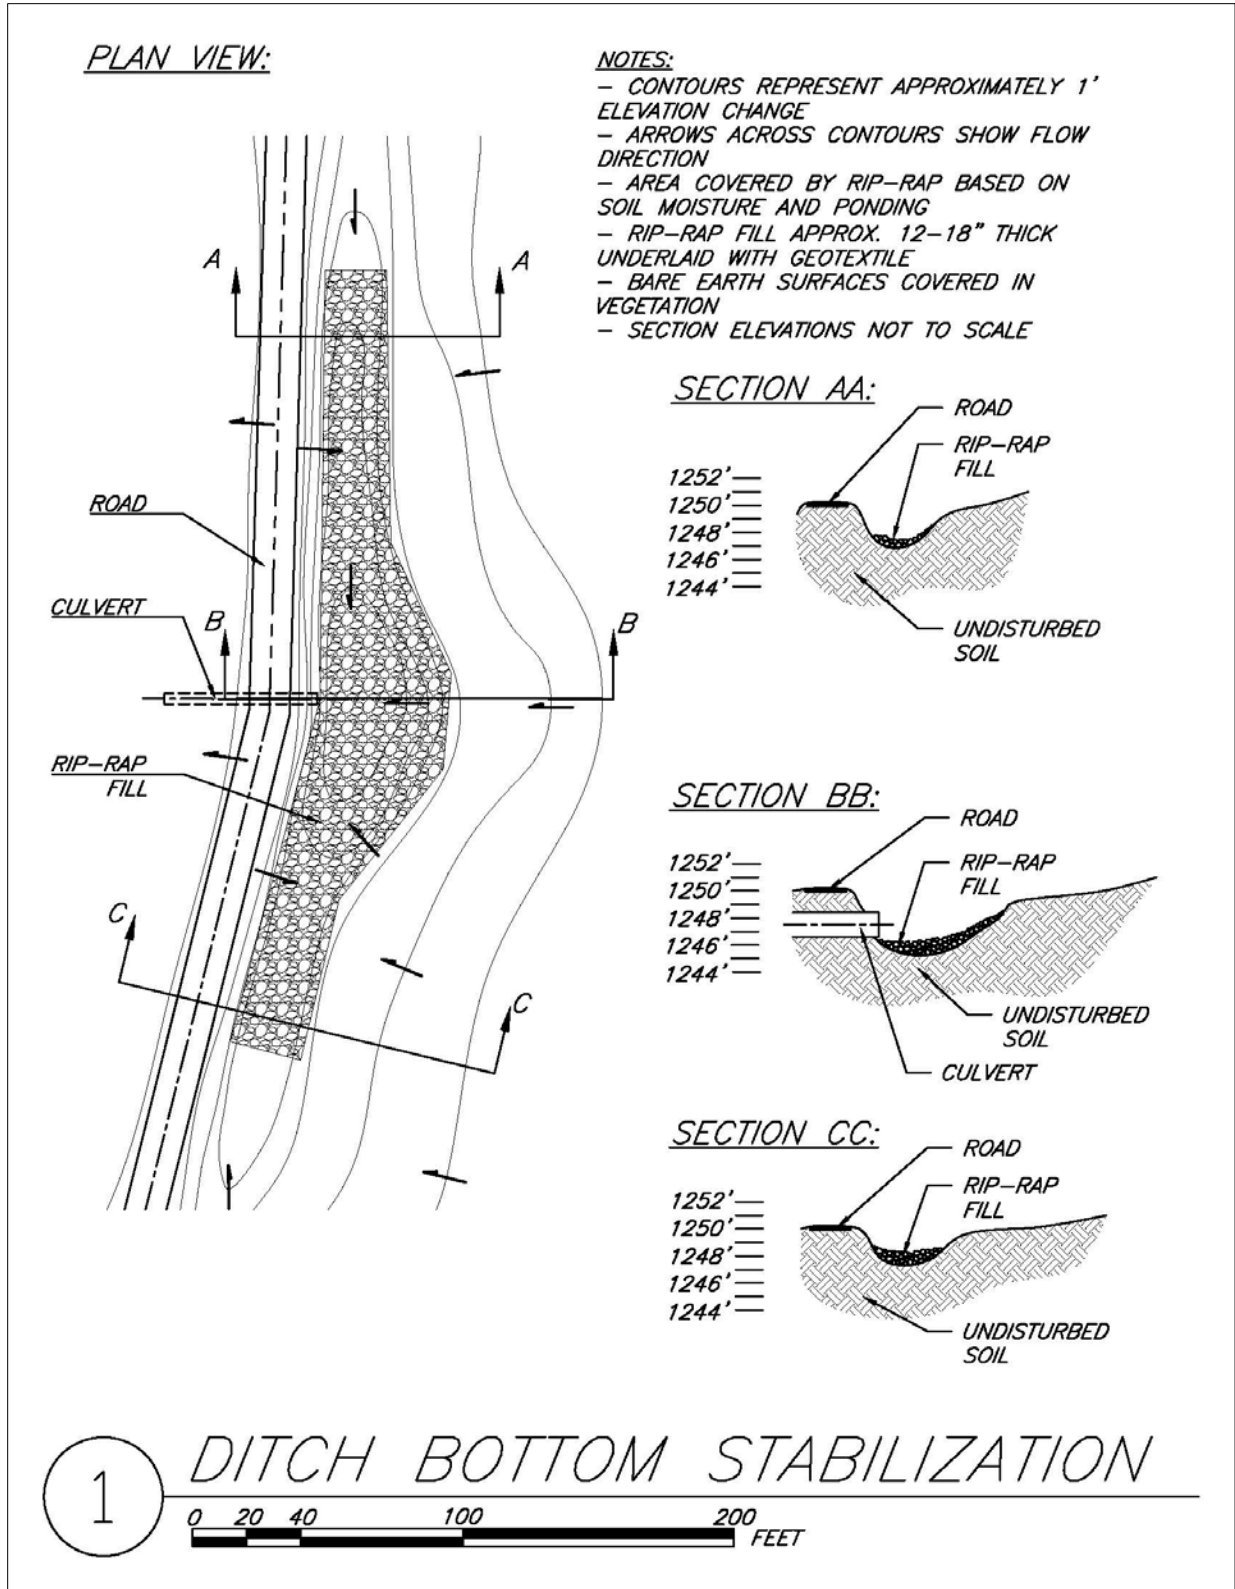
39 In this situation, where vehicles do need to cross ditches
40 and/or wet areas, the site would benefit from design
41 improvements (Figure C-2). The goal of any design in this
42 scenario would be to provide a hardened surface to protect
43 the soil below and thus prevent vehicles from degrading the
44 area. One of the simplest design solutions involves the

1 addition of a layer of riprap at the bottom and sides of the
2 ditch. The riprap would greatly reduce impacts from vehicle
3 maneuvers by creating a hard surface for vehicles to travel
4 over, while still allowing water to flow through the ditch
5 and drain from the area. The result will be reduced rutting
6 and less erosion of the underlying soil.

Figure C-2. Ditch bottom design improvement for soil/ditch stabilization (ERDC-CERL).

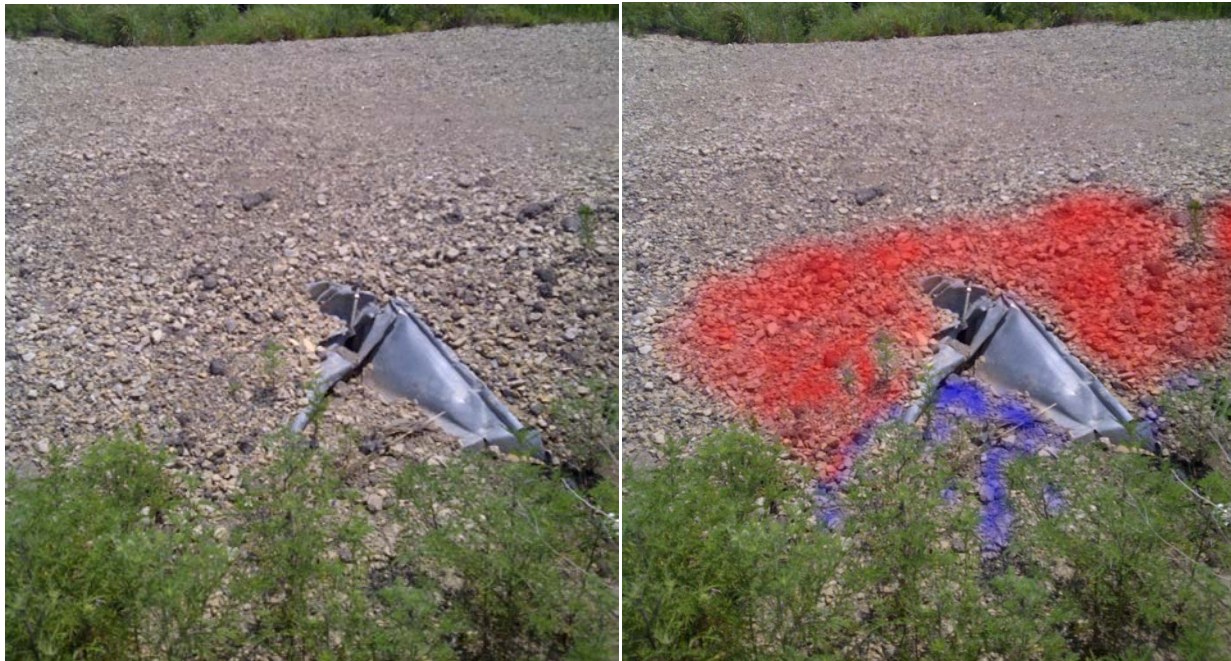
3 The picture on the left of Figure C-3 shows a culvert that
4 has been crimped by a vehicular traffic over one end. With a
5 partially crimped and collapsed structure, the culvert can no
6 longer effectively convey water underneath the road, and
7 water instead flows across the top of the road. This flow
8 then erodes the road's surface. The picture on the right
9 illustrates the erosion that has separated the gravel fines
10 from the larger rocks. The larger-sized aggregate remains
11 around the top and sides of the culvert (area in red), and
12 the smaller rocks have been washed into the depression below
13 the culvert (area in blue).

14
15 **Figure C-3. Damaged culvert blocks subsurface water passage, causing water to**
16 **flow over the road. Subsequent erosion of gravel is indicated by larger rocks**
17 **remaining at the top and sides (red area), and smaller rocks being washed**
18 **into the depression (blue area) (ERDC-CERL).**

19 Culvert malfunctions are a common and easily identified
20 issue. Generally, culvert malfunction results in a road-
21 surface erosion or stability issue. In every case, the main
22 aim should be to identify the malfunction's root cause. To
23 determine this, several elements and design parameters of the
24 existing culvert structure should be checked. First, the
25 culvert should be checked for any obstructions which would
26 prevent it from functioning properly. Physical deformations
27 of the culvert structure can also obstruct water flow and

12 In the case shown in Figure C-3, the culvert has been
13 deformed in a crimple at its outlet. The culvert should be
14 replaced with a longer culvert. Additionally, in order to
15 prevent this from happening again, design improvements should
16 be made (Figure C-4). One improvement shown would be adding a
17 24-in. or wider grass buffer along the road above the
18 culvert. This buffer will encourage drivers to avoid driving
19 over the end of the culvert. A second recommendation involves
20 placing boulders on each side of the culvert inlet or outlet.
21 This recommendation prevents vehicles from making contact
22 with the end of the culvert by placing a physical barrier
23 between vehicles and the culvert ends.

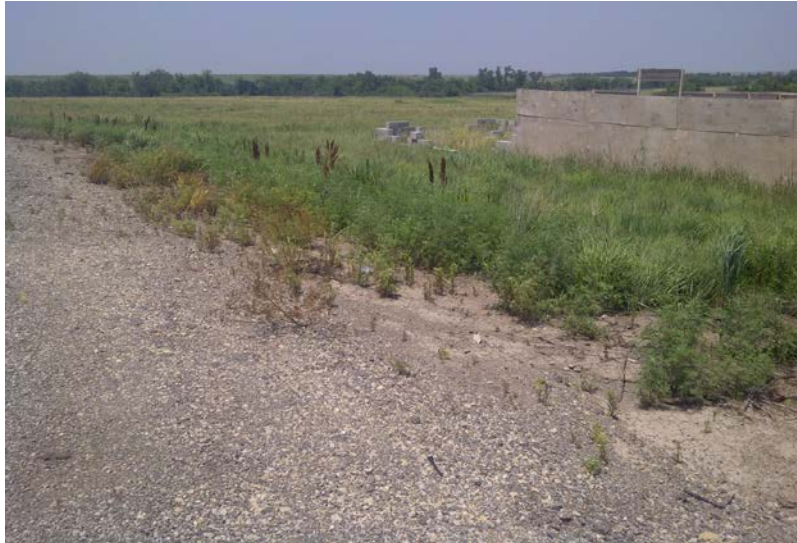
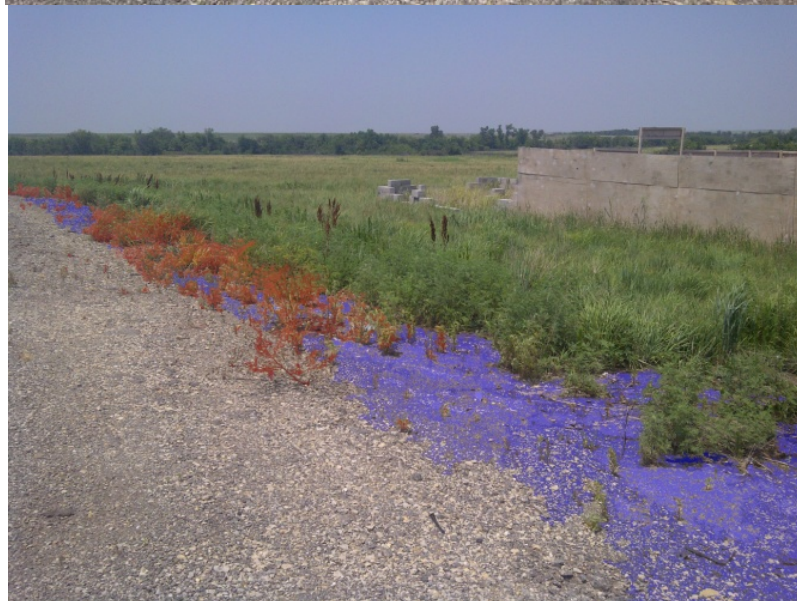
7 **Figure C-5. Herbicide-treated gravel pad (unaltered view on top). The altered**
8 **bottom image shows bare soil in purple, with vegetation death shown in red**
9 **(ERDC-CERL).**

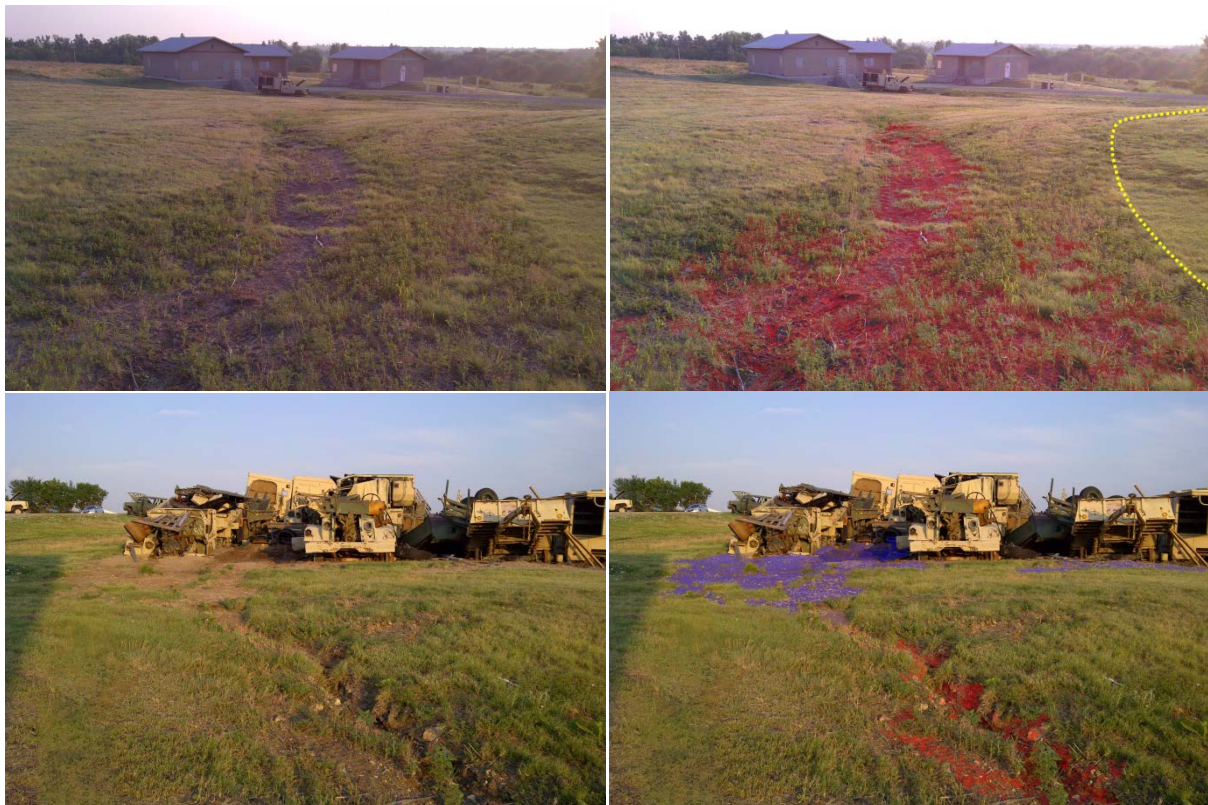
4 The two sets of pictures in Figure C-7 show rill formation
5 from water coming off impervious surface areas. The top image
6 set, showing the lower side of an old agricultural terrace in
7 a grassy area, identifies the terrace with a yellow dotted
8 line, and areas in red illustrate rill formation. In the
9 bottom set of pictures, the rill originates from an area
10 where machinery and equipment were stored for an extended
11 period of time. The equipment-covered area acts as a hardened
12 surface that does not allow water to effectively infiltrate
13 the soil (highlighted in blue). The runoff from this
14 "hardened" area then becomes concentrated in areas that show
15 up in the images as eroded areas. As shown in all the
16 pictures, a lack of vegetative cover in the areas of
17 increased water flow leaves the soil susceptible to erosion.

20 **Figure C-7. Two examples of rill formation shown by red areas in two altered**
21 **photos on right. Yellow line in upper right photo indicates an old**
22 **agricultural terrace and blue area in lower right photo indicates a hardened**
23 **area; both are causes of rill formation (ERDC-CERL).**

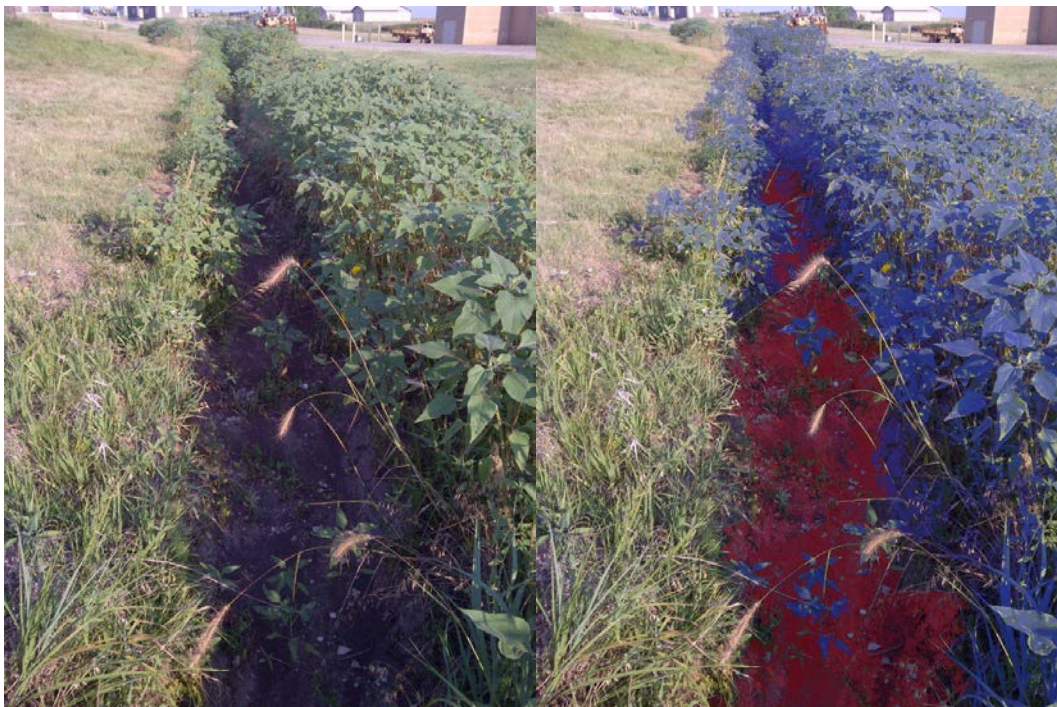
3 Similar to the issue illustrated in Permanent UTA Problem
4 Area #1, the paired images in Figure C-11 show gully
5 formation (red area). According to an informed site
6 maintenance worker, the ditch was cut in an effort to direct
7 water away from the gravel road surface because the road
8 surface was being washed away and the edges were becoming
9 undercut. However, the ditch was subsequently left bare of
10 vegetation or any other soil protective measure. The high
11 concentrations of water flow off such a large contributing
12 area caused further deepening of the ditch into the gully
13 shown in Figure C-11. The resulting gully is large and steep
14 enough that the vegetation cannot be easily managed. The
15 result is a large population of broadleaf vegetation (blue
16 area in Figure C-11). The broadleaf vegetation does not
17 provide adequate protection at the soil surface to prevent
18 erosion. If this gully continues to expand, it will result in

22
23 **Figure C-11. Gully formation is shown in red on altered photo at right,**
24 **and resulting large population of broadleaf vegetation**
25 **is shown in blue (ERDC-CERL).**

2 The gully shown in Figure C-11 should be redesigned to a
3 parabolic ditch with a rock center. The design solution
4 recognizes that vegetation will not be easily established in
5 a ditch that is meant to carry such a large amount of water
6 volume at a higher velocity from a large contributing area.
7 The rock center will protect the soil at the bottom of the
8 ditch, in addition to slowing the water's velocity. This
9 slower velocity will reduce erosion potential within the
10 ditch and where it ends. Also, the sides of the ditch will be
11 reshaped to be longer, less steep, and better able to support
12 vegetation, giving further protection from erosion. While
13 vegetation is being established, the ditch sides should be
14 lined with a rolled erosion-control product to protect the
15 bare soil. Alternatively, the rock center could be replaced
16 with a series of riprap check dams. However, check dams

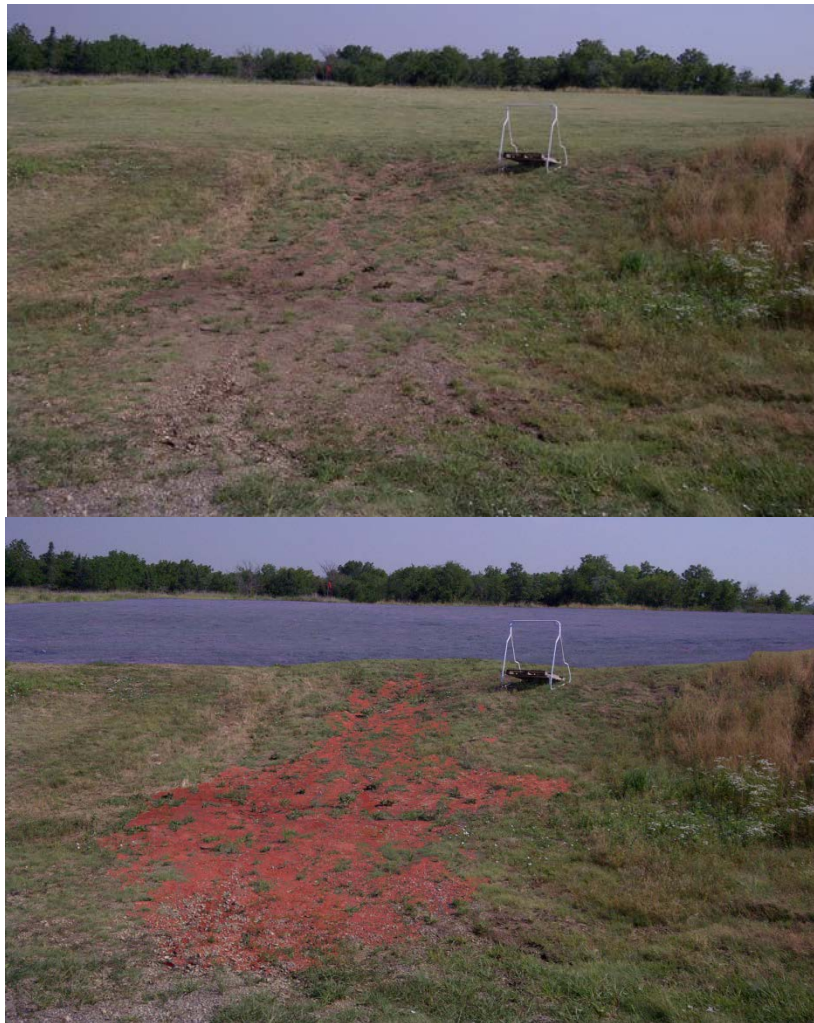
3 Figure C-13 shows a heavily-trafficked vehicle crossing
4 through a wide but shallow roadside ditch area. A drop zone
5 exists farther in field (blue area in Figure C-13), which is
6 assumed to be the navigational aim of the vehicles crossing
7 the roadside ditch. Although the ditch currently shows light
8 erosion at the crossing, it has obviously been impacted by
9 the vehicle traffic and is an area of concern. Concerns
10 include the high percentage of bare soil (shown in red),
11 known locally heavy precipitation events and resulting high
12 water flows, incurred soil compaction, and potential of
13 rutting deformation during wet soil conditions.

16 **Figure C-13. Top photo shows vehicle crossing a shallow ditch (foreground) to**
17 **reach a drop zone (background). In altered bottom photo of same scene, bare**
18 **soil is indicated in red and drop zone is shown in blue (ERDC-CERL).**

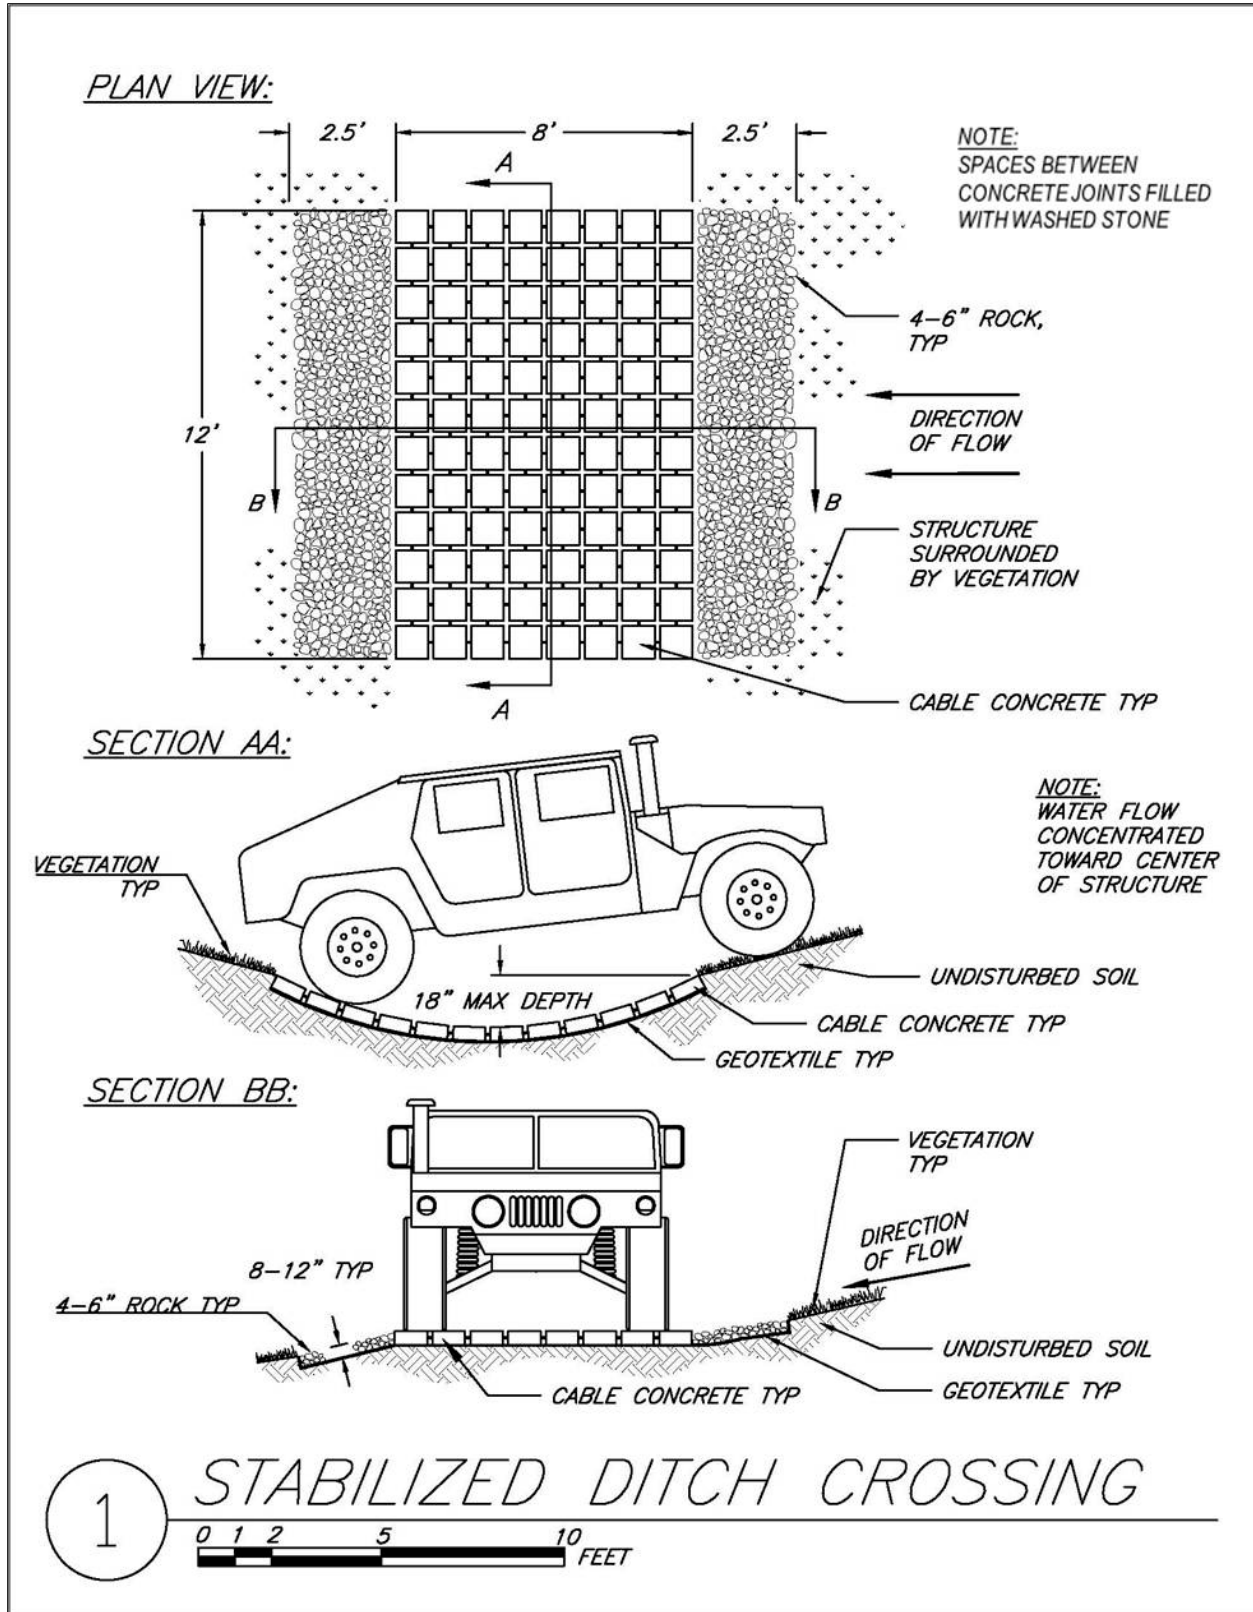
22 However, alternative materials can be used very successfully
23 to construct a low-water crossing. Riprap used in conjunction
24 with an underlying geotextile can be effectively used as a
25 low-water crossing but will limit vehicle use to off-road
26 vehicles. Also, riprap crossings are less permanent and lead
27 to higher maintenance requirements.

Figure C-14. Design for cable concrete used as a solution to stabilize ditch crossing (ERDC-CERL).

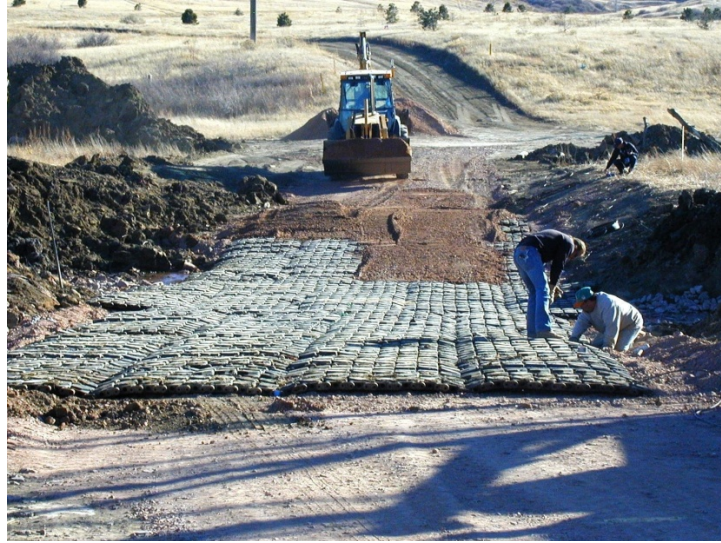
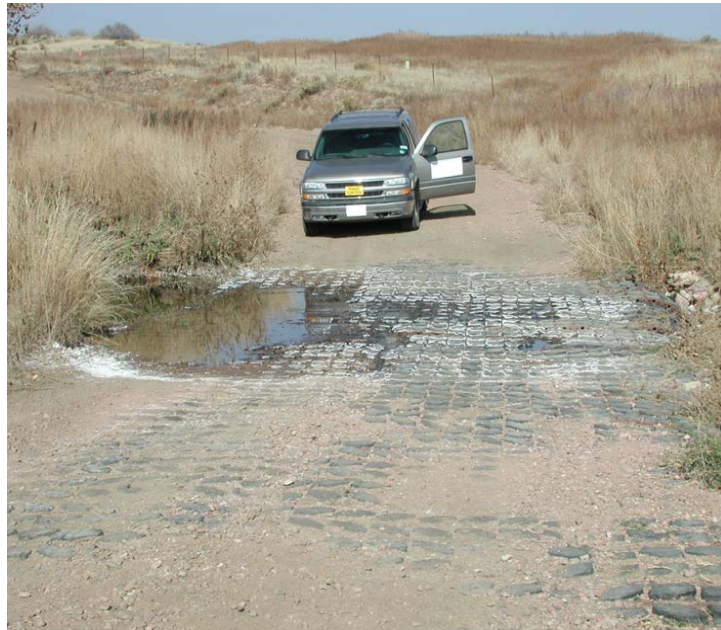
28 The second design solution utilizes the alternative material
29 of worn tank tracks. As shown by the top photo in Figure
30 C-15, tank tracks are installed in place of cable concrete.
31 The tank tracks are also compatible for use by most wheeled
32 and tracked vehicles, with additional advantages of
33 potentially lower cost and higher availability. The tank
34 track design has also proven to be more durable than other
35 commercial solutions, remaining in place during heavy
36 precipitation events or high water flows, where other low
37 water crossings wash out and require repair (bottom photo in
38 Figure C-15). This durability is due to the weight of tracks.
39 This second design solution shows the proper preparation of
40 tank tracks when used in place of cable concrete in a
41 stabilized dry ditch crossing (Figure C-16).

Figure C-15. Low-water crossings installed with used tank tracks as solution to erosion from vehicles crossing shallow ditches (top photo). The tank track design proved more durable than other commercial solutions, remaining in place during heavy precipitation events or high water flows (bottom photo) (ERDC-CERL).

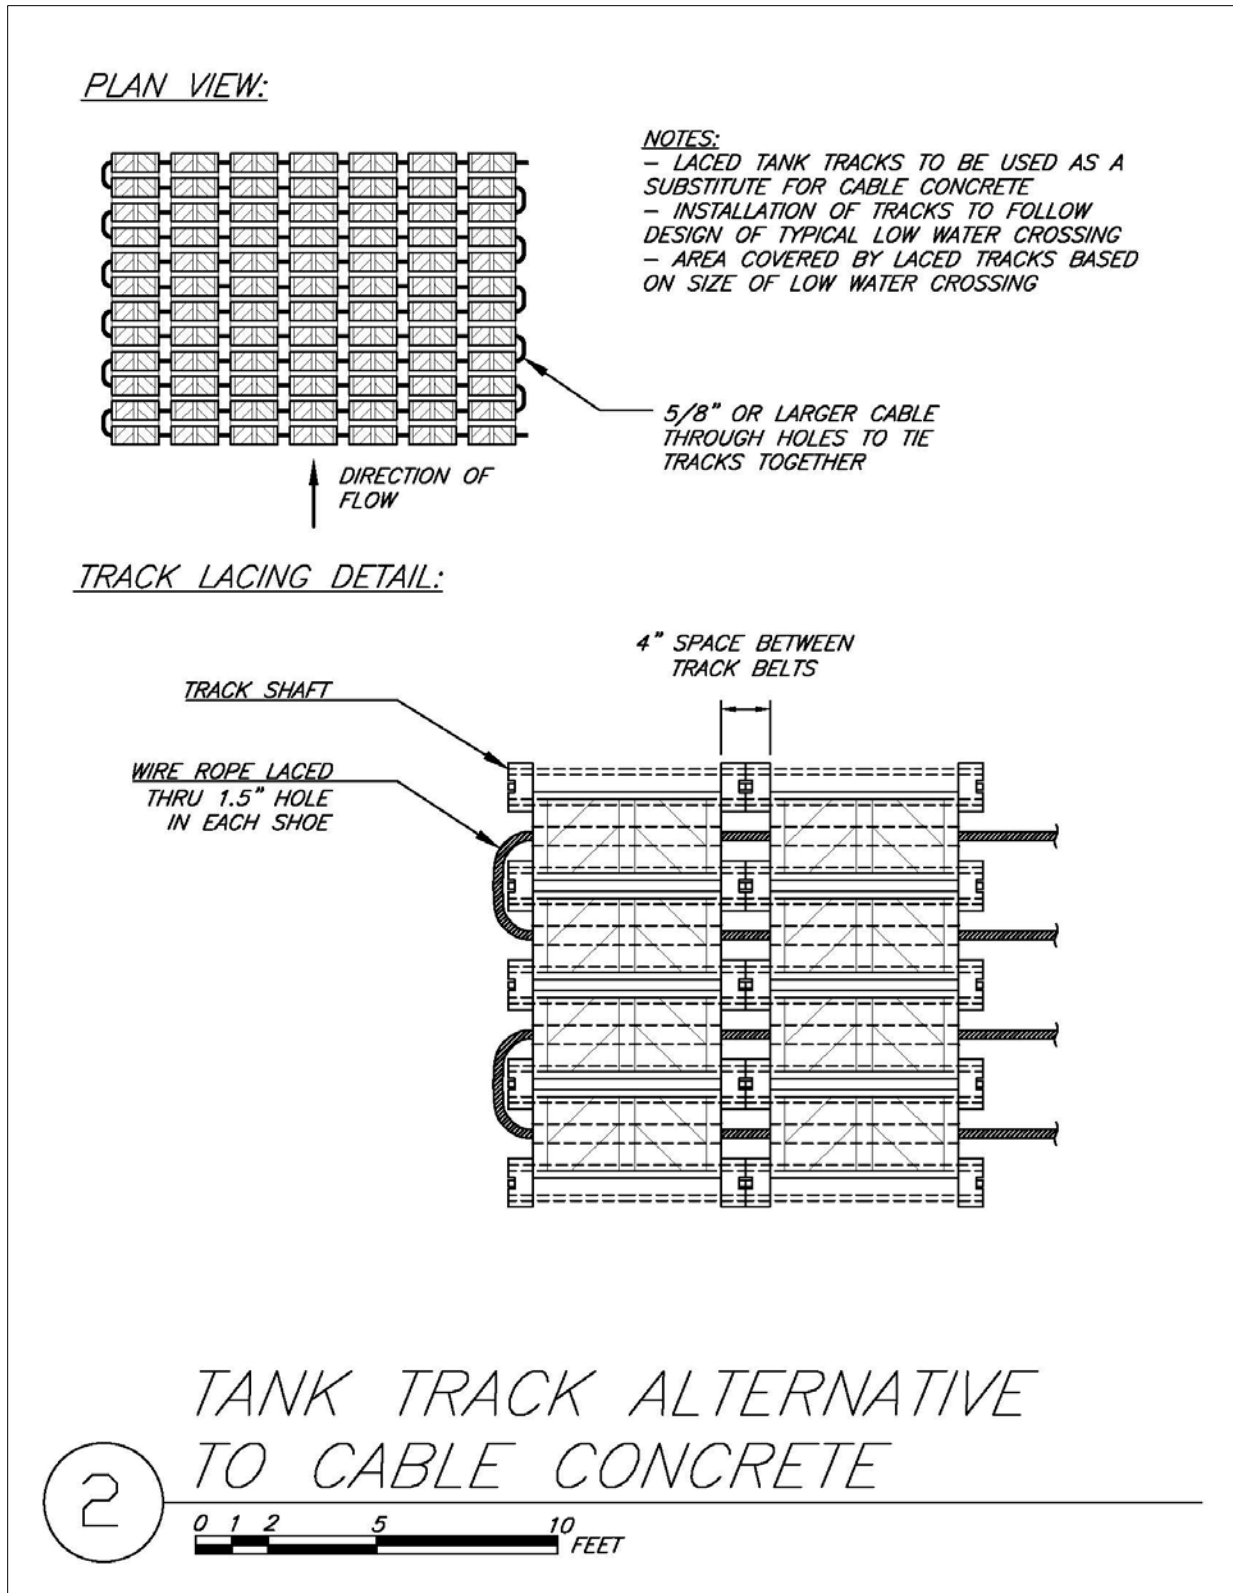
Figure C-16. Design solution when installing tank track as an alternative to cable concrete to solve soil erosion from vehicle traffic crossing a shallow ditch (ERDC-CERL).

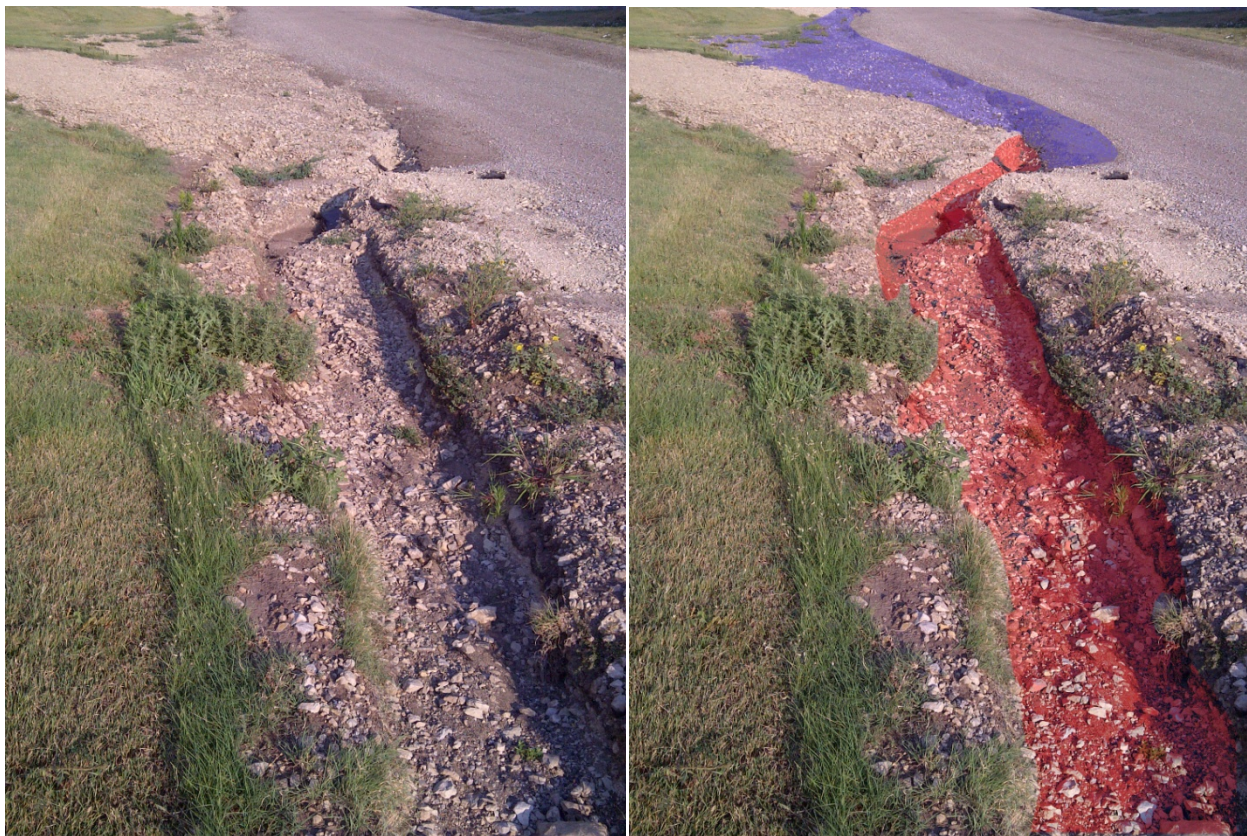
3 Figure C-17 illustrates a road being washed away due to high
4 volumes of water flow. The driveway entering the road from
5 the left concentrates water flow by obstructing the natural
6 flow down the side of the road and thus eroding the surface
7 of the road. The road shows signs of erosion where all the
8 gravel fines have been removed (blue area). Also, a gully has
9 formed at the point of concentrated flow (red area) because
10 there are no protective measures in place to convey water
11 away from the road.

12
13 **Figure C-17. Erosion caused from high-volume water flow from driveway**
14 **entering a roadway. Altered photo on right shows resulting erosion of gravel**
15 **fines (blue area) and formation of a gully (red area) (ERDC-CERL).**
