Risk Management Series

Design Guide

for Improving Hospital Safety
in Earthquakes, Floods, and High Winds

FEMA 577 / June 2007

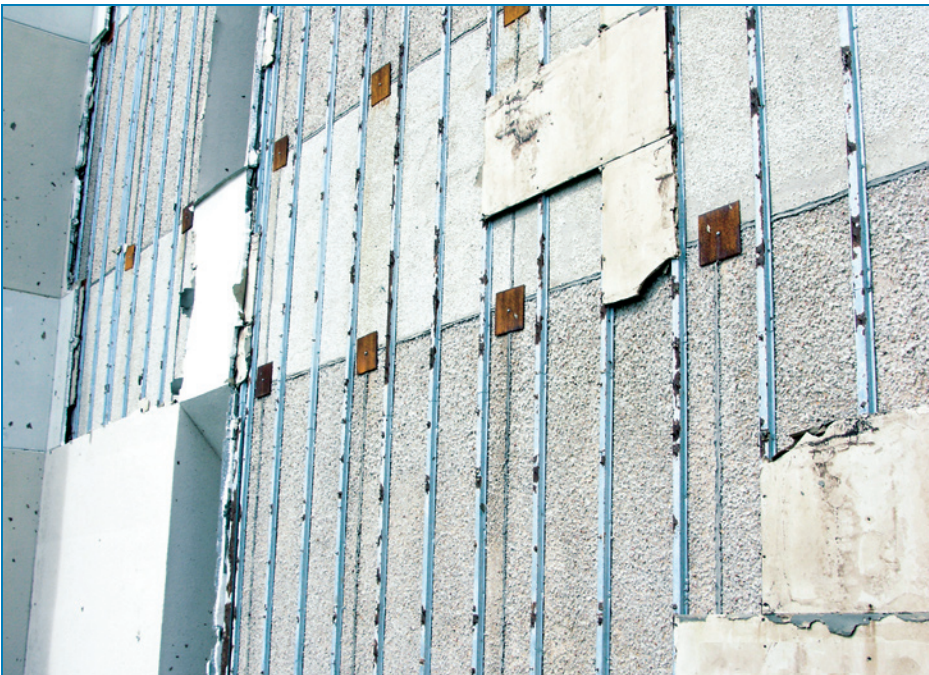
Figure 4-23: Close-up of the damaged EIFS at the hospital. In this area most of the insulation and gypsum board was blown from the steel furring channels.
