Design Guide

for Improving School Safety in Earthquakes, Floods,
and High Winds

FEMA P-424 / December 2010

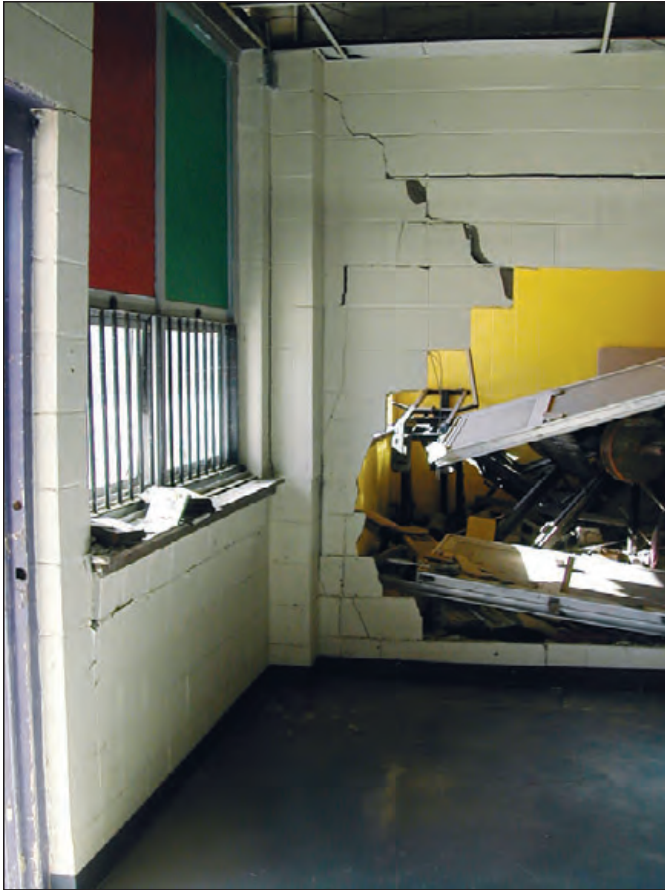
Figure 5-14: Interior unreinforced masonry walls of the Port Sulphur High School in Louisiana were damaged by hydrostatic loads associated with Hurricane Katrina's storm surge (2005)

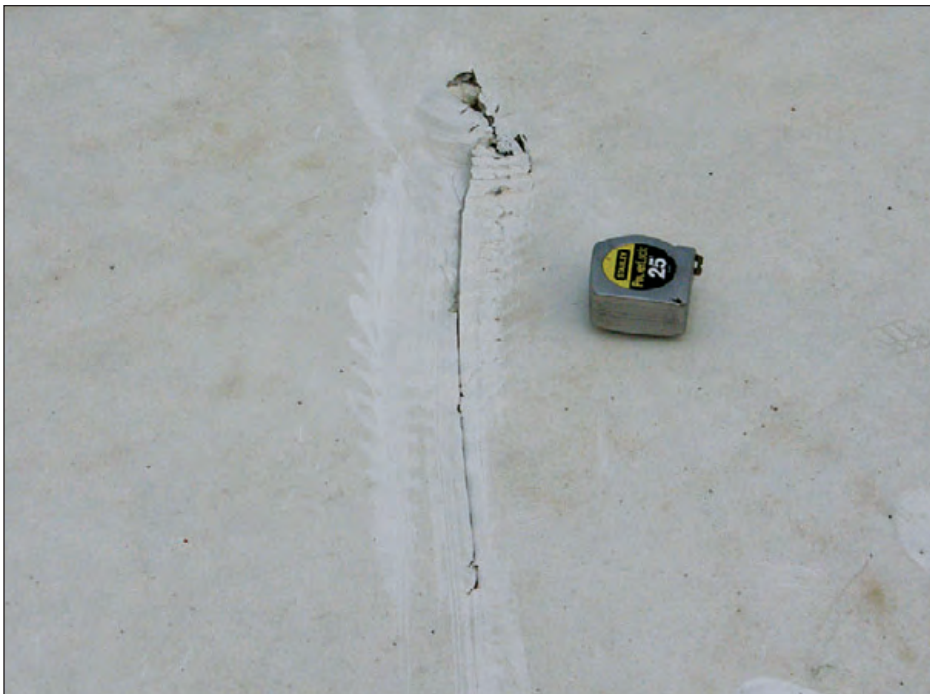
Figure 6-11: The single-ply roof membrane on this school was torn by a missile. The tear was still unprotected 6 days after it was damaged. A substantial amount of water can enter the building through such a tear, unless the deck is water tight (see Figure 6-13) or a secondary roof membrane is used as discussed in Section 6.3.3.7. Estimated wind speed: 105 to 115 mph. Hurricane Ivan (Florida, 2004)

Figure 6-10:	Plan view of a portion of the building in Figure 6-9 showing the use of a corner uplift zone in lieu of a perimeter uplift zone on the low-slope roof in the vicinity of the stair tower	6-12
Figure 6-11:	The single-ply roof membrane on this school was torn by a missile. The tear was still unprotected 6 days after it was damaged. A substantial amount of water can enter the building through such a tear, unless the deck is water tight (see Figure 6-13) or a secondary roof membrane is used as discussed in Section 6.3.3.8. Estimated wind speed: 105 to 115 mph. Hurricane Ivan (Florida, 2004)	6-15

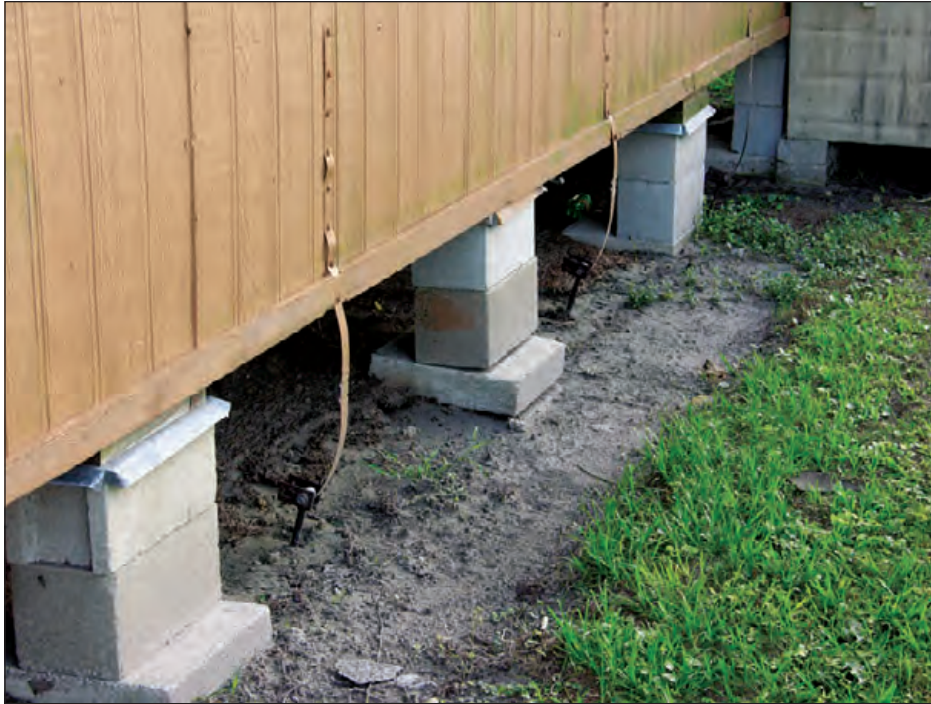
Figure 6-22: The metal straps between this portable classroom and the ground anchors were not taut. This classroom is susceptible to being blown off the piers and to overturning. See Figure 6-27 for a robust anchoring system.

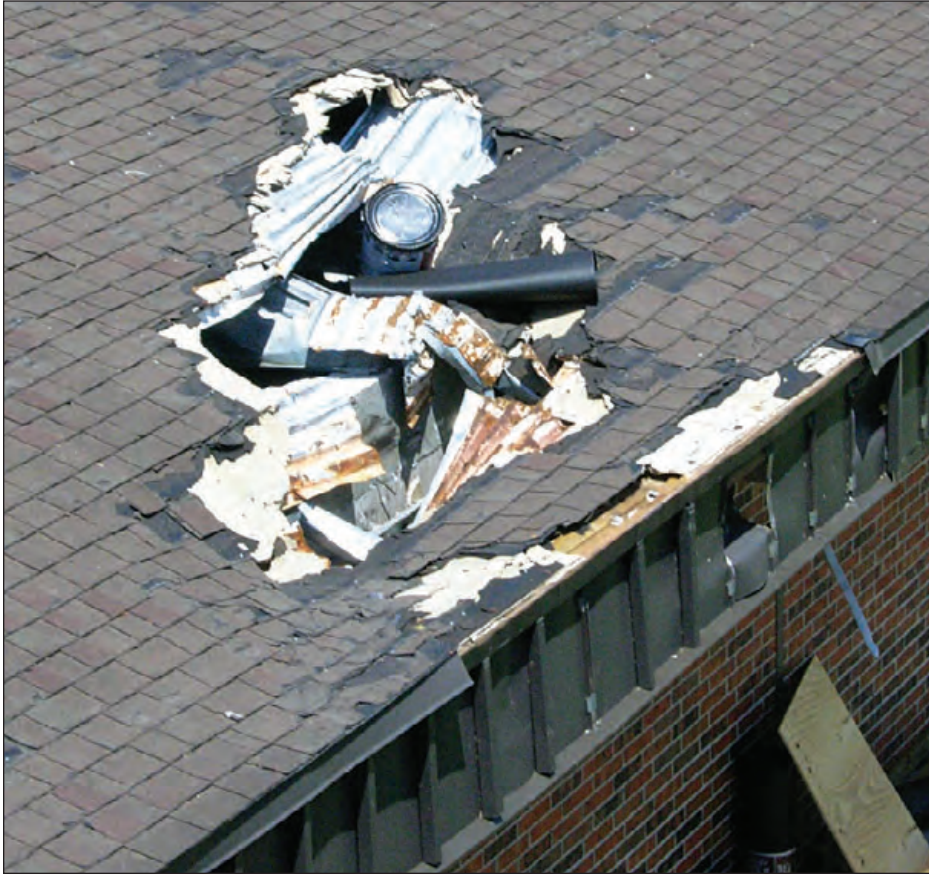
Figure 6-42:
At the school shown in Figure 6-34, wind-borne debris ruptured the proprietary composite deck system composed of light gauge corrugated metal deck and gypsum board. Estimated wind speed: 140 to 160 mph. Hurricane Charley (Florida, 2004)

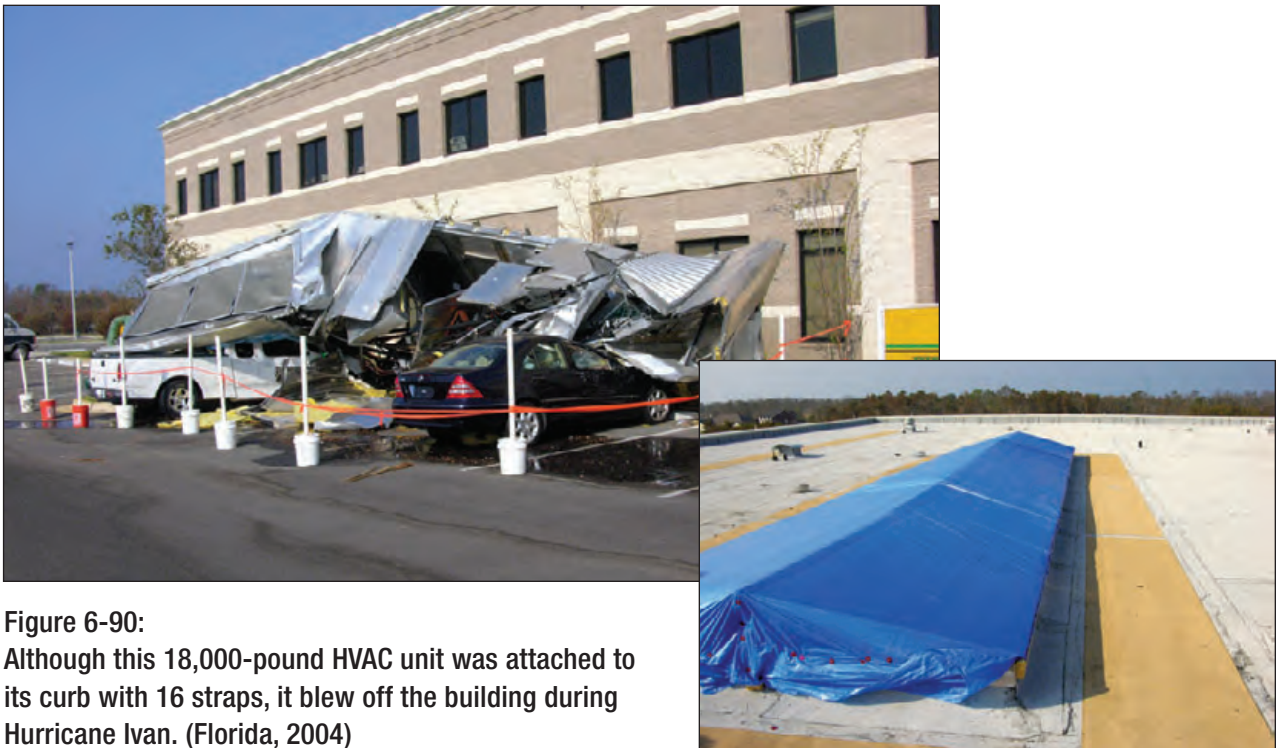
Figure 6-90:
Although this 18,000-pound HVAC unit was attached to its curb with 16 straps, it blew off the building during Hurricane Ivan. (Florida, 2004)

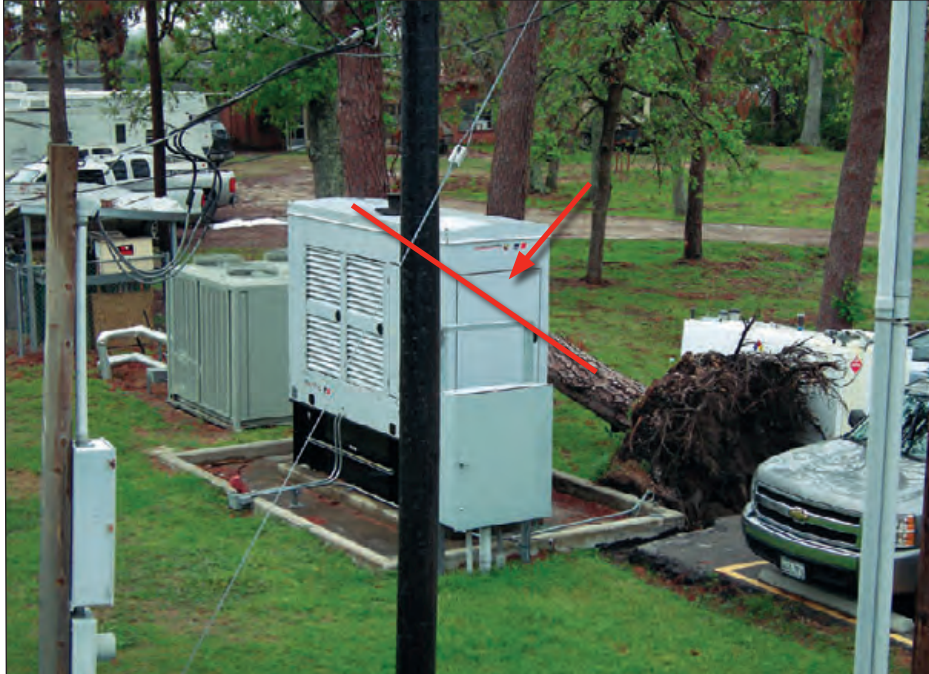
Figure 6-119:
The tree shown by the red line nearly fell on the emergency generator (red arrow). Estimated wind speed: 110 mph. Hurricane Ike (Texas, 2008)
