THE SECRETARY  
OF THE INTERIOR'S  
**STANDARDS FOR  
THE TREATMENT  
OF HISTORIC  
PROPERTIES**

WITH  
**GUIDELINES FOR  
PRESERVING,  
REHABILITATING,  
RESTORING &  
RECONSTRUCTING  
HISTORIC  
BUILDINGS**

U.S. Department of the Interior  
National Park Service  
Technical Preservation Services

2017

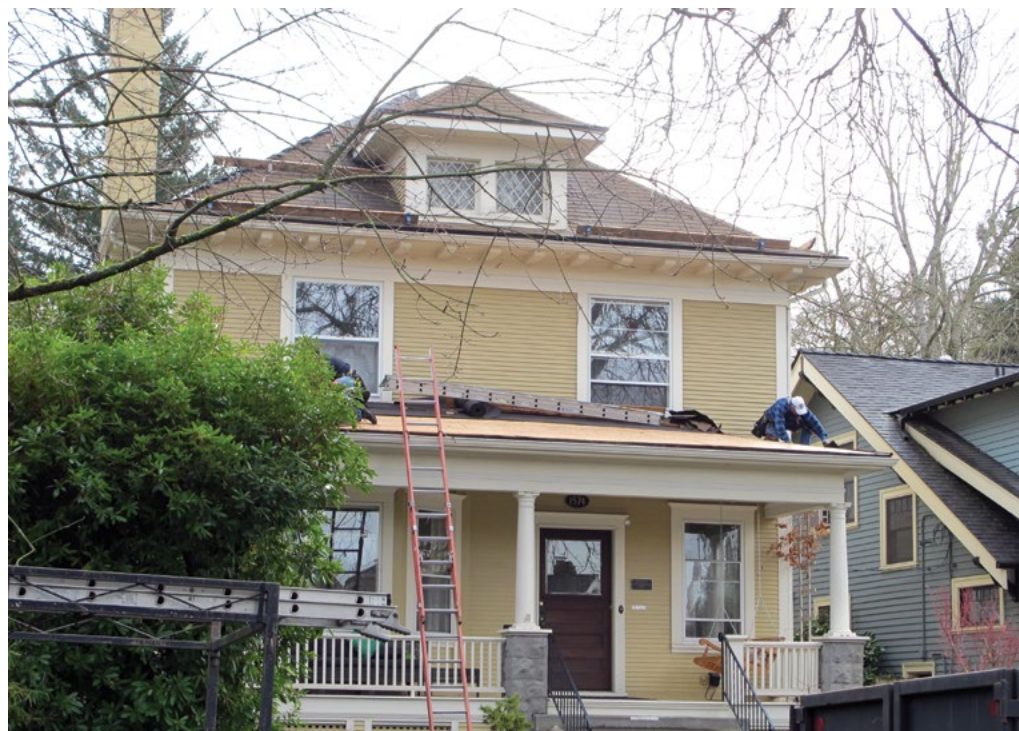
[16] The deteriorated asphalt shingles of this porch roof are being replaced in kind with matching shingles.

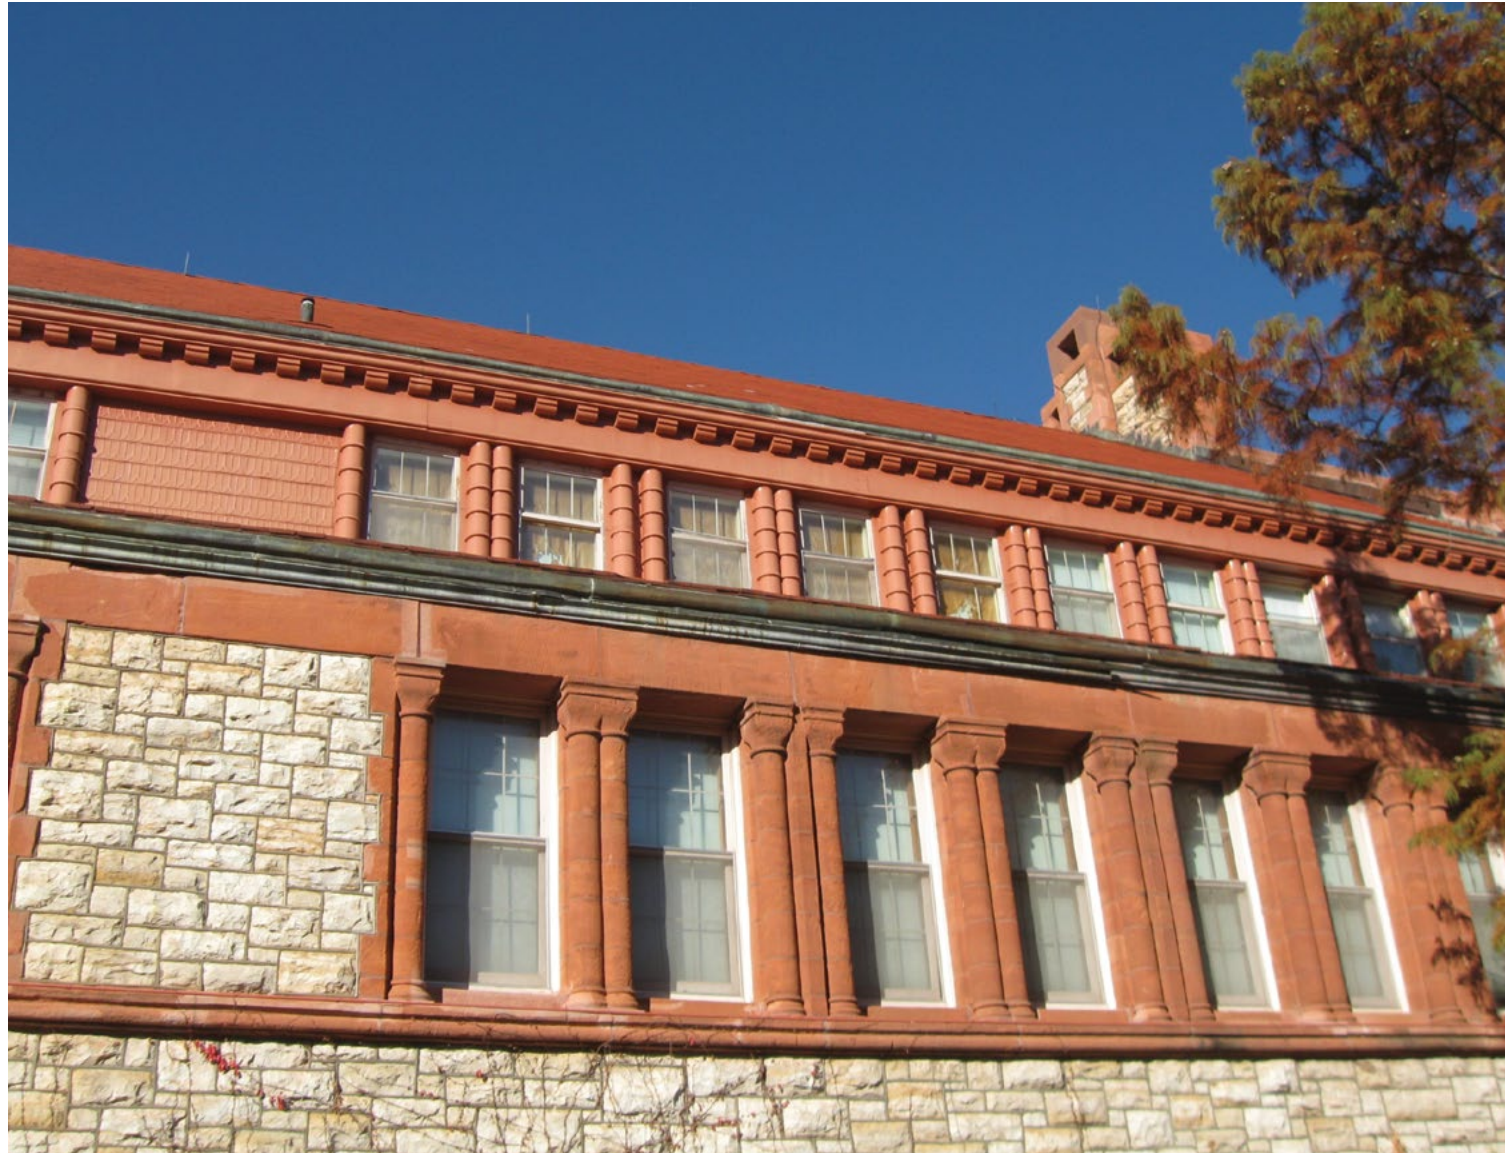
[6] Preliminary work before starting restoration revealed that the columns and the decorative shingles ornamenting the top floor of this historic building were fabricated of metal to imitate the red sandstone used elsewhere on the building.
