# ENGINEERING AND CONSTRUCTION BULLETIN

**No. 2009-3**

**Subject:** Ceramic Coated Piston Rods

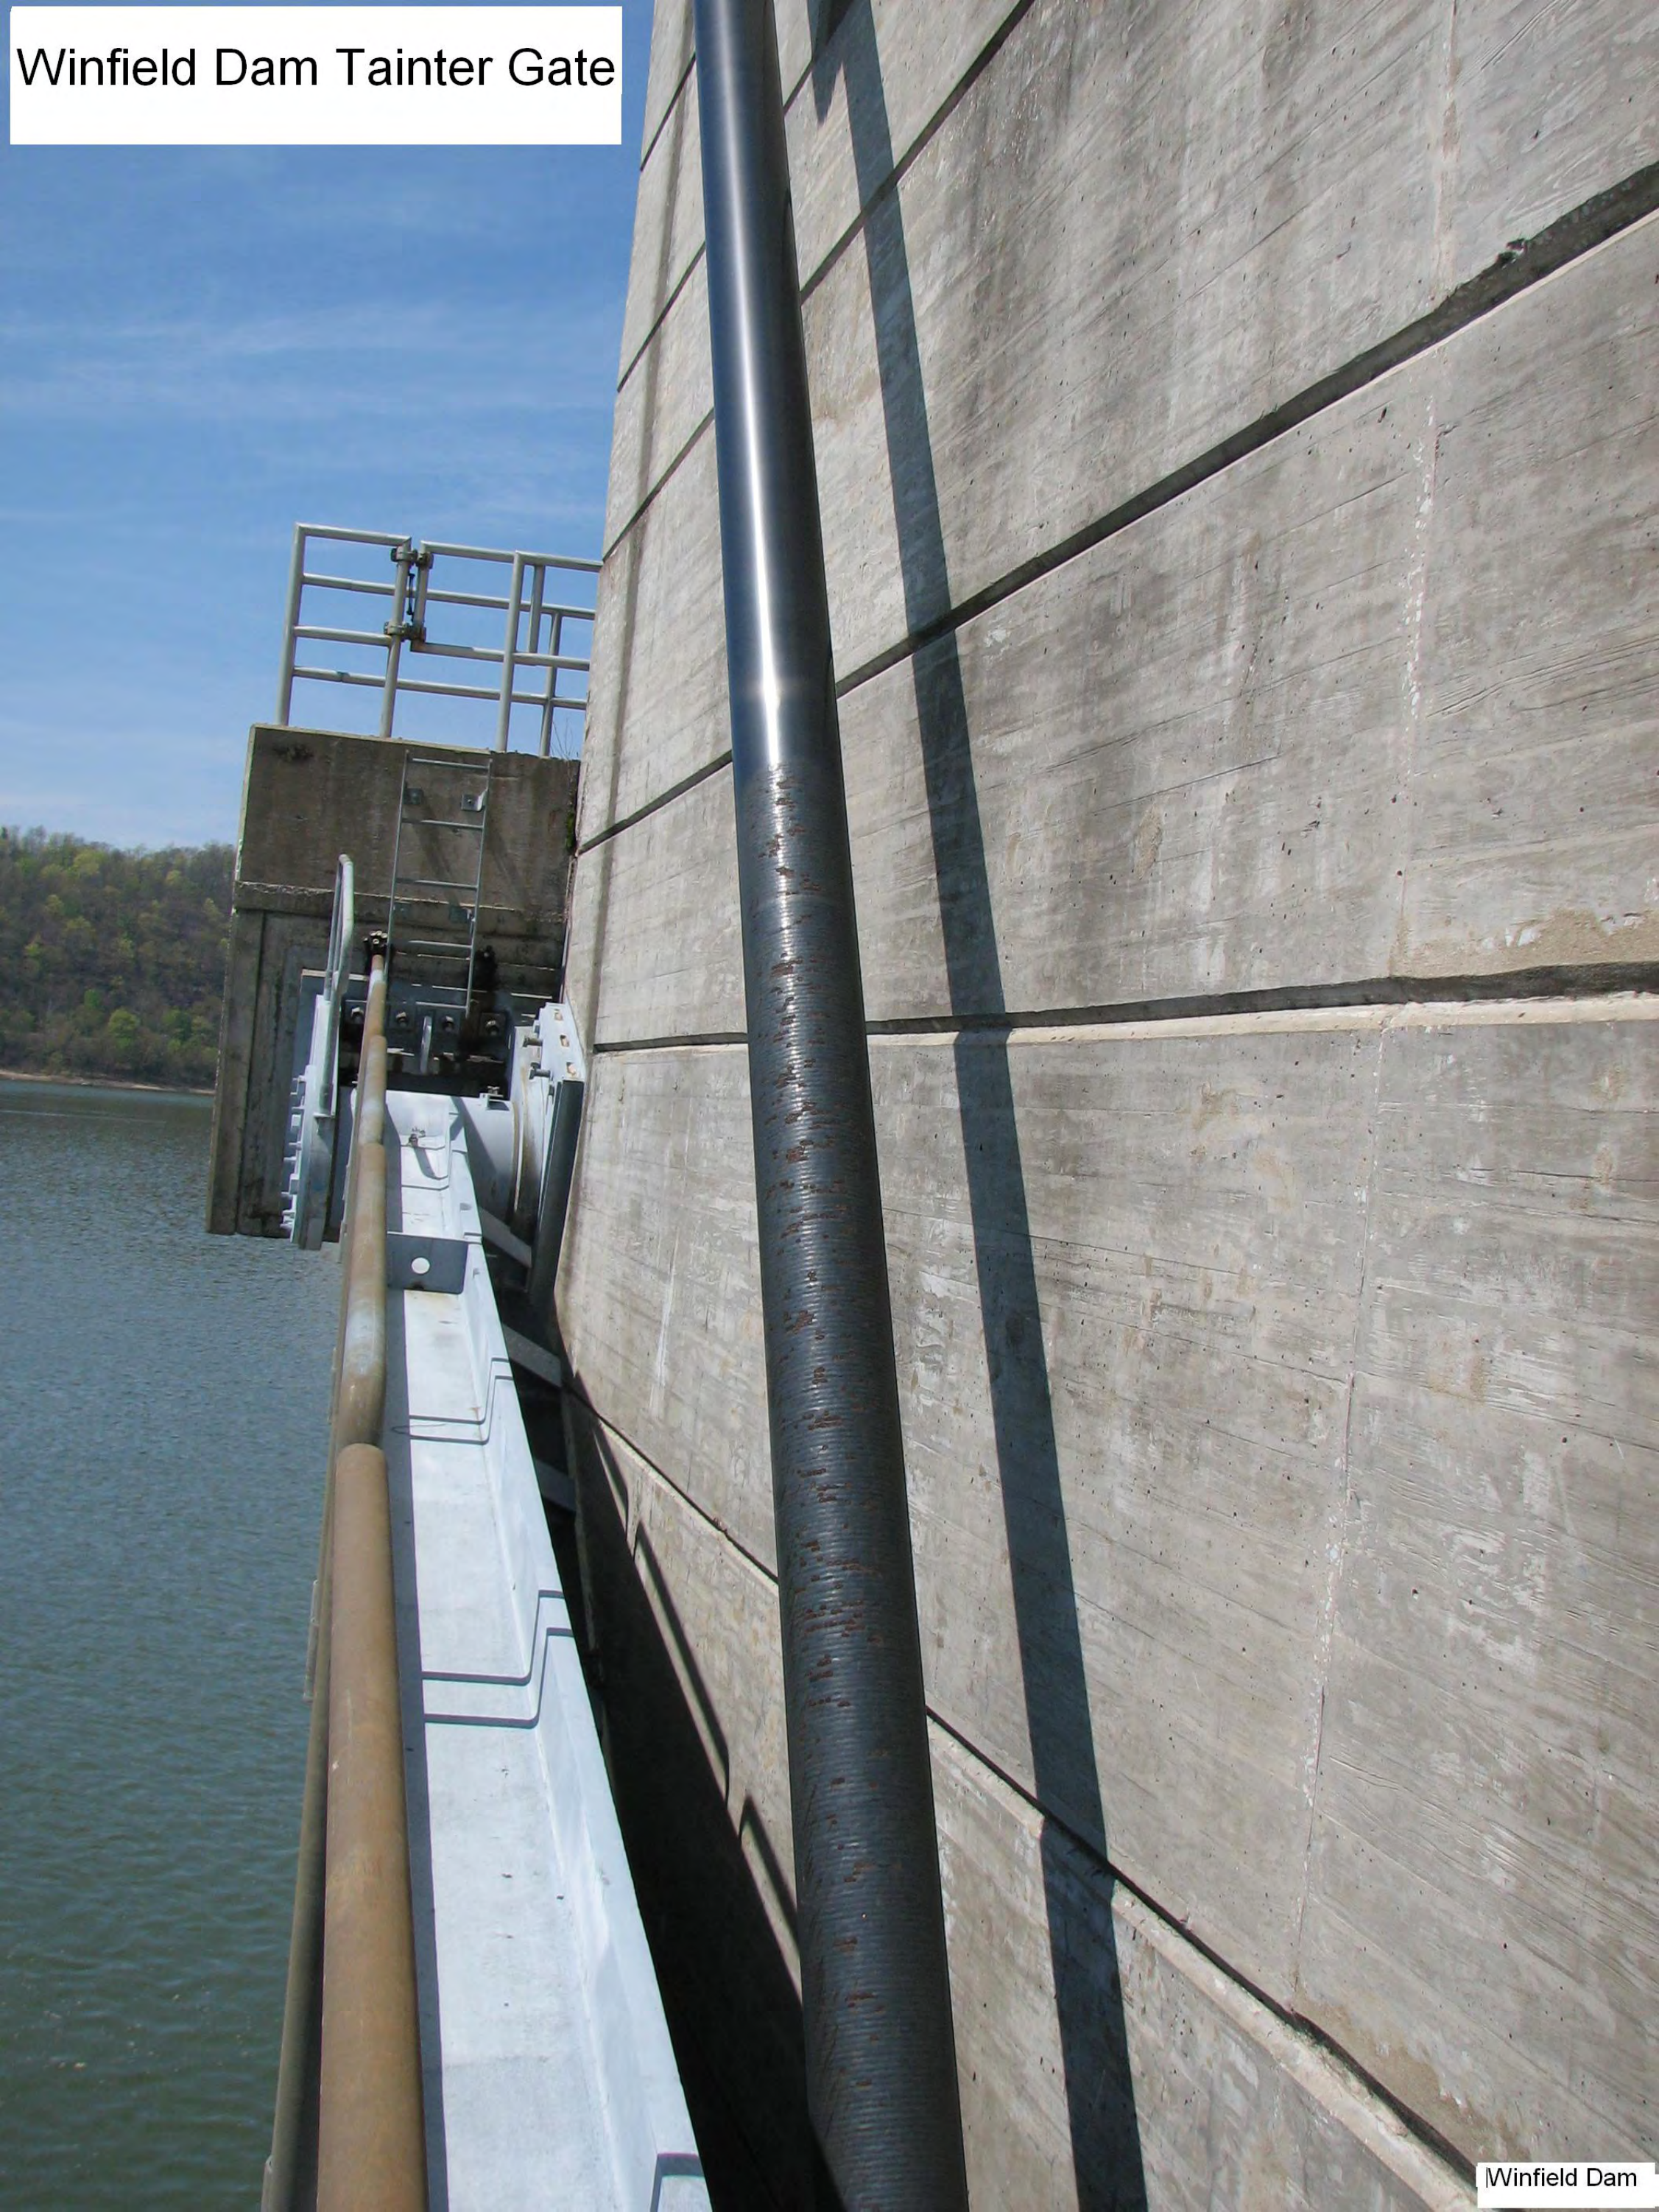
Winfield Dam Tainter Gate

2. Winfield Dam tainter gates, Olmsted Lock miter gates, and Braddock Dam tainter gates have all experienced failures of the ceramic coating on its piston rods. Winfield Dam has been in operation since mid-1990 and Braddock Dam since 2002. The hydraulic cylinders at Olmsted Lock were installed in 2000 but the lock will not be in regular use until the dam is completed. The piston rods at Winfield and Braddock Dams are rarely fully retracted into the hydraulic cylinder. Olmsted Lock miter gates are routinely exercised and the gates are stored in the open position with the piston rod fully retracted, but a portion of the rod remains exposed. The exposed portion is where failure occurred. Leaving the piston rod exposed to the elements for long periods is believed to allow moisture to penetrate the pores of the ceramic coating and slowly corrode the carbon steel base metal. The attached photos show that the corrosion of the base metal for both Winfield Dam and Olmsted Lock is obvious. The Braddock Dam piston rod coating is in the early stage of failure, and corrosion was observed only by magnified examination of the rod's surface.

4. Performance of ceramic coated piston rods at Corps CW projects has proven not to be satisfactory. It may work well for installations where the gates are operated frequently, but even for those projects, a part of the rod (next to the clevis end) remains exposed to the elements and subject to coating failure. Based on the information provided above, Corps guidance and criteria will be revised to eliminate the option of ceramic coated rods. All new projects, and rehabilitation and repair projects should, depending on the installation, specify chrome plated stainless steel or nickel and chrome plated carbon steel piston rods in accordance with [UFGS 41 24 27.00 10](#).
