PUBLIC WORKS TECHNICAL BULLETIN 200-1-45
1 FEBRUARY 2007

**DECONSTRUCTION OF WWII-ERA WOOD
FRAMED BUILDINGS**

DECONSTRUCTION OF WWII-ERA
WOOD FRAMED BUILDINGS

1. Purpose. This Public Works Technical Bulletin (PWTB) provides case studies and lessons learned on the deconstruction of excess or surplus buildings at seven Army installations. PWTB 200-1-23 provides detailed technical guidance for the recovery, reuse, and recycling of materials from building deconstruction.

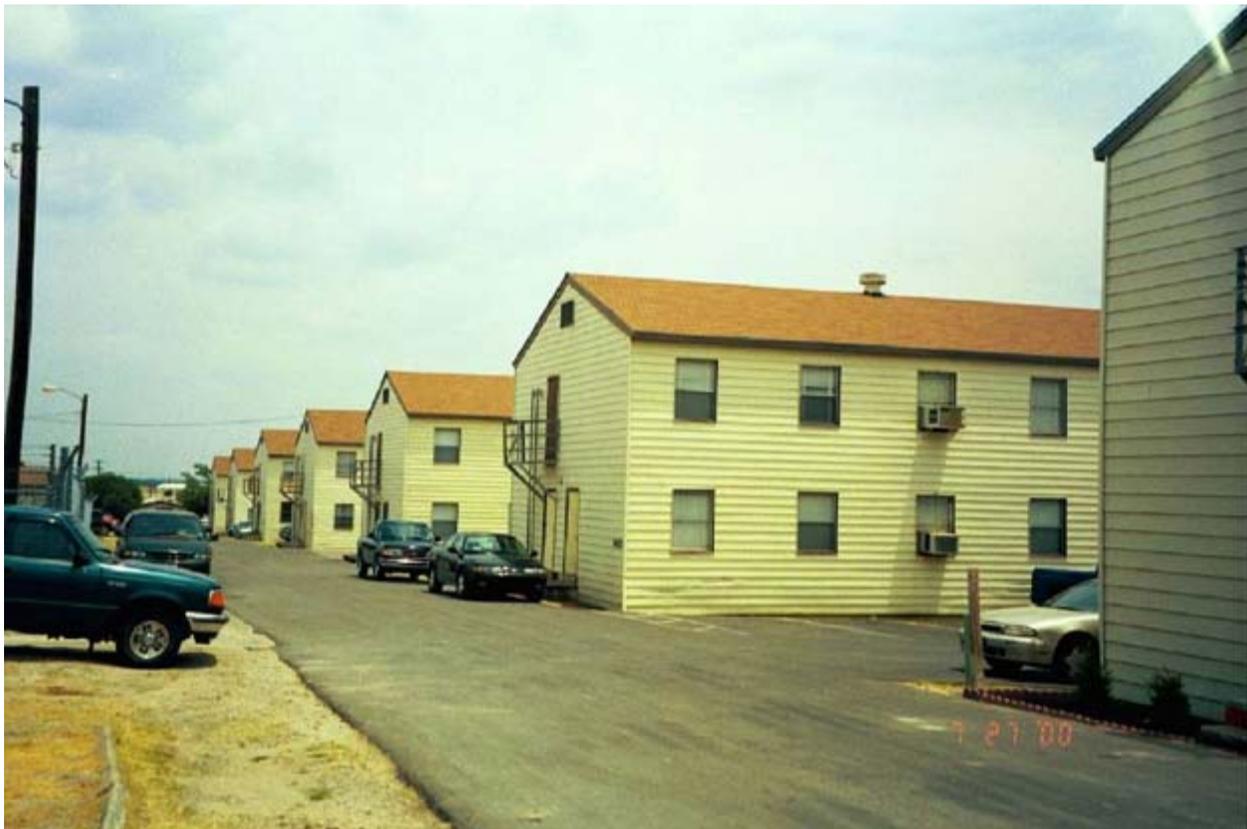
Figure A1. Typical WWII-era, wood-frame buildings at Fort Hood.

In the past, the Army has commonly removed surplus buildings from its real property inventory through conventional demolition of the buildings and then landfilling the demolished debris. Conventional demolition generally does not produce salvageable material. Demolishing an average two-story World War II-era barracks (Figure A1) produces nearly 400 tons of debris.

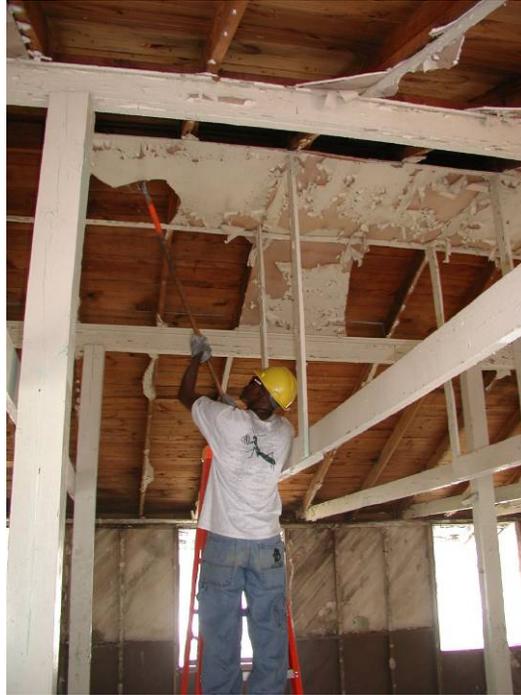
Figure A2. Removing drywall at Fort McClellan.

Examples of building deconstruction activities are the removal of siding, sheetrock, windows, wall studs, flooring, trusses, and wood trim. Indoor and outdoor deconstruction activities are depicted in the following photographs (Figures A-2 through A-4).

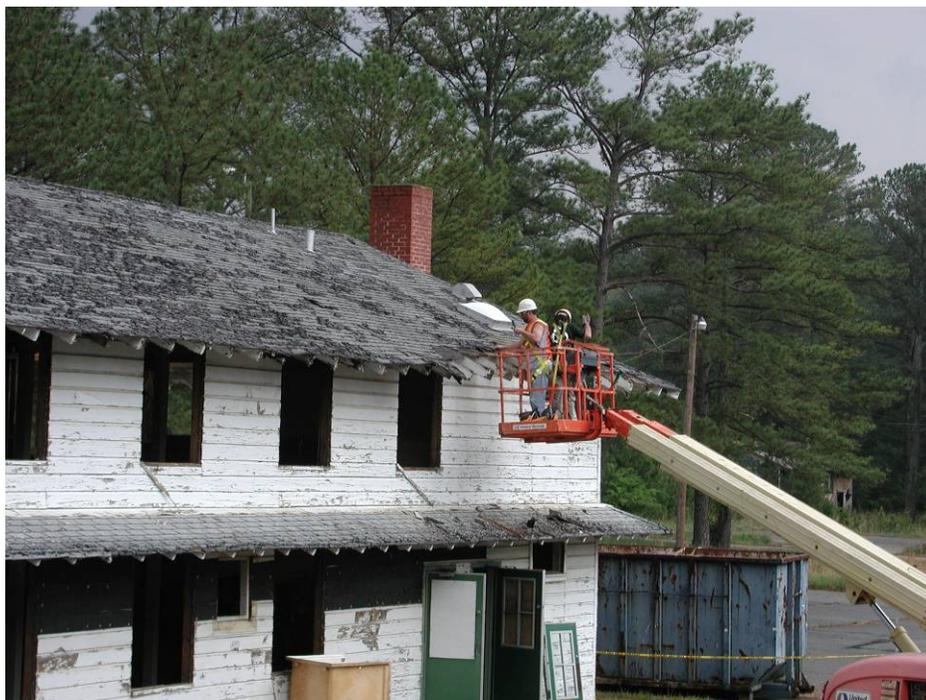
Figure A3. Removing eaves at Fort McClellan.

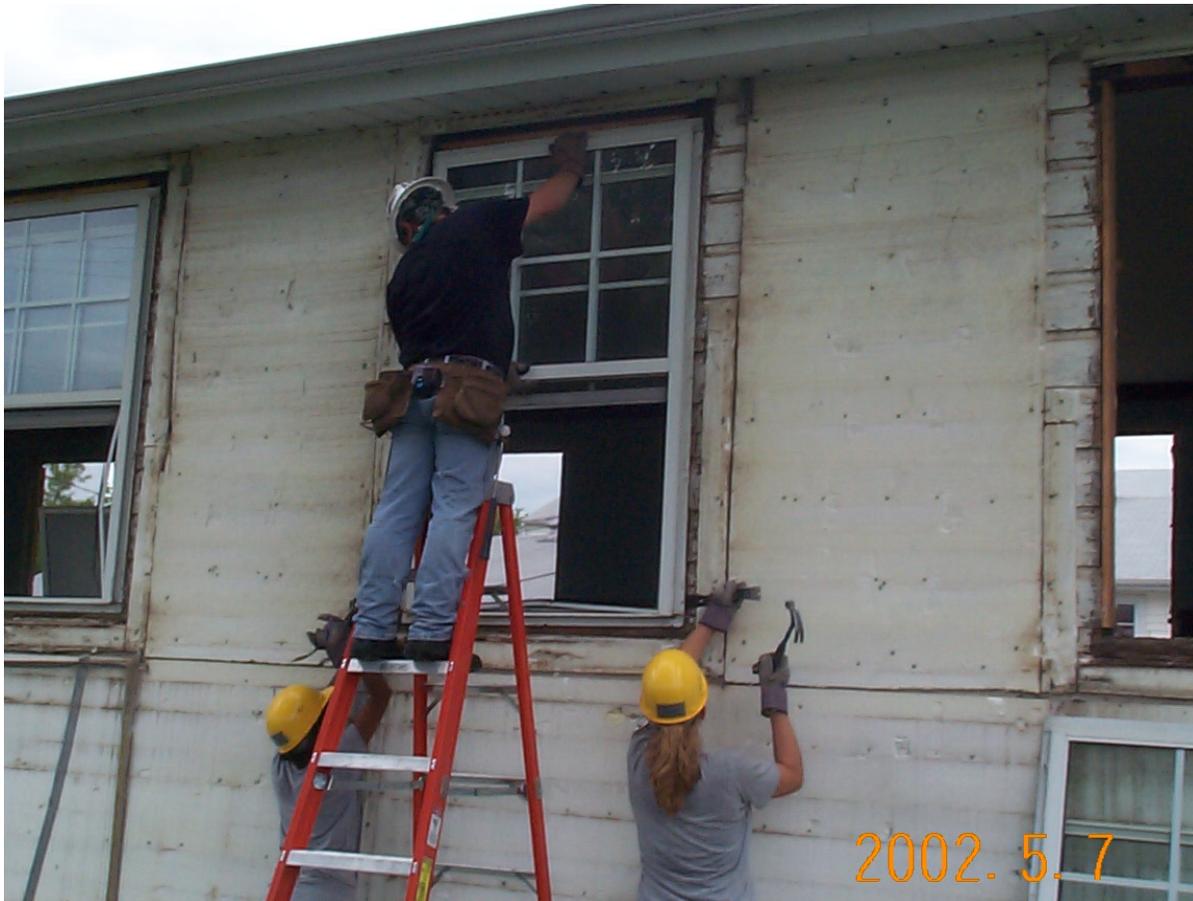
Figure A4. Removing windows at Fort Campbell.

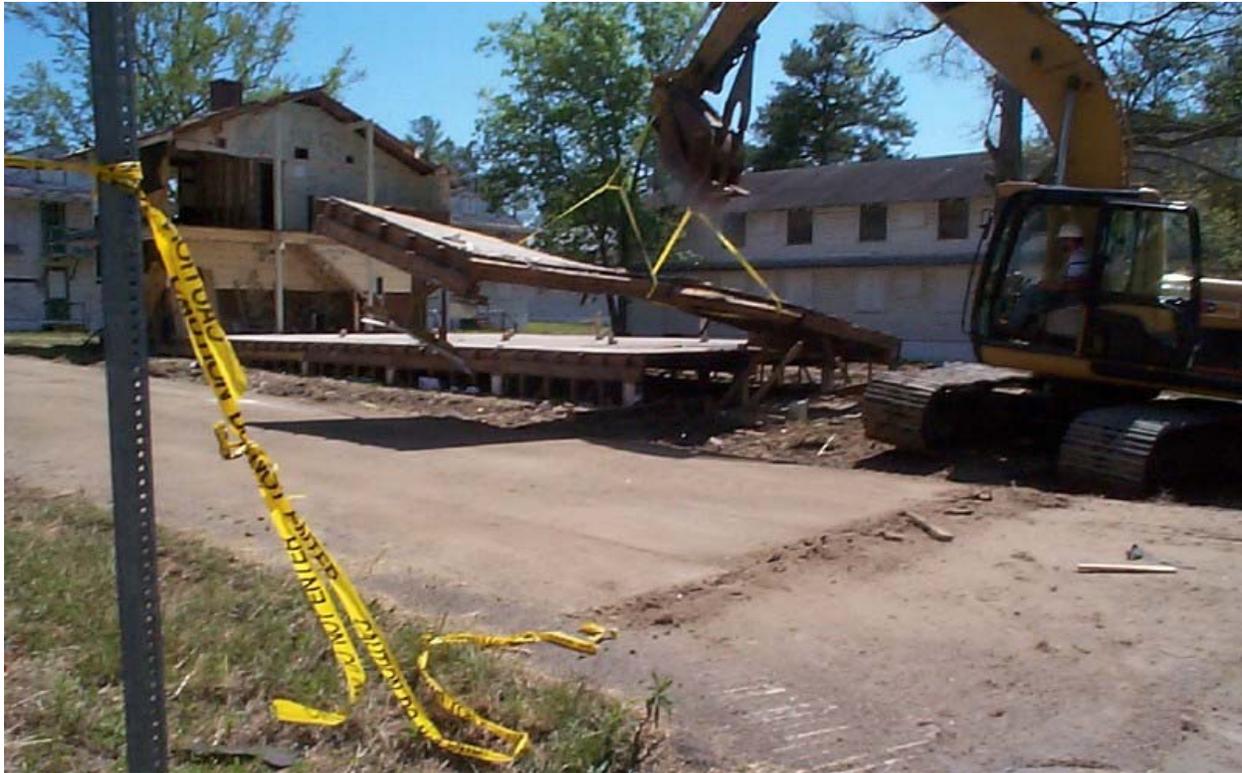
Deconstruction methods can be manual, panelized, mechanical, or a combination thereof. An example of panel deconstruction is the removal of large sections of roof decking by cutting the decking into panels between rafters and removing the panels all at once. Figure A5 shows the panelization method of deconstruction.

Figure A5. Floor panelization at Fort McClellan.

Panelization allows roof, wall, and floor sections to be removed more quickly than manual methods but will reduce salvage yields. Manual deconstruction generally yields a higher percentage of salvaged materials than panel deconstruction. Manual deconstruction takes longer than panel deconstruction, however.

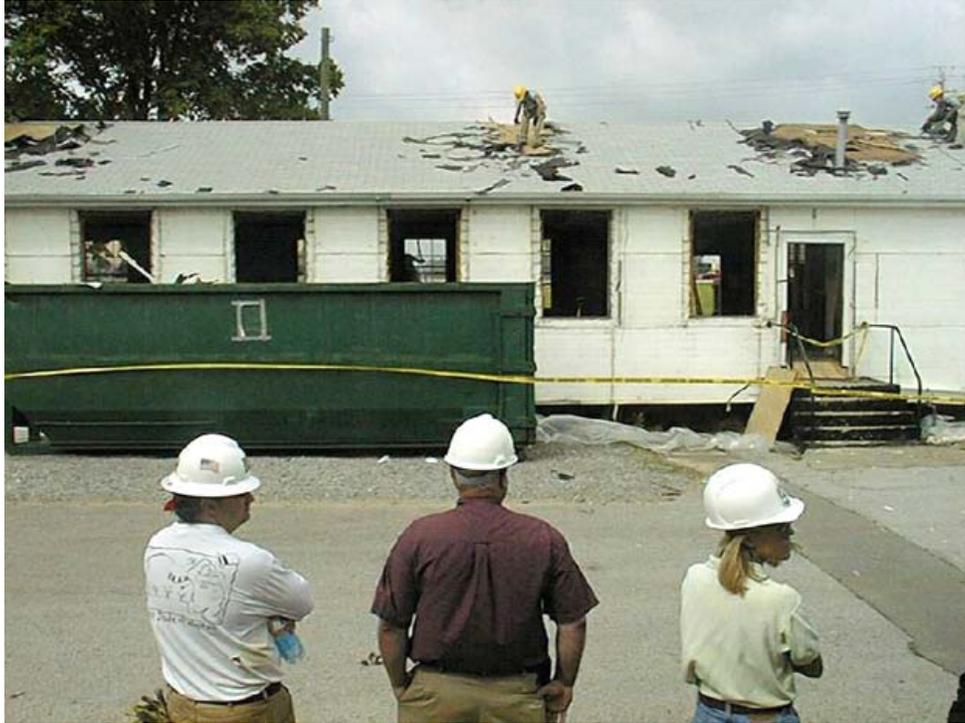
Figure A7. Building deconstruction at Fort Campbell.

The second deconstruction project (Figures A7 through A9) was a pilot study ERDC's Construction Engineering Research Laboratory (ERDC-CERL), an HfH affiliate of Austin, Texas, the FPL, and the University of Florida's Center for Construction and Environment.

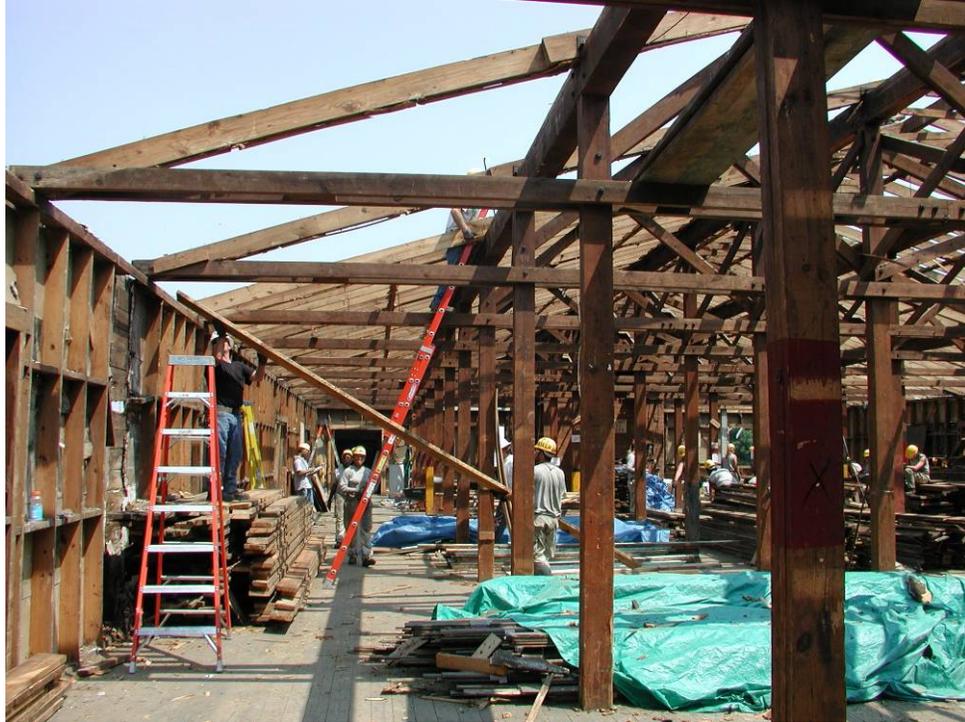
Figure A8. Building deconstructed down to the frame at Fort Campbell.

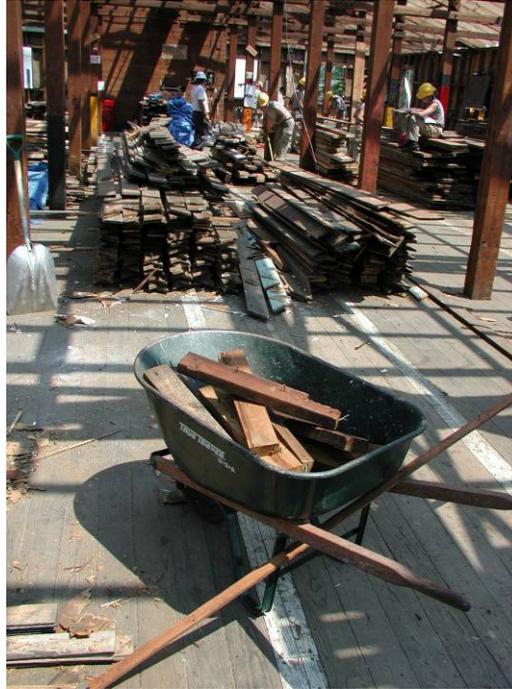
Figure A9. Stacking salvaged wood at Fort Campbell.

The processing of material includes activities like removing nails from wood items and cutting, sorting, and stacking of items. Cleaning may be required of items to be salvaged. Items may be processed from the building to a staging area. Trash and unusable materials that cannot be recycled may be removed and placed in dumpsters located on the job site.

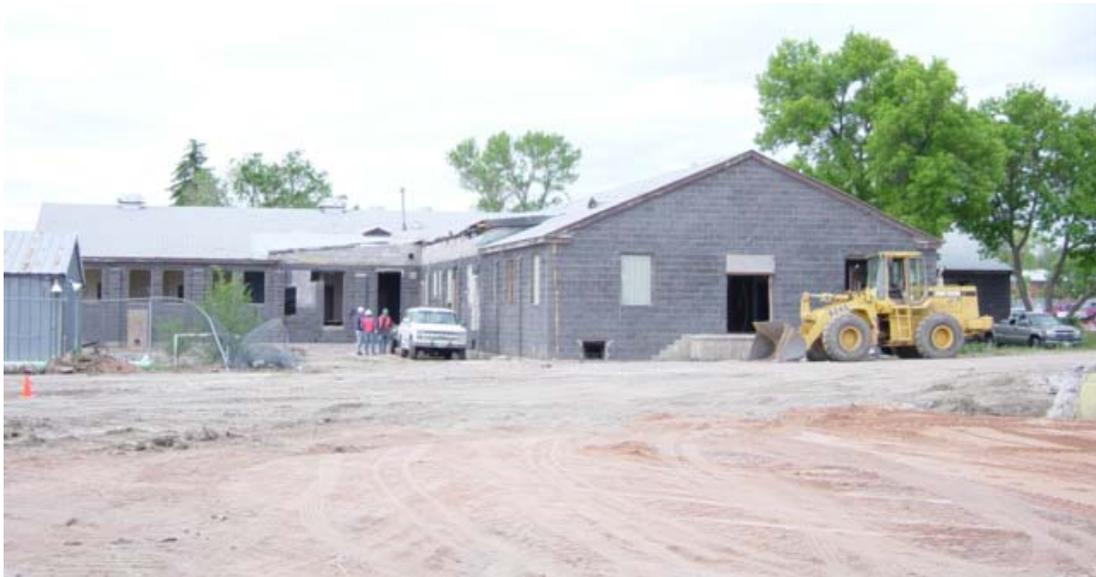
Building 6286 was a 13,128 sq ft, single story, World War II-era structure. It had a concrete masonry unit (CMU) exterior with 2 x 4 wood interior partition walls. It had wood rafters and "skipsheet" roofing. The roof sheeting was 1 x 10 and 1 x 12 butt-jointed boards with as many as five layers of asphalt roofing (generally three layers of shingles). The roof structure was supported by bolted trusses in some areas and a web truss style in the west wing. The interior surface of the roof was sheet rocked in some areas. The exterior of the building consisted of 2 x 2 x 10 nailers pinned to the CMU exterior wall. The building had been used in urban warfare training exercises. The building had some flooring comprised of a single layer of 2.25-in. tongue-and-groove (T&G) fir. Other areas had a plywood subfloor. The floor was supported on 2 x 12 floor joists, beams, and poured-concrete posts.

Figure A10. Building 6286 at Fort Carson, shortly before deconstruction.

Buildings 6286 (Figure A10) and 227 were selected for deconstruction based on their distinct building types and planned removal dates. Buildings 6286 and 227 required different deconstruction approaches and techniques.

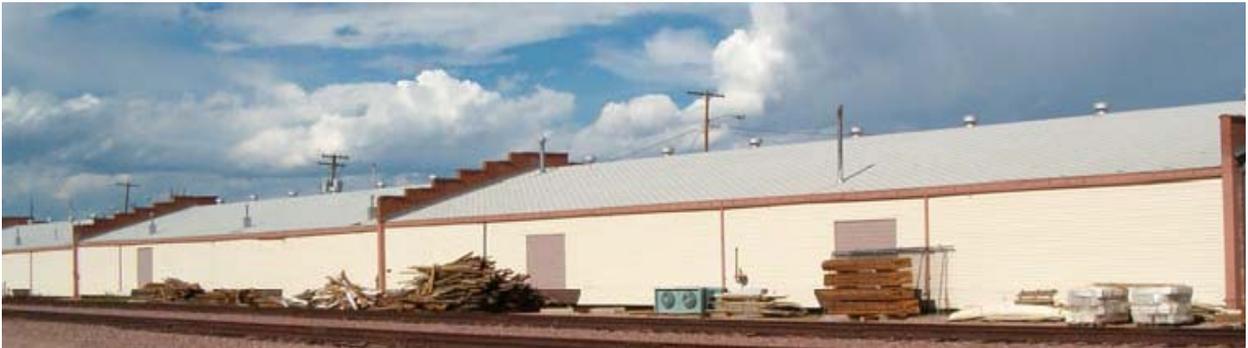
dimensions were approximately 70 ft x 130 ft (10,000 sq ft). It was a single-story structure of wood construction, with few interior partition walls (approximately 1,500 sq ft of partitioned interior), wood rafters and skip-sheet roofing with four layers of asphalt shingle and rolled roof. The wood-frame building design of this warehouse was well suited for deconstruction.

Figure A11. Building 227 at Fort Carson.

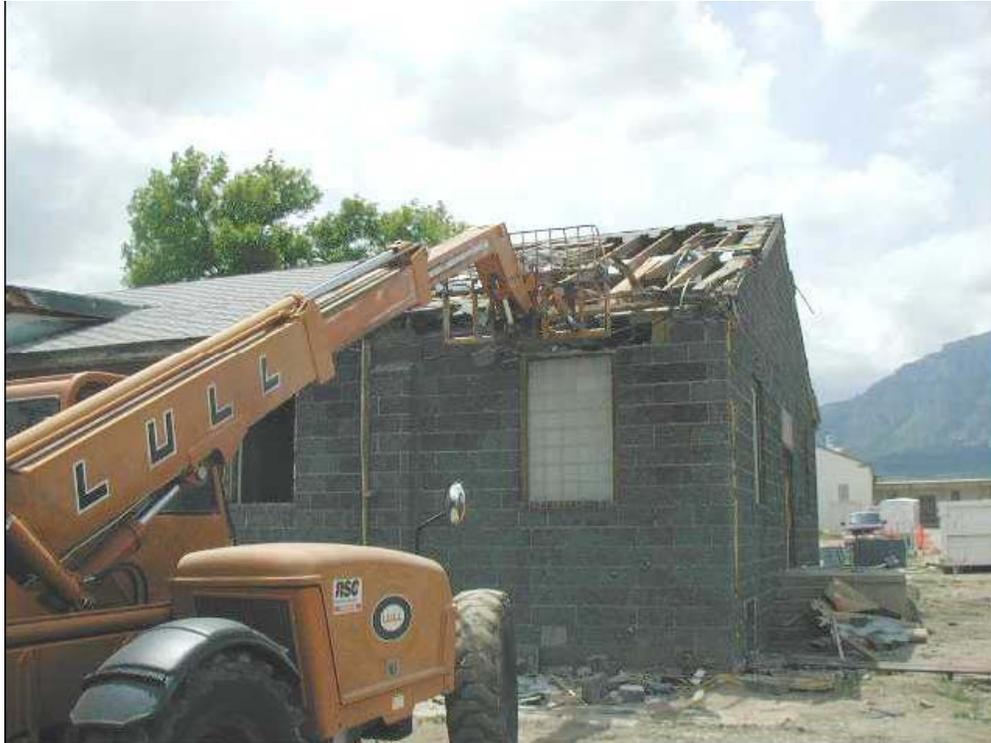
The roof sheeting was sought as a harvestable product. Relief cuts using a circular saw were made from peak to soffit every 16 ft. The reach forklift was used to peel off sections of the roof (Figure 12).

Figure 12. Reach forklift removing a roof section.

Fort Carson used this method to enable preservation of the rafter boards. Trusses were lowered using the reach forklift so that they could be disassembled on the relatively safer ground. The 2 x 6 x 20 joists on the north wing of the building were harvested by pulling out the exterior walls, allowing the ceiling to fall to the decking. On the east wing, however, rafter boards were pulled, and interior ceiling drywall was loosened and dropped to the floor exposing the ceiling joists. This wing also had the attic space finished with drywall, which added to the debris and labor required to harvest the joists. At this point, steel tubing cross bracing for lateral support was encountered. Fort Carson discovered that each 2 x 6 x 20

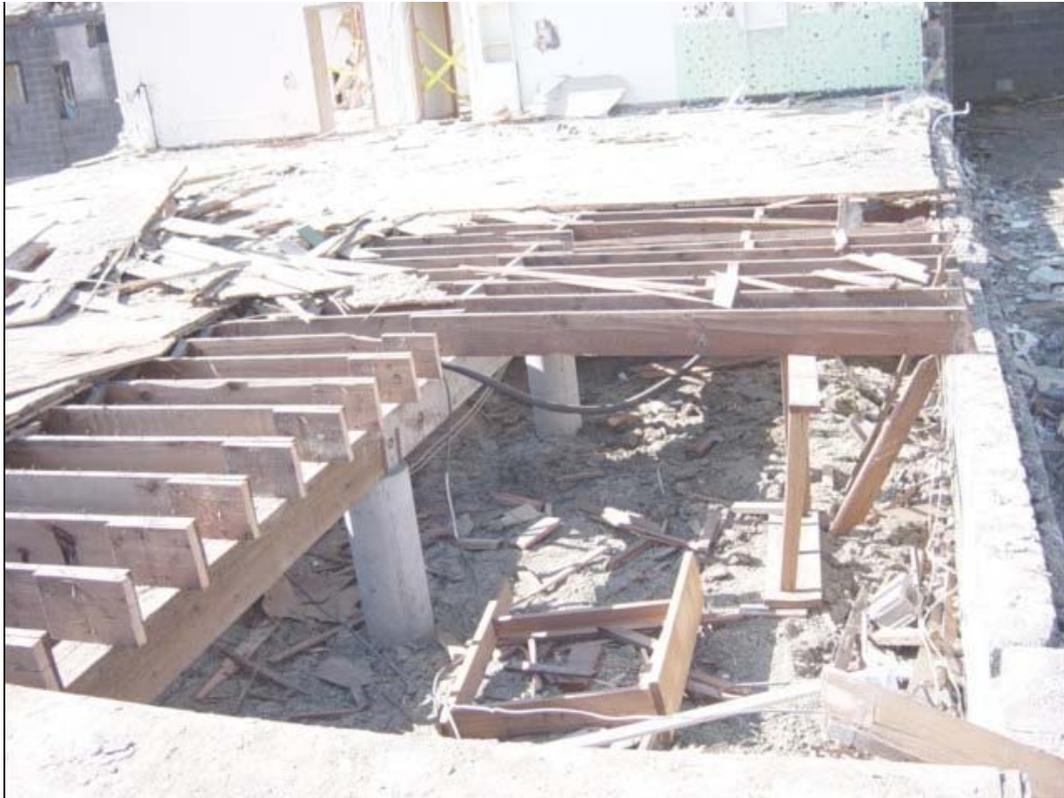
Wood flooring, concrete pillars, and footers (Figure A13) were sought for reuse and recycling. Plywood subflooring was pulled up, exposing 2 x 12 floor joists. The floor joists were then removed by hand and either denailed or recycled. Most of the floor joists in the north and south wing had been exposed to extreme temperatures from the steam pipes beneath the building. These floor joists had dry rot, so a reach forklift was used to lift off the subflooring and accumulate it for recycling rather than for reuse or resale. An excavator was then used to pluck the floor joists from the foundation and place them in a stockpile. Once the flooring was removed, the excavator was used to retrieve the concrete pillars and foundation for recycling.

Figure A13. Floor joists and concrete piers exposed during deconstruction of building 6286.

The HTHW pipe steam leaks generated excessive heat and caused the floor joists to bake. This precluded a good harvest of usable boards.

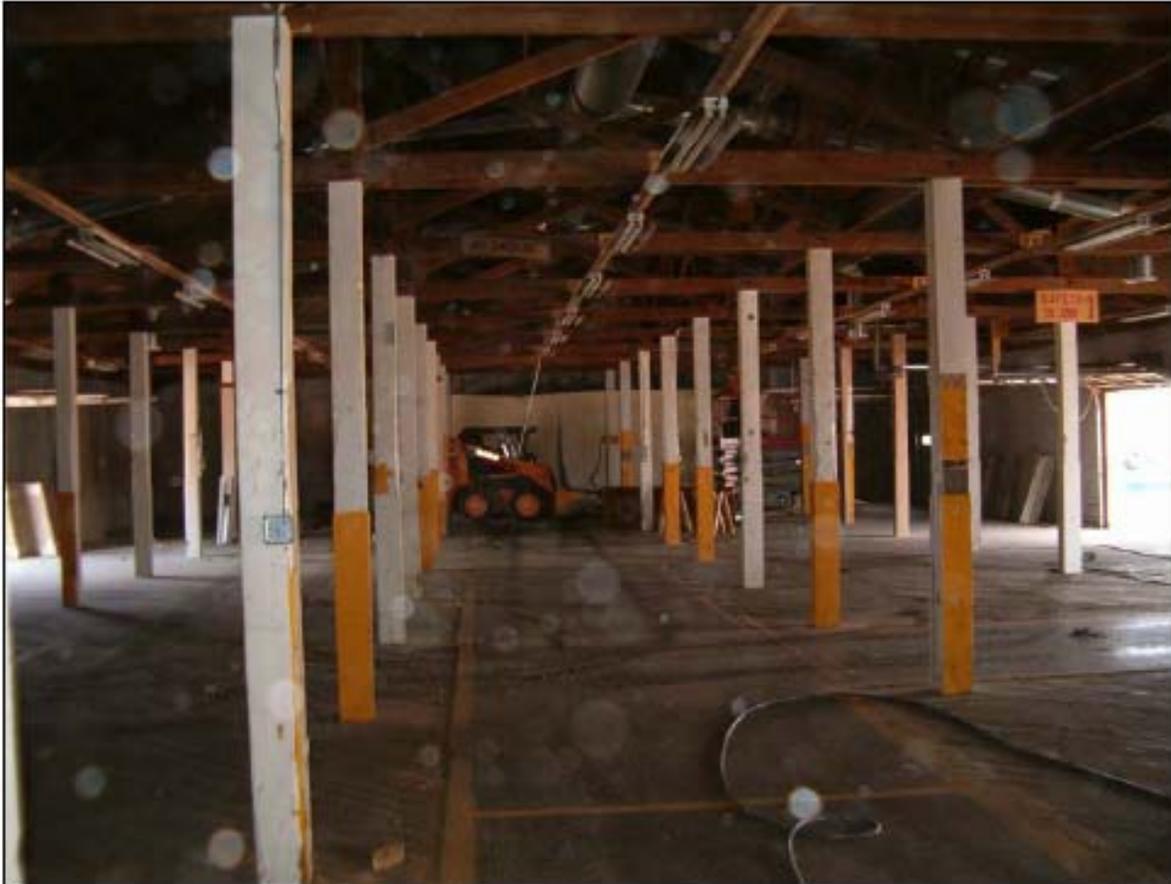
were bolted/bracketed to the bottom of the rafters. The interior surface of the roof was sheeted with 3/8-in. fiber board. Blown-in, cellulose insulation sandwiched between the fiber board and roof sheeting was removed using a vacuum truck.

Figure A14. Interior view of columns and roof structure in building 227.

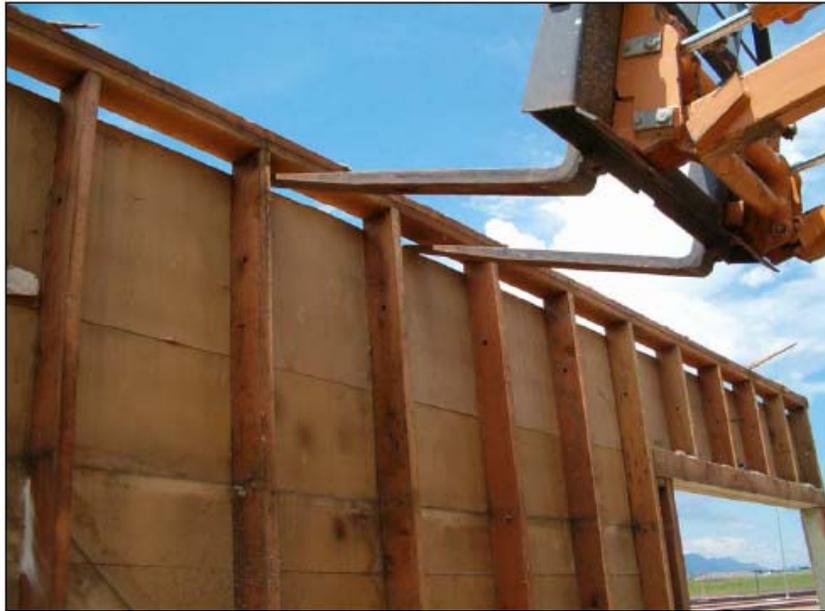
Building 227's exterior was covered with vinyl siding. The building exterior was characterized by 2 x 6 x 10 studs with 1 x 8 lap siding with lead painted exterior. The interior surface of the exterior walls was 1 x 6 T&G and painted with LBP. The exterior walls were removed using the reach forklift (see Figure A15) and dropped inside the building.

Figure A15. Reach forklift removing exterior walls

Vinyl and lap siding were removed from the inside using claw hammers and flat bars. Fort Carson reports that the presence of LBP on the siding did not negatively impact the siding removal process. Three members of the workforce were outfitted with lead air monitoring cassettes and monitored for lead exposure. None of the individuals exceeded Occupational Safety and Health Administration (OSHA) action levels. Precautionary measures were taken to adequately wet the walls prior to removal in other areas. Fort Carson felt this technique aided in reducing the amount of dust exposure for workers.

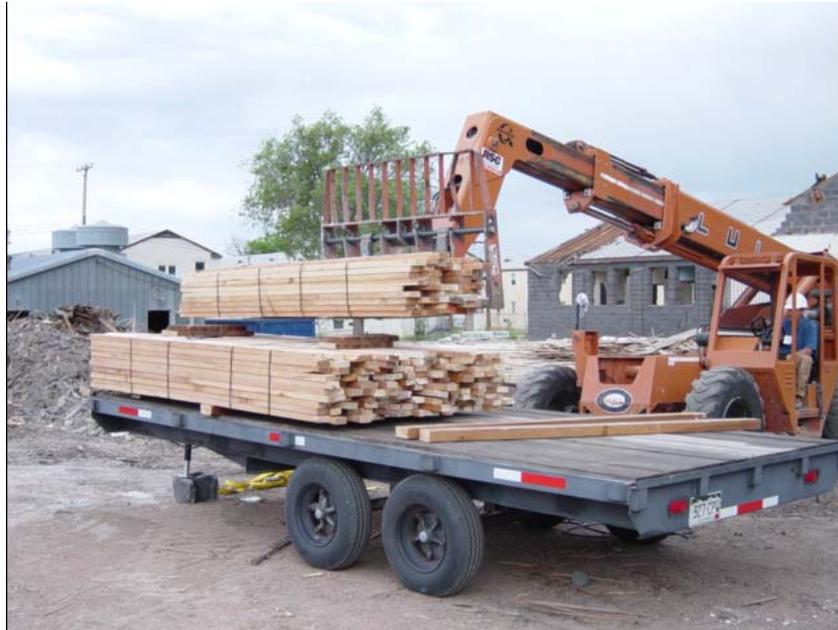
Most of the reusable material salvaged for resale was lumber, which equated to approximately 18,000 linear feet. Figure A17 shows harvested wood bundled for reuse and sale at Fort Carson.

Figure A17. Harvested wood bundled for sale.

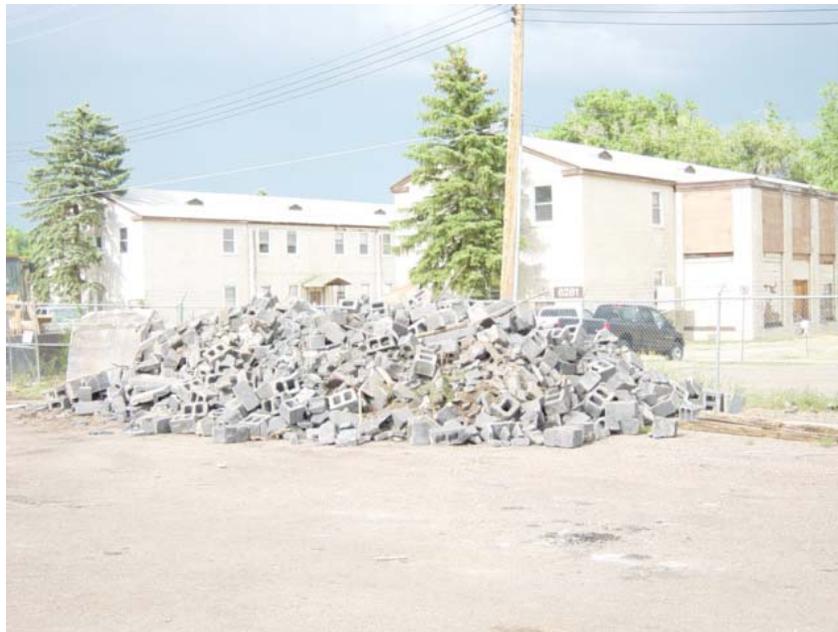
Exterior cinder block walls and glass block were sought as recyclable products (see Figure A18). Fort Carson had hoped to recover the cinder block for use as aggregate on Fort Carson's combat roads and trails. The glass block was intended for resale. But the accumulated cinder block had to be disposed of as rubble due to the unavailability of an Army Reserve Engineer Unit's rock crusher. The material could not be accumulated on site. Fort Carson felt that if they could have executed the recycling of this block as planned, it would have made a significant impact on the future removal techniques employed for buildings similar to building 6286.

Figure A18. Cinder block intended for recycling.

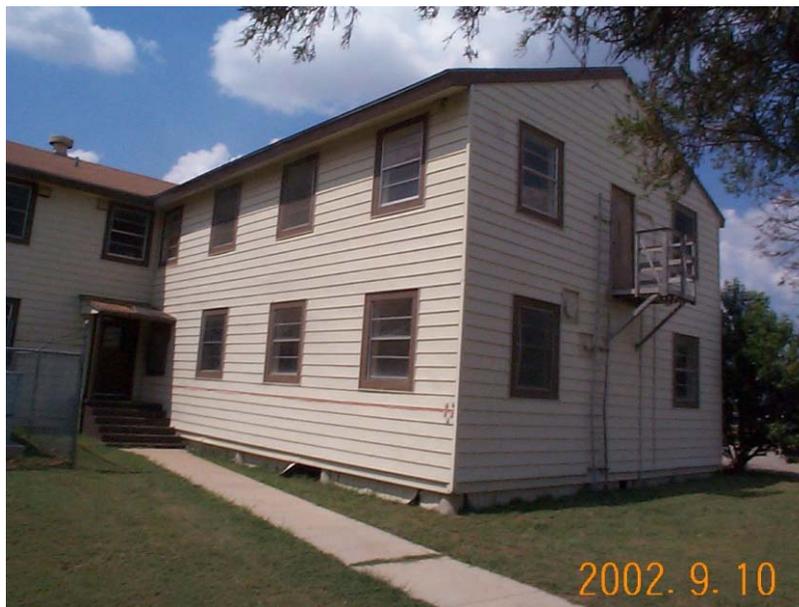
Figure A19. Building 919 at Fort Hood.

Fort Hood wanted to remove building 919 (see Figure A19) as quickly as possible using deconstruction rather than conventional demolition practices. In doing so, however, Fort Hood also wanted to evaluate deconstruction methods that would yield the maximum amount of salvaged/recycled material from a particular building. So the project was established as a research project to compare manual deconstruction methods with panel deconstruction methods. Fort Hood hoped to determine an optimal combination of manual and panel deconstruction methods for further deconstruction projects at Fort Hood.

Building 919 turned out to have three levels of flooring and multiple layers of siding. The outside layer of siding was metal, which was recycled. Fort Hood determined that the initial layer of wood lap siding contained LBP. Fort Hood was hopeful the initial layer of lap siding would be in useable condition (minimal peeling and chipping). Unfortunately, the condition of this lap siding was too poor for HfH to use. Fort Hood was unsuccessful in securing a device to plane the siding to remove the LBP.

An extra floor layer was found in September 2004. Discovered under two layers of flooring were 9 in. x 9 in. tiles that contained mastic with asbestos. A contractor for Fort Hood had surveyed the building for ACM before the deconstruction project began. Based on those results, Fort Hood estimated that only a small fraction of one bathroom floor contained asbestos material: an approximate area of 100 sq ft. Actually, approximately 12,000 sq ft of flooring was required to be abated. Fort Hood secured funding from HNC for the abatement of this tile. The cost of abatement was \$50,000. The abatement work delayed the project by almost 2 months in addition to the cost it added to the project.

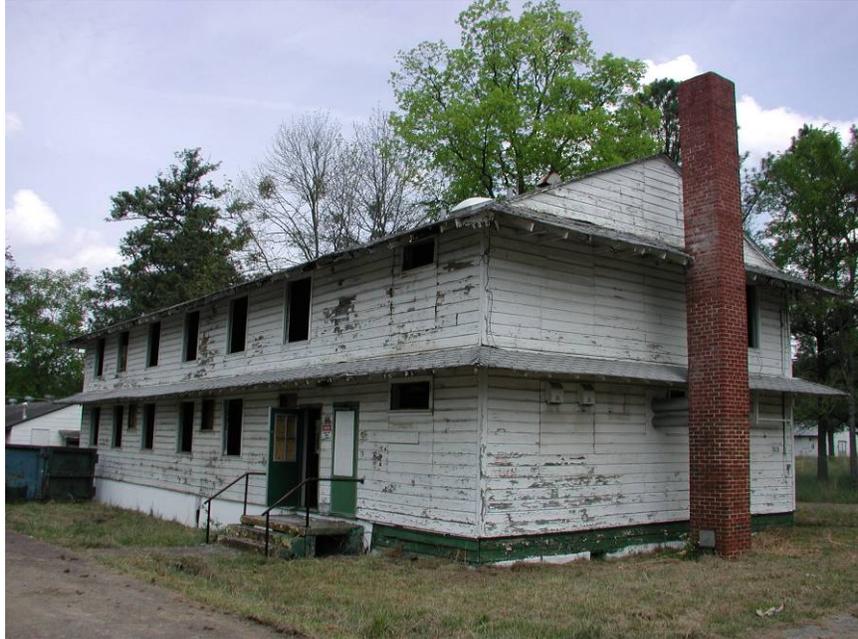
Three WWII-era barracks were dismantled: buildings 830, 844, and 829 (Figure A20). Each building was approximately 4,500 sq ft. Each of the buildings had a brick chimney, which Fort McClellan had hoped could be partly salvageable. The brick chimneys, originally about 8-ft tall, were added to the buildings probably circa 1970s. The bricks in the upper part of the chimneys appeared to be concreted together. Initial attempts at knocking down the top bricks were unsuccessful. The buildings were of balloon construction (i.e., the studs went up two floors). These buildings were 70 ft in length (including the 10 ft on the end that was a bathroom/boiler room), 30 ft in width, and about 8 ft in height. The buildings were divided into bays, each 10 ft in length.

Figure A20. Building 829 at Fort McClellan.

Building 829 had much water damage and a severe mold problem, so not much was salvageable. Building 829 was dismantled using mechanical means. The panelization method at Building 844 involved roof assemblies, walls, and floors that were all cut into 10 ft by 10 ft (or larger) panels and then carried by a

The barracks selected for the study were found to have extensive LBP and severe water damage. Bldg 829 had much water damage and mold, so there was not much to salvage, except for bathroom and plumbing fixtures, boiler room items for scrap metal, and concrete supports and bathroom and boiler room floors. Thus, material recovery rates were significantly lower than what would be expected for typical barracks deconstruction.

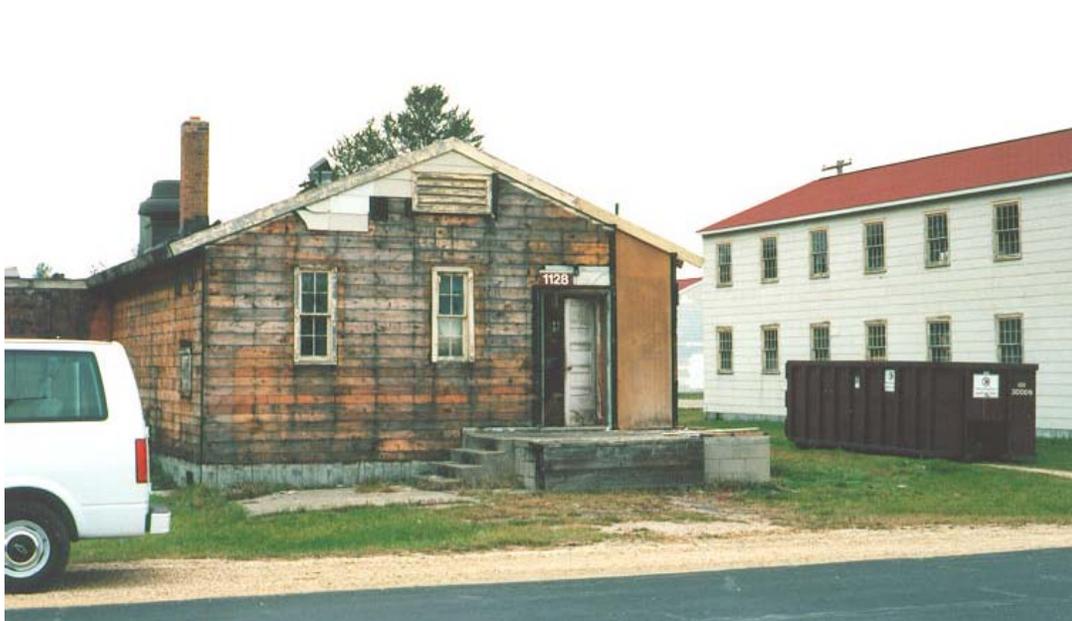
Figure A21. WWII building at Fort McCoy.

Fort McCoy removes surplus World War II-era buildings (Figure A21) with their deconstruction program. The Fort McCoy DPW reports that, since 1992, more than 140 buildings have been deconstructed for an estimated savings of \$3.5 million.

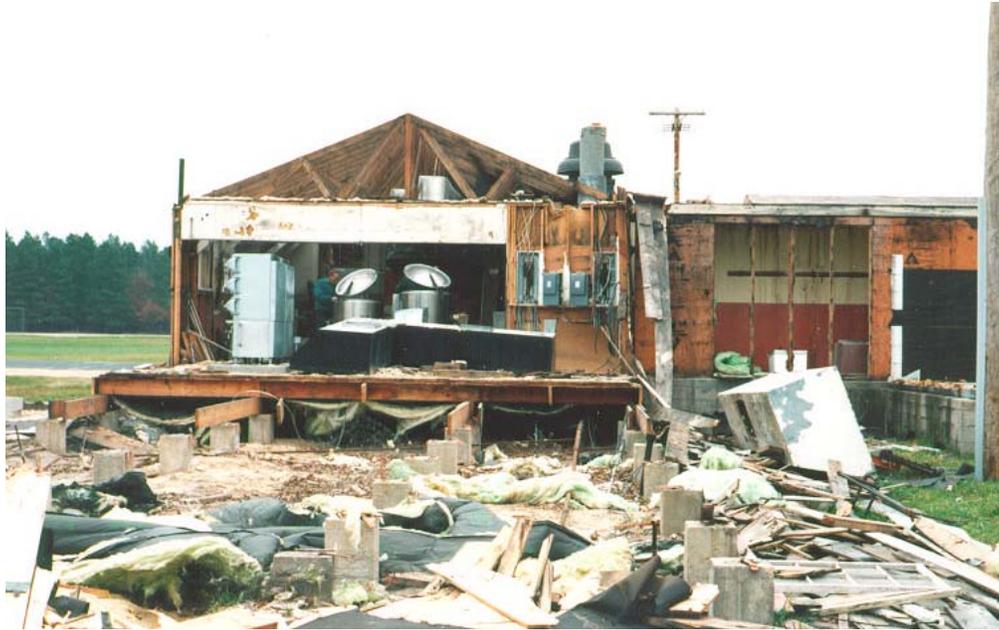
Figure A22. Fort McCoy mess hall under deconstruction.

The typical design of a World War II-era wood building has a foundation of concrete piers (instead of the more modern continuous poured foundation or blocks). Individual contractors typically have no means to remove these piers, so their removal is not required.

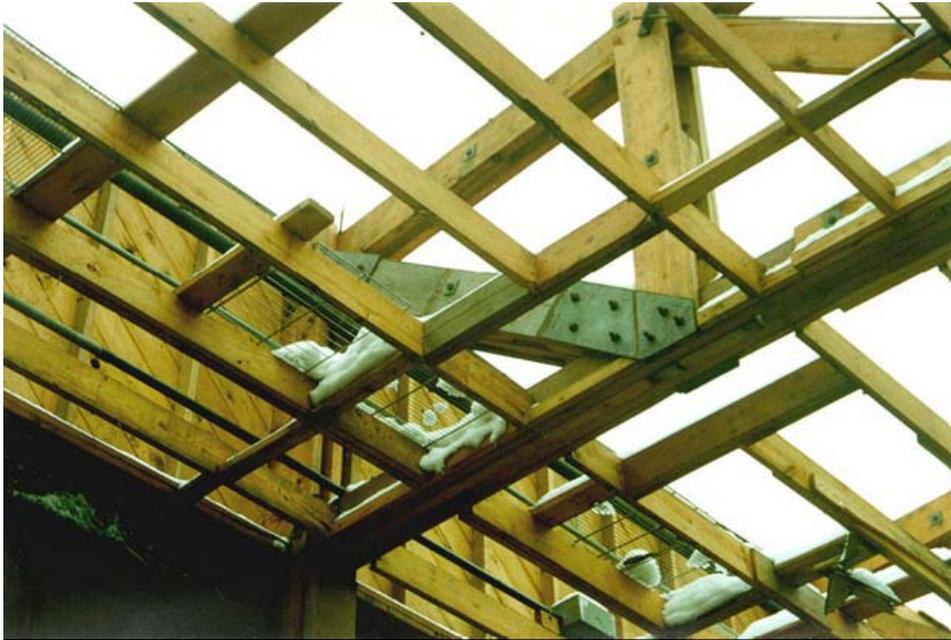
Figure A23. Roof trusses of WWII-era theater.

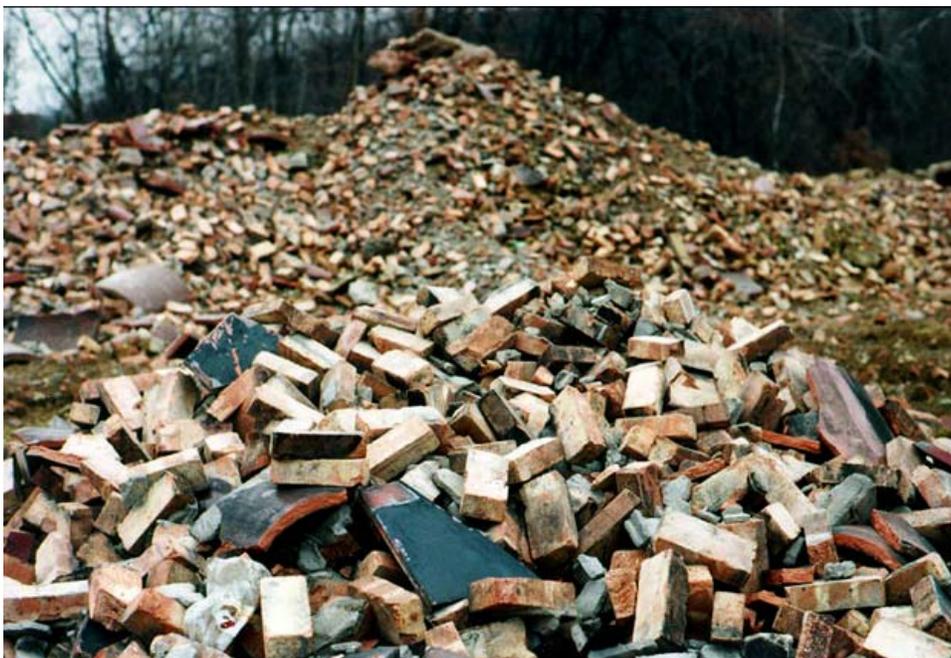
Fort McCoy uses troop equipment and labor to remove concrete foundation piers as part of a training exercise for Engineering units. Fort McCoy grinds the bricks from the large chimneys attached to the buildings (Figure A24) into landscaping material.

Figure A24. Salvage bricks from chimneys.
