PUBLIC WORKS TECHNICAL BULLETIN 200-3-28
29 OCTOBER 2004

**AN EVALUATION OF LOW-IMPACT TIRES ON
MILITARY LANDS**

Public Works Technical Bulletin
No. 200-3-28

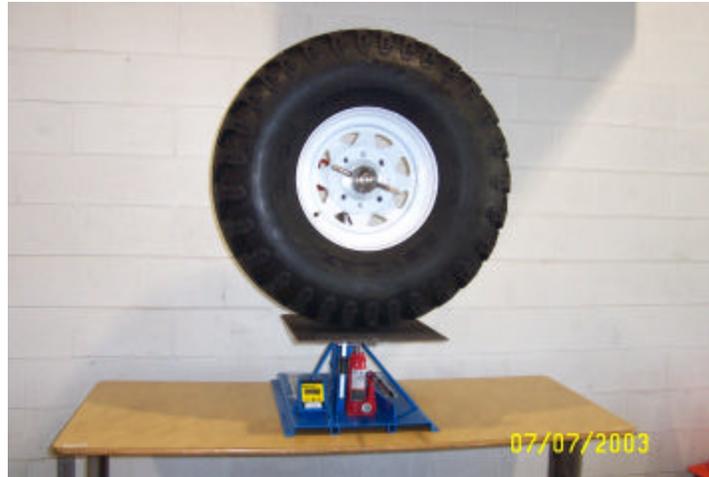
Each of the four tires was tested to measure deflection and footprint area at 600-2,000 lb in 200-lb increments at pressures ranging from 10 to 30 psi in 5-psi increments. The pressures were measured with an Intercomp electronic pressure gage (InterComp, Inc., Lauderdale By the Sea, FL). The tire was placed on the Intercomp Tire Tester with a one-quarter-inch thick 18 x 18-inch steel plate for the contact surface (Figure C1). The plate was marked with a grid to measure the footprint area.

Figure C1. Hard surface test.

The following test procedure, as recommended by Intercomp, was conducted. The load cell was zeroed with no contact with the tire. The jack was moved up until there was a 10-lb load on the tire and the electronic ruler was zeroed. The jack was then moved up one-tenth of an inch and allowed to settle for 3 minutes. The jack was again moved up until a 600-lb load was on the tire. A footprint and deflection measurement was made. The deflection was measured using the electronic ruler on the tire tester. The footprint was measured by placing a thin plastic ruler as far under the tire as it would go. The length and width were then read from the grid on the steel plate.

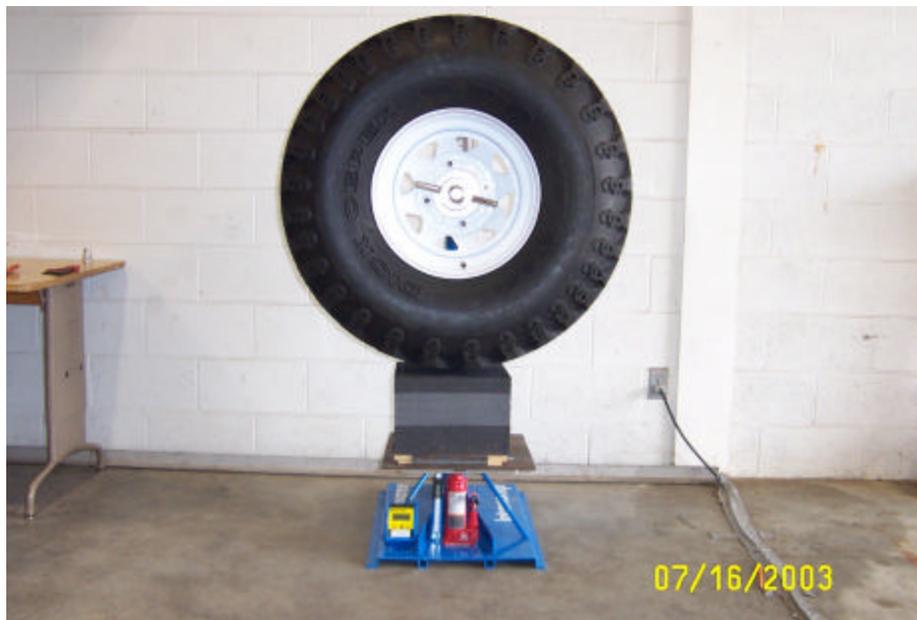
Each of the four tires was tested to measure deflection on a soft surface at 600 to 2,000 lb in 200-lb increments at pressures ranging from 10 to 30 psi in 5-psi increments. The procedure used was the same as for the hard surface test except the tire was placed on the Intercomp Tire Tester with an 8-inch thick 12 x 12-inch polyethylene foam pad for the contact surface to simulate soil (shown in Figure C21).

Figure C21. Soft surface test.

The deflection measured in the soft surface test is the total deflection, including the deflection of the tire and the foam. The total deflection was plotted versus load for each tire at the different pressures and for the different tires at the same pressure. The foam deflection was found by subtracting the tire deflection (found in the hard surface test) from the total deflection. This foam deflection was plotted versus load for each tire at the different pressures and for the different tires at the same pressure. Foam deflection is an indicator of the tire sinkage or rutting potential.

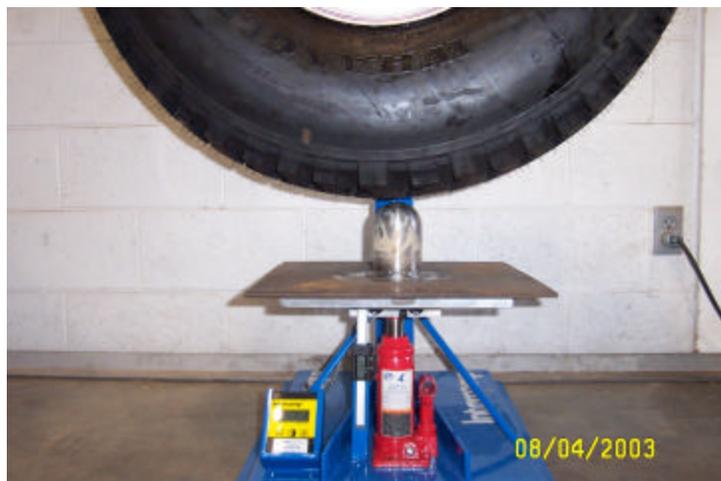
Each of the four tires was tested to measure the conformability of the tire over an object at 600 to 2,000 lb in 200-lb increments at pressures ranging from 10 to 30 psi in 5-psi increments. Each tire was placed on the Intercomp Tire Tester with a steel plunger for the contact surface. The plunger was 4.5 inches in total height, 3 inches in diameter, and the top was a hemisphere with a radius of 1.5 inches as shown in Figure C31.

Figure C31. Plunger test.

The load cell was zeroed with no contact with the tire. The jack was moved up until there was a 10-lb load on the tire and the electronic ruler was zeroed. The jack was then moved up one-tenth of an inch and allowed to settle for 3 minutes. The jack was moved up until the load on the tire was 600 lb. A deflection measurement was made using the electronic ruler. The jack was moved up to increase the load by 200 lb. After measurements were made up to 2,000 lb, the load was released, the tire pressure was adjusted, and the process was repeated on the other tires. The tire deflection onto the plunger was plotted versus load for each tire at the different pressures and for the different tires at the same pressure.

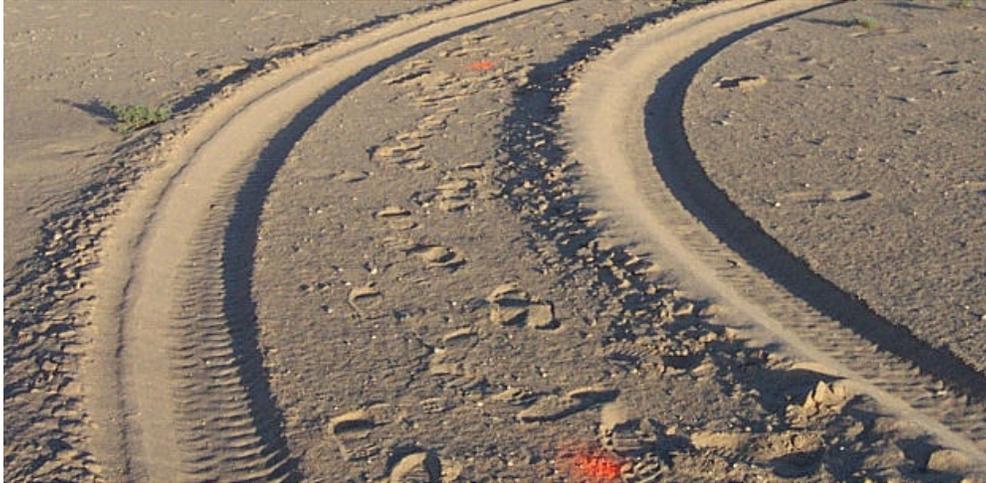
Soil impacts, including disturbed width, pile width, and rut depth, were measured along the spirals. Figure D6 shows the sand impact in the forms of both rut and pile. The GPS positions of the vehicle were collected by using the Trimble AgGPS 132 with Omnistar differential correction (Trimble, Sunnyvale, CA). The GPS data were logged every second. Dynamic properties (velocity and turning radius) were derived from the GPS data.

Figure D6. Sand impact.

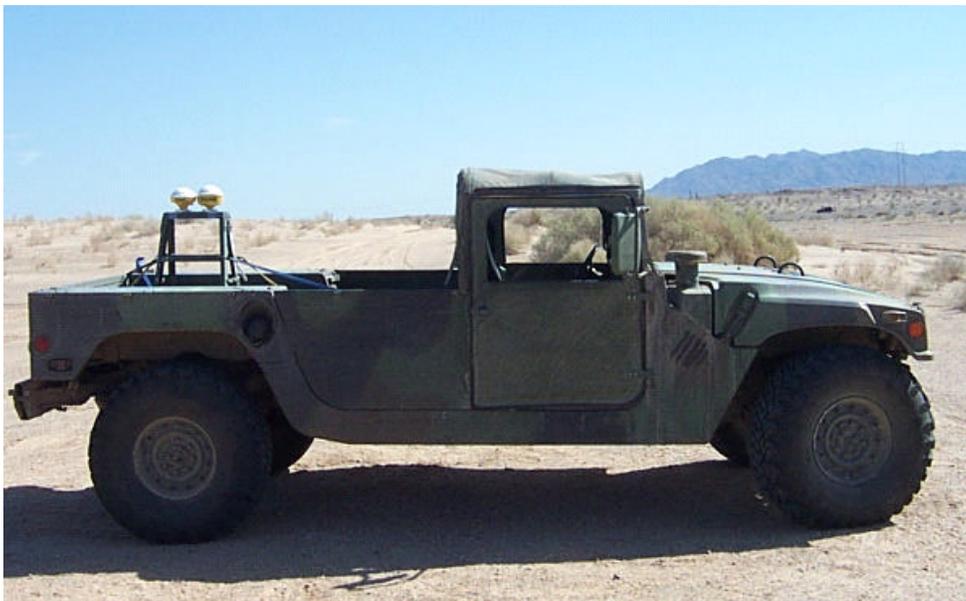
Test vehicle. Figure D8 shows the HMMWV test vehicle (model number 1097A1). The candidate low-impact tire is the 38/15.50X16.5 LRC Dick Cepek F-C Kevlar. The reference tire is the 37/12.50R16.5LT LRD Goodyear MT.

Figure D8. Sand impact test vehicle.

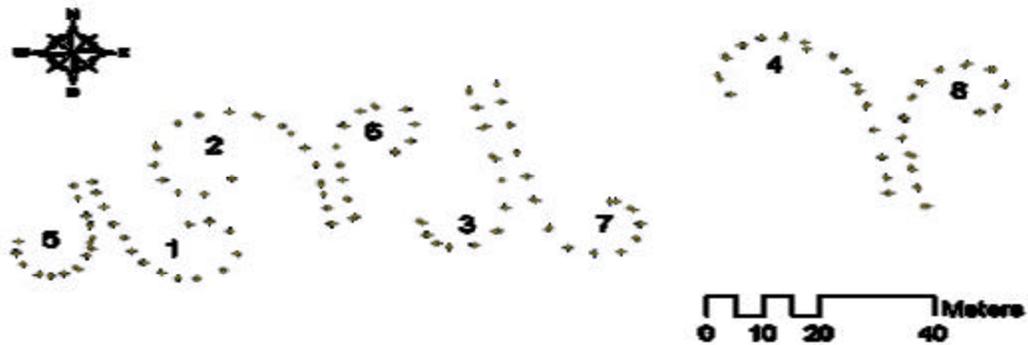
The soil impact data were determined at each point shown in Figure D9. The figure shows the GPS tracking positions of the sand impact spirals.

Figure D9. Sand spiral impact points.

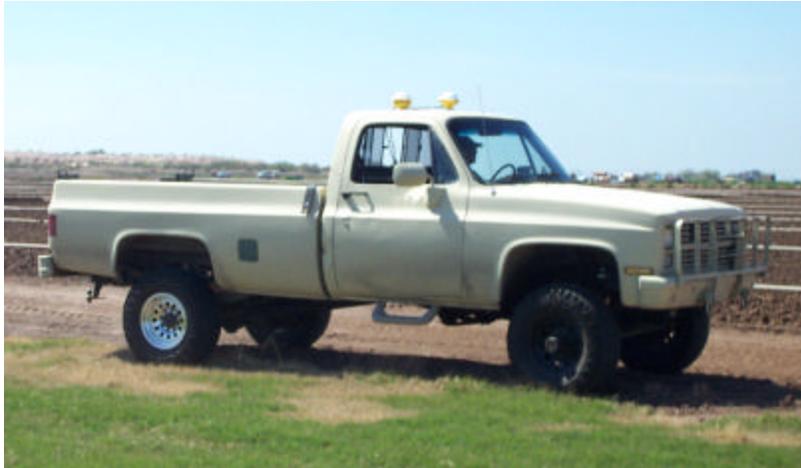
pressure ranged from 40 to 43 psi. The Cooper tire is similar to the standard radial Goodyear tire. For the Mickey Thompson tire, the maximum load/pressure rating was 2,755 lb at 45 psi. The measured tire pressure ranged from 25.4 to 25.6 psi.

Figure D18. Vegetative impact test vehicle.

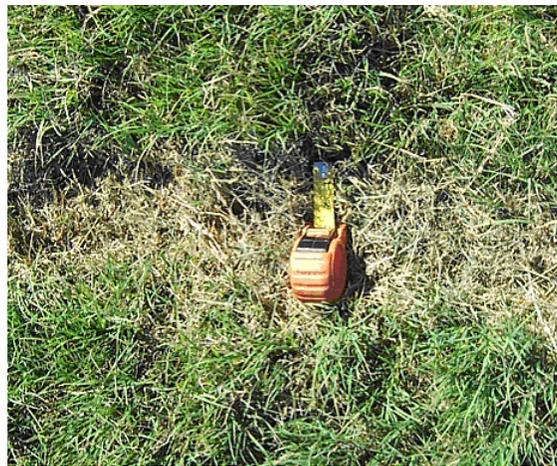
Yuma Proving Ground results. Impact severity is the percentage of vegetation that has been removed or scraped from the disturbed area. Figure D20 illustrates measurement of the vegetative impact. Because the soil strength of the field was strong and the test vehicle was not heavy, high values of impact severity were not visually observed in the test, so impact comparisons were conducted using disturbed width.

Figure D20. Vegetative impacts are measured.
