THE SECRETARY
OF THE INTERIOR'S
STANDARDS FOR
REHABILITATION &

ILLUSTRATED
GUIDELINES ON
SUSTAINABILITY
FOR
REHABILITATING
HISTORIC
BUILDINGS

U.S. Department of the Interior
National Park Service
Technical Preservation Services

2011

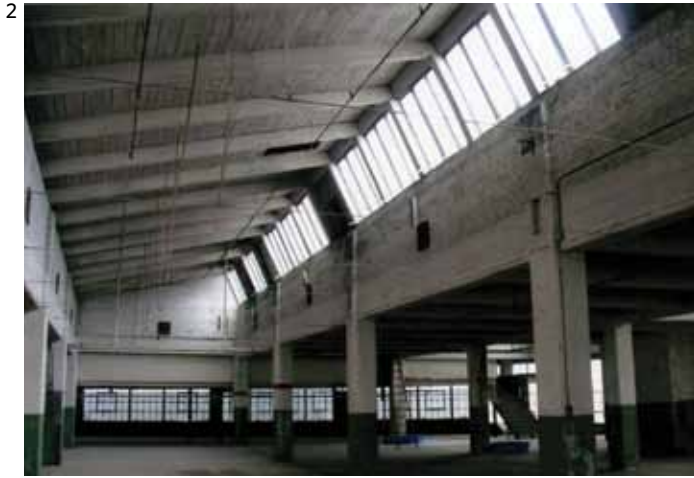
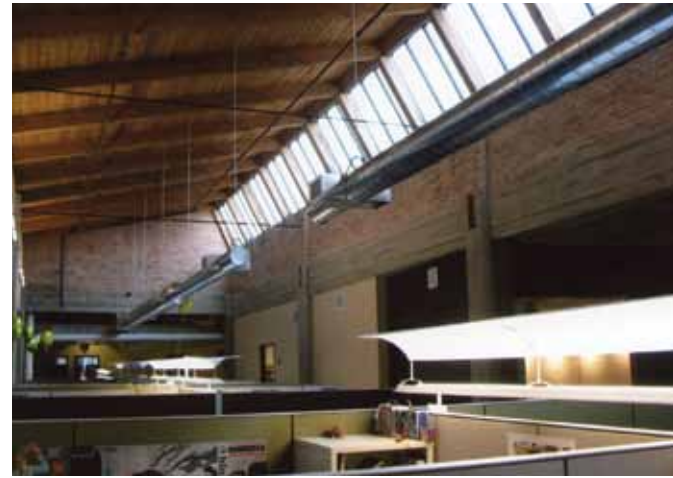
[2-3] Clerestory windows provide natural light in a historic industrial building: Before and after rehabilitation.

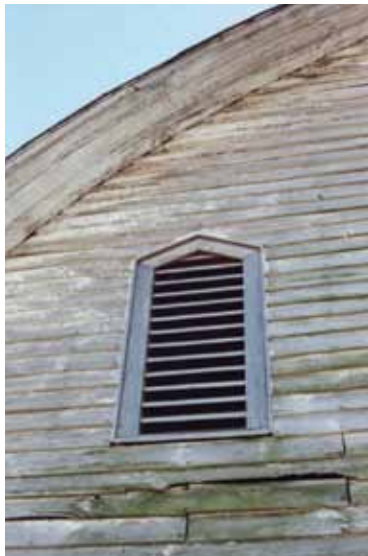
Recommended: [55-57]
Wood vents in the gable ends of a historic house and a barn and cast-iron oval vents in a masonry foundation traditionally helped air circulate.

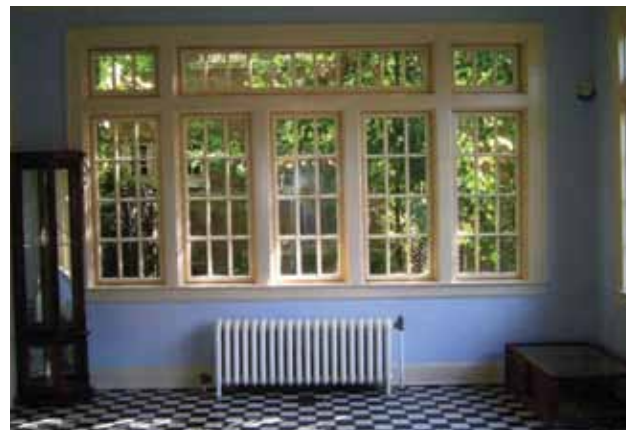
60

Recommended: [60] Original radiators that are still functional and efficient were retained in the rehabilitation of this historic house.

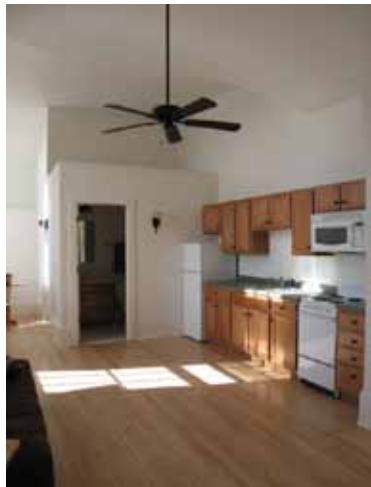
58

Recommended: [58] Ceiling fans enhance the efficiency of HVAC systems in historic buildings.

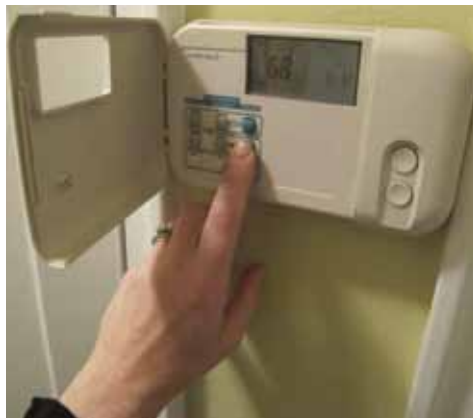
59

Recommended: [59] Installing a programmable thermostat can help existing systems to operate more efficiently.

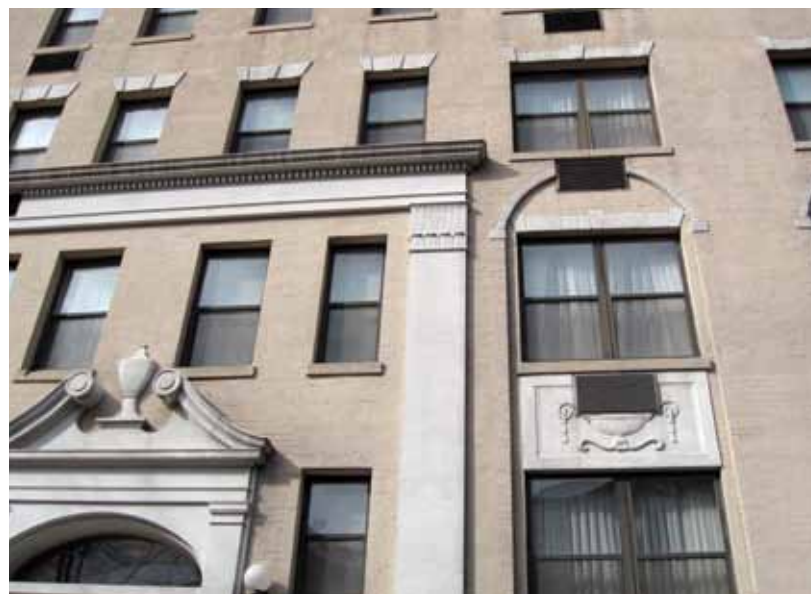
61

Not Recommended: [61] The cuts made in the brick and the decorative stone trim to install through-the-wall air conditioners have not only destroyed building material, but have also negatively impacted the character of this historic apartment building.

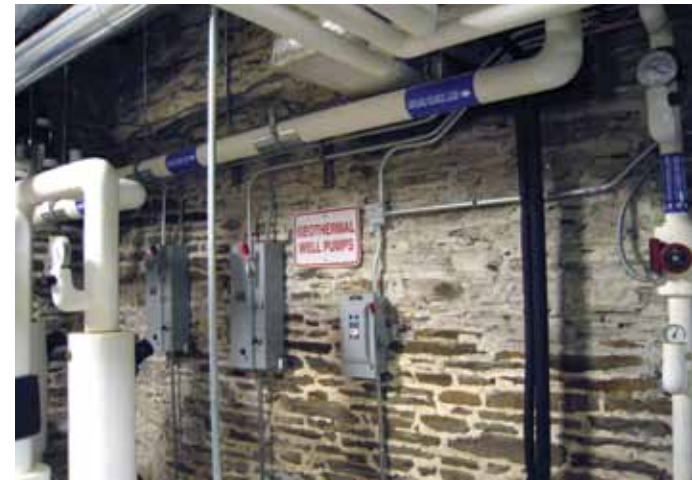
Recommended: [70-71] A geothermal system was installed on the property of this historic mansion, but only after an archeological investigation was conducted of the grounds.

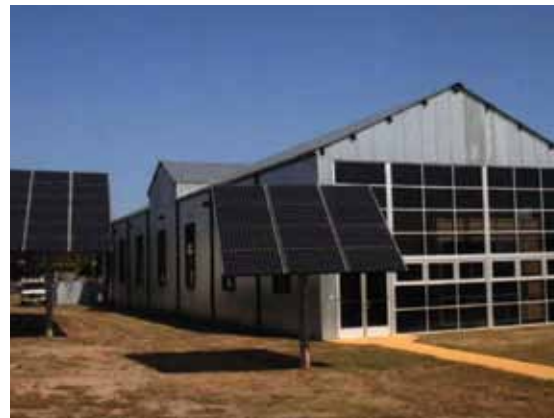
74

Recommended: [74] Free-standing solar panels have been installed here that are visible but appropriately located at the rear of the property and compatible with the character of this industrial site.

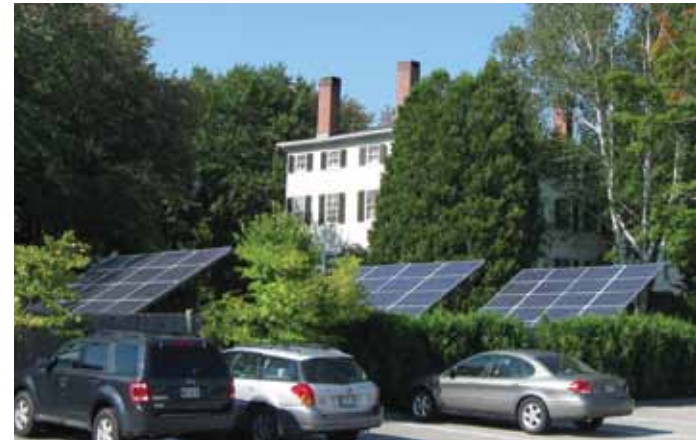
79

Not Recommended: [79] Although installing solar panels behind a rear parking lot might be a suitable location in many cases, here the panels negatively impact the historic property on which they are located.

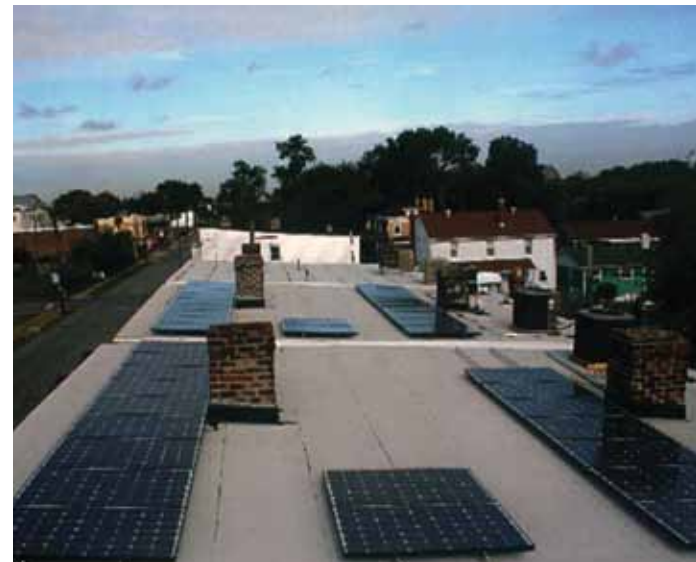
78

Recommended: [76-77] Solar panels, which also serve as awnings, were installed in secondary locations on the side and rear of this historic post office and cannot be seen from the front of the building. [78] Solar panels placed horizontally on the roof of this historic building are not visible from below.

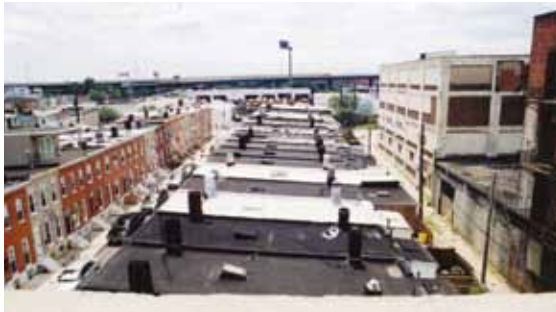
86

Recommended: [85-86] A cool or green roof is best installed on a flat roof where it cannot be seen from the public right of way and will not negatively impact the character of the historic building.

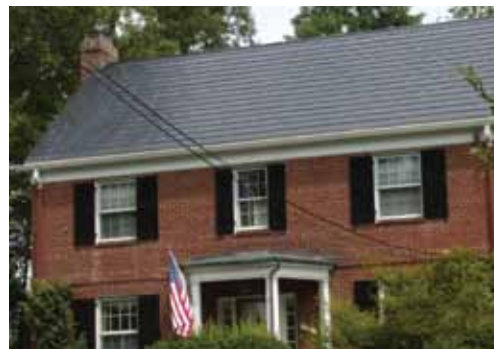
87

Not Recommended: [87] Historic roofing materials in good condition should be retained rather than replaced with another material perceived as more sustainable, such as, in this case, solar roofing shingles.

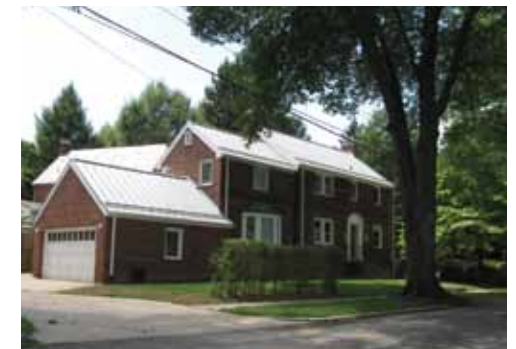
88

Not Recommended: [88] This new, cool white metal roof is not an appropriate material or color for this historic mid-20th century house.

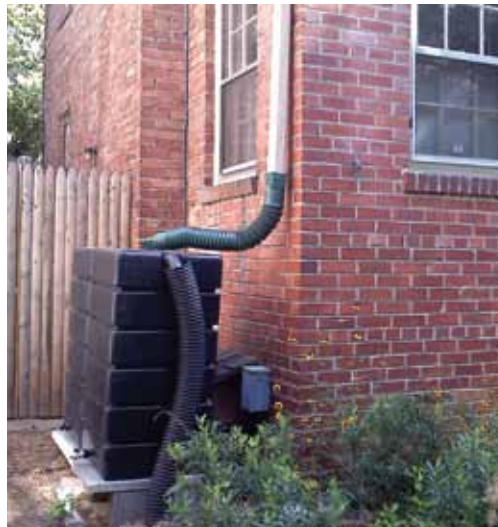
Recommended: [98-100] Rain gardens and rain-water collection tanks are features that may be added to a historic property to improve storm-water management and increase on-site water use.
