DEPARTMENT OF THE AIR FORCE
HEADQUARTERS AIR FORCE CIVIL ENGINEER SUPPORT AGENCY

9 FEB 2006

SUBJECT: **Engineering Technical Letter (ETL) 06-2: Alkali-Aggregate Reaction in Portland Cement Concrete (PCC) Airfield Pavements**

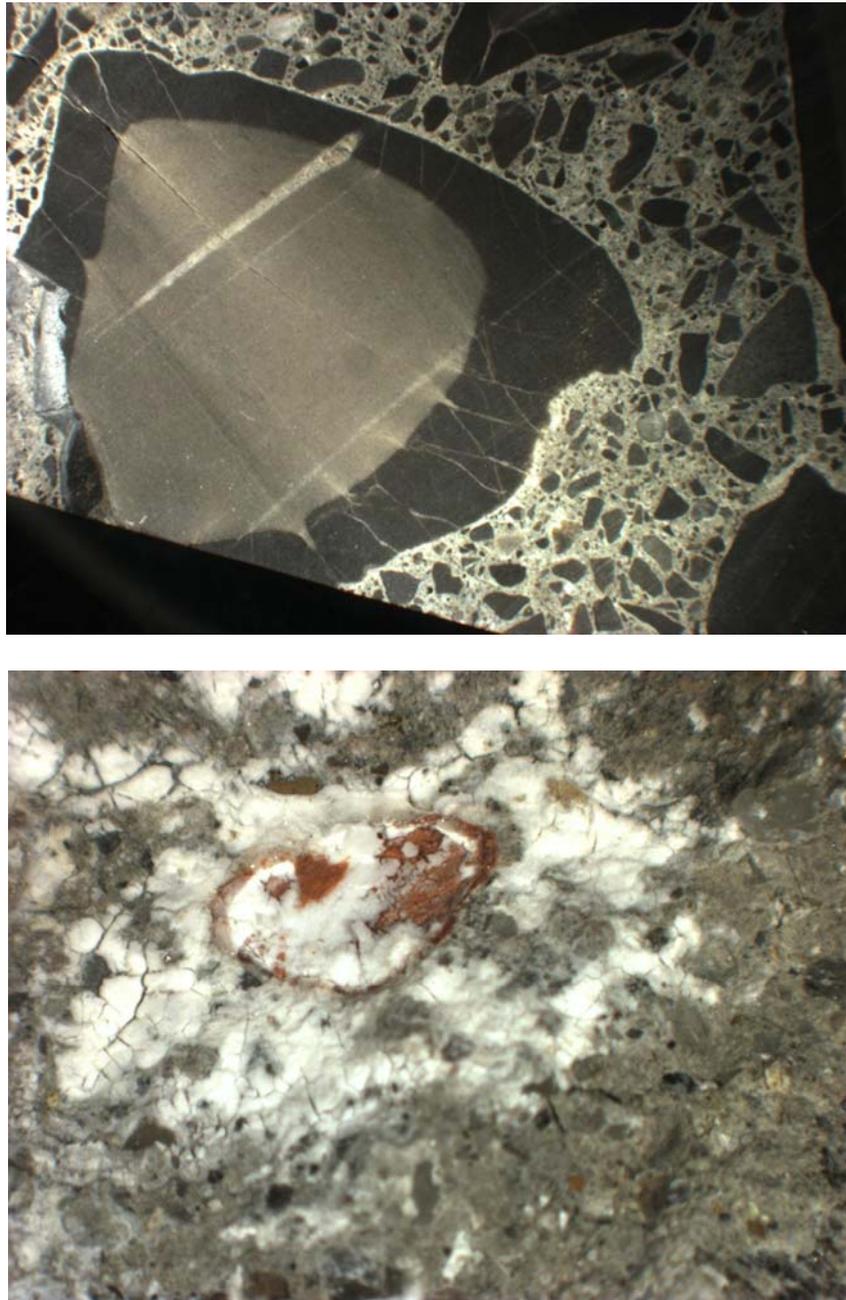
9. Field Symptoms of ASR. The ASR gel (Figure 1) around or within the reacting aggregates absorbs water and increases in volume. This can lead to cracking as the

Figure 1. Examples of Alkali-Aggregate Gel. It may appear as a dark rim around an aggregate particle (top) or as a light-colored deposit on or within the aggregate or in the surrounding matrix (bottom). Note cracks caused by the expansion of the gel in the aggregates and paste.

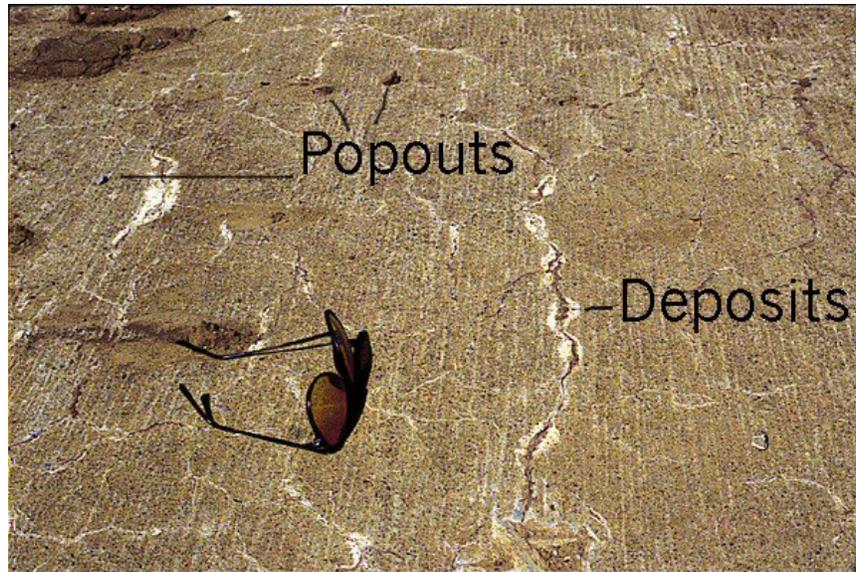
Figure 5. Example of Popouts and Deposits at Cracks, Tinker AFB. The deposits may or may not be related to ASR and require a chemical analysis if their origin is to be determined.

9.2. Popouts. As the compressive forces within the concrete increase, individual aggregate particles may be dislodged. These particles—or popouts—then pose a potential aircraft FOD hazard. Figure 5 shows an example of popout fragments from ASR. Popouts also develop in concrete that has aggregates such as chert or shale that are vulnerable to freezing or contain other unsound particles.

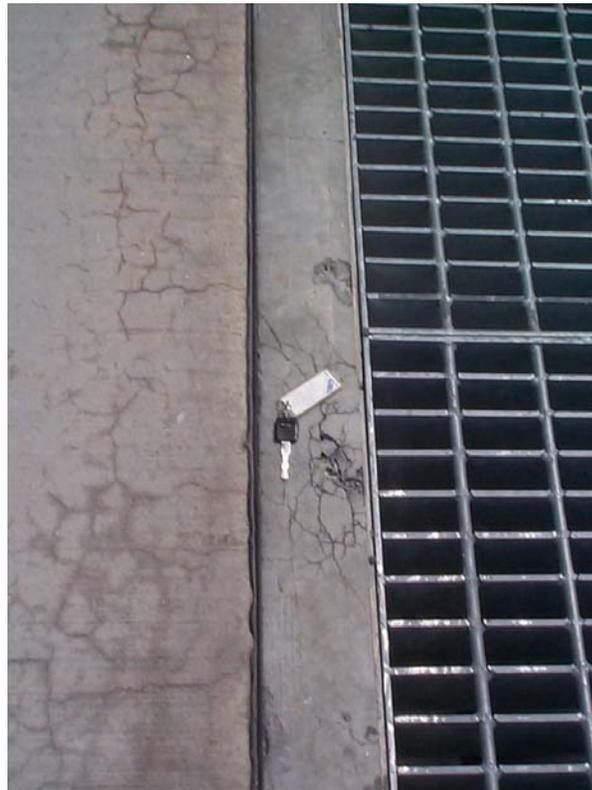
9.3. Expansion. The internal expansive forces increase as the ASR gel absorbs water, the concrete volume increases and the concrete in the field literally grows. This leads to differential movements, closing of expansion joints, damage to adjacent structures, spalling at joints, and similar problems. In an extreme example at Andrews AFB, Maryland, the expansive forces were severe enough to cause an entire lane of parking ramp slabs to fail and tent up (similar to concrete pavement blowups occasionally observed on roads) in one morning. Figure 7 shows an example of differential movement between two slabs caused by ASR expansion in the concrete. Such movement on airfields may be a few inches or a foot or more. In Figure 8, the asphalt shoulder has been upheaved by the ASR expansion in the adjoining concrete. Structures such as trench drains within the pavement may suffer serious misalignment or breakage and the compressive forces at the joint may cause severe spalling. In Figure 9, note that in the ASR-induced cracking in the concrete to the left of the drain, the expansion joint between the concrete and trench wall is squeezed closed; spalling is developing in the concrete because of high

compressive stresses from the expanding concrete, and the trench grate is tightly jammed as the trench walls have been forced inward. A forklift will be needed to pull the trench drain grate free. Any structures adjacent to pavement undergoing ASR volume expansion are vulnerable to damage. Expansion joints that are normally used to isolate the structures from the normal thermal and moisture movements of the concrete pavement will be unable to cope with the magnitudes of movement encountered in ASR-driven volume expansions. Figure 10 shows a terminal building column pushed out of alignment by the ASR expansion in the adjacent pavement. The building had to be abandoned.

Figure 9. Trench Drain Damage from ASR Expansion, Holloman AFB.
