DEPARTMENT OF THE AIR FORCE
HEADQUARTERS AIR FORCE CIVIL ENGINEER SUPPORT AGENCY

19 DEC 2007

SUBJECT: **Engineering Technical Letter (ETL) 07-10: Evaluation and Restoration of Folded Fiberglass Mats (FFM)**

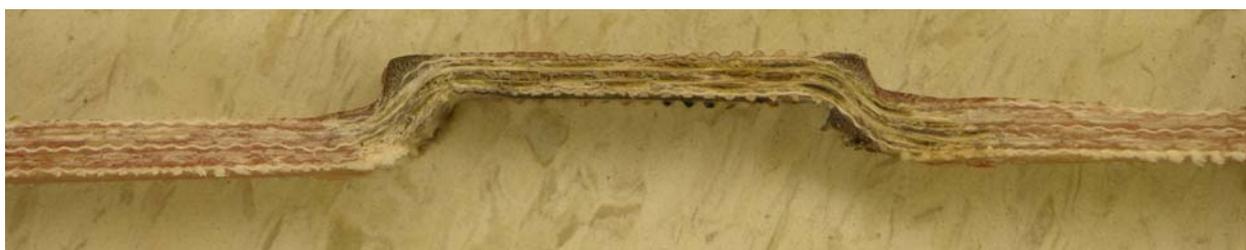
Figure 6. Alternate Hinge Fabrication

which have only been exposed to storage environments have also exhibited this type of damage, as seen in Figure 5. These cases are likely caused by elastomer shrinkage, folding strains, ultraviolet radiation damage, and/or thermal stresses. Any hinge areas that are torn, regardless of tear length, are not suitable for use. Such hinges must be replaced as allowed in approved repair methods. Some FFM manufacturers have attempted to address the occurrence of hinge tears by controlling the location of bending, in turn stress concentrations, in new elastomer hinges as seen in Figure 6. Such procedures may decrease the occurrences of tears and delaminations near hinges. At this time these hinges have not undergone proper testing or usage to validate such beneficial claims.

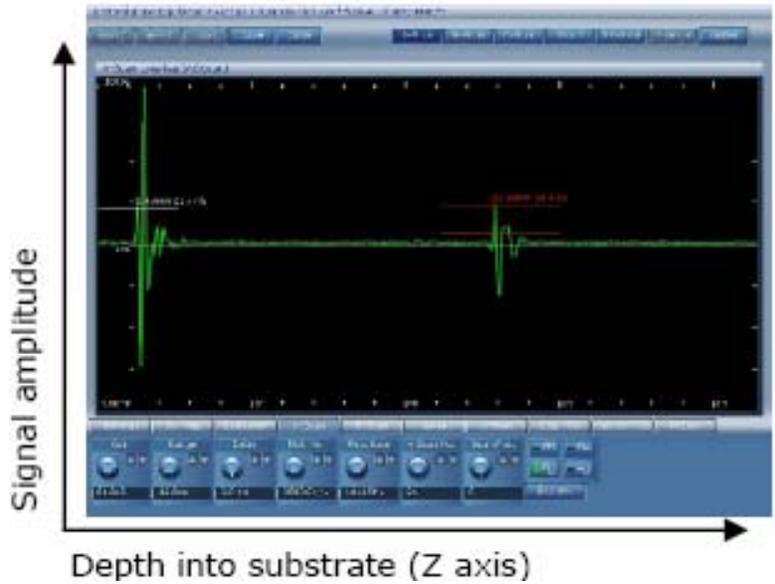
Figure 9. Example of A-Scan Plot Showing Surface and Bottom of FFM

6.3.2. Use of Wheel Probe. In the Level II evaluation, visual inspection will still function as the method for initially locating damage. After the damage is located and recorded on an evaluation sheet (see Attachment 2), the ultrasonic wheel probe may be used by a trained operator to evaluate the severity of the internal FFM damage. It may be necessary to test an undamaged section of the same FFM as a control for comparative purposes. Signal amplitude and attenuation data from the wheel probe system, coupled with acceptance criteria from a Level I evaluation, can then be used to make an overall judgment on each panel's condition. The ultrasonic wheel probe should employ a wheel probe sensor operating between 2 to 5 MHz (megahertz) for signal clarity. A light film of water should be evenly applied to the surface of the smooth side (bottom side) of the FFM panel to serve as a coupling agent for the sensor. The wheel probe should be rolled across the damaged section at a rate of approximately 8 inches (200 millimeters) per second. A signal gain of at least 30 dB (decibels) is required to amplify the test results for analysis. The scanner's software will produce three plots for analysis: an A-scan, B-scan, and C-scan. The A-scan is sound echo response from a single position, as shown in Figure 9. The scan typically shows two amplitude peaks at the surface and bottom of the mat. Any defect inside the mat will reflect the ultrasonic energy before it reaches the bottom of the panel, resulting in an additional peak between the surface and bottom peaks. The B-scan is produced when a number of A-scans are performed along a linear length, for example by rolling the sensor across the mat surface in a straight line. An

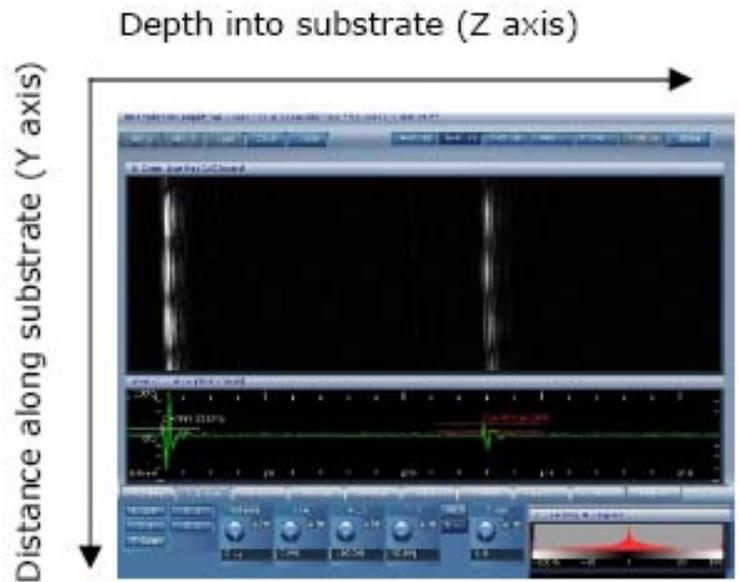
Figure 10. Example of B-Scan Plot Showing Results for One Roll Width Scan

example of a B-scan is shown in Figure 10. The C-scan uses a color-scale to represent the amplitude of the data thereby producing a pictorial representation of any change in the internal structure of the FFM. An example of a C-scan of an undamaged panel is shown in Figure 11. An example of an FFM panel with significant impact damage is shown in Figure 12. The software will permit the user to reformat the C-scan to select a binary color scale to sharply contrast damaged versus undamaged areas, as shown in Figure 13.
