DEPARTMENT OF THE AIR FORCE
HEADQUARTERS AIR FORCE CIVIL ENGINEER SUPPORT AGENCY

19 DEC 2007

SUBJECT: Engineering Technical Letter (ETL) 07-10: Evaluation and Restoration of Folded Fiberglass Mats (FFM)

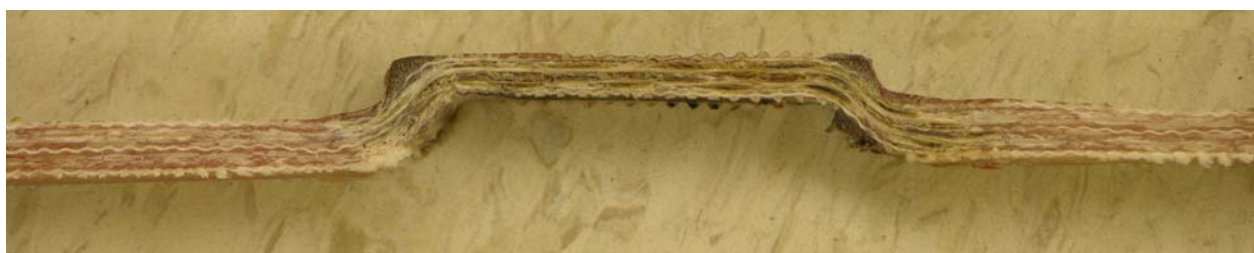
Figure 6. Alternate Hinge Fabrication

which have only been exposed to storage environments have also exhibited this type of damage, as seen in Figure 5. These cases are likely caused by elastomer shrinkage, folding strains, ultraviolet radiation damage, and/or thermal stresses. Any hinge areas that are torn, regardless of tear length, are not suitable for use. Such hinges must be replaced as allowed in approved repair methods. Some FFM manufacturers have attempted to address the occurrence of hinge tears by controlling the location of bending, in turn stress concentrations, in new elastomer hinges as seen in Figure 6. Such procedures may decrease the occurrences of tears and delaminations near hinges. At this time these hinges have not undergone proper testing or usage to validate such beneficial claims.

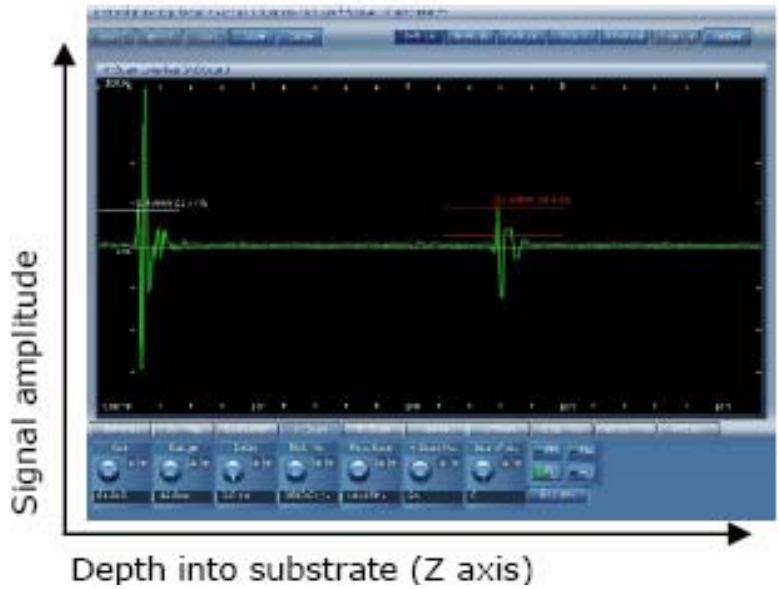
Figure 9. Example of A-Scan Plot Showing Surface and Bottom of FFM

6.3.2. Use of Wheel Probe. In the Level II evaluation, visual inspection will still function as the method for initially locating damage. After the damage is located and recorded on an evaluation sheet (see Attachment 2), the ultrasonic wheel probe may be used by a trained operator to evaluate the severity of the internal FFM damage. It may be necessary to test an undamaged section of the same FFM as a control for comparative purposes. Signal amplitude and attenuation data from the wheel probe system, coupled with acceptance criteria from a Level I evaluation, can then be used to make an overall judgment on each panel's condition. The ultrasonic wheel probe should employ a wheel probe sensor operating between 2 to 5 MHz (megahertz) for signal clarity. A light film of water should be evenly applied to the surface of the smooth side (bottom side) of the FFM panel to serve as a coupling agent for the sensor. The wheel probe should be rolled across the damaged section at a rate of approximately 8 inches (200 millimeters) per second. A signal gain of at least 30 dB (decibels) is required to amplify the test results for analysis. The scanner's software will produce three plots for analysis: an A-scan, B-scan, and C-scan. The A-scan is sound echo response from a single position, as shown in Figure 9. The scan typically shows two amplitude peaks at the surface and bottom of the mat. Any defect inside the mat will reflect the ultrasonic energy before it reaches the bottom of the panel, resulting in an additional peak between the surface and bottom peaks. The B-scan is produced when a number of A-scans are performed along a linear length, for example by rolling the sensor across the mat surface in a straight line. An

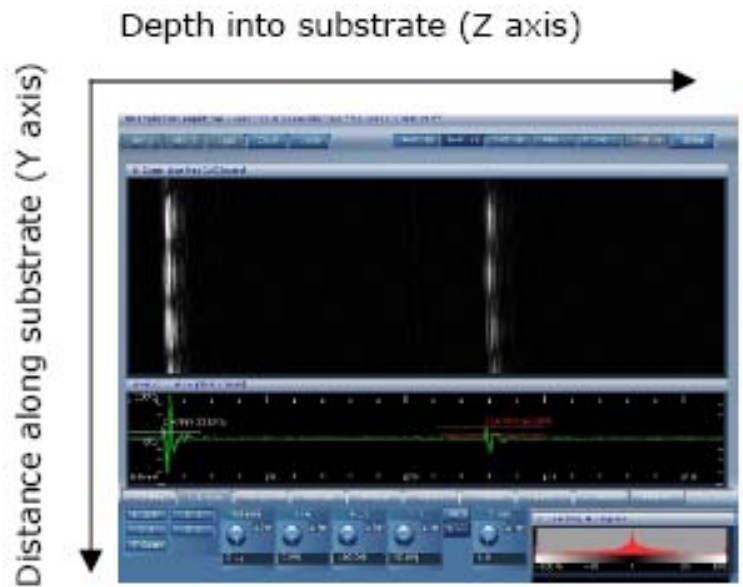
Figure 10. Example of B-Scan Plot Showing Results for One Roll Width Scan

example of a B-scan is shown in Figure 10. The C-scan uses a color-scale to represent the amplitude of the data thereby producing a pictorial representation of any change in the internal structure of the FFM. An example of a C-scan of an undamaged panel is shown in Figure 11. An example of an FFM panel with significant impact damage is shown in Figure 12. The software will permit the user to reformat the C-scan to select a binary color scale to sharply contrast damaged versus undamaged areas, as shown in Figure 13.

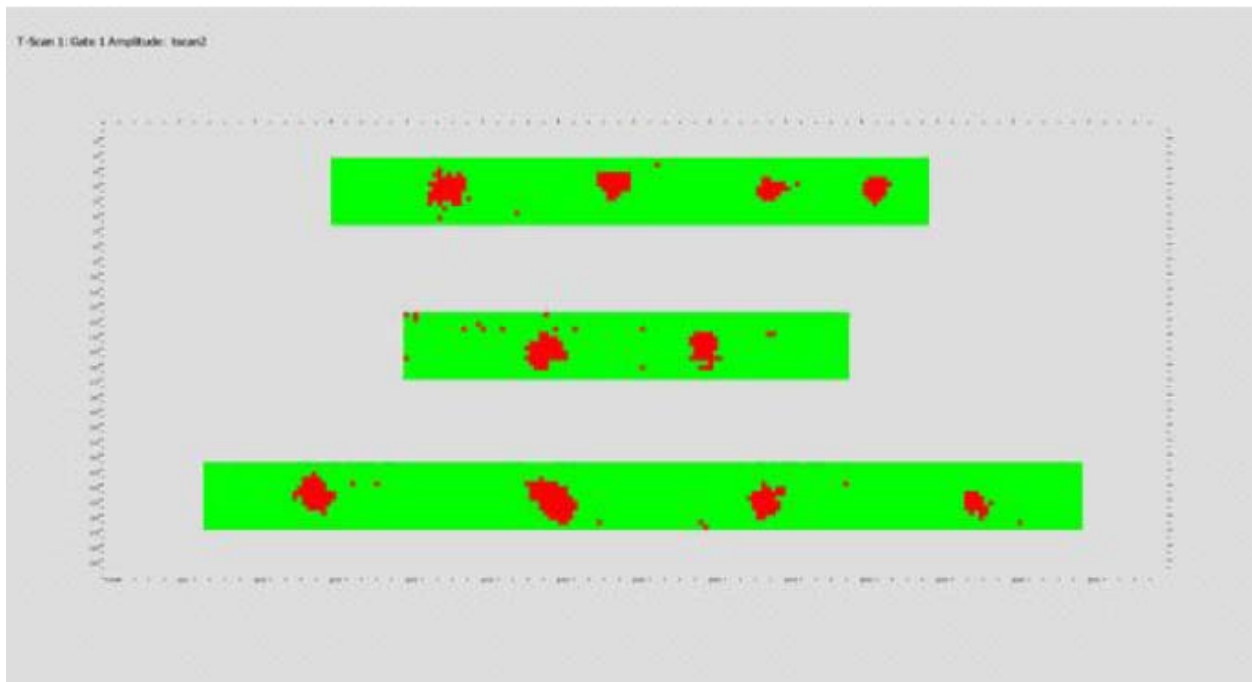
Figure 13. Example of C-Scan Plot Showing Pass-Fail Results Using Binary Colors

Tears	None acceptable.	Level II evaluation unnecessary.
Localized Impact	No more than five 1-inch (25 mm) or greater diameter occurrences per square foot. No impact areas in excess of 4 inches (100 mm) in diameter are permitted.	Impact areas will appear as defined concentric discolorations in the C-scan as shown in Figure 12. Localized impact damage that indicates connections to adjacent damaged areas are more severe.
Unclassified Damage	Use judgment with above criteria.	Damage will appear as discolored sections. The size of discolored areas and interconnectivity between areas shown on the C-scan can assist in determining the severity of the damage.
