Naval Facilities Engineering Command

Lessons Learned from Design & Engineering of Naval Facilities

NAVFAC P-1010
October 1985

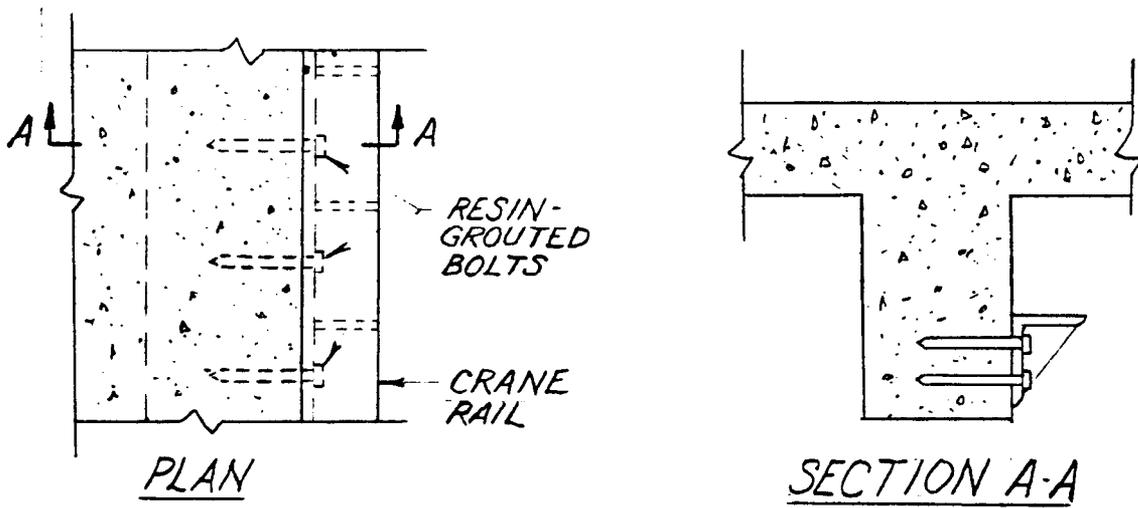
Fig. 11

The resin-grouted bolts may also be useful in anchoring the rails of Overhead Electric Traveling (OET) Cranes. Typically, the crane rails are supported by steel or concrete columns. However, an angle with stiffener plates could be anchored to a spandrel beam to achieve the same result at a lower cost (Figure 11). In situations where excessive crane loads would require impractical bolting schemes, the anchors may be used in combination with columns to substantially reduce the cost of the columns. This railing system would be very reliable because of the anchor bolt's extremely high pullout values and because it is unaffected by dynamic loading.

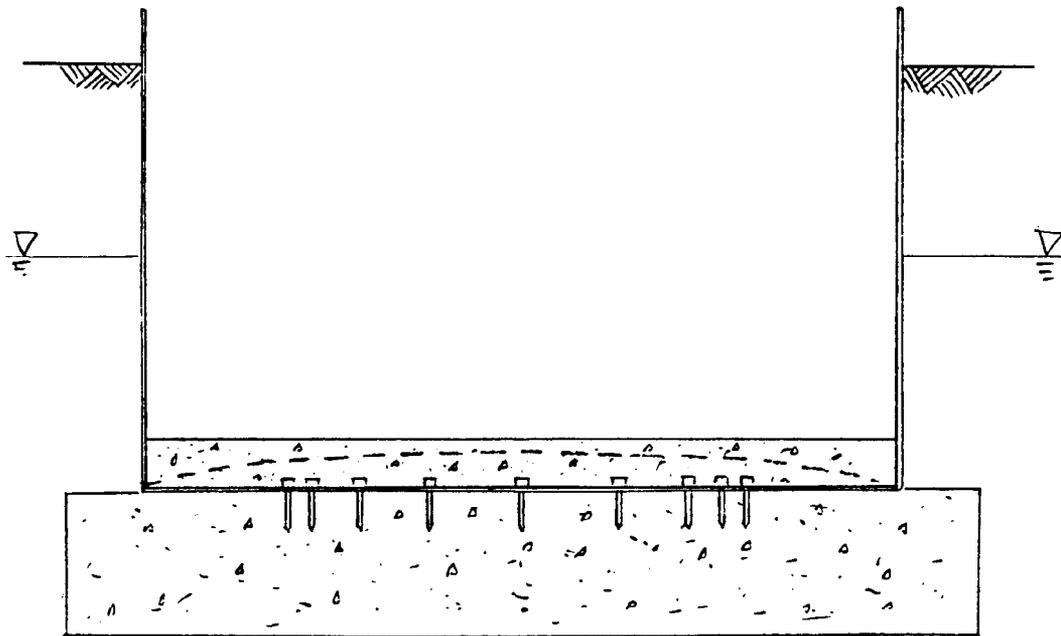
Fig. 12

Underground steel fuel tanks subject to uplift due to hydrostatic pressure can be anchored by using the chemical anchoring system. Holes may be drilled through the bottom of the tank to grout the bolts into the concrete foundation below (Fig. 12).

NOTE: DOTTED LINE REPRESENTS DEFORMED SURFACE OF TANK.

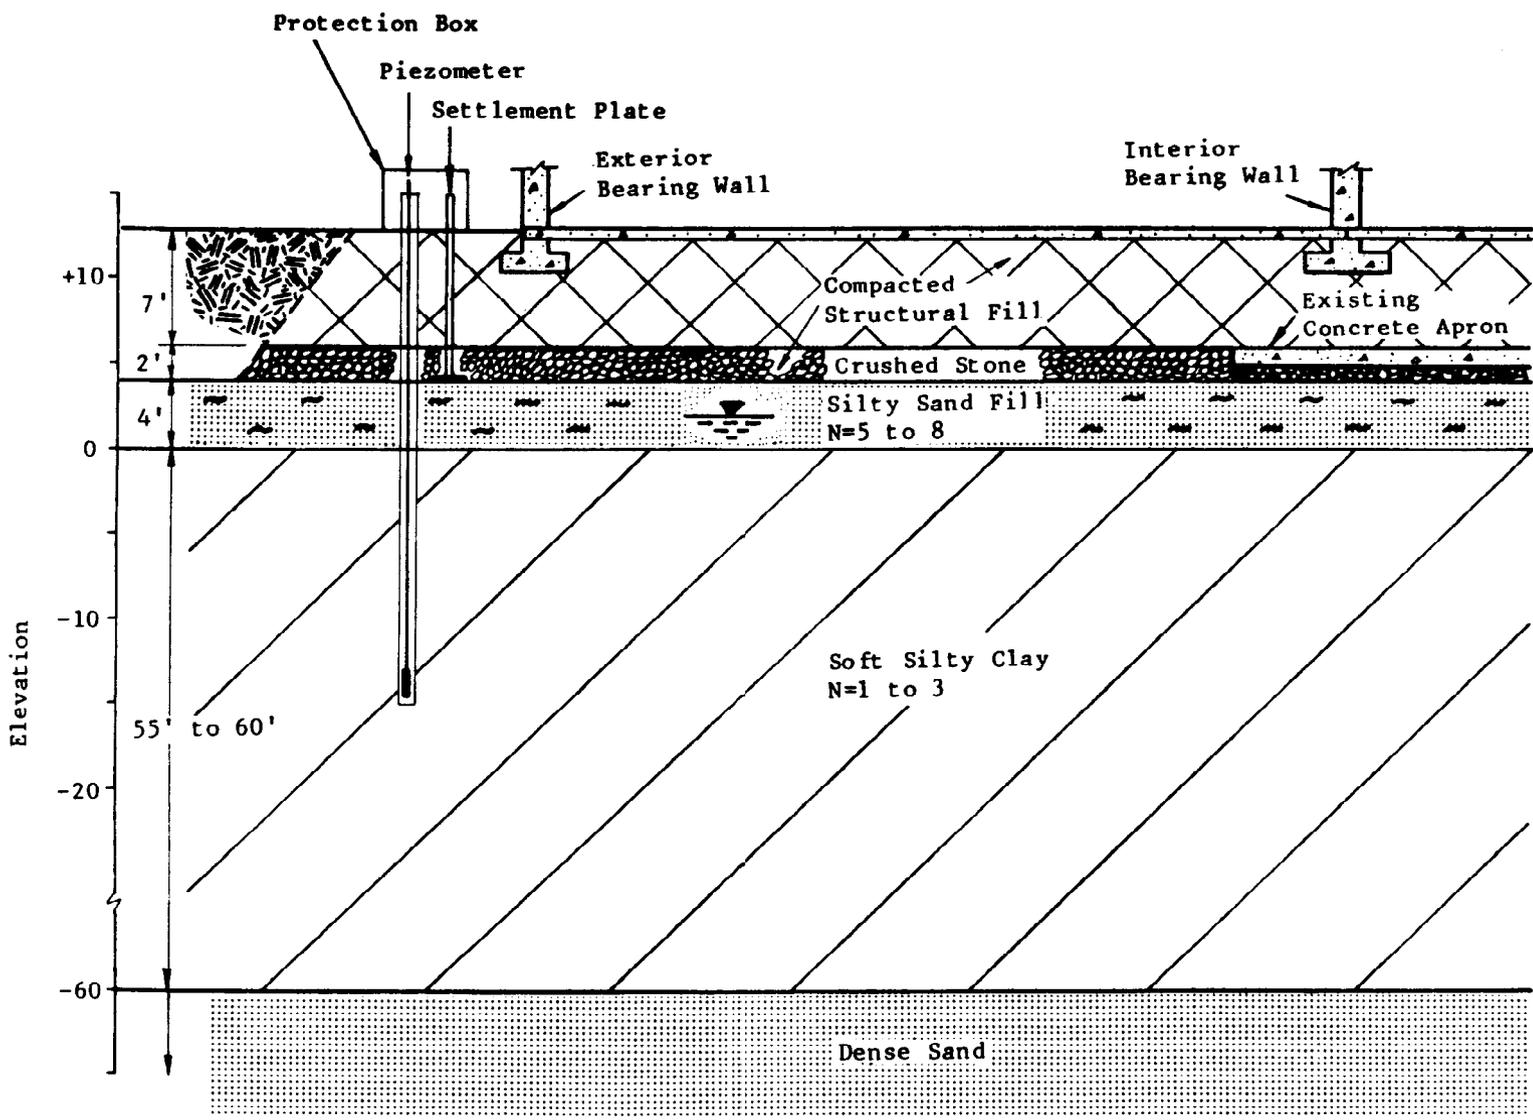
Fig. 1. Compacted fill was placed on a two feet thick layer of crushed stone. In the area where concrete apron existed, it was left in place to substitute for crushed stone base. Foundation soils are 4 feet of recent medium dense sand fill, which is underlain by 55 to 60 feet (17 to 18 m) thick, highly compressible clay.

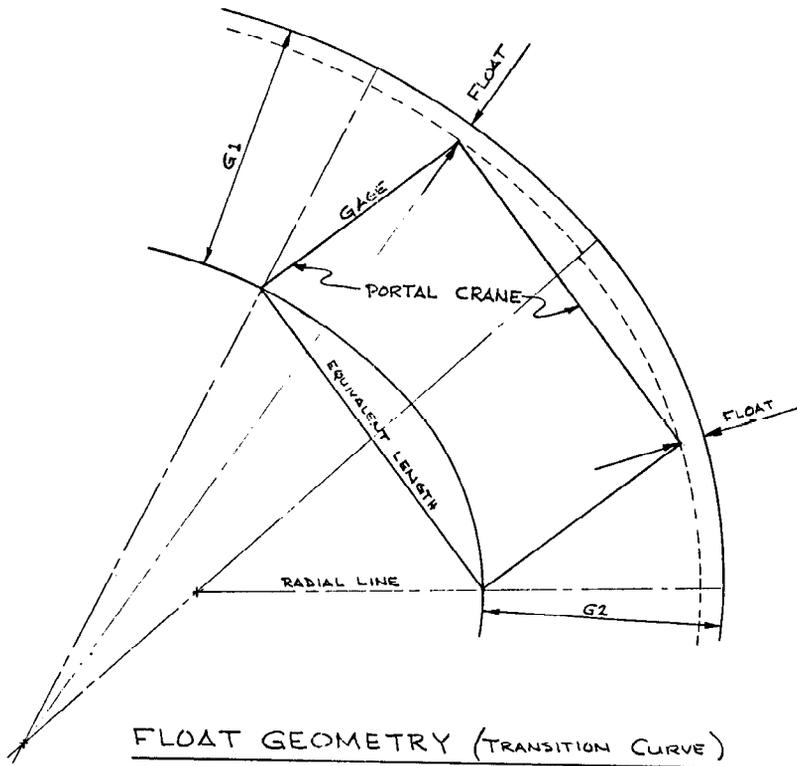
FIGURE 1

Symptom: Portal cranes were experiencing difficulty going around curves. This was evident by the high pitch sound of metal to metal contact as a number of cranes transverse the curves around drydocks.

Collection of Facts: A west coast shipyard proposed that the float that provides a means for cranes to go around curves, designed on portal cranes, should be redesigned so they would operate by the available centrifugal force generated by the crane going around a curve. Float has lateral or sideways movement capability that is built into portal crane running gear. This lateral movement is necessary because the geometry of the rectangular crane frame on a curved track does not allow the corners of the crane to touch both rails (See Figure 1). This phenomenon occurs because the ends of the crane do not fall on a radial line.

If a given crane is operated on a curve of constant radius, the gage can be adjusted so no float is required. However, if cranes of the same gage, but different lengths/wheel configurations, are operated on the same curve, different gage adjustments are required. Therefore, a compromise alignment **must be adopted and the difference absorbed by a float mechanism on each crane.**
