Corrosion Factors in DoD Facilities

FINAL Submittal

Vision Point Systems

10/24/2014

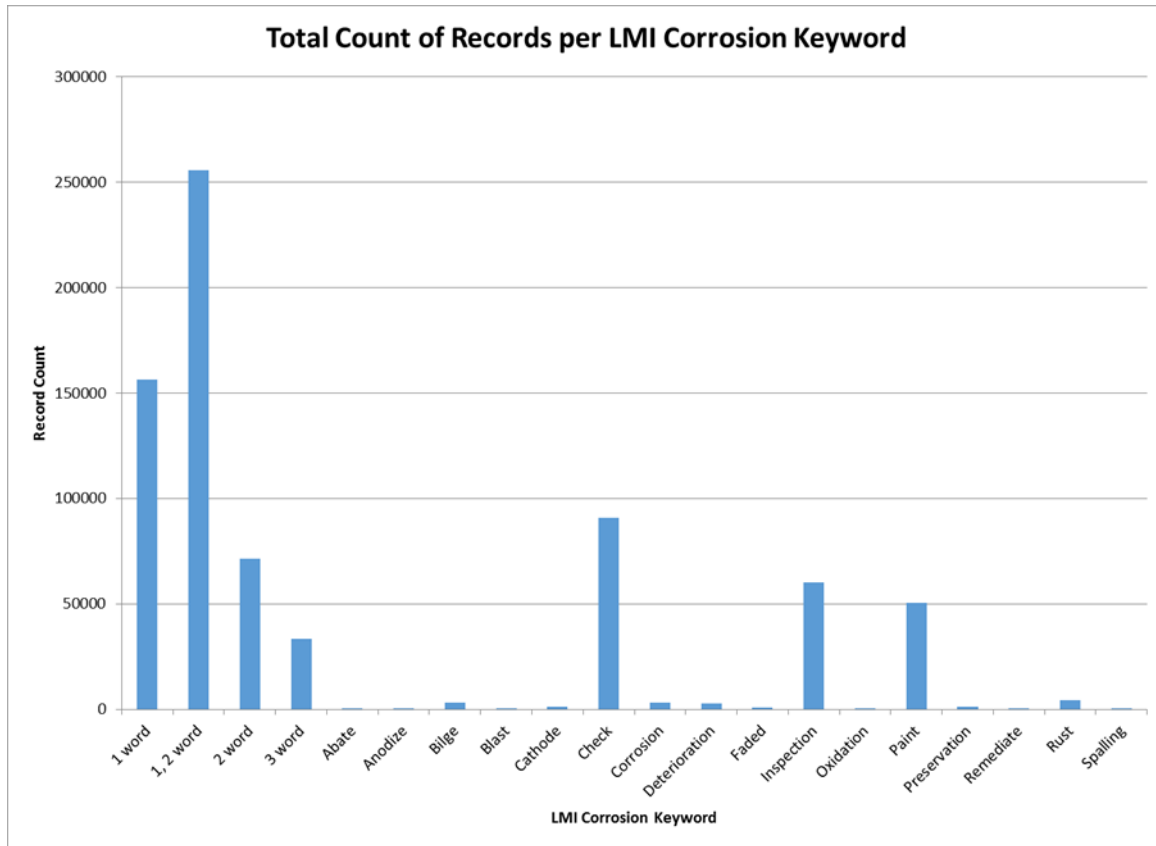
Figure 1. Count of Corrosion Records per LMI Corrosion Keyword

was presented in a pivot table of all corrosion records for all Fiscal Years. As shown in Figure 1, the phrases 1-word; 1,2-word; 2-word; and 3-word are significant.

These phrases refer to non-explicit Corrosion Keywords that are designated as 1-word, 2-word, 3-word, or 1,2-word which refer to the noun, verb, and/or adjective that comprise any given corrosion record. Words that are identified by the non-explicit Corrosion Keywords were pulled from a craftsman roundtable matrix that was created by LMI. The craftsman roundtable matrix is considered proprietary by LMI and was not available for our analysis. However, any given record indicates which words qualify as its respective verb, noun, and/or adjective. It was decided to substitute the maintenance verb for the records lacking a defined corrosion keyword. From there, maintenance verbs were examined on a per-cost driver basis. It was observed that all cost drivers had roughly three to five verbs, which comprised the vast majority (frequently over 80%) of the associated costs for that cost driver. As such, these top verbs were extracted for each cost driver and became the list of critical verbs for analysis. This down-selected list of critical verbs was then combined with the remaining Corrosion Keywords. This list now contained several words that were functionally describing the same thing and needed to be combined for further analysis. Therefore, the words inspect, inspection, and check were all combined into “inspection.” The words paint and re-paint were combined into “paint.” The words rust and corrosion were combined into “corrosion.” The keywords Oxidation and Anodize both were observed to have records which required further separation. Within the Oxidation keyword results, records for paint and corrosion existed. A search was conducted within the maintenance operation description text field for
