Naval Facilities Engineering Command

Inspection of Wood Beams & Trusses

NAVFAC MO-111.1 September 1985

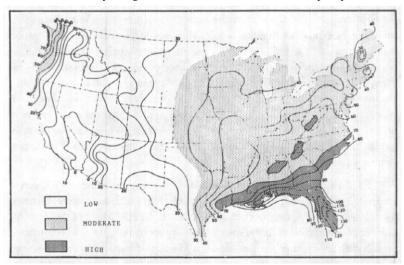
Figure 1-1. Climate index for decay hazard (higher numbers indicate a higher decay hazard).

The climate index map for decay hazard (Fig. 1-1) shows the effect of geographic location on the rate at which decay advances. The most severe location in the United States is the southeastern states where rainfall is high, and the weather is warm and humid. In the northeast and midwest decay advances at a somewhat slower rate. Near the coast in the northwest, decay hazard is moderate, but on the coast it can be severe. Most of the southwest is very dry, so decay is less hazardous.

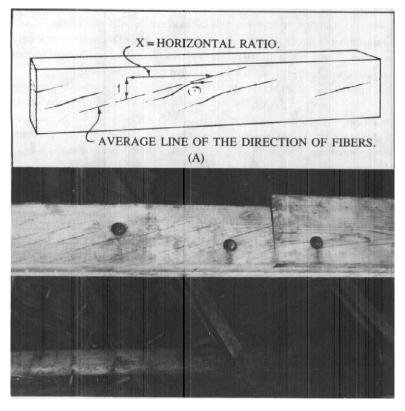
Figure 1-2. Slope of Grain. (Slope of grain (A) is indicated by a ratio of vertical to horizontal distance, such as 1 in 10. Slope of grain (B) is evident from checks. The member at the left has a slope of grain much steeper than allowed by structural grades. Slope of grain in the member at the right is low enough to be accepted by some structural grades.)

Cross grain is of two kinds, spiral or diagonal. Spiral grain is a growth characteristic in which the wood fibers are inclined spirally around the tree instead of parallel to the axis of the trunk. It is easily detected by the inclination of seasoning checks with respect to the direction of length of the piece. Diagonal grain results from sawing a crooked tree or from not sawing parallel to the bark. and can be detected by the trace of the annual rings on a radial surface. Cross grain is shown in Figure 1-2.

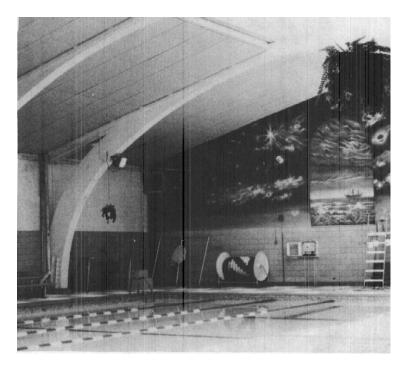
Figure 1-3. Swim Pool Areas. (Swimming pool areas may develop high humidities which increase the potential for condensation and consequent decay problems. Humid air alone will not result in wood wet enough to decay.)

1.2.2-A HOW THE BUILDING IS USED AND UNUSUAL LOADING. Normal operations carried on in a building can contribute to deteriorating of wood, especially if the function was not considered in the original design. Any operation that involves a lot of water (Fig. 1-3) or steam (Fig. 1-4) increases the potential for the wood to be at a high moisture content and for consequent decay or possibly insect problems. Some examples are shower rooms, swimming pools. and laundries. The high humidity resulting from these operations may cause condensation on cold surfaces with resultant wetting of the wood. Problems may also develop where water contacts wood or where steam from driers or steam lines is close to wood members. Various manufacturing or processing operations may also introduce excessive moisture to the inside of the building. Although adequate ventilation may have been included in the design, these high moisture situations should alert the inspector to a greater potential for decay than in a building that is consistently dry.

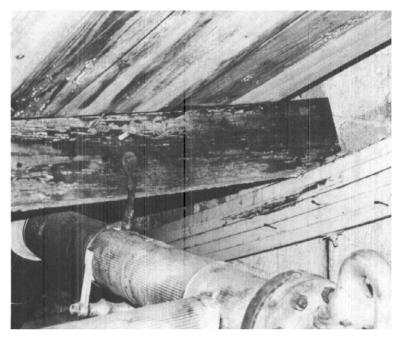
Figure 1-4. Decay Caused by Steam Lines. (Steam lines close to wood components may cause some deterioration of wood due to high temperatures, and leaks in the lines may create moisture problems.)

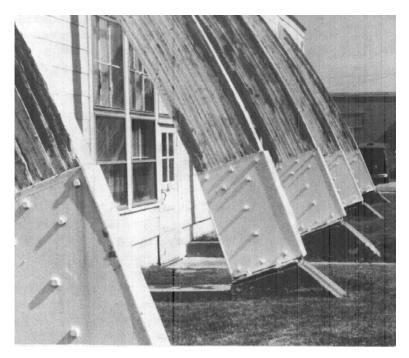
Figure 1-5. Outside Structural Members. (Structural members extending outside the roof line are particularly vulnerable to decay because of exposure to rain. These arches were being repaired at the time the picture was taken.)

in the performance of those members. When wood members extend outside the wall, and particularly beyond the roof line, there is a high potential for decay unless they are preservatively treated. If such members are strictly for esthetic effect without serving a structural function, the building may not be endangered; however. when structural support such as an arch base (Fig. 1-5) is outside the building, any deterioration can have a major impact on the safety of the building. Special attention should be given to exposed end grain of wood since water is absorbed much faster in the grain direction than it is absorbed across the grain. Proper flashing over the top and ends of wood members often gives good protection, but total enclosure of the end may accelerate decay by trapping water. Also, ends of members supported on horizontal surfaces may be subject to absorbing water that stands on the surface. If these exposed members are near the ground, lawn watering or backsplash from rain may cause additional wetting. Any ground contact of wood is a major hazard unless the wood has been preser-

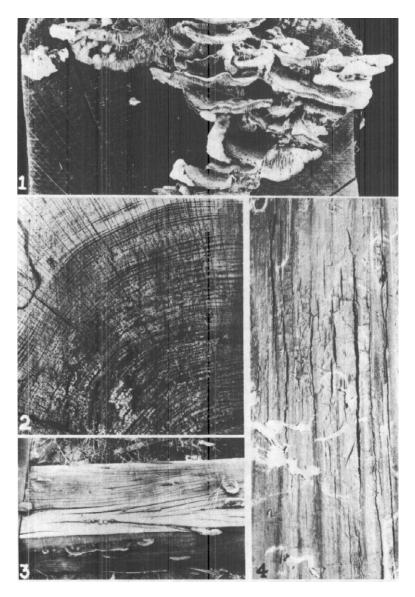
Figure 1-6. Examples of fungal growths and associated decay. (1) Fruiting bodies; (2) Advanced decay; (3) Fruiting bodies without obvious decay on surface of wood; (4) Fungal growth on surface and advanced decay evidenced by checks both across and with the grain. (M31901F)

The growing stage of fungi consists of microscopic threads called hyphae which in mass form cottony or felt-like growth/ It is hyphae that penetrate and "branch out" within wood and cause decay. When conditions are suitable, fungi produce spore-bearing structures called fruiting bodies (Fig. 1-6). The fruiting bodies of most decay fungi are mushroom or bracket shaped.

The presence of fruiting bodies (Fig. 1-6) or "mushrooms;" indicates that decay is present in members where the bodies occur. Fruiting bodies may appear at any stage of deterioration.

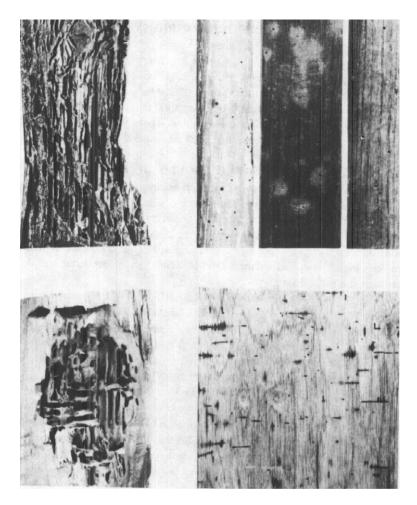
Figure 1-7. Types of insect damage most likely in a building. (Upper left.) Termite attack; feeding galleries often parallel to the grain and containing excrement and soil. (Upper right.) Powder-post beetle attack; emergence holes. prevalently filled with wood flour and not associated with discolored wood. (Lower left.) Carpenter ant attack; nesting galleries usually cutting across the grain and free of residue. (Lower right.) Beetle attack: feeding galleries (made in the wood while green) free of residue and the surrounding wood darkly stained.

Insect Damage. Various types of termites, beetles, carpenter ants. and bees utilize wood as a food source or for nesting purposes. Damage by wood-boring insects can usually be recognized without difficulty (Fig. 1-7). Evidence of their presence may be entrance or departure holes, the size of which depends upon the insect involved. In many instances the accumulation of powdery material in the vicinity of the hole indicates insect activity. Extensive insect activity can result in structural failure of members.

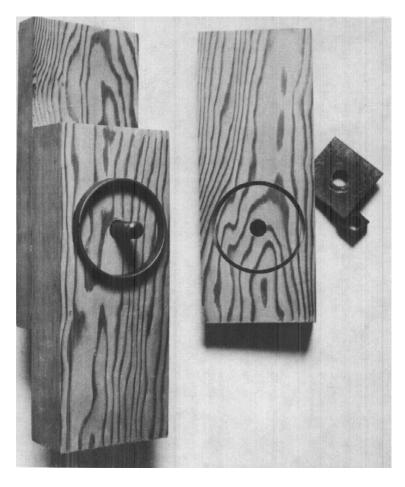
Figure 2-1. A split-ring connector installed in one member. The facing member has been drilled to receive the connector. Where the joint between facing members is not tight, probe through the connection with a thin metal to determine if the connector was installed or not.

Look for separations between members at joints which indicate obvious looseness of connectors. Also look for bolt holes where split-ring connectors were intended but not installed (Fig. 2-1).

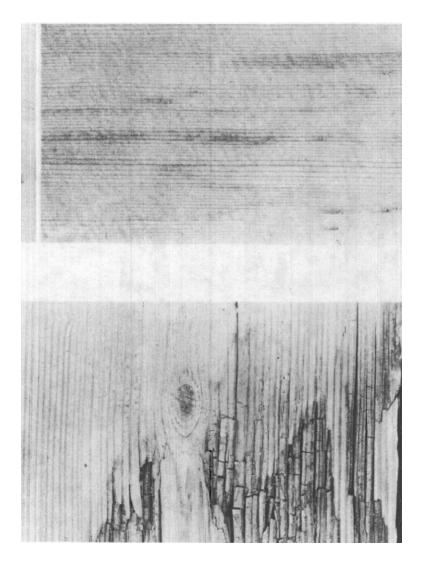
Figure 2-2. Stages of decay. (Top) Early stage evidenced by discoloration in surface and, at left. in end grain. (Bottom) Late stage, with cracked and collapsed wood. An abnormal brown color will be imparted to the wood by this type of decay.

2.2.1-B DECAY. Decay may result in abnormal coloration of the wood. The first indication of decay is often the appearance of brown streaks or blotches (Fig. 2-2). As wood approaches advanced stages of decay, it loses luster and

When decay has reached an advanced stage, it is usually quite easy to decide if the deterioration in a member is due to decay. especially if fungal growths (fruiting bodies) are present. There may be localized depression or sunken faces (Fig. 2-2) over decay pockets which extend close to the surface of the member. Many times advanced stages of attack are accompanied by shrinking of the wood and appearance of cracking in cubical patterns. Evidence of retained moisture over a period of time, especially at the junction of timbers. often indicates attack.

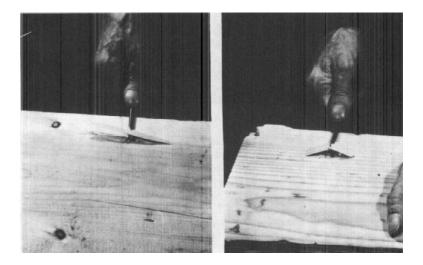
Figure 2-3. The pick test for early decay. (Left) Sound wood pries out as long slivers. (Right) decayed wood breaks abruptly across the grain without splintering.

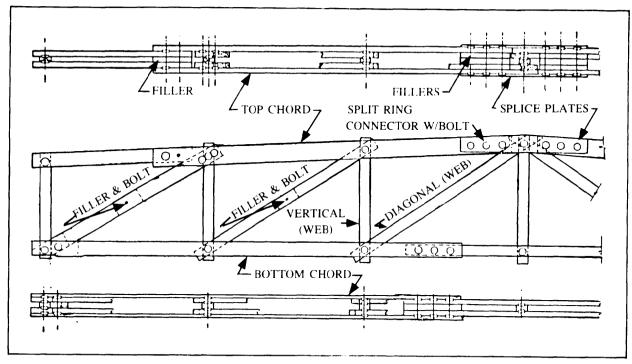
Figure 3-1. Elements of a typical heavy-timber truss are shown in this elevation plus top and bottom view.

Elements of a typical heavy-timber truss are shown in Figure 3-1. Any of the following signs of distress (Figs. 3-2 through 3-6) indicate a need for more detailed investigation as described under PROCEDURES in Chapter 2. Since trusses are often supported by heavy-timber columns, these columns should be evaluated at the same time. The same principles of deterioration apply. Specific application to columns is discussed under various signs of distress.

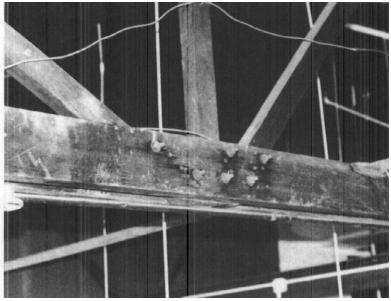
Figure 3-3. Trusses with rating 80. No deflection, significant splits, or loose connectors. Staining around connector indicates a constant moisture problem with possible decay.

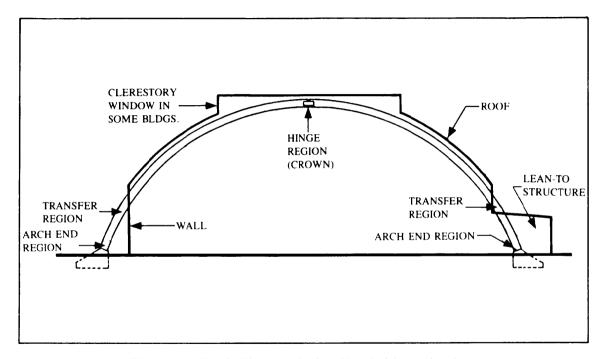
Figure 4-1. (Sketch) Elements of a three-hinged glulam arch and a commonly used roof system are shown in this schematic of a building cross section.

Elements of a typical glulam arch are shown in Figure 4-1. Any of the following signs of distress (Figs. 4-2 - 4-6) indicate a need for more detailed investigation as described under PROCEDURES in Chapter 2.

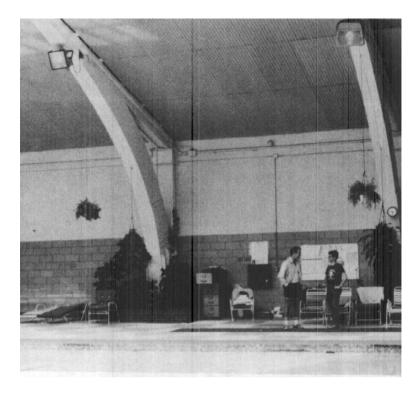
Figure 4-2. Glulam arches with rating 100. No sign of deflection or deterioration.

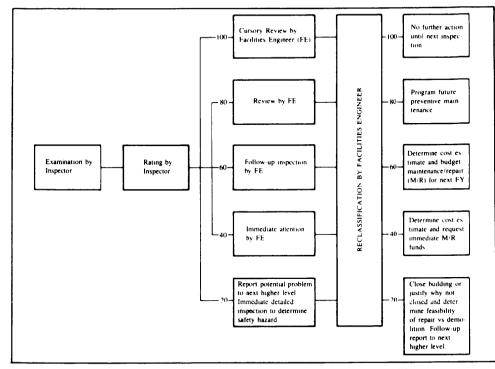
Figure 5-1. Suggested implementation method for glulam arches and heavy timber trusses.

The inspection and rating of glulam arches and heavy timber trusses will be useful only if evaluated and used as a basis for action. While the higher ratings may require only a cursory review, the facilities engineer must conduct a more detailed inspection of the structures that receive lower ratings. Such an inspection may result in reclassification of the structure. If the inspection verifies the need for action, further study may be required to establish the cost of repairs, and possibly to evaluate the economics of making repairs versus demolition and replacement of the building. A suggested implementation method for the inspection results is shown in flow chart form in Figure 5-1.
