PUBLIC WORKS TECHNICAL BULLETIN 200-1-151  
15 OCTOBER 2015

**UPDATE OF  
DECONSTRUCTION ALTERNATIVES  
FOR WORLD WAR II-ERA BUILDINGS**

a. This Public Works Technical Bulletin (PWTB) reports on deconstruction options for World War II (WWII)-era Army buildings, in addition to three case studies that document deconstruction practices, problems, and lessons learned.

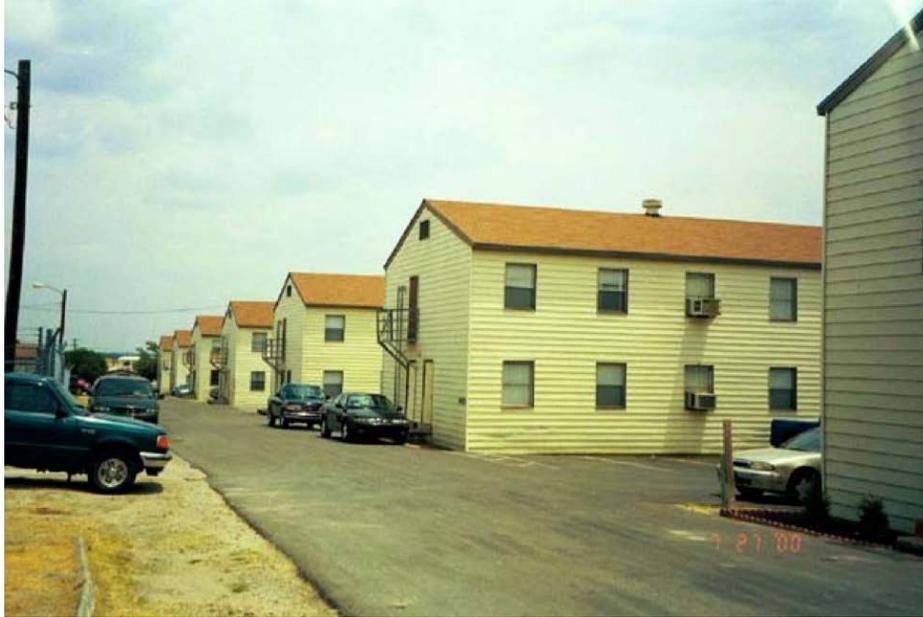
Figure A-1. Typical WWII-era, wood-framed buildings at Fort Hood in 2000.

Even though steel-framed buildings are often disassembled, the deconstruction process is used mostly on wood-frame buildings. The deconstruction contract's cost may affect the viability of using deconstruction, depending on the value of the building's contents and materials. Usually, a high-value project for the Army is demolishing an average two-story World War II (WWII)-era barracks (Figure A-1). Since much of the debris is valuable old-growth wood, deconstructing a WWII building will usually provide a higher return for the time and effort expended.

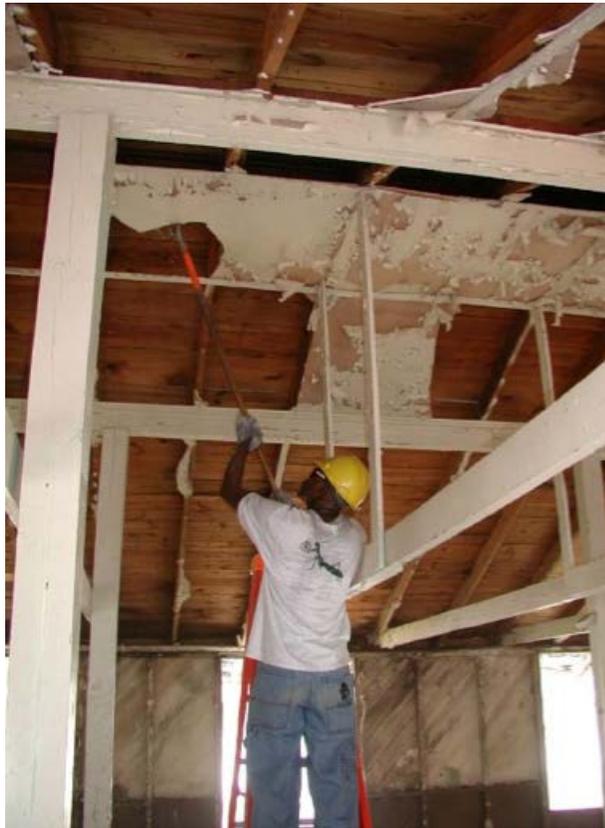
**Figure A-2. Removing drywall in 2003 at Fort McClellan (Joyce Baird, ERDC-CERL).**

Examples of building deconstruction activities are the removal of siding, sheetrock, windows, wall studs, flooring, trusses, and wood trim. Some of these indoor and outdoor deconstruction activities are depicted in Figure A-2 through Figure A-4.

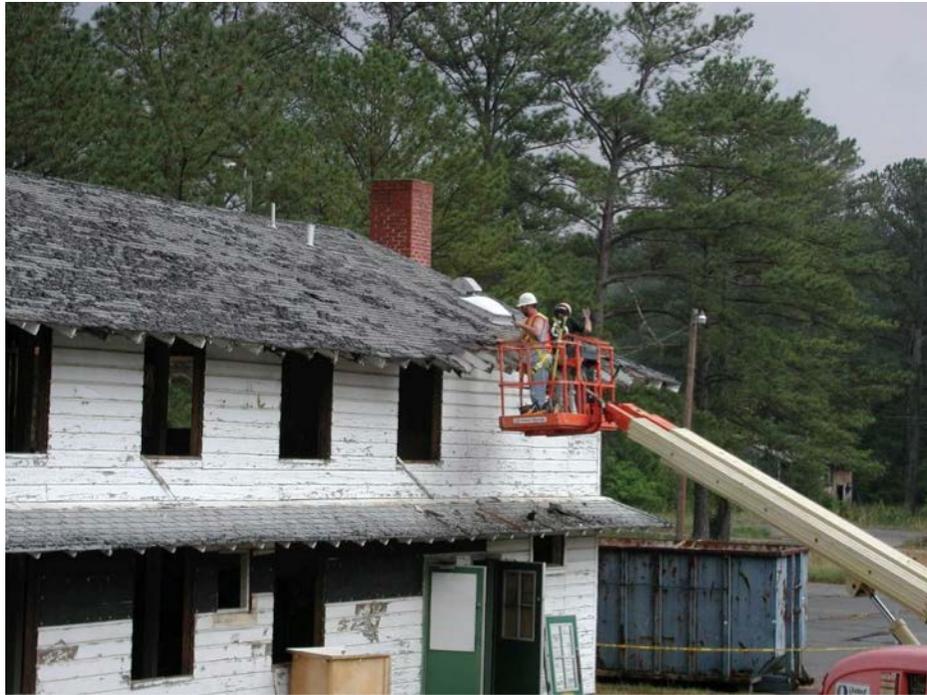
Figure A-3. Removing eaves at Fort McClellan in 2003  
(Joyce Baird, ERDC-CERL).

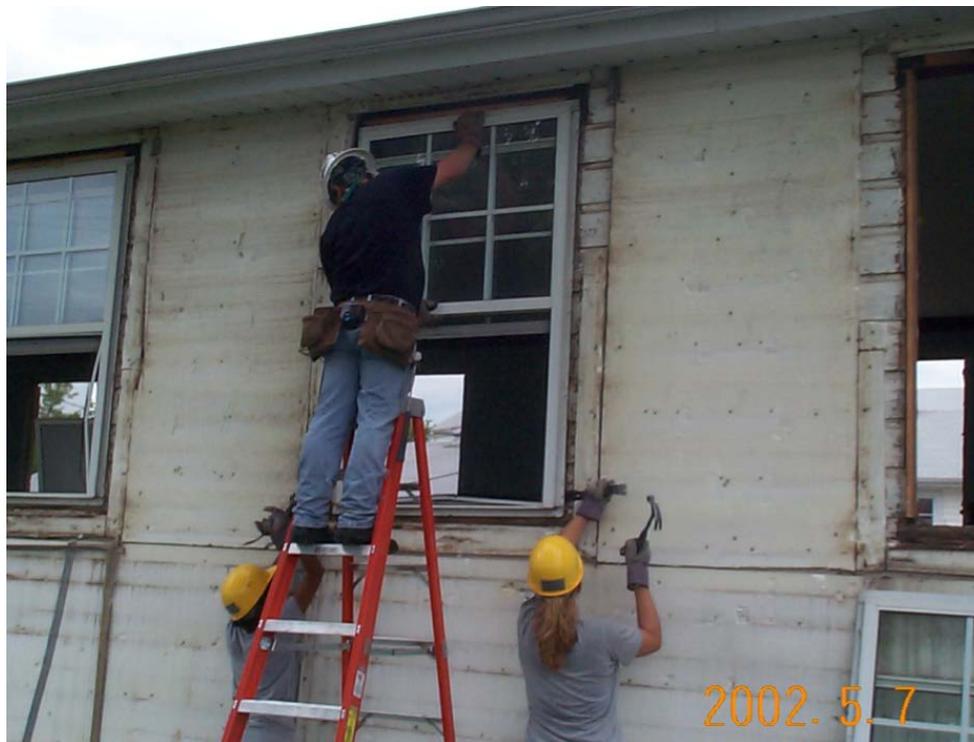
Figure A-4. Removing windows at Fort Campbell in 2002  
(Joyce Baird, ERDC-CERL).

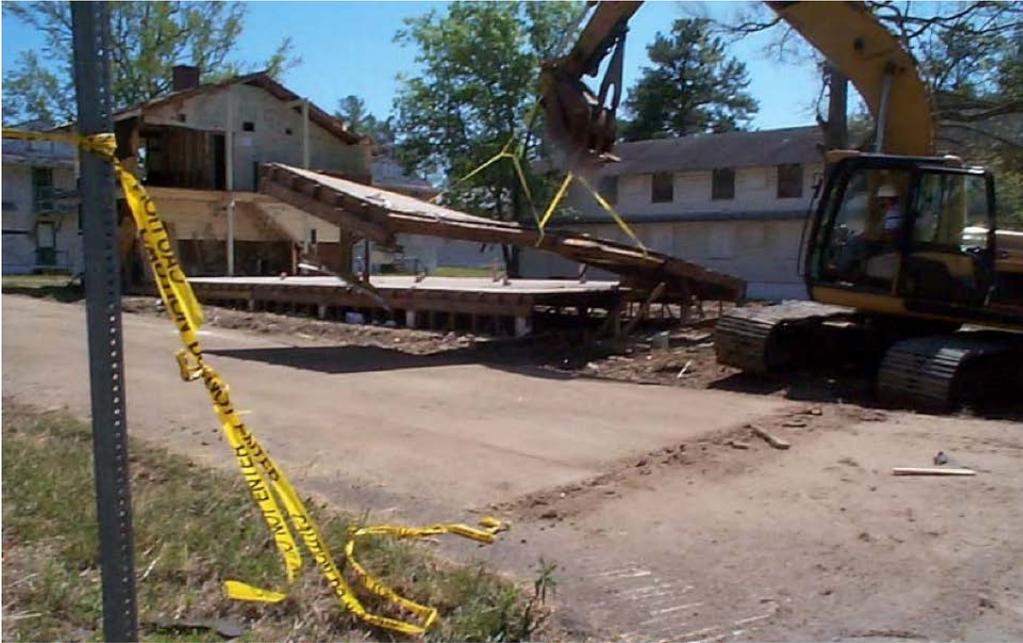
**Figure A-5. Floor panelization at Fort McClellan in 2003  
(Joyce Baird, ERDC-CERL).**

An example of panel deconstruction is the removal of large sections of roof decking by cutting the decking between the rafters into panels and removing the panels all at once. Figure A-5 shows the "panelization" method of deconstruction. Panelization allows roof, wall, and floor sections to be removed more quickly than manual methods but will reduce salvage yields.

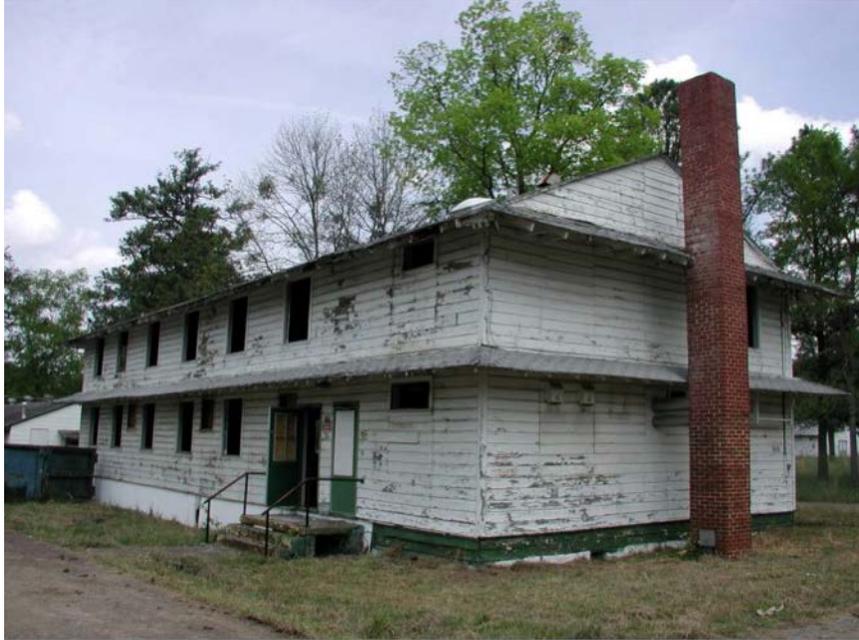
**Figure B-1. Building 829 at Fort McClellan.**

Because Building 829 at Fort McClellan had considerable water damage and a severe mold problem, not much was salvageable. Thus, it was dismantled using mechanical means. By contrast, manual methods were used to deconstruct Building 830, and

The barracks selected for the study had extensive amounts of lead-based paint (LBP) and severe water damage. Building 829, in particular, had a mold and water damage problem. Little could be salvaged from Building 829 except bathroom and plumbing fixtures, boiler room items for scrap metal, and concrete supports from bathroom and boiler room floors. Thus, material recovery rates were significantly lower than what was expected from typical barrack deconstructions.

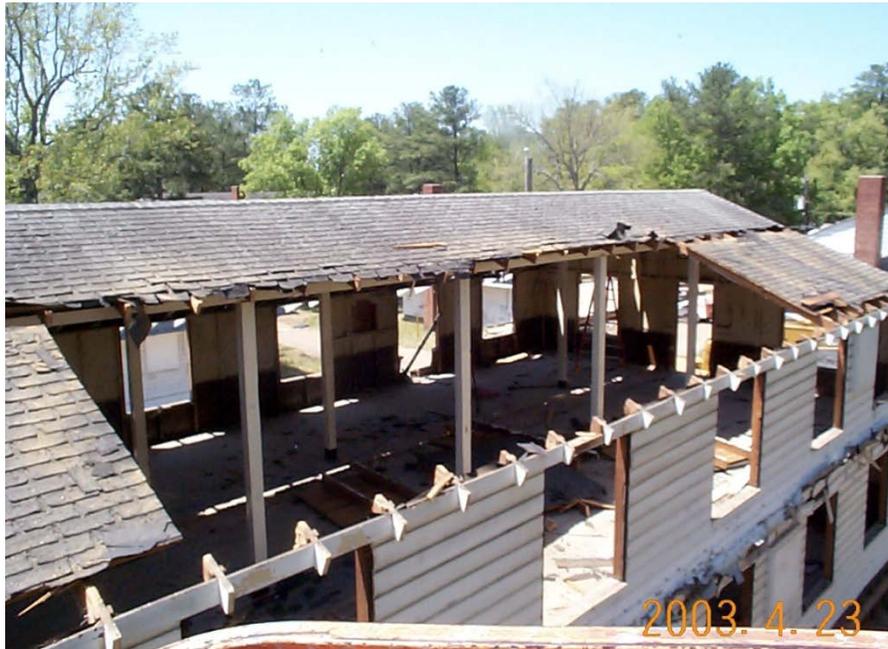
Figure B-2. Removing roof panels at Fort McClellan in 2003 (Joyce Baird, ERDC-CERL).

Building 844 was dismantled using the panelization method. The panelization method involved cutting roof assemblies, walls, and floors into 10 x 10 ft (or larger) panels which were then carried by a skid steer to a salvage area.

Figure B-2 through Figure B-7 illustrate mechanical-assisted dismantling processes demonstrated during this project.

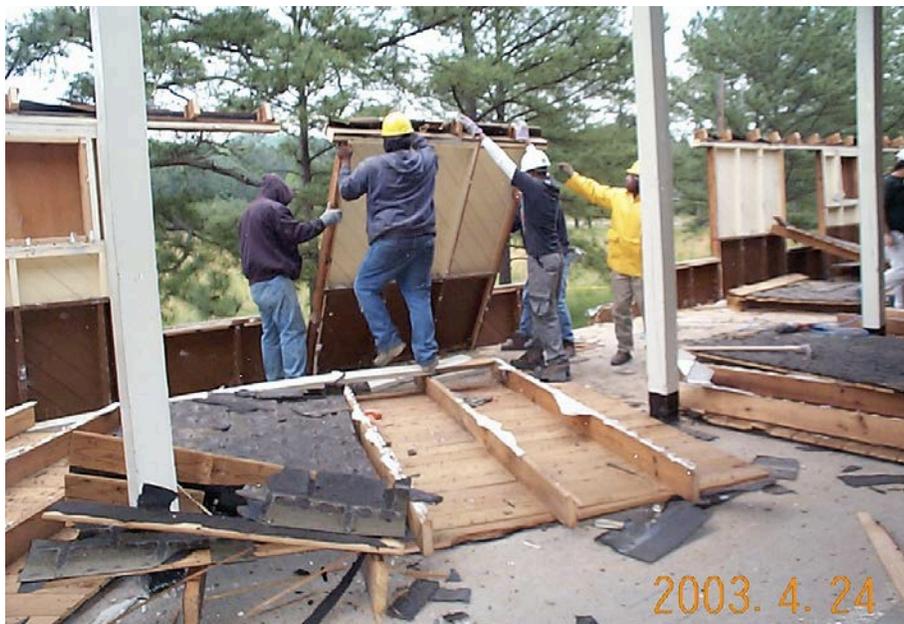
Figure B-3. Removing upper floor wall panels at Fort McClellan in 2003 (Joyce Baird, ERDC-CERL).

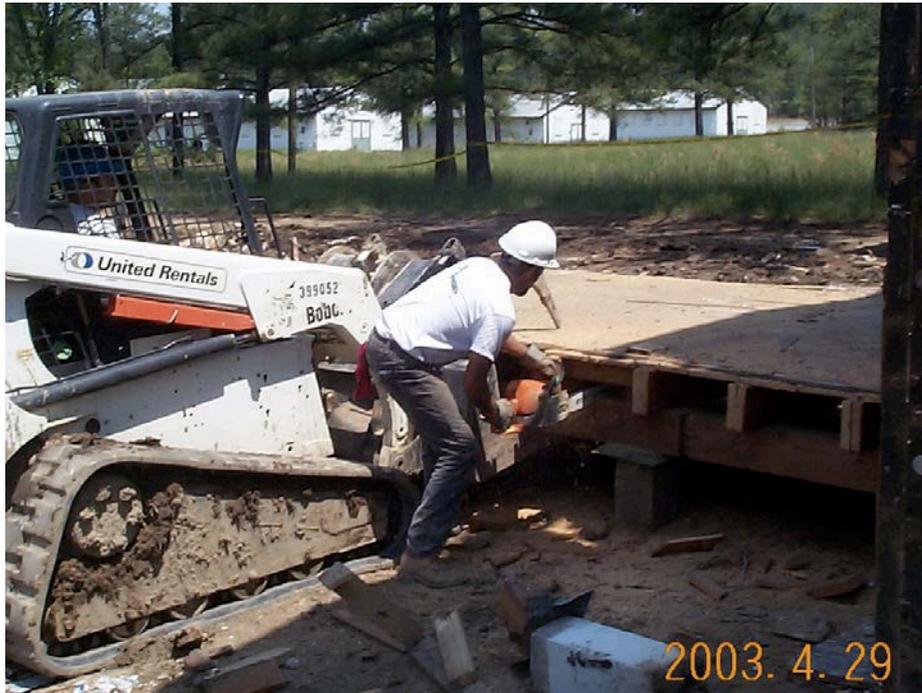
Figure B-4. Cutting floor panels at Fort McClellan in 2003  
(Joyce Baird, ERDC-CERL).

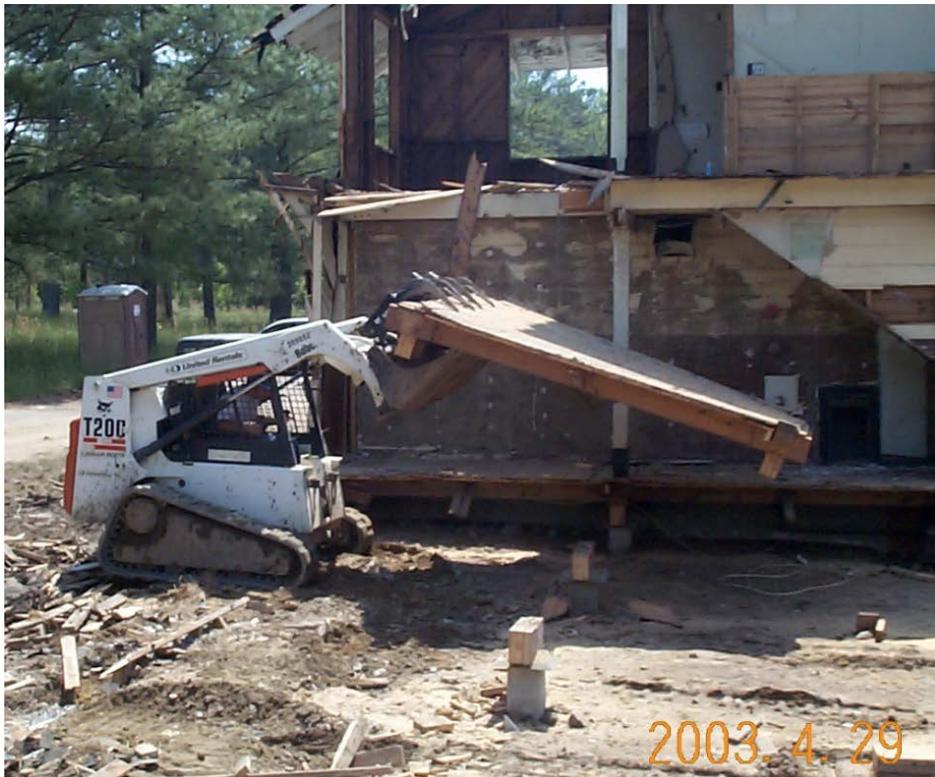
Figure B-5. Moving floor panels with skid steer at Fort McClellan in 2003  
(Joyce Baird, ERDC-CERL).

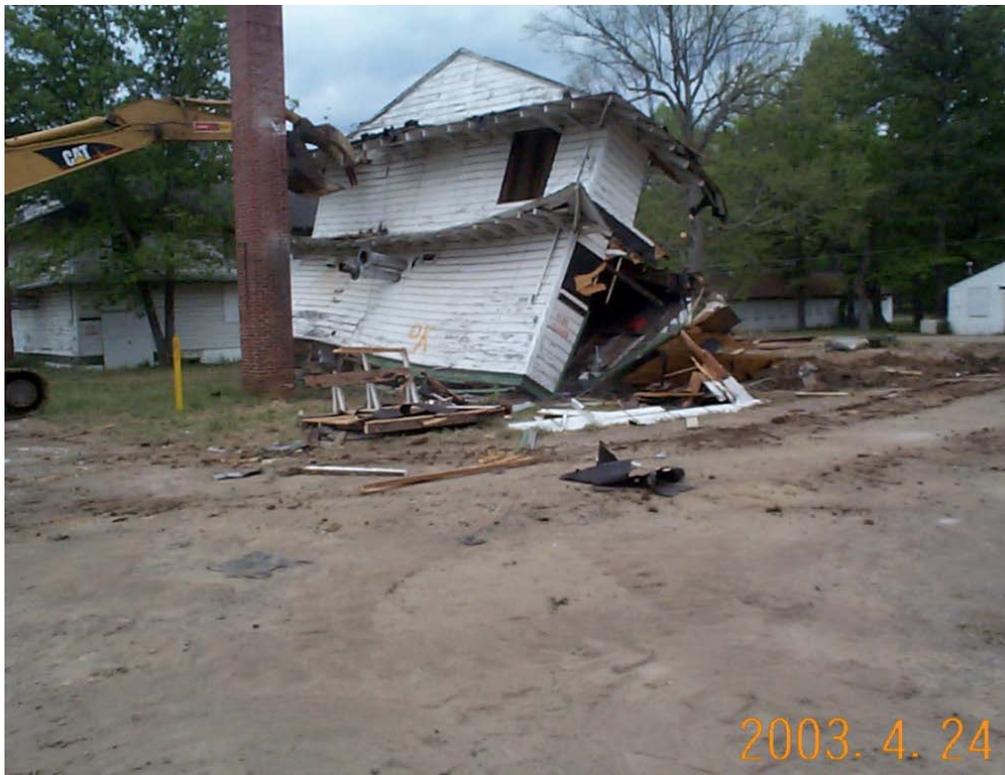
Figure B-6. Using a track hoe to tip remnant building shell after salvage at Fort McClellan in 2003 (Joyce Baird, ERDC-CERL).

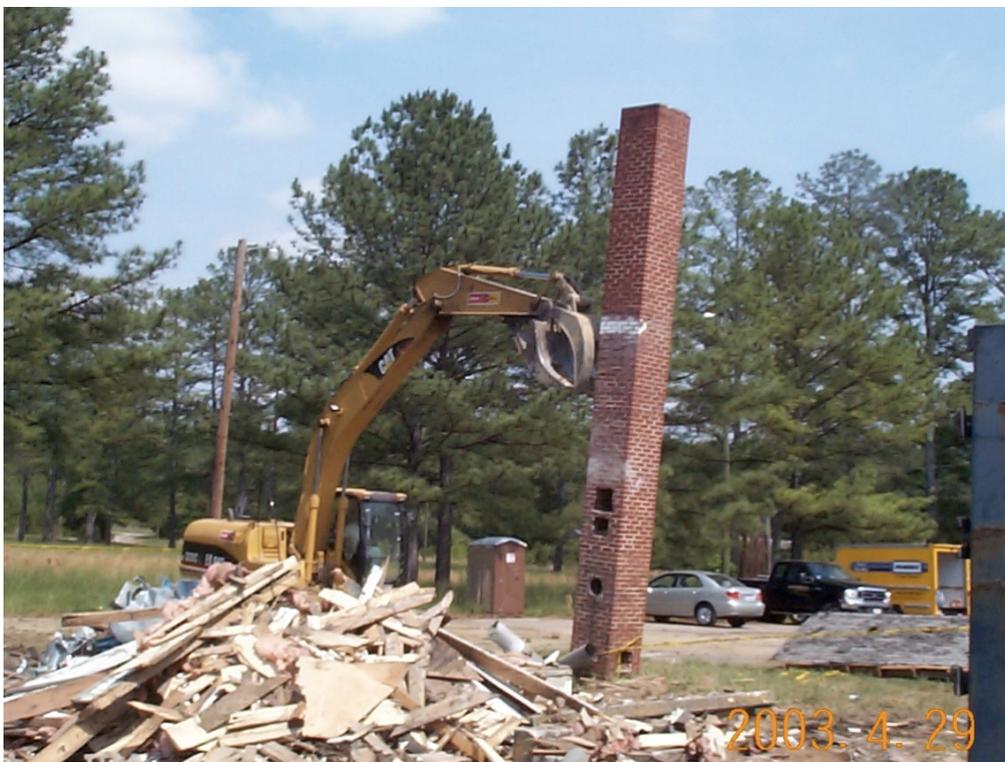
Figure B-7. Tipping chimney separately with track hoe to break apart bricks for potential recycling at Fort McClellan in 2003 (Joyce Baird, ERDC-CERL).

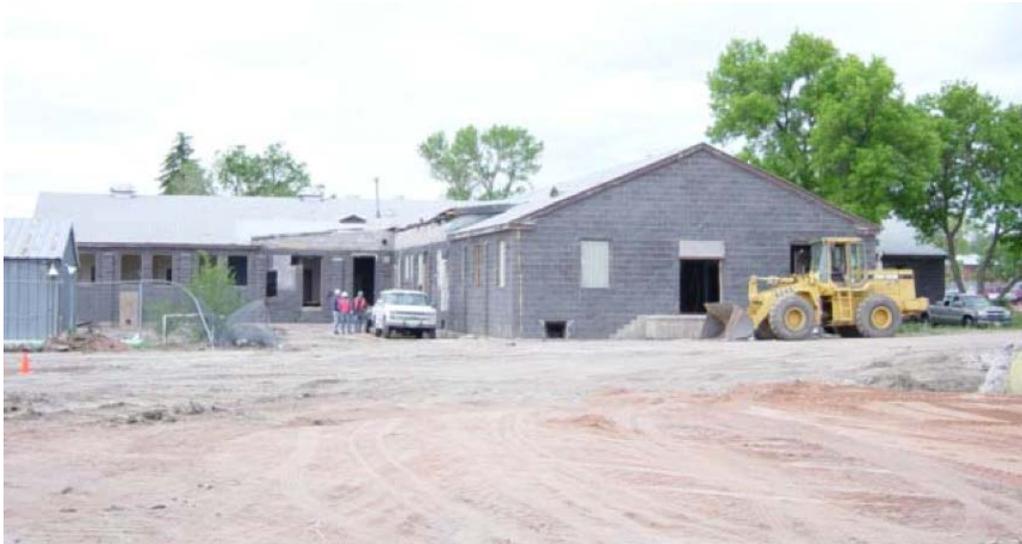
**Figure B-8. Building 6286 at Fort Carson, showing CMU exterior shortly before deconstruction (Innovar 2005).**

In Building 6286, much of the harvestable product was damaged (e.g., windows, interior doors, and lights), so most of the deconstruction effort focused on the available higher-yield items (i.e., not damaged and more available). Overall, budget and time constraints allowed for only 8,000 sq ft of deconstruction. The remaining 5,128 sq ft was removed by mechanical demolition practices.

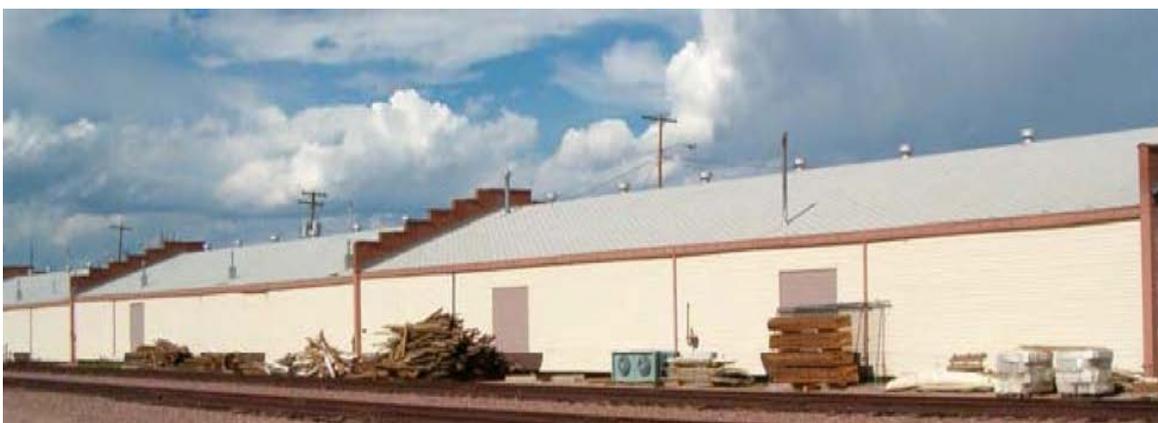
**Figure B-9. Building 227, a WWII-era warehouse at Fort Carson in 2005 with mostly wood exterior (Tom Napier, ERDC-CERL).**

Building 227 (Figure B-9) was one of six WWII-era warehouse buildings located near the Fort Carson rail yard. The building dimensions were approximately 70 x 130 ft (9,100 sq ft). It was a single-story structure of wood construction with few interior partition walls, and it had wood rafters and skip-sheet roofing covered with four layers of asphalt shingle and rolled roofing material. Brick firewalls separated various building sections. The wood-framed building design of this warehouse was well suited for deconstruction.

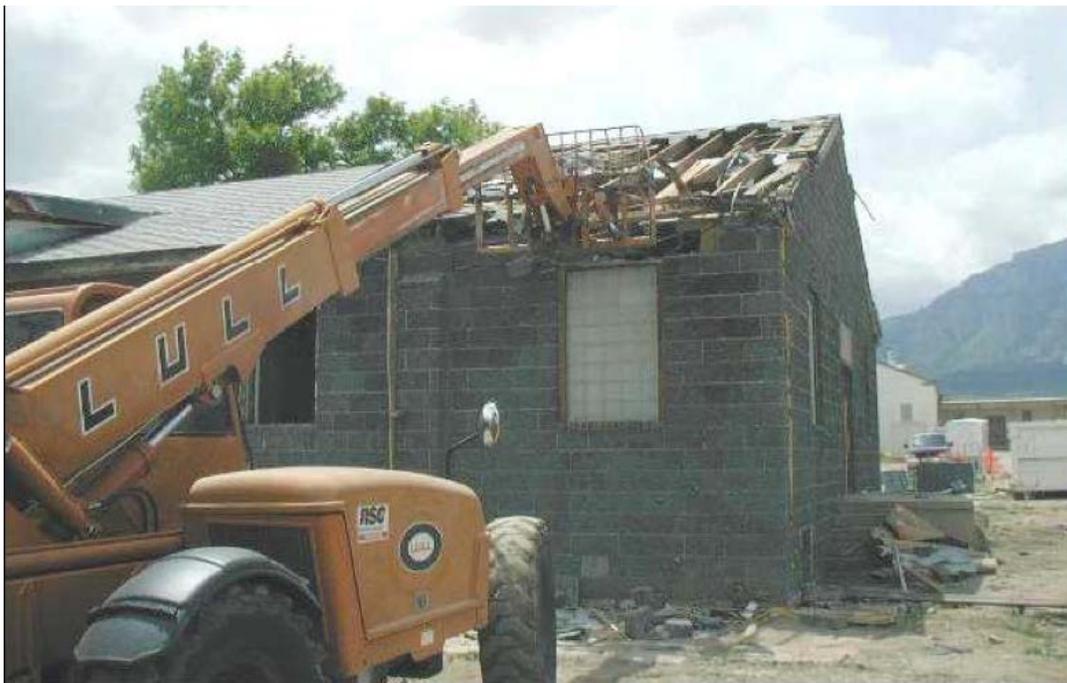
**Figure B-10. Reach forklift removing a roof section of Building 6286 (Innovar 2005).**

from the inside of the exterior walls. A reach forklift was used to push the interior finish away from the cinder blocks, an action which produced cleaner cinder-block debris.

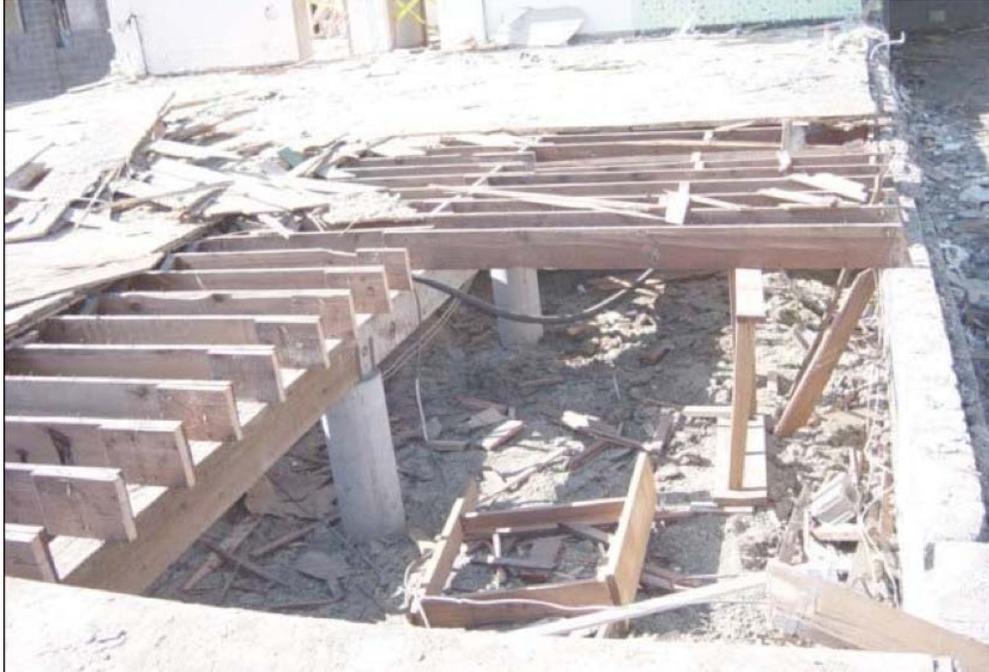
**Figure B-11. Floor joist and concrete piers exposed during deconstruction of Building 6288 (Innovar 2005).**

Wood flooring, concrete pillars, and footers (Figure B-11) were sought for reuse or recycling. In addition, the 2x12 floor joists under the plywood subflooring were removed by hand and derailed either for reuse or recycling. Most of the floor joists in the north and south wings were exposed to extreme heat from the steam pipes located beneath the building. This exposure resulted in dry rot and a subflooring that could only be recycled rather than reused or resold. When the flooring was removed, an excavator retrieved concrete pillars and foundation for recycling. Foundation floor joists were stockpiled.

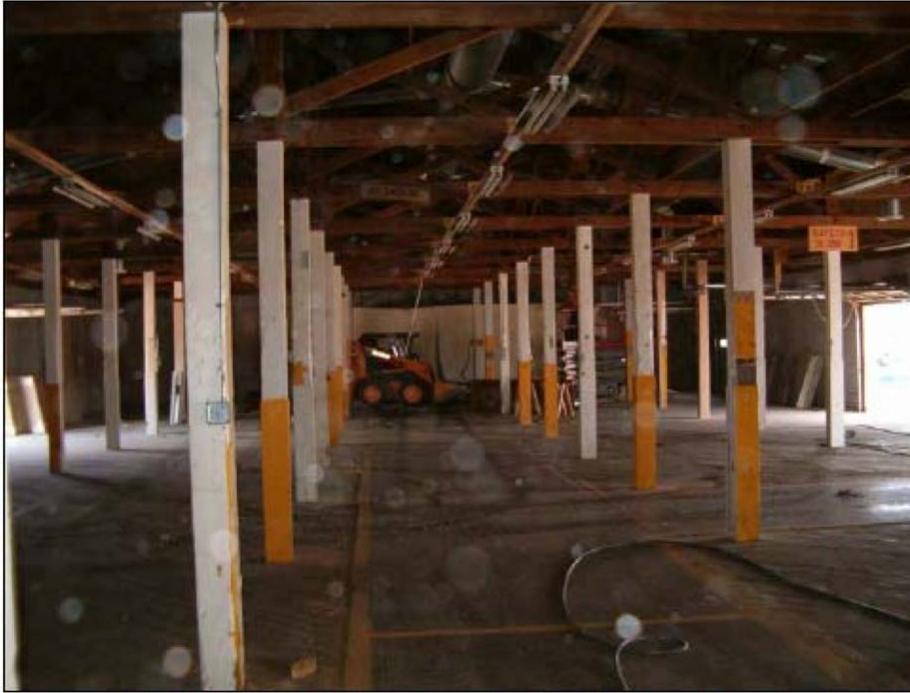
**Figure B-12. Interior view of columns and roof structure in Building 227 at Fort Carson (Innovar 2005).**

The roof sheeting was 1x10 and 1x12 butt-jointed boards. The roof had up to five layers of asphalt shingles which were removed by hand labor using mostly claw hammers and flat bars. The roof structure was supported by 8x8 built-up columns extending from the floor joists through the flooring and up to the rafters, spaced 12 ft on center (Figure B-12). Columns were bolted or bracketed to the bottom of the rafters. The interior surface of the roof was sheathed with 3/8-in. fiberboard. Blown-in cellulose insulation that was sandwiched between the fiberboard and roof sheeting was removed using a vacuum truck.

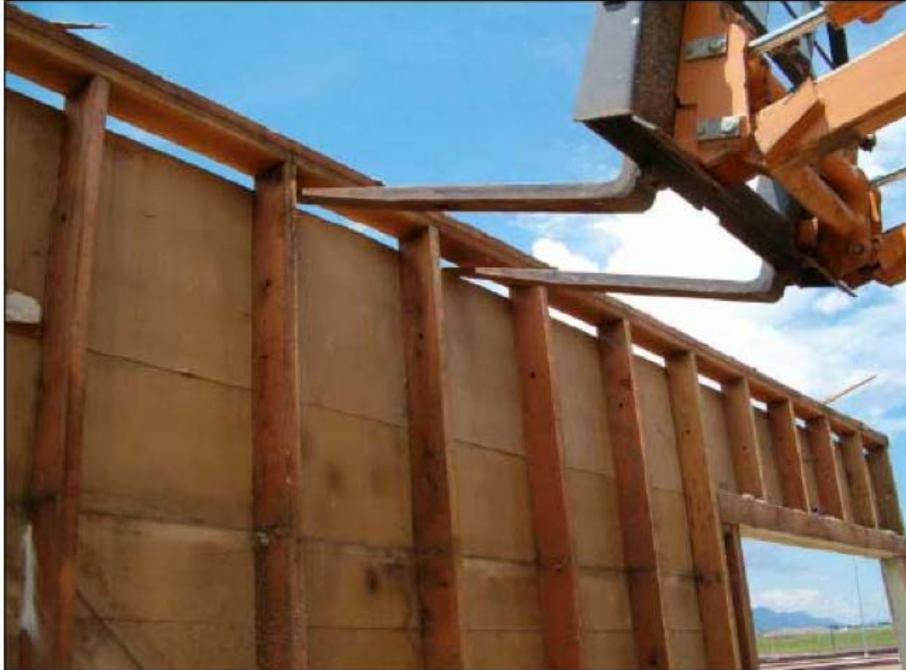
**Figure B-13. Reach forklift removing exterior walls of Building 227 at Fort Carson (Innovar 2005).**

A portion of Building 227's exterior was covered with vinyl siding. The building also had a lead-painted exterior portion made up of 2x6x10 studs and 1x8 lap siding. The interior surface of the exterior walls was made of 1x6 tongue-and-groove wood flooring painted with LBP. The exterior walls were removed using the reach forklift (Figure B-13) and dropped inside the building to keep them within the building footprint for later disassembly.

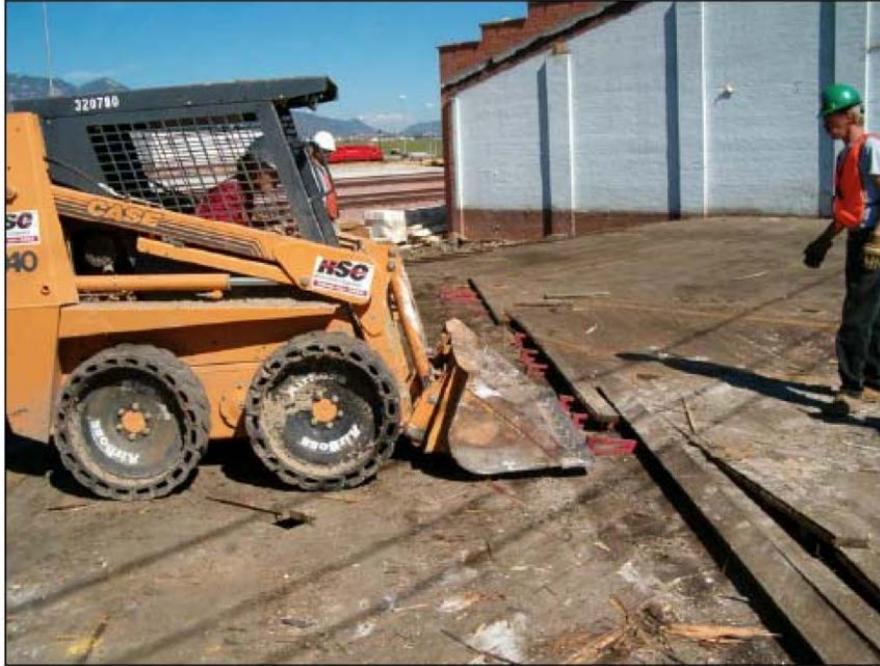
Figure B-14. Removing flooring with skid-steer loader at Building 227 (Innovar 2005).

The second layer of flooring was toe-nailed into the first layer on-diagonal. Steel wedges were used to loosen this second layer. Sledgehammers, first thought to facilitate deconstruction, were initially used to pound the wedges into the flooring, but this method proved slower and less efficient than the skid-steer equipment that could push the wedges into the flooring (Figure B-14).

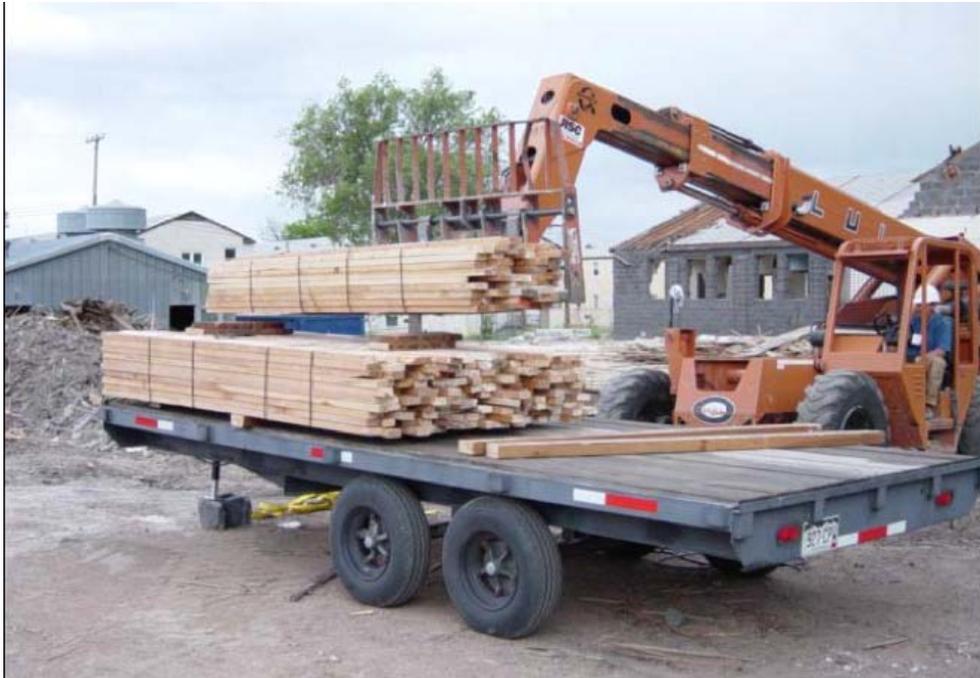
Figure B-15. Harvested wood, bundled for sale at Fort Carson (Innovar 2005).

Most of the reusable material salvaged for resale was lumber (approximately 18,000 linear feet); this material was bundled for reuse and sale (Figure B-15). Table B-1 summarizes the deconstruction and demolition data for Building 6286.

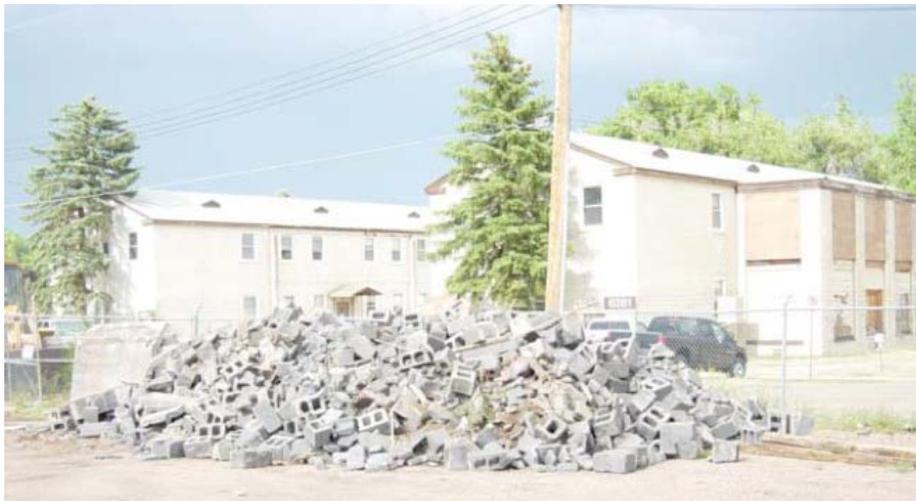
**Figure B-16. Cinder block intended for recycling from Building 6286, but instead disposed as rubble due to unavailability of rock crusher (Innovar 2005).**

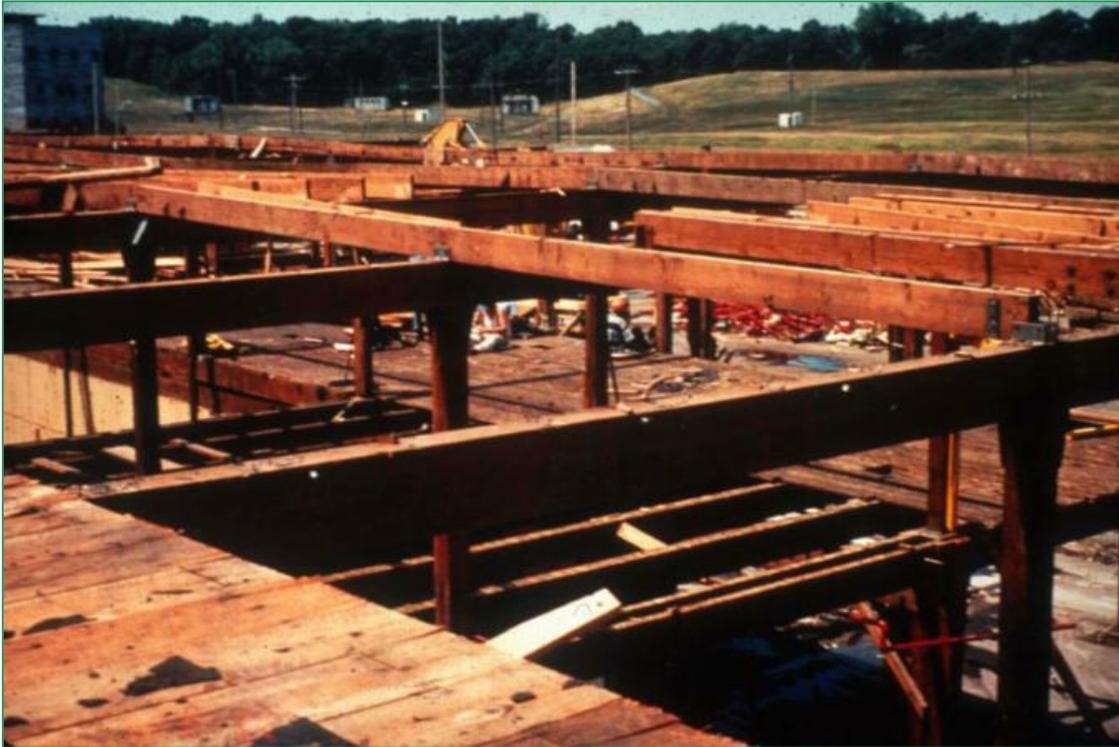
Figure B-17. Timber salvage at TCAAP in 1995 (TCAAP).

they were best suited. Roofing removal and asbestos-containing material (ACM) removal were handled separately. Then, a timber salvage company specializing in dismantling timber buildings was contracted to maximize timber recovery.

Figure B-17 and Figure B-18 show two of the buildings at TCAAP being deconstructed.

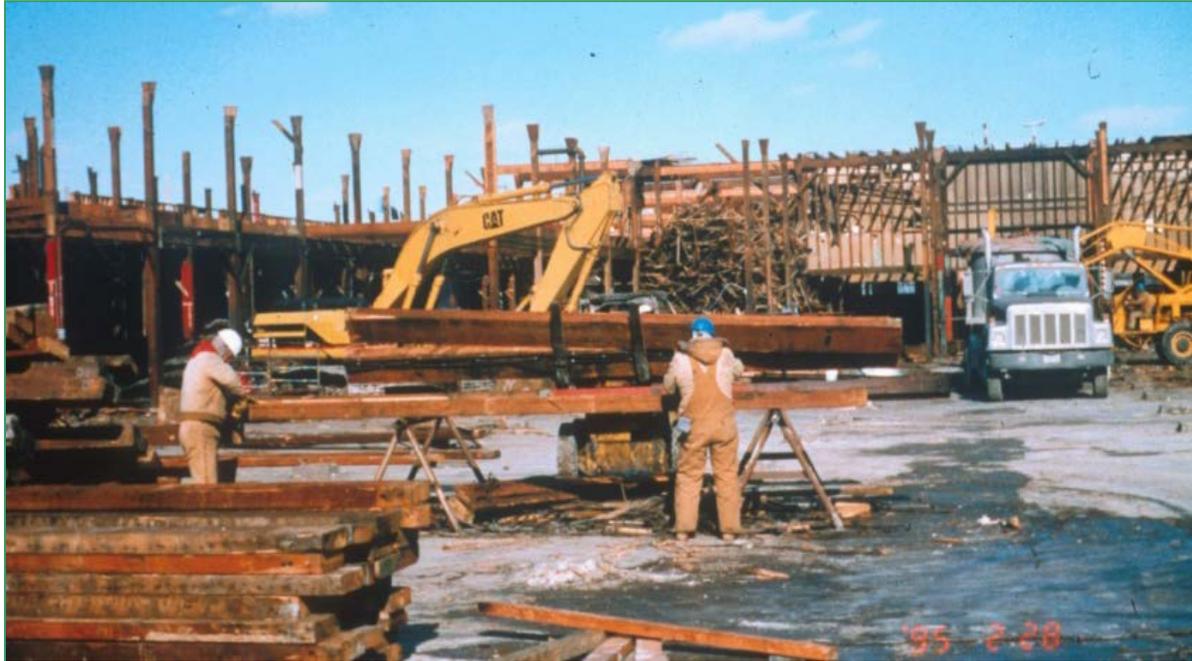
Figure B-18. Timber salvage at TCAAP in 1995 (TCAAP).
