Risk Management Series

for Improving Critical Facility Safety
from Flooding and High Winds

FEMA 543 / January 2007

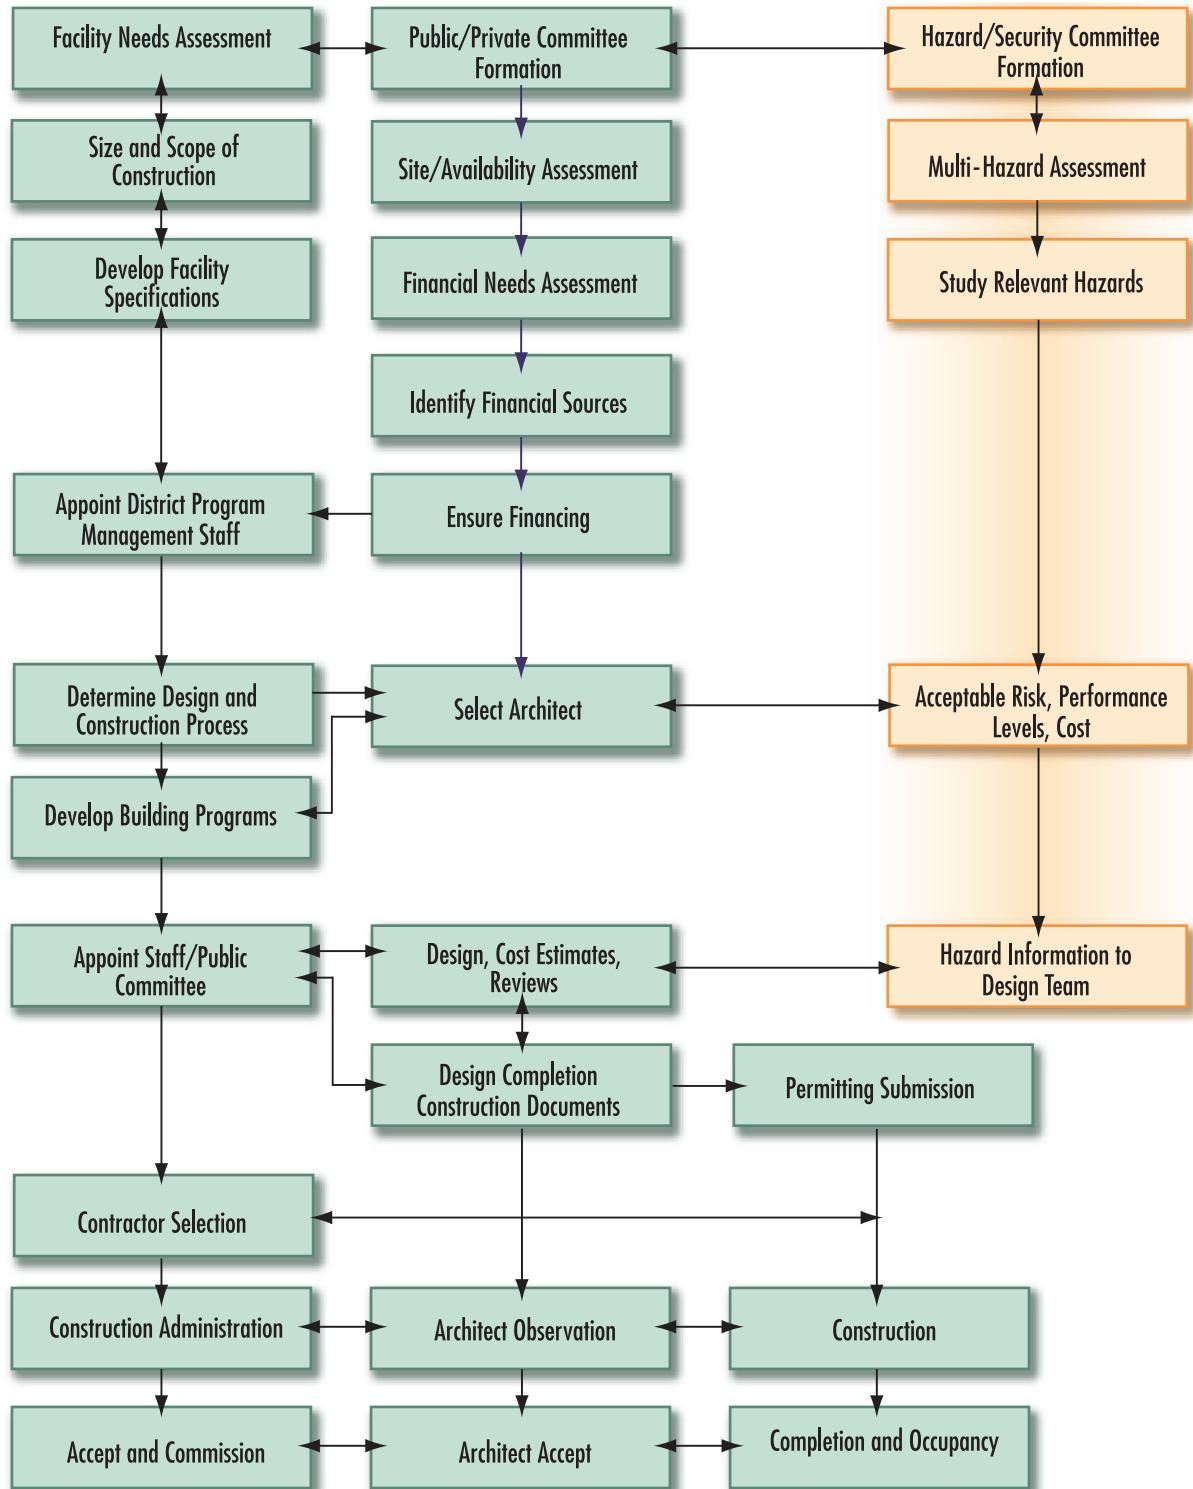
The sequence of the above steps may vary, depending on the complexity of the program; some steps may be implemented simultaneously. Figure 1-3 shows a flow chart of this typical process. Also shown (in the five boxes to the right) are specific activities related to designing for multiple hazards and how these activities fit into the construction process.

Figure 1-3: Process flow chart for decisionmakers

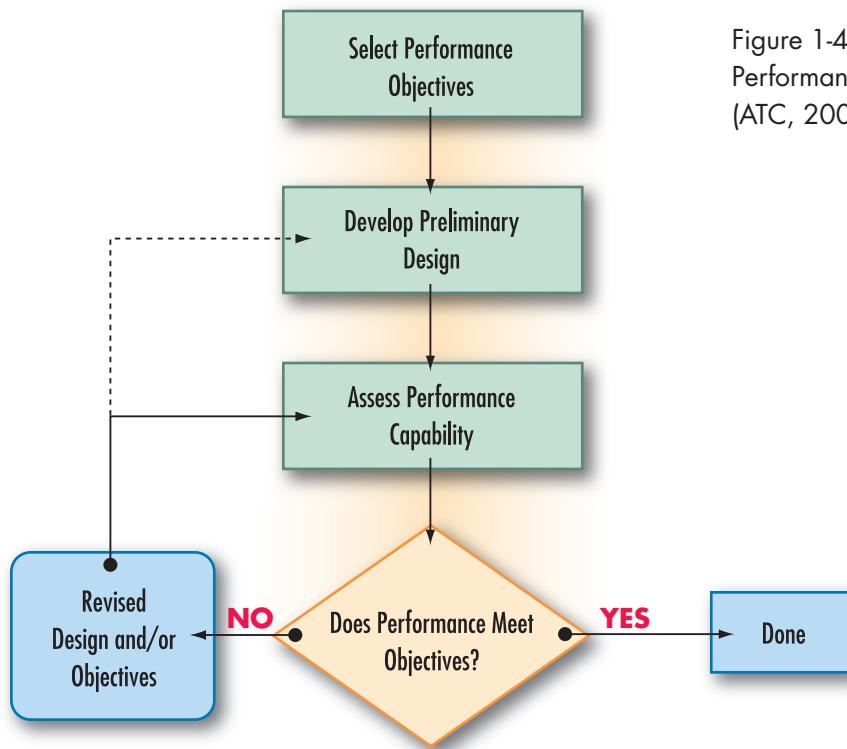
Figure 1-4:
Performance-based design flow diagram
(ATC, 2003)

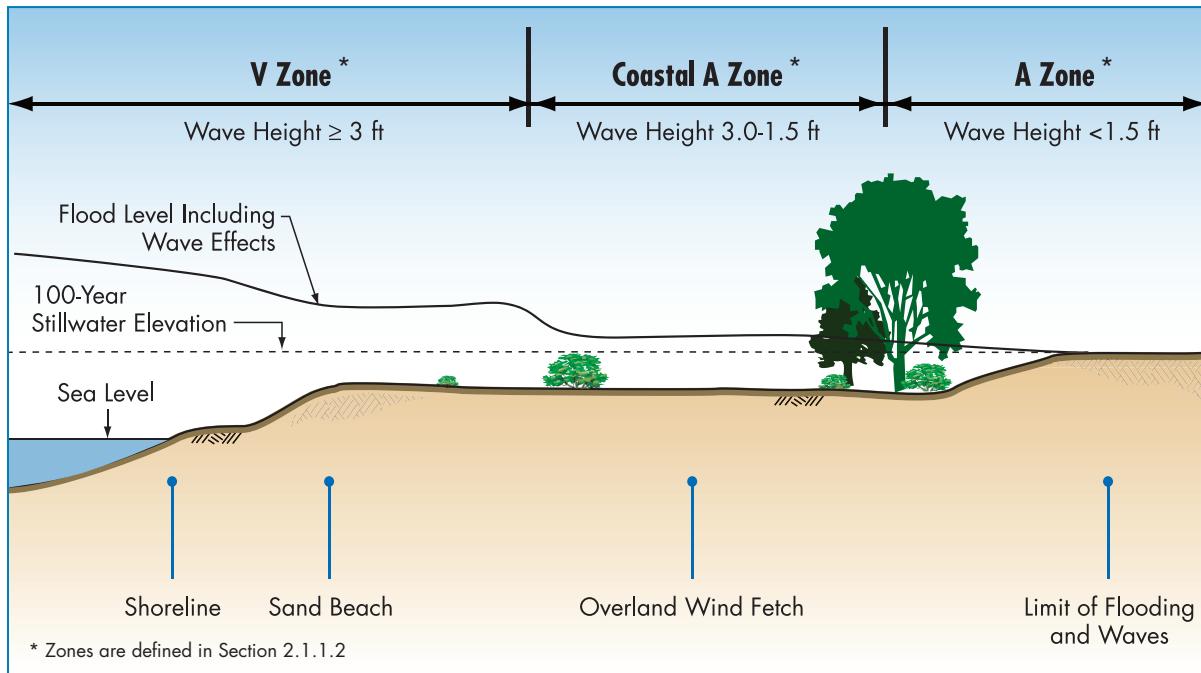
Figure 2-2: The floodplain along an open coast

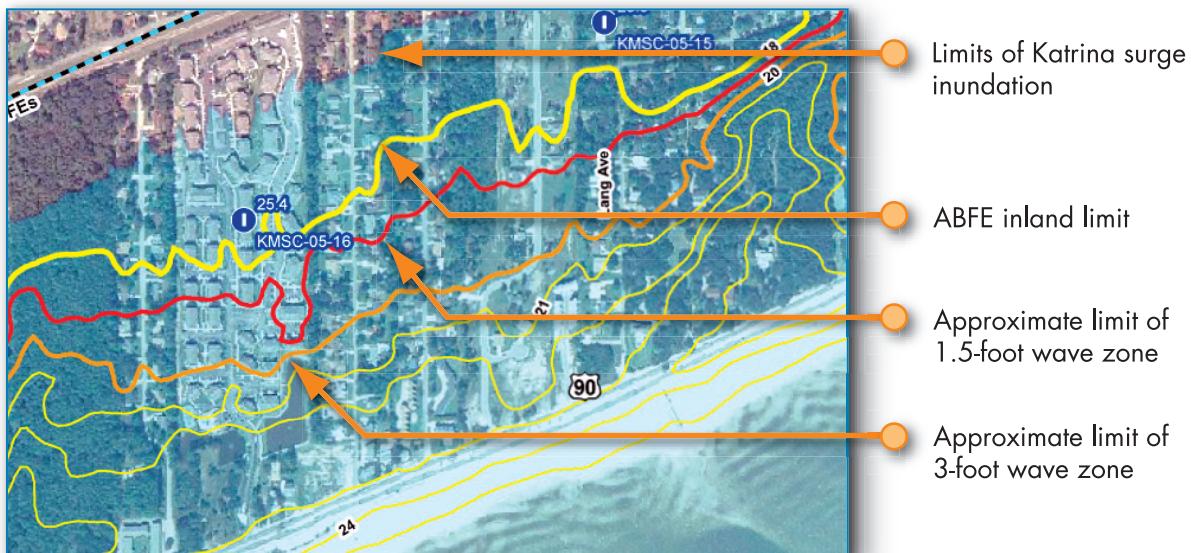
Figure 2-5: Example of a flood recovery map showing ABFEs and other flood hazard information.

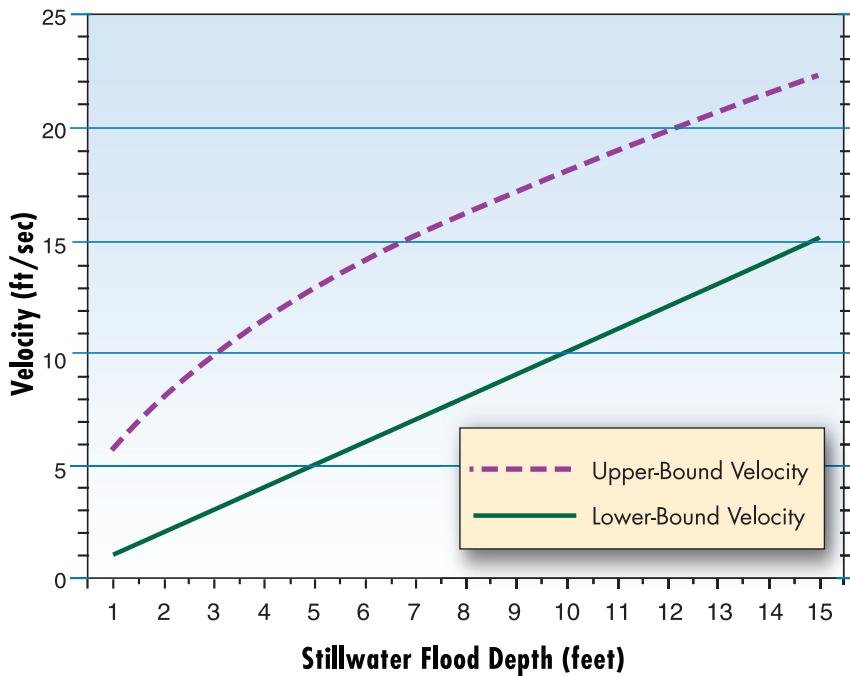
Figure 2-7 shows the general relationship between velocity and stillwater depth. For design purposes, actual flood velocities are assumed to lie between the upper and lower bounds. Conservative designs will take into account the upper bound velocities.

Figure 2-7:
Velocity as a function of
stillwater flood depth

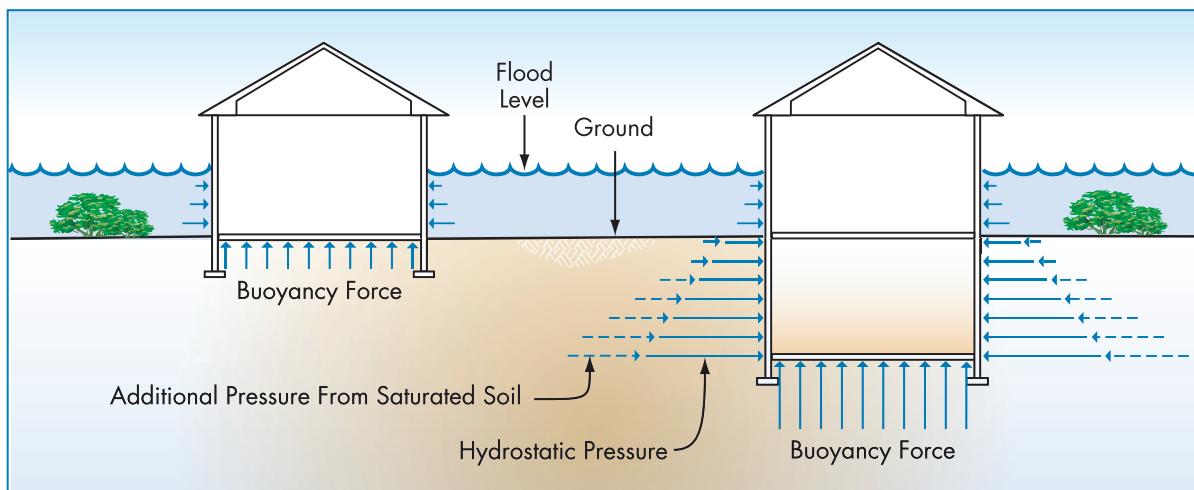
Figure 2-8: Hydrostatic loads on buildings

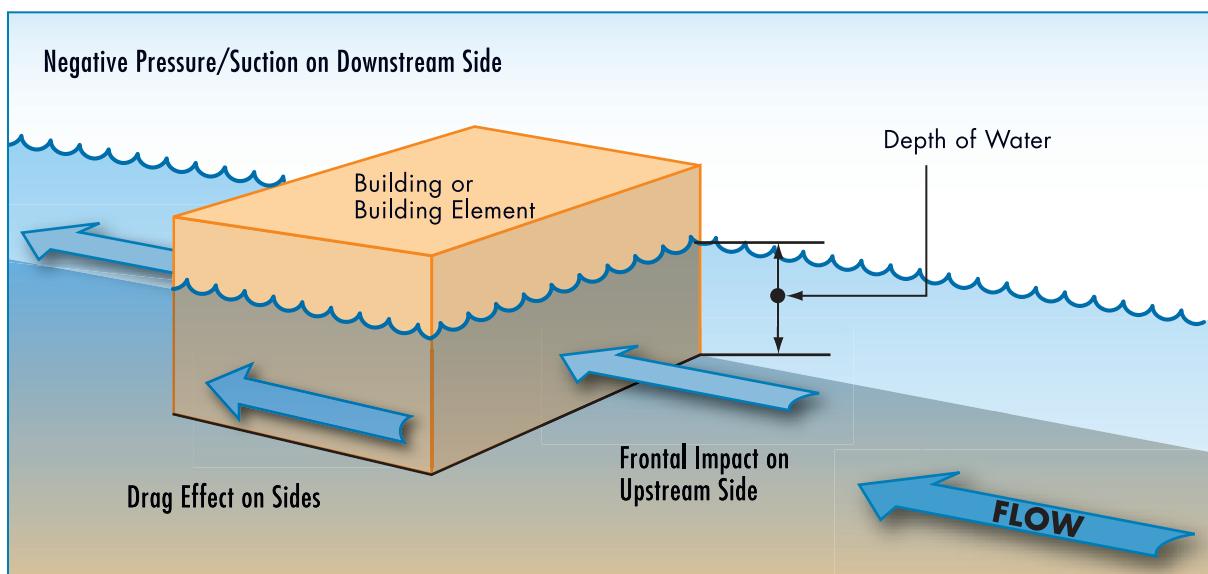
Figure 2-9: Hydrodynamic loads on a building or building element

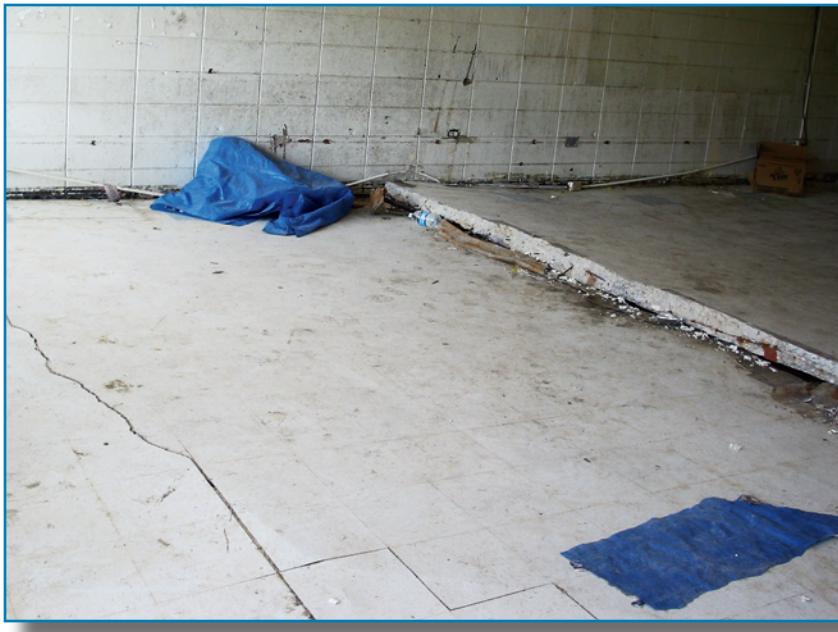
Figure 2-15:
Concrete floor ruptured
by hydrostatic pressure
(buoyancy). Hurricane
Katrina (2005)

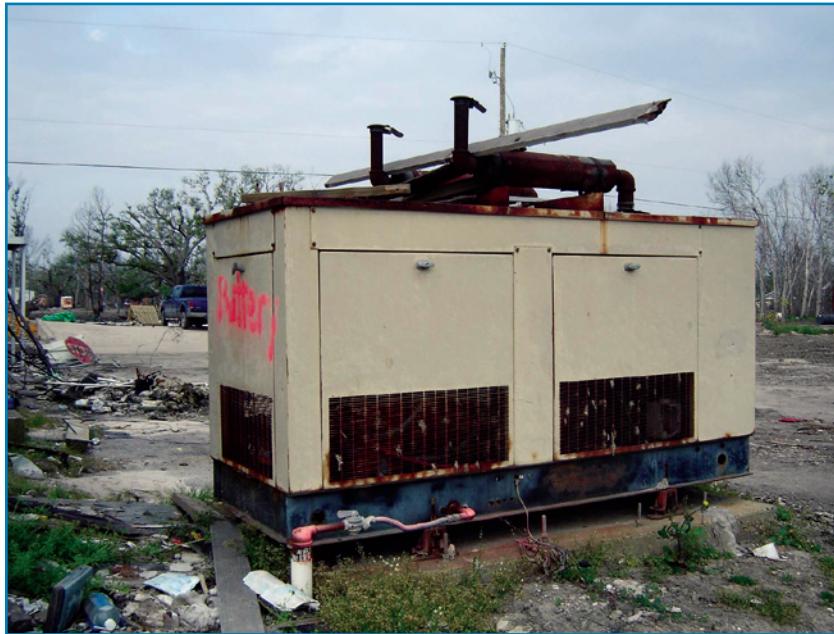
Figure 2-20:
Although it was anchored and not displaced by floodwaters, this generator was out of service after being submerged.

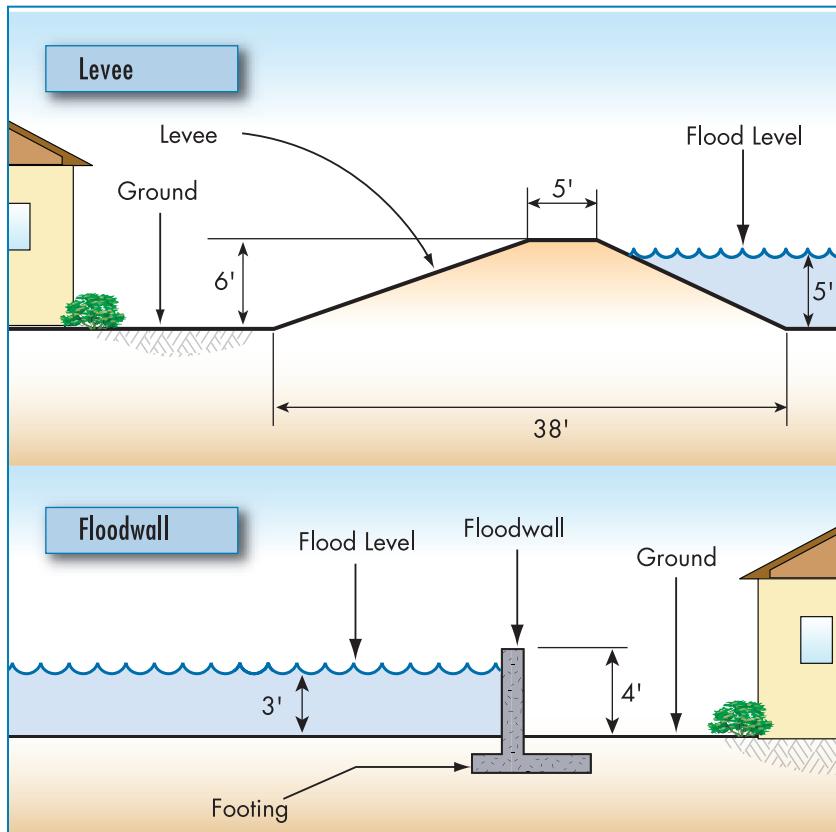
Figure 2-23:
Schematic of typical
earthen levee and
permanent floodwall

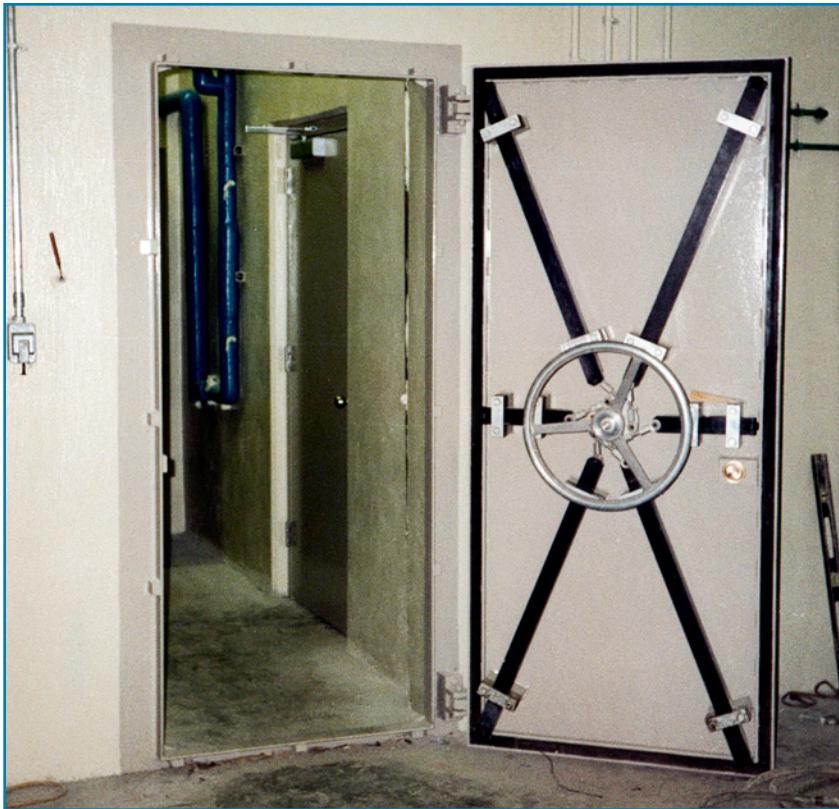
Figure 2-29:
Permanent watertight doors for deep water

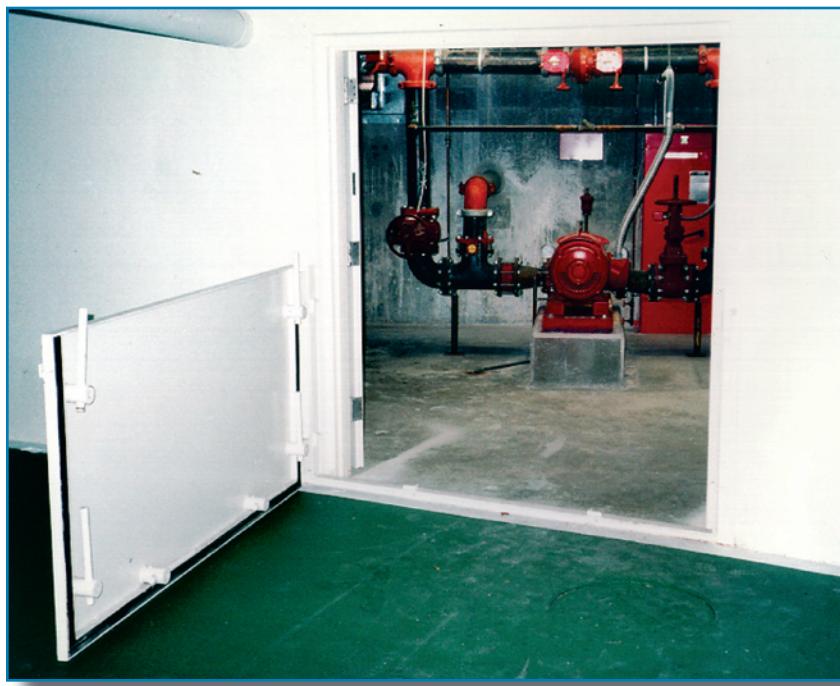
Figure 2-31:
Equipment room with
watertight door

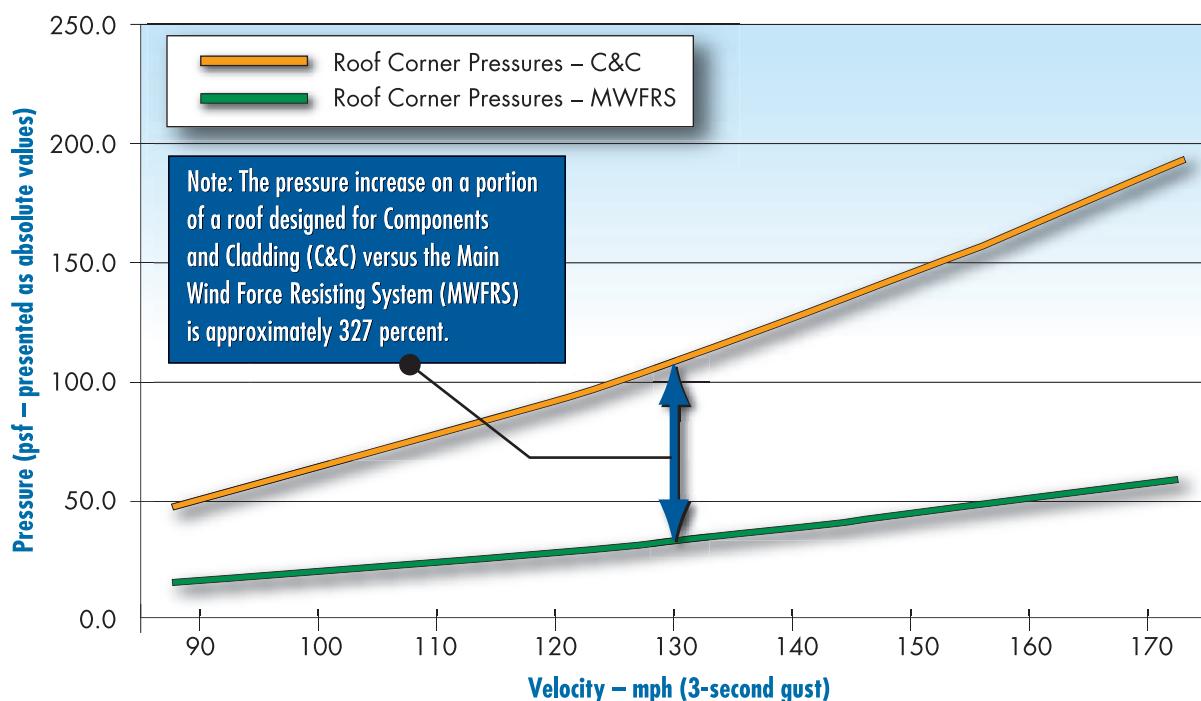
Figure 3-5: Wind pressure as a function of wind speed

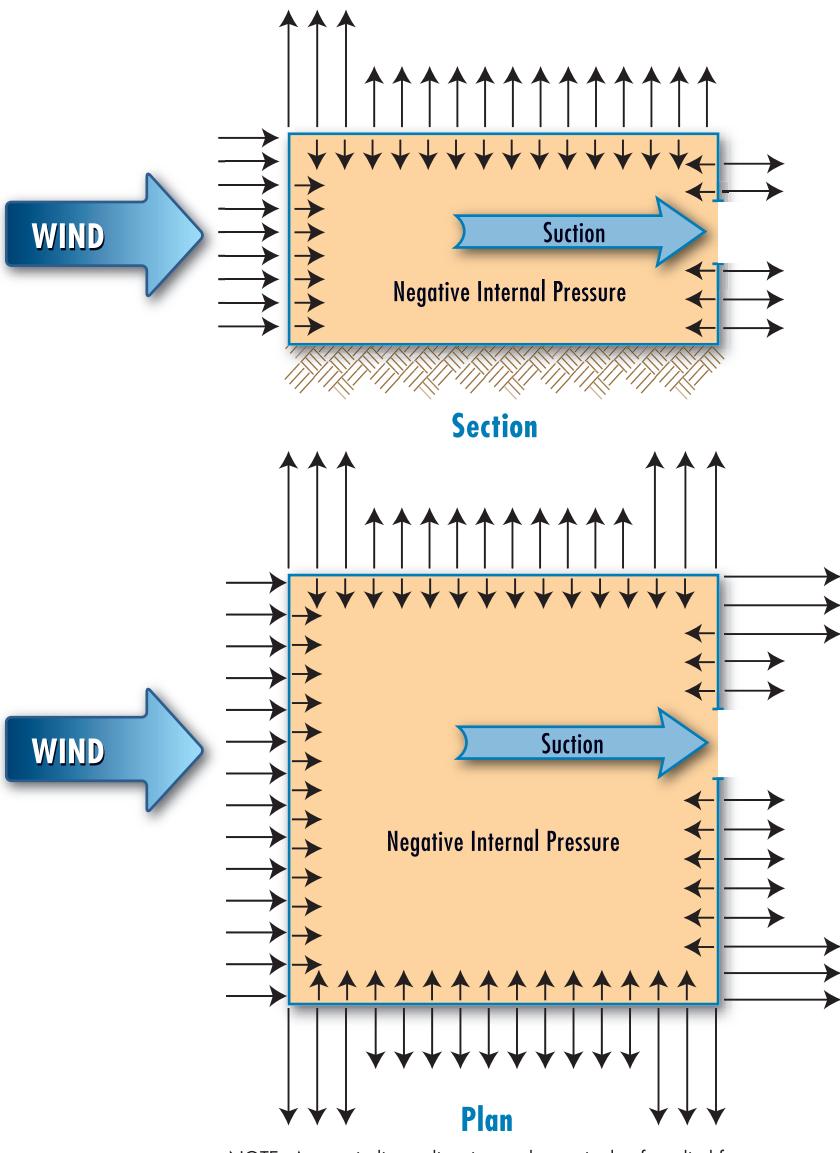
Figure 3-7:
Schematic of internal
pressure condition when the
dominant opening is in the
leeward wall

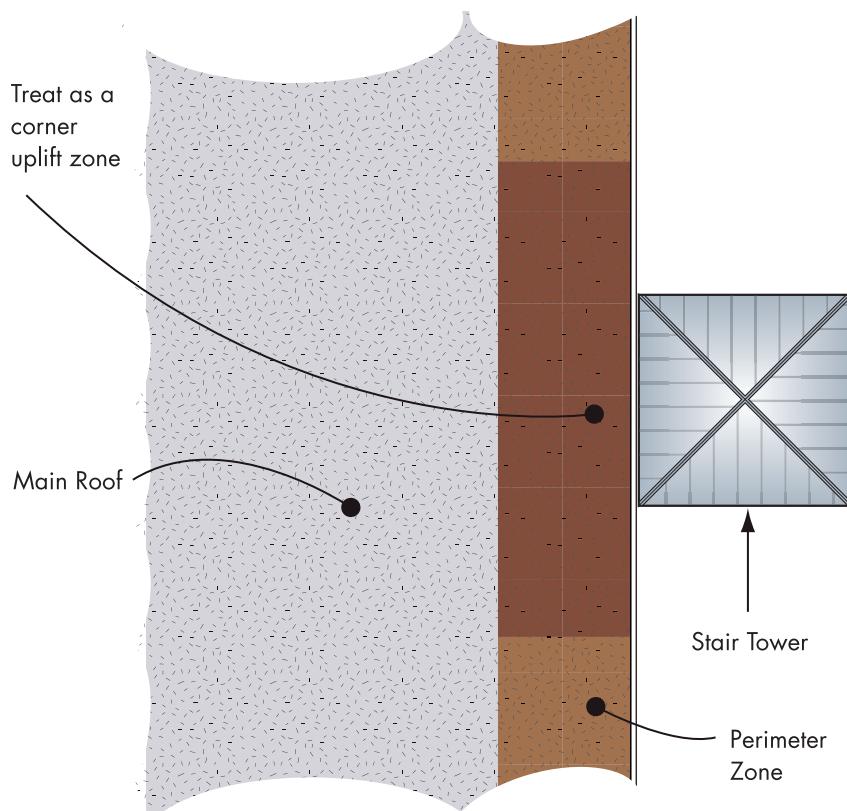
Figure 3-11:
Plan view of a portion of the building in Figure 3-10 showing the use of a corner uplift zone in lieu of a perimeter uplift zone on the low-slope roof in the vicinity of the stair tower

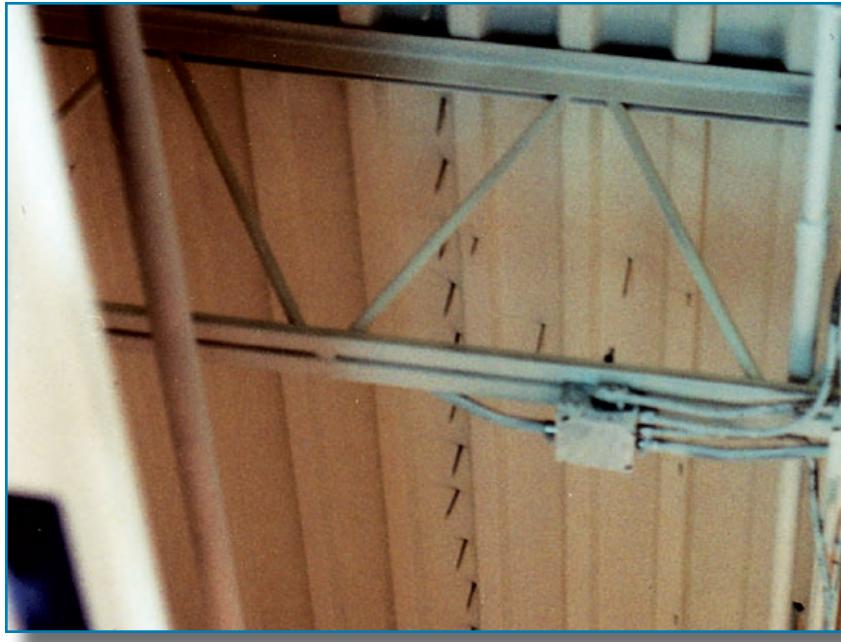
Figure 3-60:
View of the underside of
a steel deck showing the
mechanically attached
single-ply membrane
fastener rows running
parallel to, instead of
across, the top flange of
the deck.

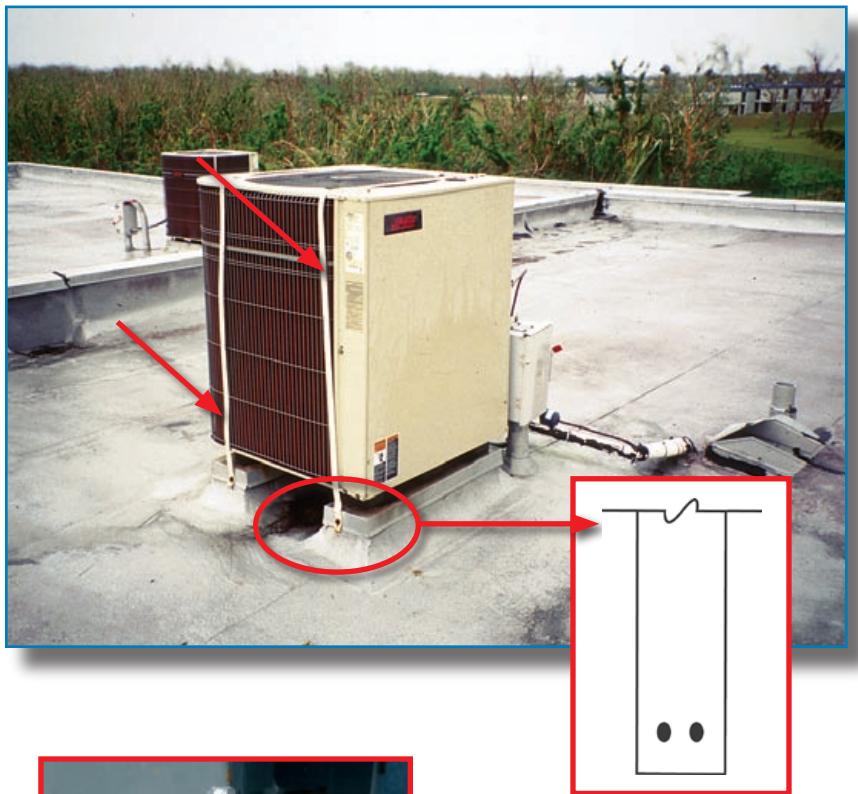
Figure 3-75:
Failure of vibration
isolators that provided
lateral resistance but no
uplift resistance caused
equipment damage.
A damaged vibration
isolator is shown in the
inset. Hurricane Katrina
(Mississippi, 2005)

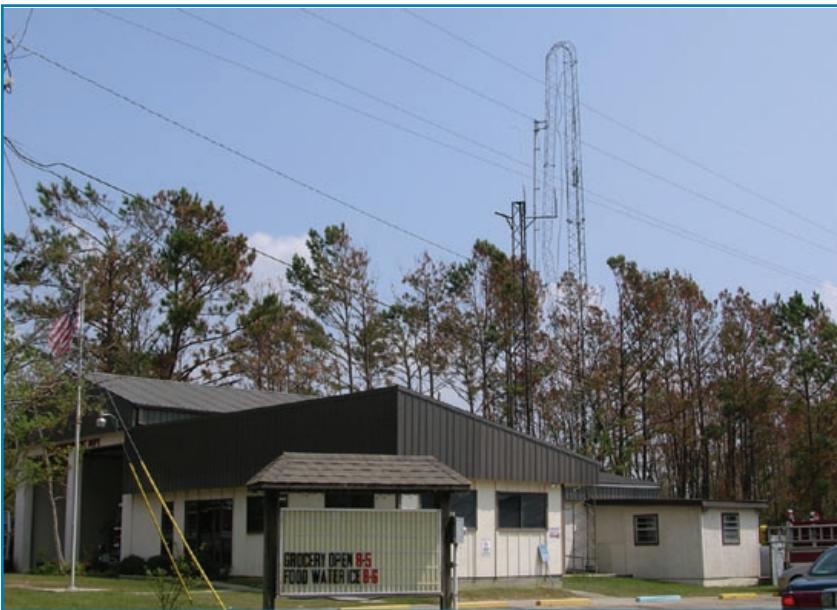
Figure 3-80:
The antenna tower at
this fire station buckled.
Hurricane Katrina
(Mississippi, 2005)

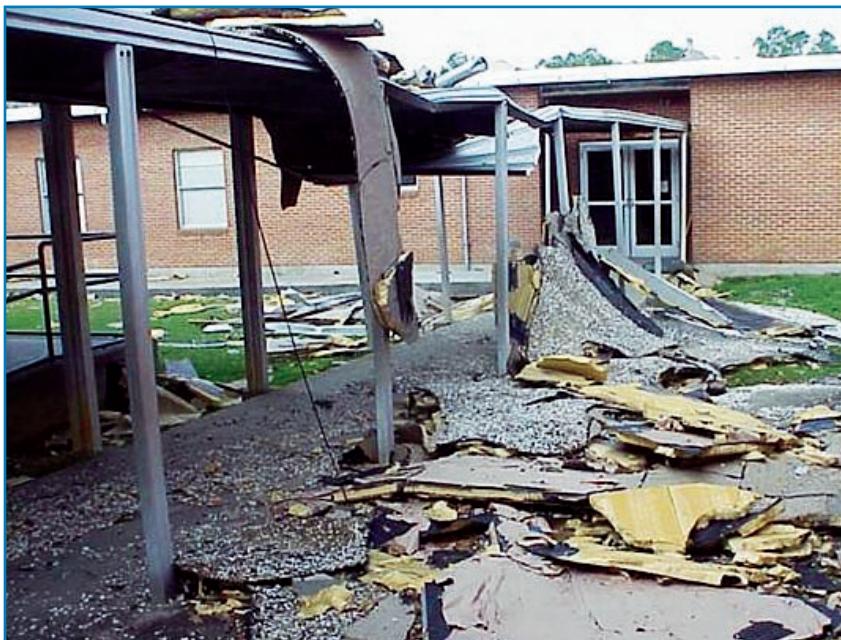
Figure 3-83:
Open walkways do
not provide protection
from wind-borne debris.
Hurricane Katrina
(Mississippi, 2005)

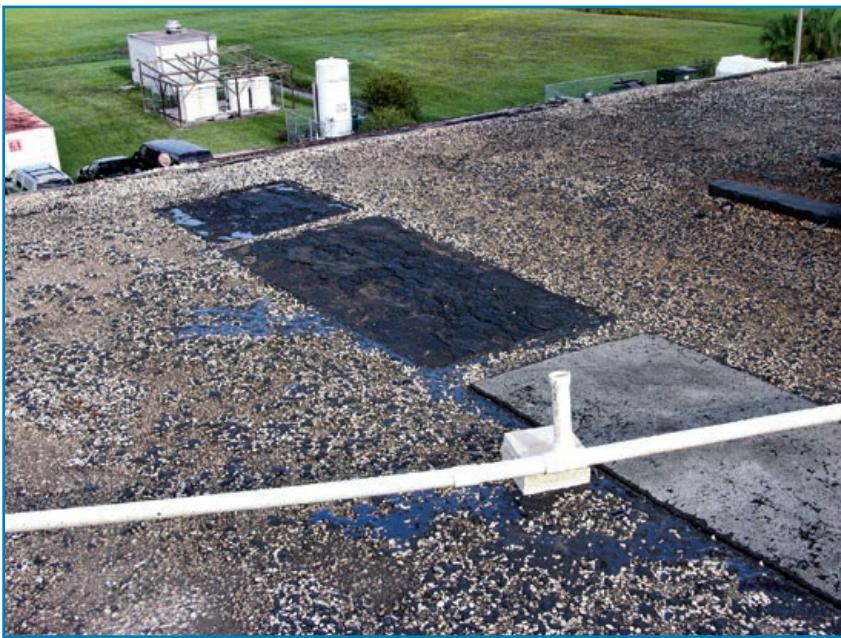
Walkway pads: Roof walkway pads are frequently blown off during hurricanes (Figure 3-92). Pad blow-off does not usually damage the roof membrane. However, wind-borne pad debris can damage other building components and injure people. Walkway pads are therefore not recommended in hurricane-prone regions.

Figure 3-92:
To avoid walkway pad blow off, as occurred on this hospital roof, walkway pads are not recommended. Hurricane Charley (Florida, 2004)

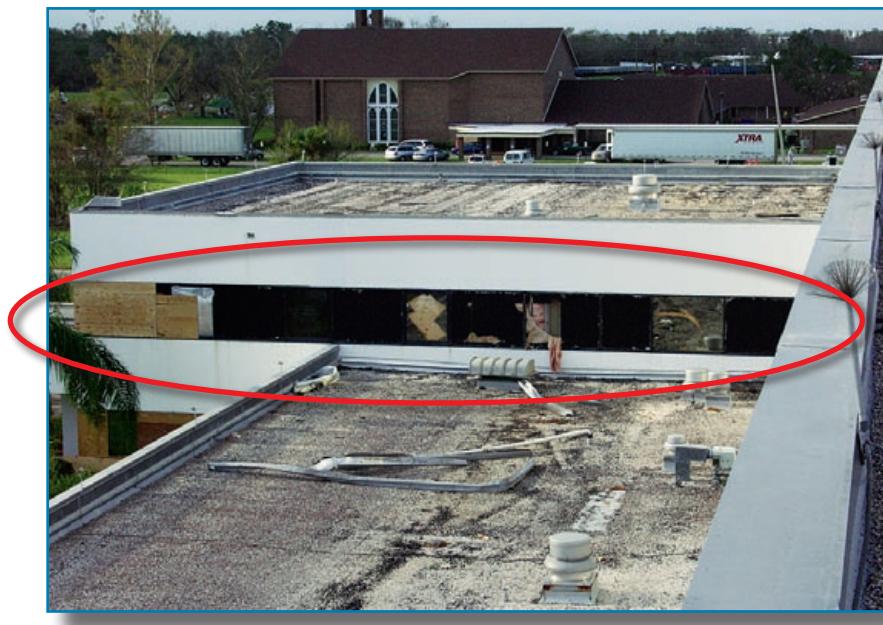
Figure 3-114:
Aggregate from the
hospital's built-up roofs
broke several windows
in the intensive care unit,
which had to be evacuated
during the hurricane.
Hurricane Charley
(Florida, 2004)

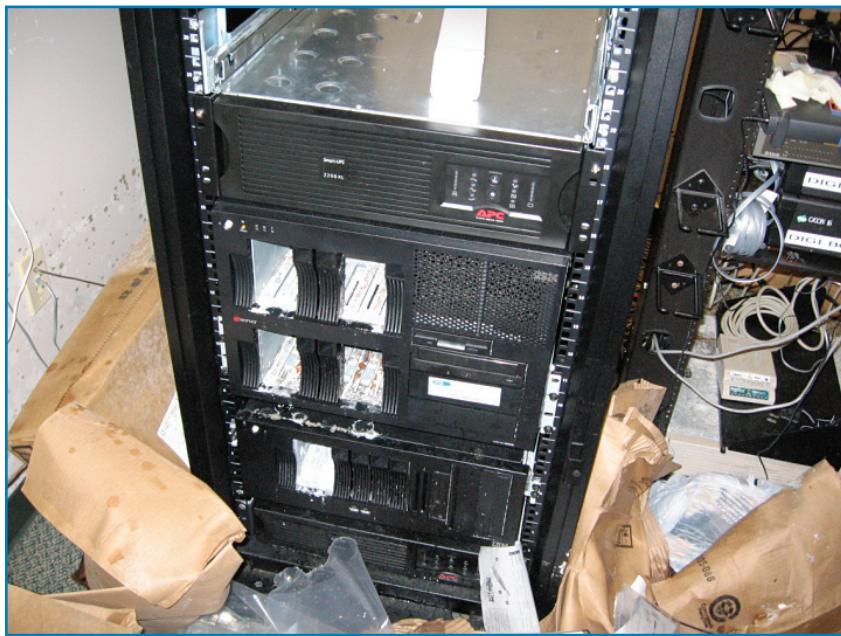
Figure 4-14:
Damaged computer
network equipment at
Hancock Medical Center

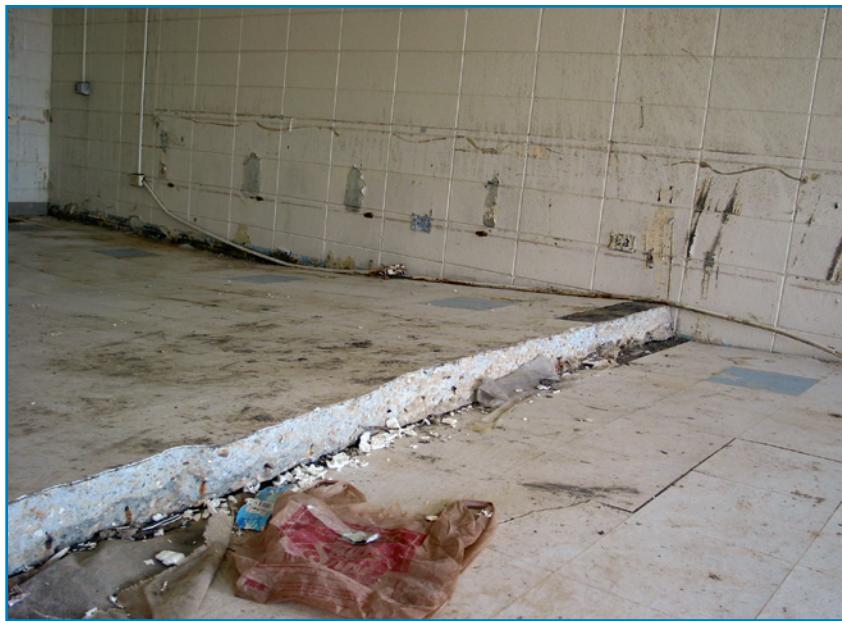
Figure 4-23:
Cracked concrete floor slab at Charles B. Murphy Elementary School

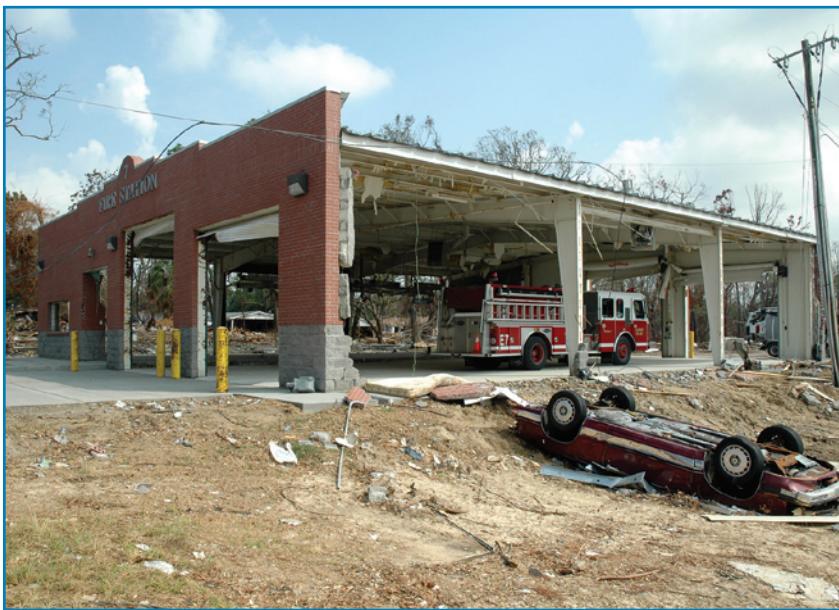
Figure 4-40:
Exterior walls on the
Gulfport Fire Station #7
washed away by the
storm surge

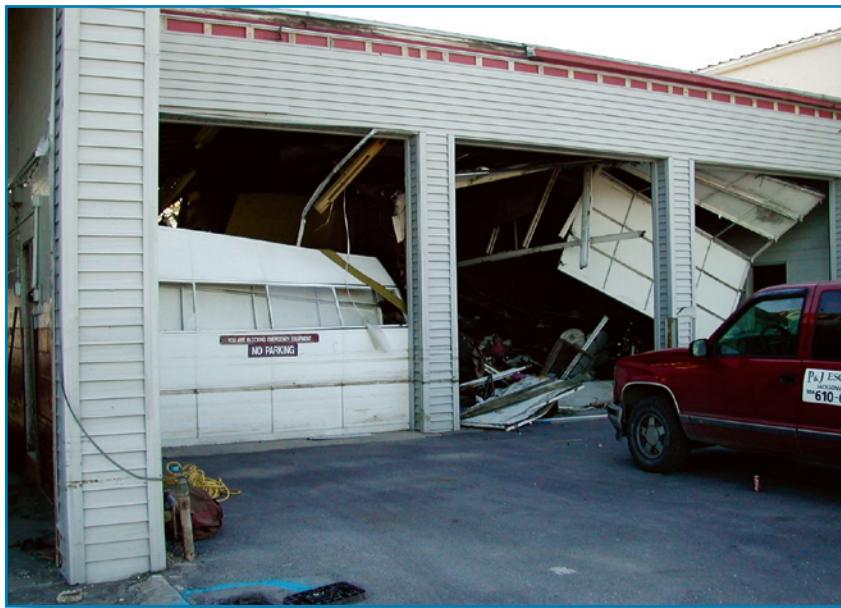
Figure 4-45:
Damaged apparatus bay
doors at Port Sulphur
Volunteer Fire Department.

Fire stations are especially susceptible to breaches of the building envelope, because of their large sectional and rolling doors that are usually not strong enough to resist wind forces, and even less so the hydrodynamic forces of storm surge. The apparatus bay doors failed in many fire stations affected by flooding. (see Figures 4-39 and 4-45).
