PUBLIC WORKS TECHNICAL BULLETIN 200-1-115
15 DECEMBER 2011

**LOW-WATER CROSSINGS —
LESSONS LEARNED**

LOW-WATER CROSSINGS – LESSONS LEARNED

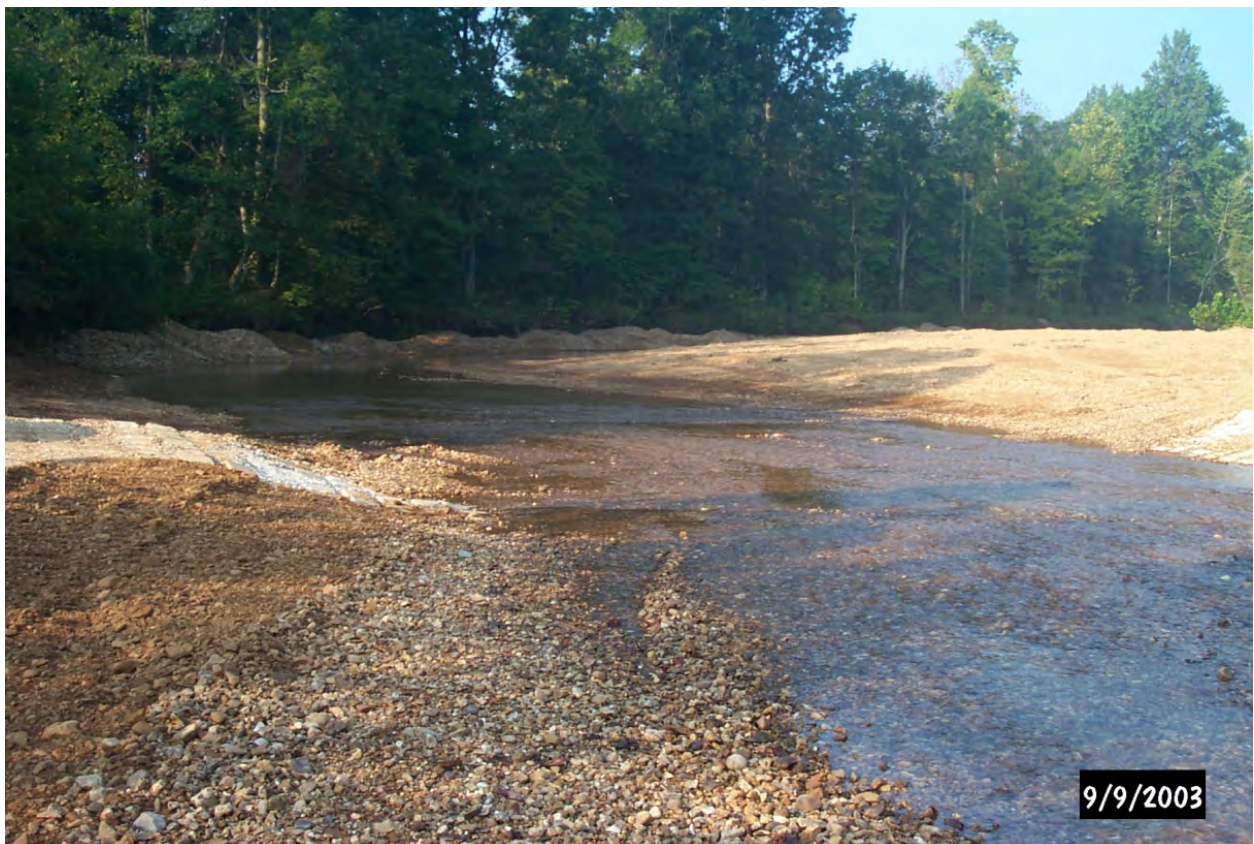
Figure A-1. This completed articulated concrete crossing is an example of an unvented ford (photo by Chris Collins, Fort Campbell, KY).

Unvented fords are usually selected on ephemeral streams (streams with temporary flow during or after a precipitation event) or streams with shallow flows that are safe to drive through. The fords can be either at or above-grade of the stream bed. At grade is typically chosen if any concern about wildlife or erosion exists. Figure A-1 shows an unvented cable-concrete ford that is at grade.

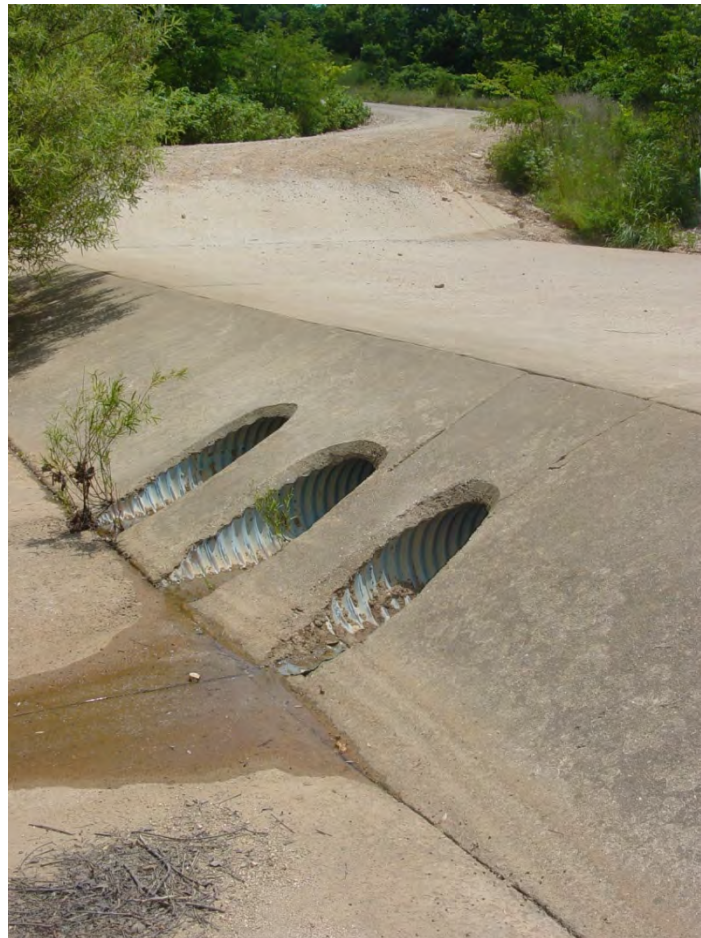
**Figure A-2. Vented low-water crossing
(photo by Joe Proffitt, Fort Leonard Wood, MO).**

Vented crossings keep the vehicles out of the water most of the year as long as the flows are low. The number and size of culverts depends on the geometry of the stream and the flow characteristics. The crossings are designed to be low and overtop in extreme storms (Figure A-2). It is less likely that a vented ford will be used on military training lands due to its life-cycle cost. However, the road network that accesses these areas may have vented fords at locations crossing large or frequent streamflow where traffic volume, vehicle type, and personnel safety require them.

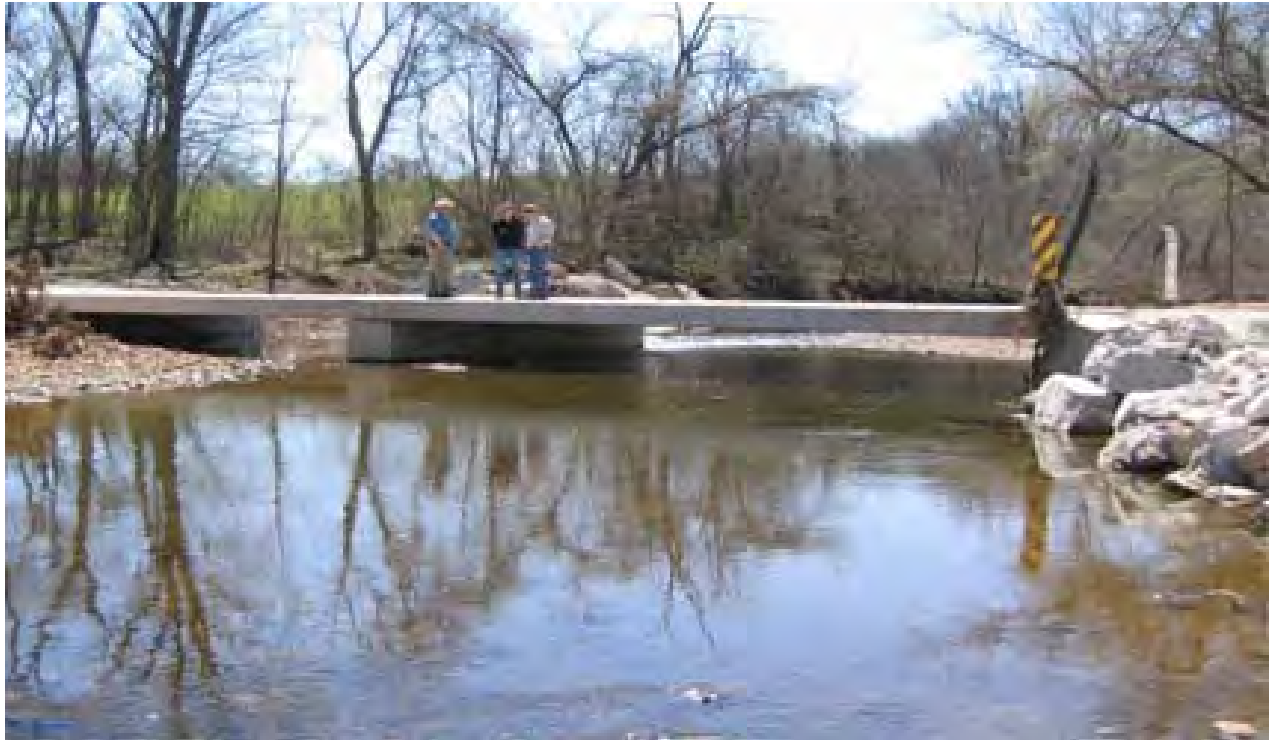
**Figure A-3. Low-water bridge
(photo courtesy of U.S. Fish and Wildlife Service, MO).**

Low-water bridges are the final type of LWC. Low-water bridges are very similar to other bridges except they are built lower (Figure A-3). Similar to the vented crossings, the water level can rise above the driving surface. These structures typically have a bridge deck and footings if the stream is wide enough.

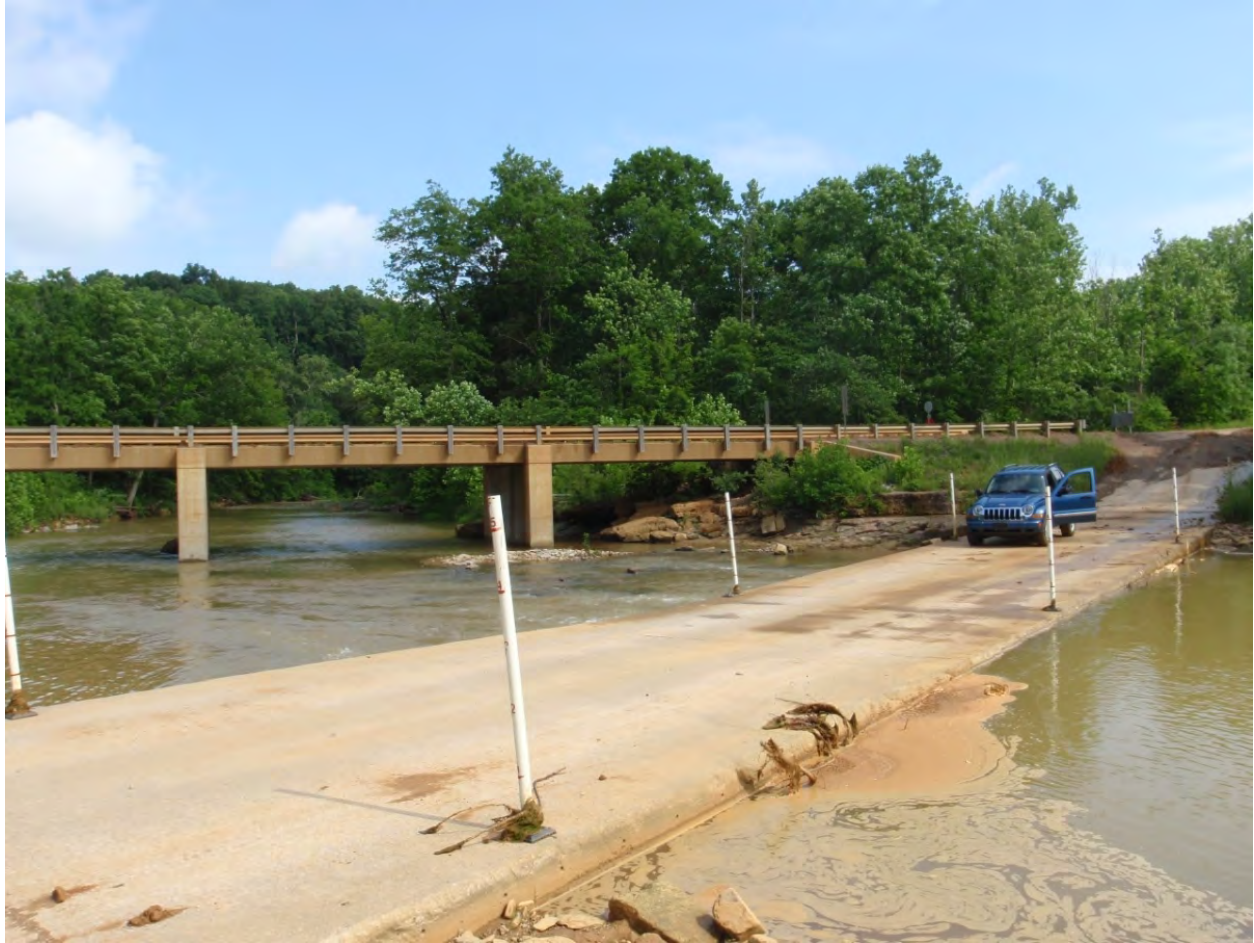
**Figure B-1. Low-water crossing situated next to bridge.
(Photo by Scot Serafin, Fort Knox)**

Unvented LWCs are favored for several reasons: cost, ease of installation, low channel maintenance requirements, and stream habitat preservation for threatened and endangered species. Additionally, unvented fords are useful in naturally unstable channels such as alluvial fans and braided systems or channels with a high variability of flow (Clarkin et al. 2006). An unvented LWC is more economical than a bridge for use on low-traffic roads. They can also be used if an existing bridge is not designed to hold extreme vehicle loads (Figure B-1).

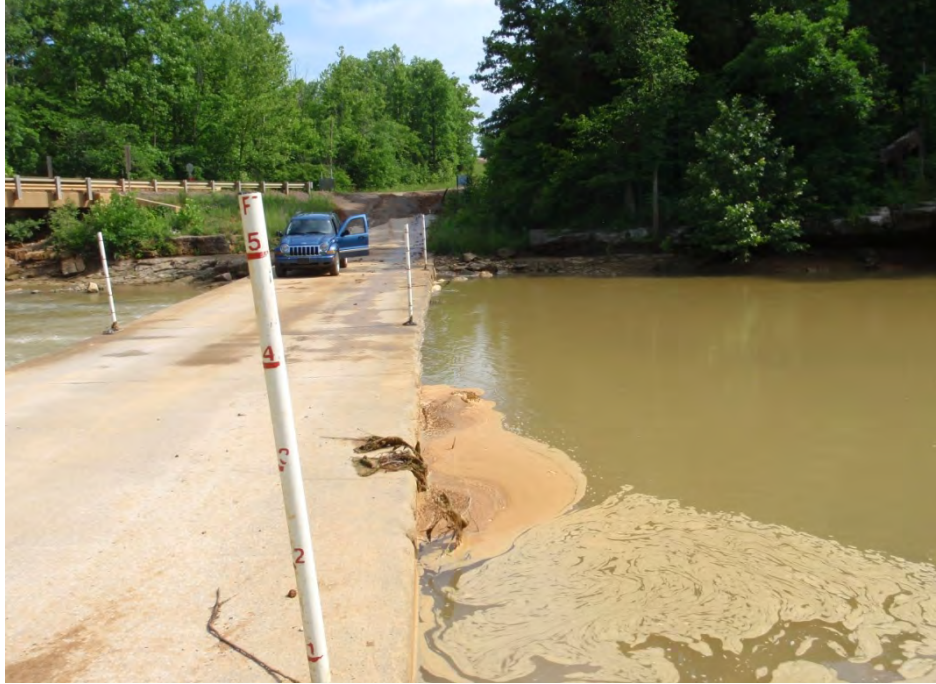
**Figure B-2. Markers along edge of LWC with depth marks
(photo by Scot Serafin, Fort Knox, KY).**

The safety of those using the crossing is also critical. Markers are essential to show the edge of the above-grade crossing if the road is not well defined (Figure B-2). Without markers, it can be difficult to know where the edge is when the water level rises.

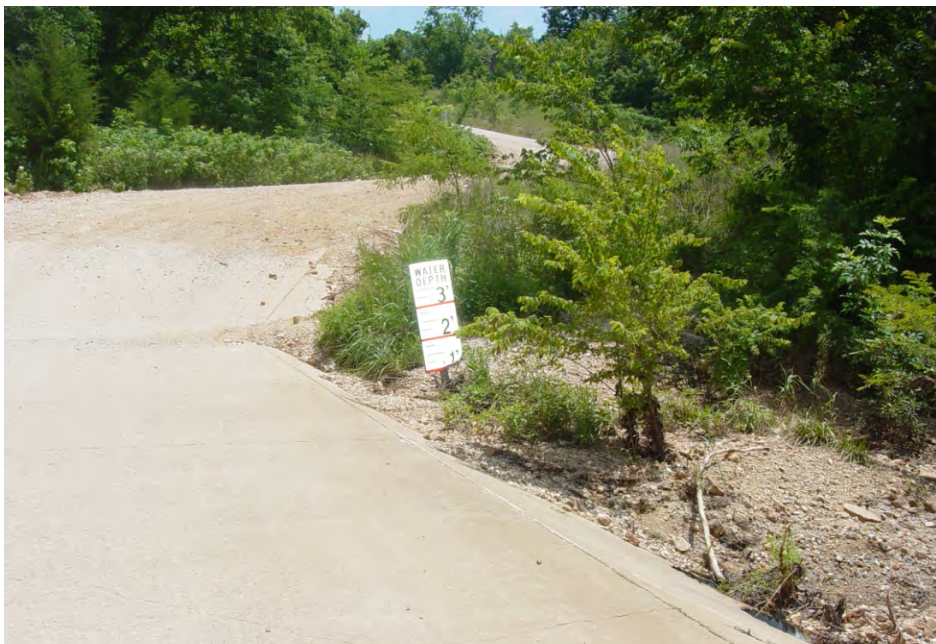
**Figure B-3. High-water depth gauge
(photo by Joe Proffitt, Fort Leonard Wood, MO).**

Depth gages are also required for safety (Figure B-3). Lighter vehicles are still subject to the forces of the stream's flow and drivers must make an informed judgment to determine if it is safe to cross.

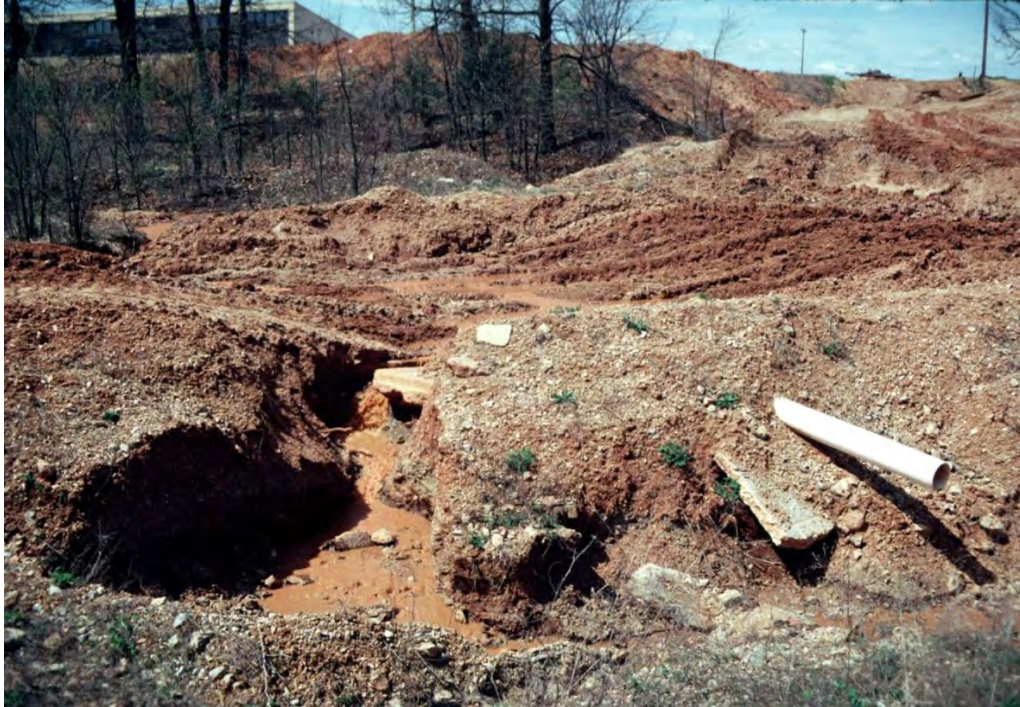
Figure C-1. Crossing before improvement showing blown culvert, erosion, and scouring of an improperly sited and designed crossing (photo by Joe Proffitt, Fort Leonard Wood, MO).

Natural low-water unvented ford crossings can be used in some cases where the stream bed is solid and traffic is rare. This option is the most inexpensive, but not necessarily the safest or most environmentally friendly for the stream if the traffic load surpasses the load the crossing is capable of handling. These crossings may cause the surface of the stream bed to break down and result in erosion and sediment transport downstream (Figure C-1).

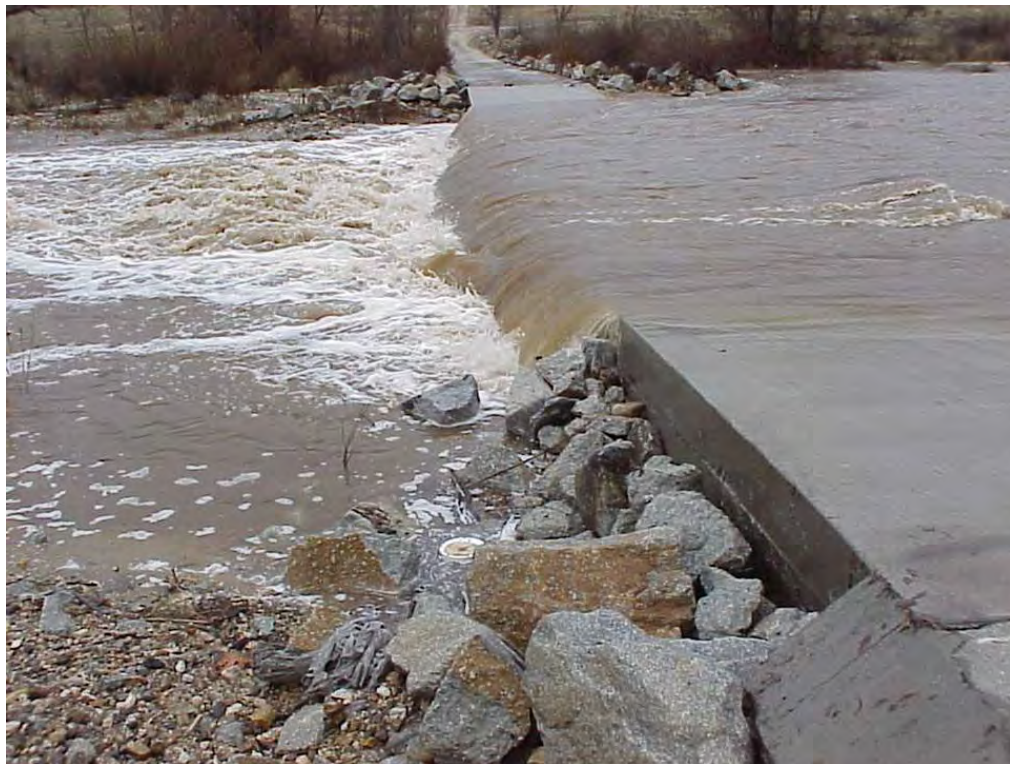
Figure C-2. Narrowed stream where scouring is occurring (photo by Art Hazebrook, Fort Hunter Liggett, CA).

Narrowing the flow across the ford is not good for the environment because when the flow is narrowed, the flow velocity is increased. Increasing the velocity of the flow will increase erosion. The crossing in Figure C-2 has two problems. The flow is narrowed when it crosses the cement, and the downstream edge is scouring from the water dropping off the LWC.

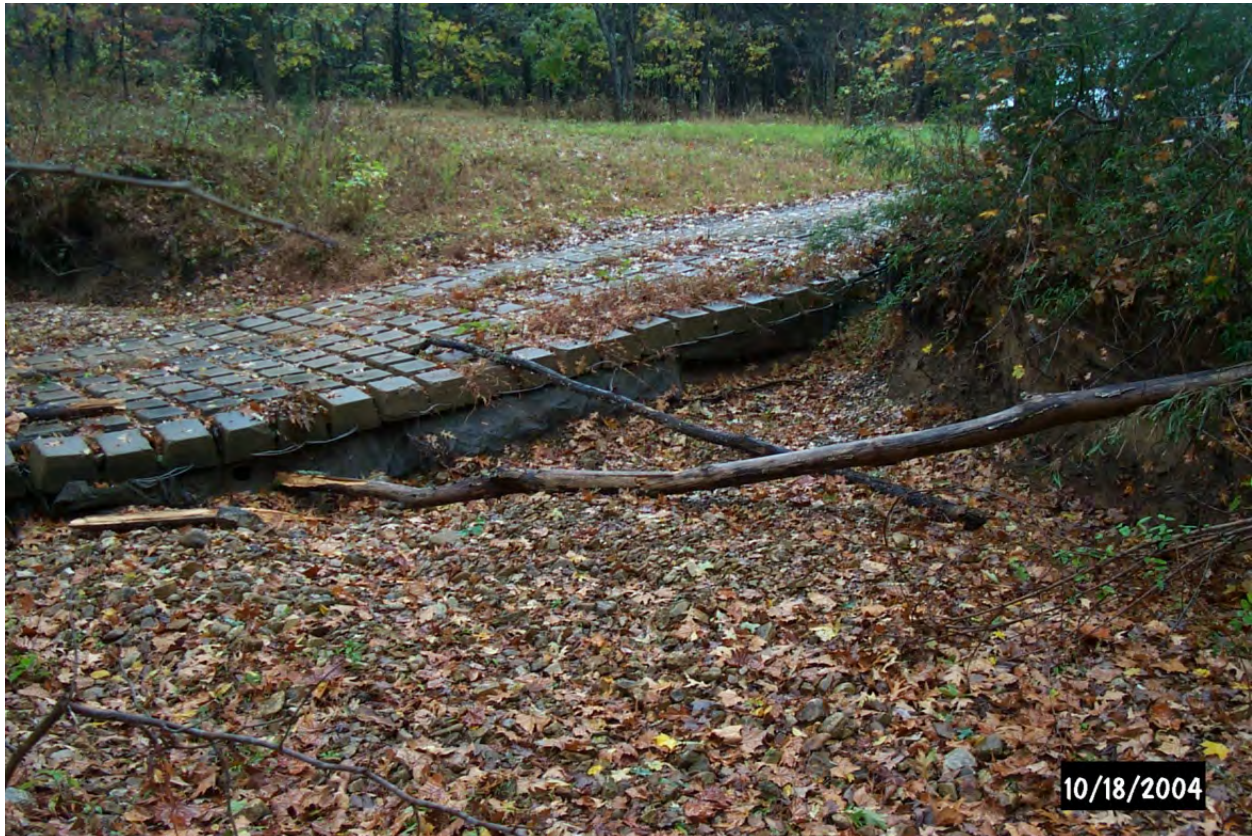
Figure C-3. Scouring has occurred on downstream edge of crossing (photo by Chris Collins, Fort Campbell, KY).

Scouring (Figure C-3) can be very dangerous. In higher flows, the edge cannot be seen. It could be disastrous if there is a large drop and a vehicle gets off the crossing. Riprap can be added to reduce this effect.

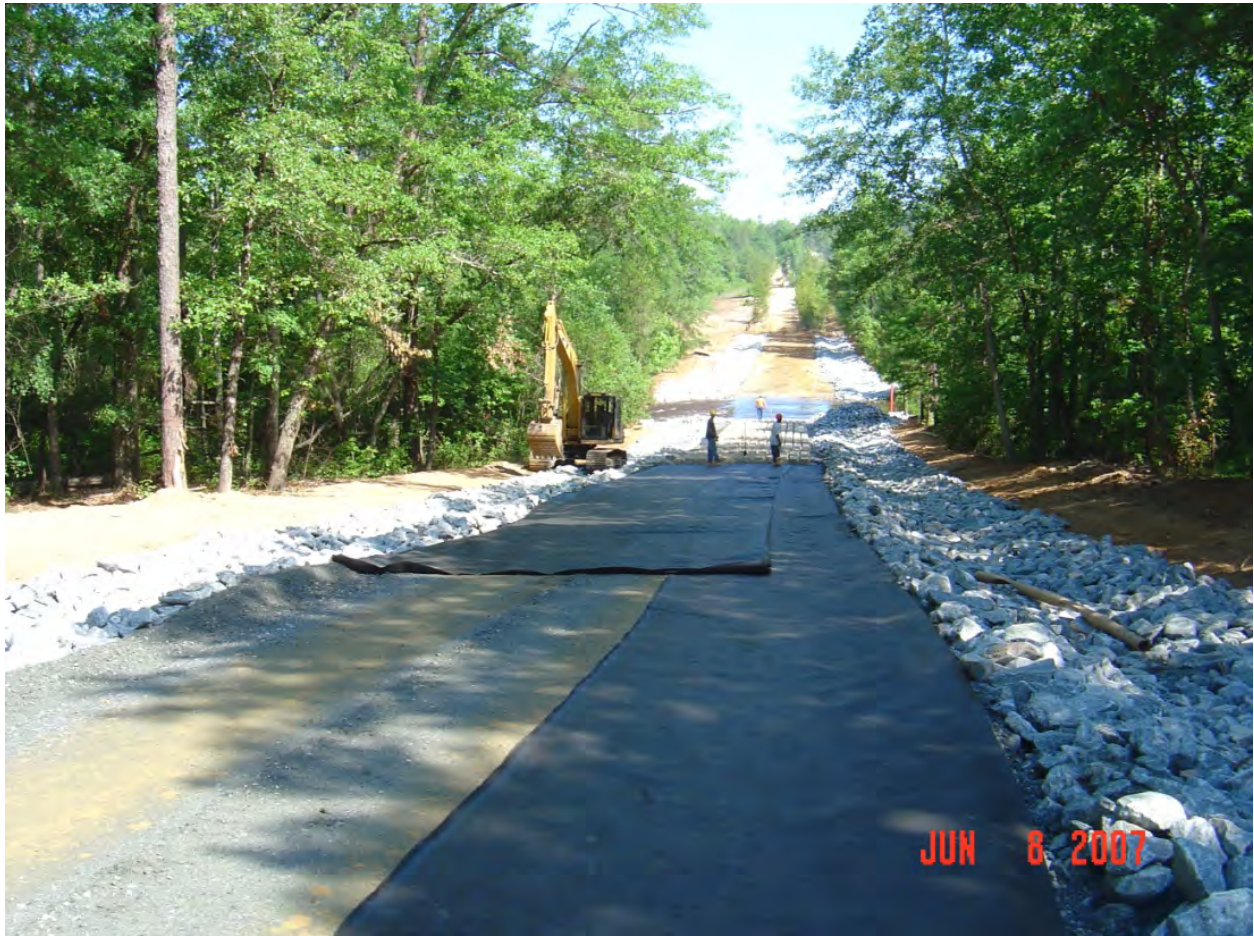
Figure C-4. LWC installation with rip rap used in ditches to prevent erosion (photo by Johnny Markham, Fort Benning, GA).

Along with scouring on approaches, ruts from traffic and gullies can be formed from water running into the stream from the approach. Proper water diversions are a possible way to lessen this unwanted consequence (Figure C-4).

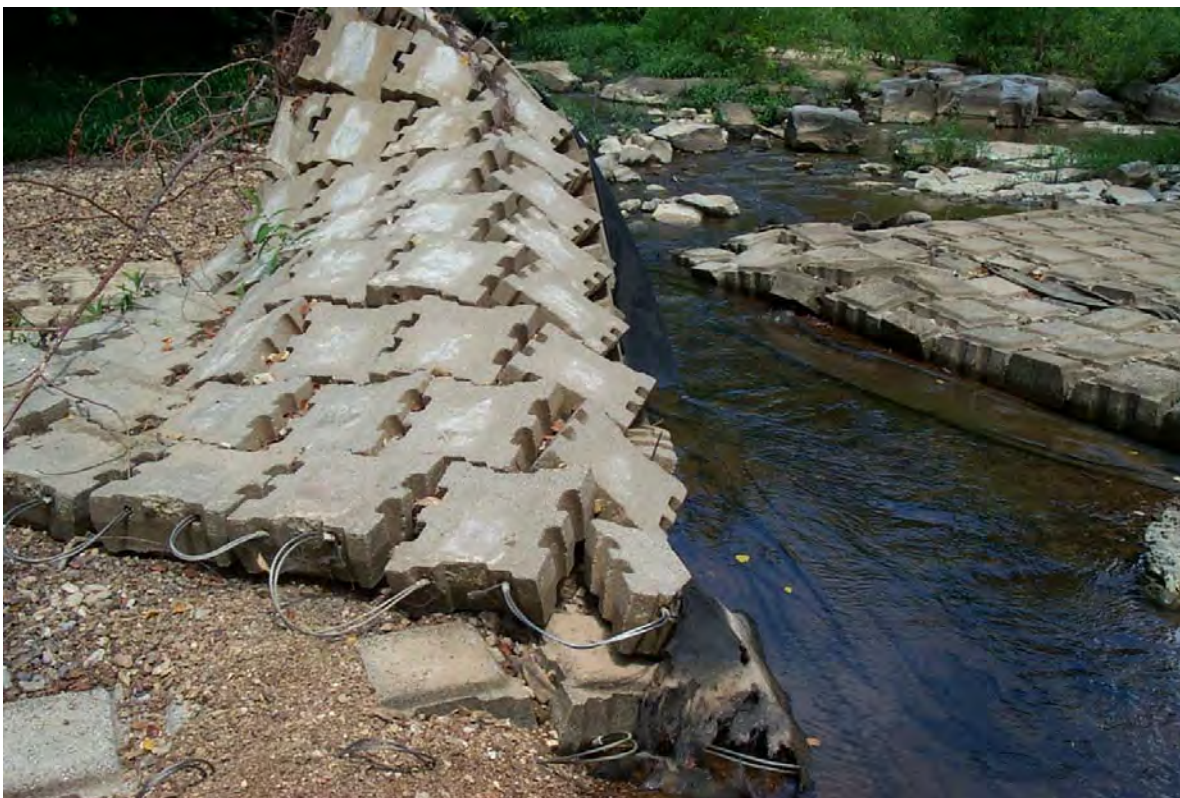
Figure C-5. Articulated concrete was not sufficiently anchored (photo by Chris Collins, Fort Campbell, KY).

Crossing location is paramount in the success of an articulated concrete crossing. Conditions must ensure that they can be anchored well to the stream bed (Figure C-5). Additionally, they must also be watched for scouring. Presence of these sorts of issues may point to a crossing that was installed in an unsuitable part of the stream.

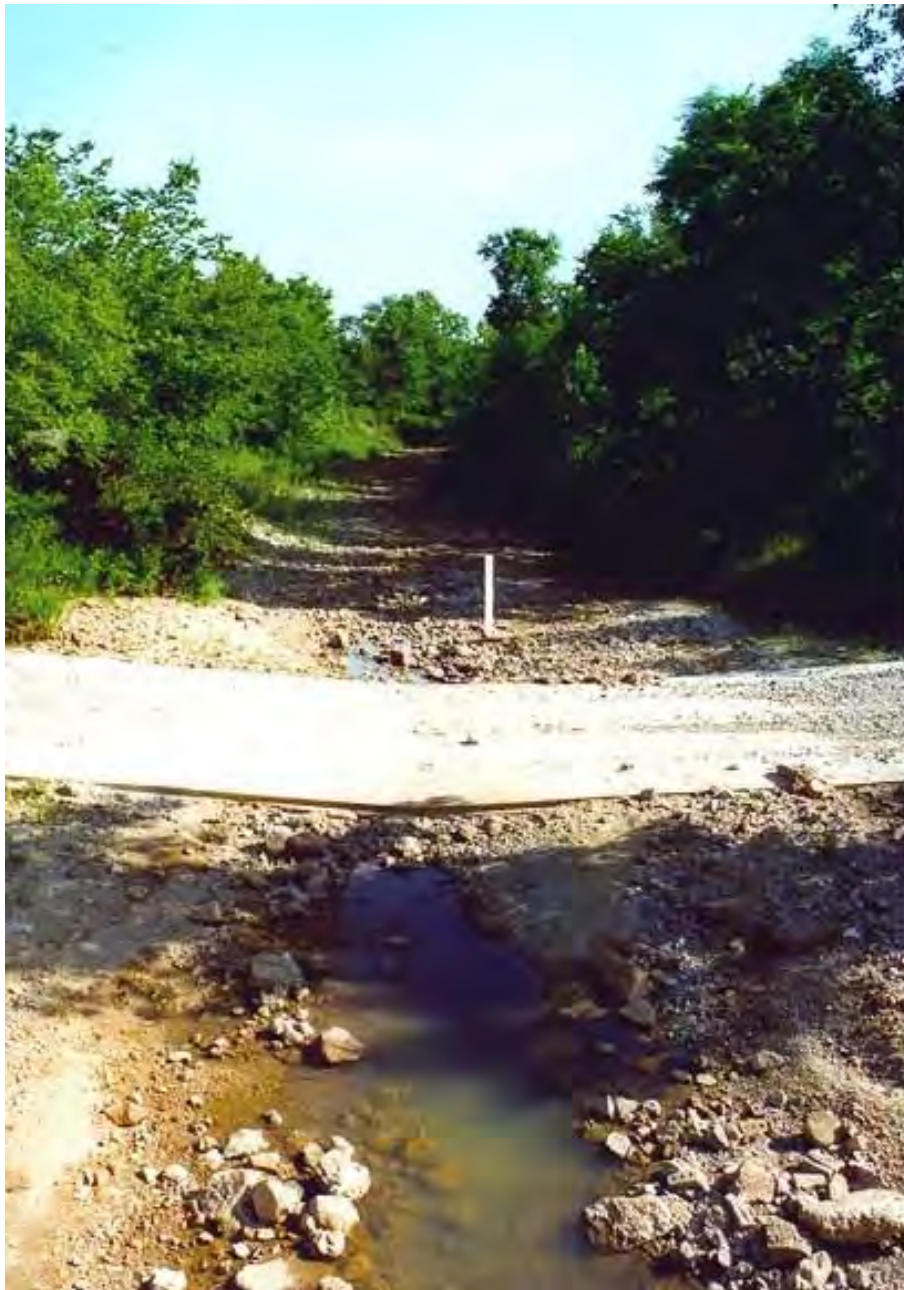
**Figure C-6. Cement slab LWC
(photo by Joe Proffitt, Fort Leonard Wood, MO) .**

Cement slab crossings (Figure C-6) offer a smooth driving surface and last longer than an articulated block crossing. However, the cement slab affects the stream flow and downstream sides of the crossing and can create scour on the stream bed. If the scour or other force contributes to the failure of the crossing,

they are quite costly to repair seeing that cement trucks may be unable to access LWCs in remote parts of the rangeland. Scouring may need to be addressed with rip rap on the downstream edge to disperse the stream's energy. Sediment deposition on the road surface may also be an issue and removal may be necessary.

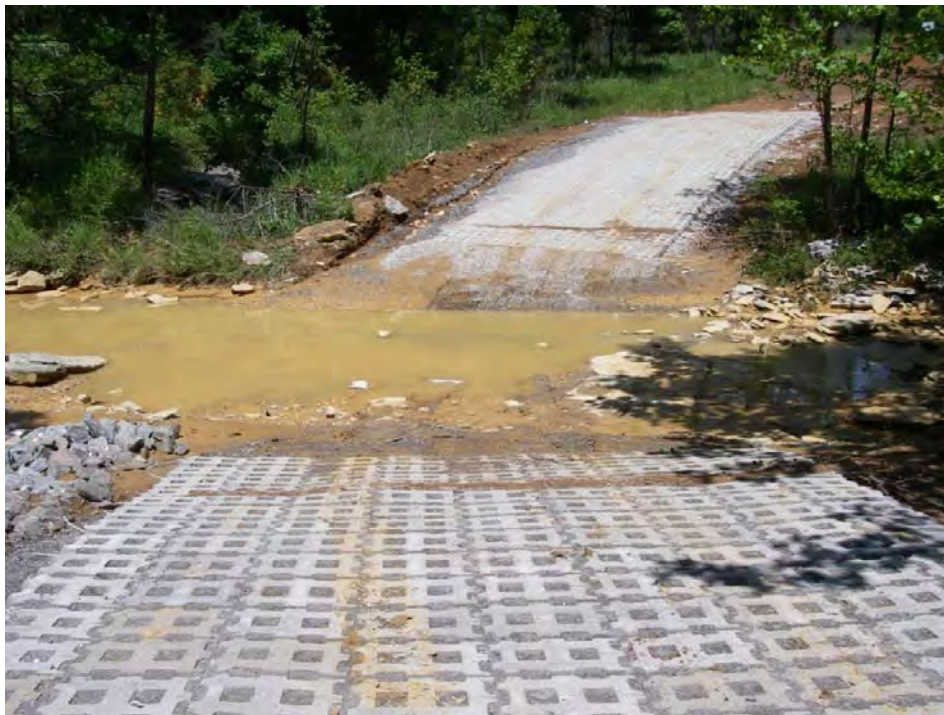
**Figure C-7. Interlocking blocks on approaches
(photo by Scot Serafin, Fort Knox, KY).**

Interlocking blocks are relatively inexpensive and provide a low-impact solution for an LWC that will carry the heaviest military vehicles. Installation of the blocks is faster than heavier, solid cement interventions, taking a day on average. Upon completion, the interlocking block crossings appear to mesh well with the surrounding landscape aesthetics (Figure C-7).

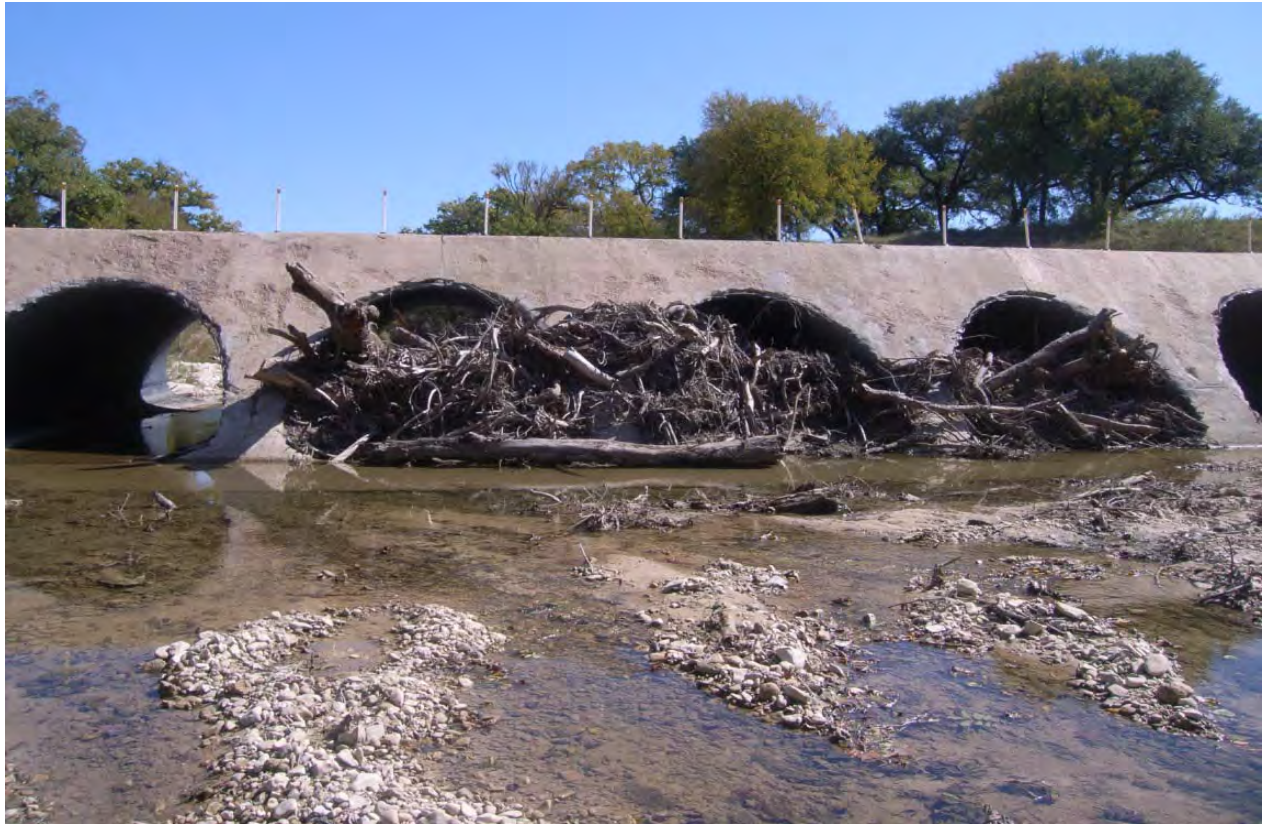
Figure C-8. Large, plugged culverts
(photo by Jerry Paruzinski, Fort Hood, TX) .

On the con side, heavy military vehicles can crush any exposed ends of the culverts. Culverts can also cause the stream to lose its natural hydrological properties and can clog from debris (Figure C-8) flowing down the stream or from beaver activities. In high flows, the crossing can become a restriction impeding access, become a safety issue to personnel, or result in an increase in erosion and sediment loads.

Since vehicles tend to damage the edges of the vented crossings or road maintenance crews may intentionally crimp the culverts shut to reduce potential for clogging or further vehicle damage, maintenance on culverts is required. Routine maintenance involves the removal of sediments, clogs, and debris. Additional maintenance is needed to keep culvert ends as open and "un-crimped" as possible to help reduce the potential for restricted flow.
