PUBLIC WORKS TECHNICAL BULLETIN 200-1-72
30 SEPTEMBER 2011

**ARMY CRITICAL AREA REVEGETATION
ESTABLISHMENT STRATEGIES (ARMY CARES)**

Public Works Technical Bulletin
No. 200-1-72

ARMY CRITICAL AREA REVEGETATION
ESTABLISHMENT STRATEGIES (ARMY CARES)

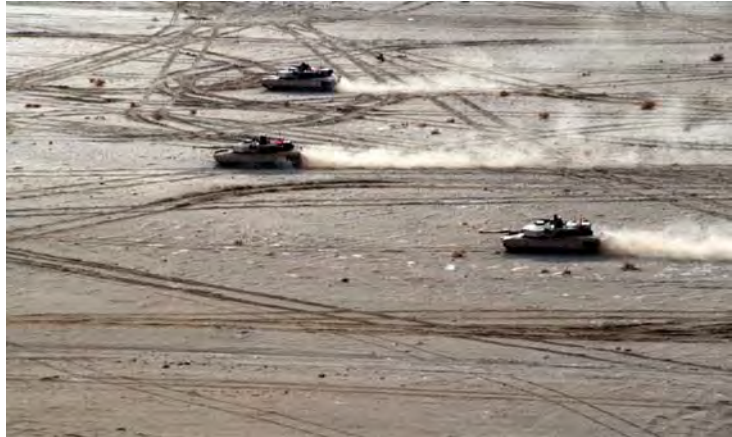
Figure A-1. An example of severely eroded land due to military operations.

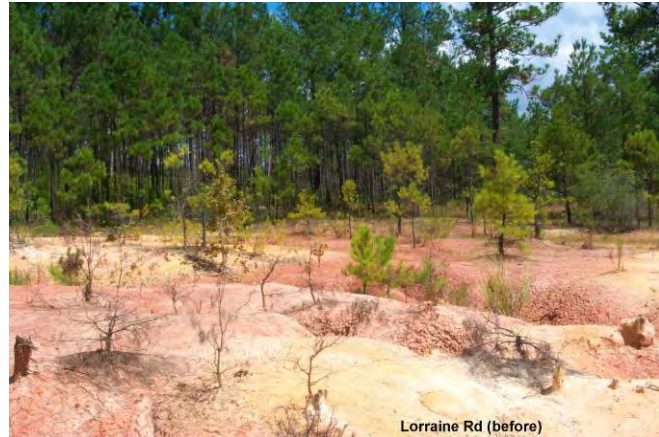
Figure A-2. View of Lorraine Road before restoration measures were implemented.

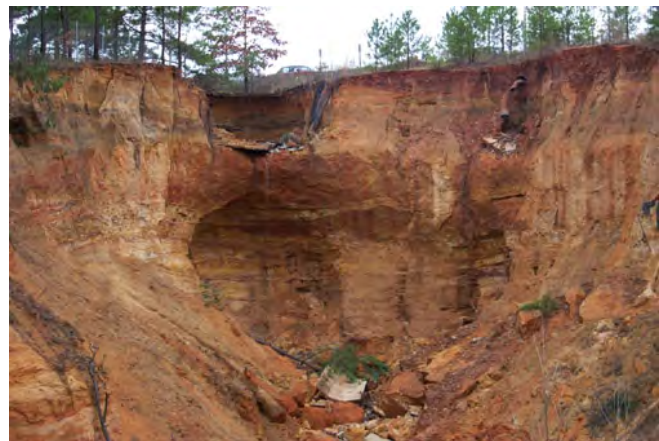
Figure A-3. This gully at Kelley Hill, Fort Bragg, started at the stormwater outfall.

Nevertheless, not all land degradation and soil erosion/sedimentation problems are a direct cause of military training impacts. For example, the gully shown in Figure A-3 started at a stormwater outfall. It measured 95-ft across and 45-ft deep before restoration measures were implemented (Gary Hollon, Soil Conservationist, Environmental Management Division, Fort Benning, pers. comm. 2008). The culvert inlet erosion shown in Figure A-4 shows a similar problem. Although the origin and cause of concentrated flow may be damage by tracked- or wheeled-vehicular traffic, placement of riprap around the culvert is not an appropriate solution. Critically eroded and degraded areas on Army training and testing lands are among the most chronic and aesthetically displeasing sites.

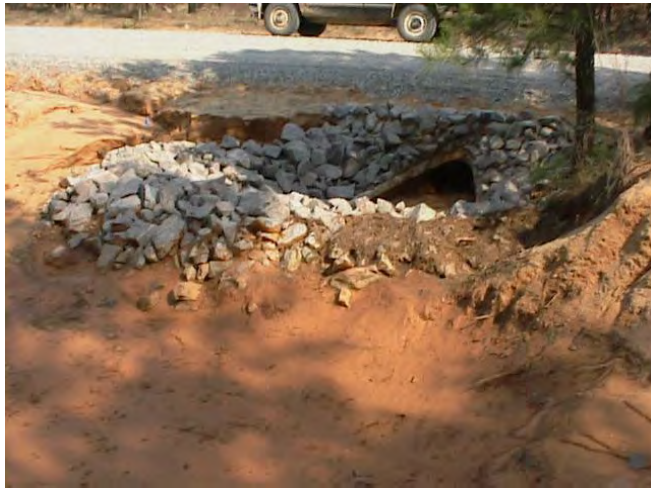
Figure A-4. Riprap placed around this culvert inlet is not the appropriate solution to the erosion problem.

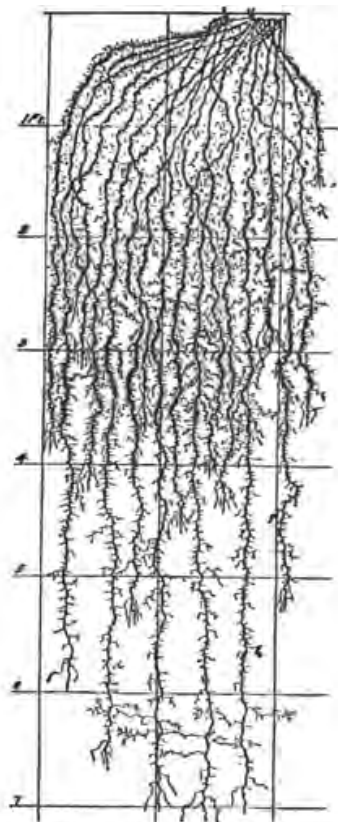
Fig. 1. Root system of sand hill bluestem with roots reaching more than 7 feet deep. From Plant Ecology by Weaver and Clements.

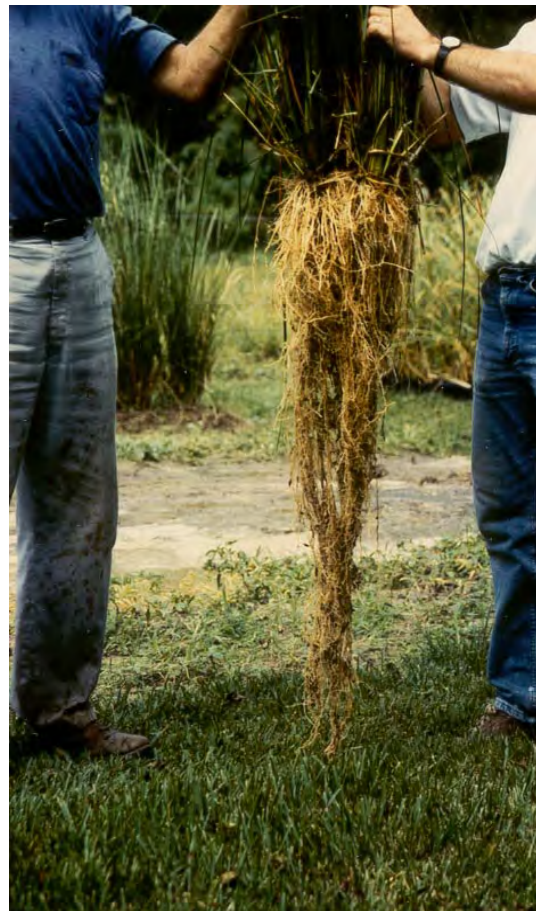
Figure B-1. Root system of (left) sand hill bluestem and (right) Vetiver grown in Champaign, IL. (Source for bluestem drawing is Weaver and Clements 1938.)

If the plant's canopy protects the soil above from erosive forces of falling rainfall, the root system below provides "nature's best engineered" anchoring mechanism by reinforcement from long and fibrous roots (Figure B-1), thereby contributing to soil stability. Figure B-1 shows a 7-ft-long fibrous root system of native bluestem grass that is found almost all over the United States. During research on Vetiver (see Appendix E for details), a growth of over 3 ft in 12 weeks was observed in the root system of a Sunshine variety tested in Champaign, IL and Sunshine, LA. Vetiver plants grown on a sandy loam hilltop in Thailand exhibit an exposed root system of Vetiver measuring over 25-ft-deep into the earth.

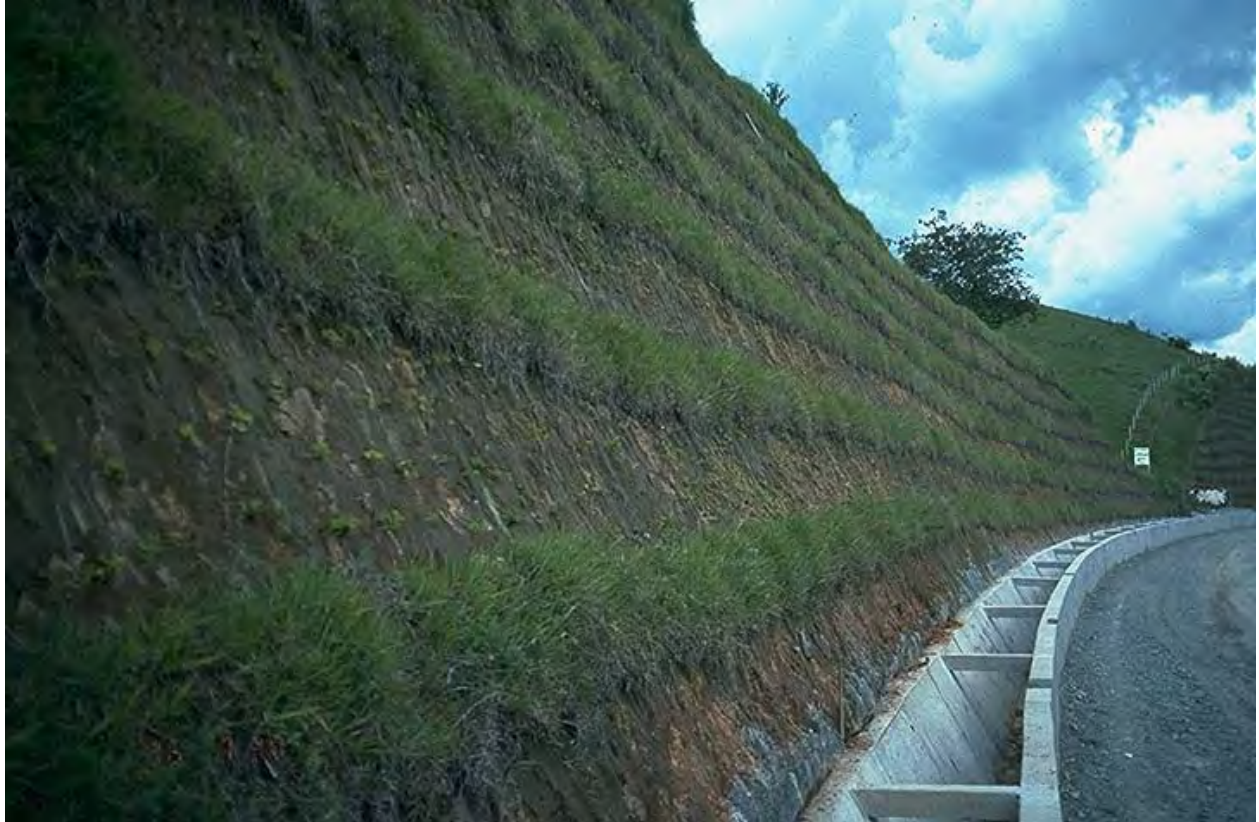
Figure B-2. Hedge grasses may be the only choice of vegetation on steep slopes.

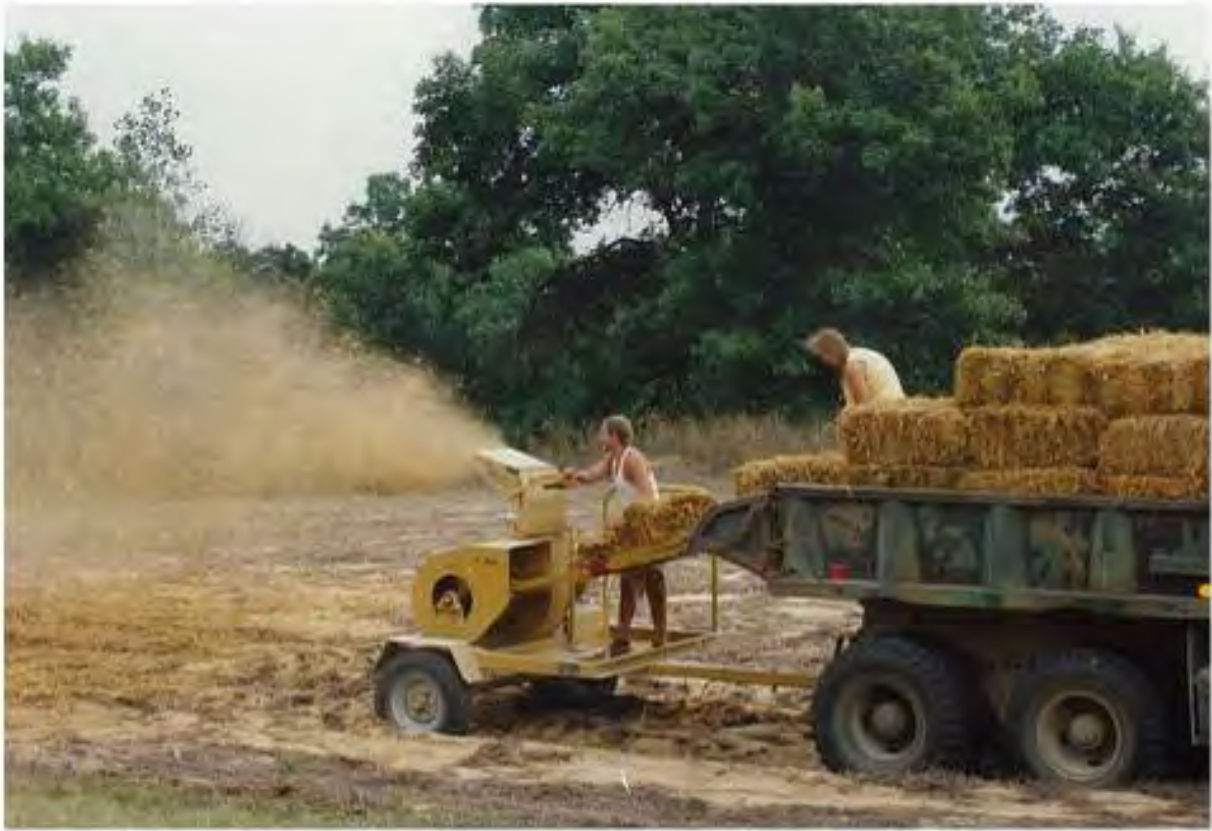
Figure B-3. Grain straw mulch applied at 4,000 lb/acre.

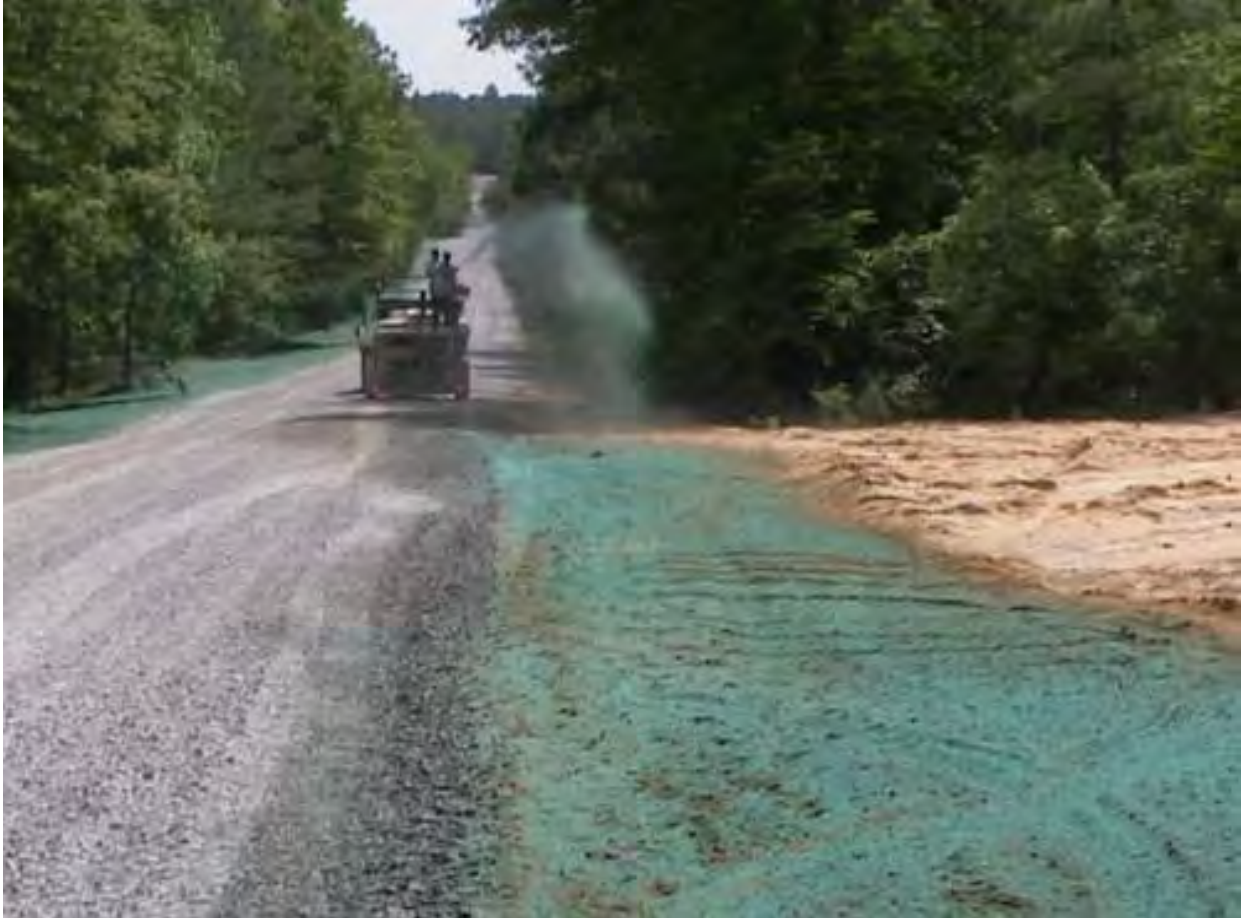
Figure B-4. The hydroseeding process sprays seed, mulch, and other materials that have been mixed with water.

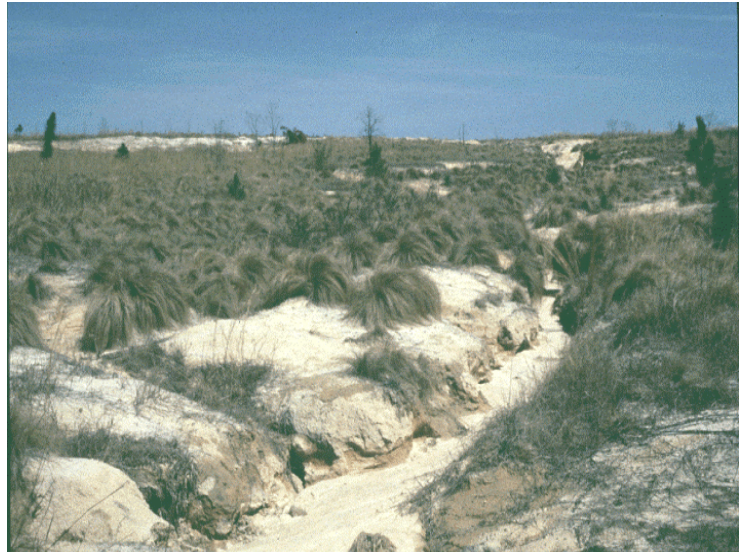
Figure C-2. Concentrated runoff and erosion produced these gullies at Salerno DZ, Fort Bragg, NC.

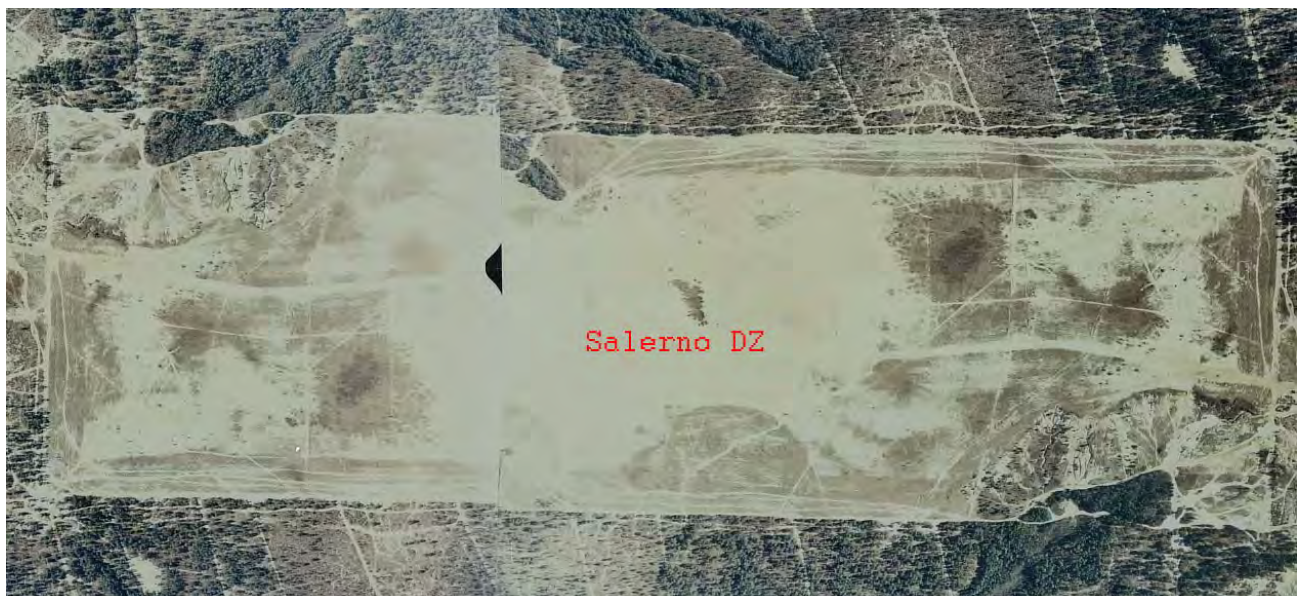
Figure C-3. Salerno DZ in December 1995 before restoration, showing the normal practice of keeping the drop zone free of all woody and grassed vegetation, which resulted in severe erosion and degradation.

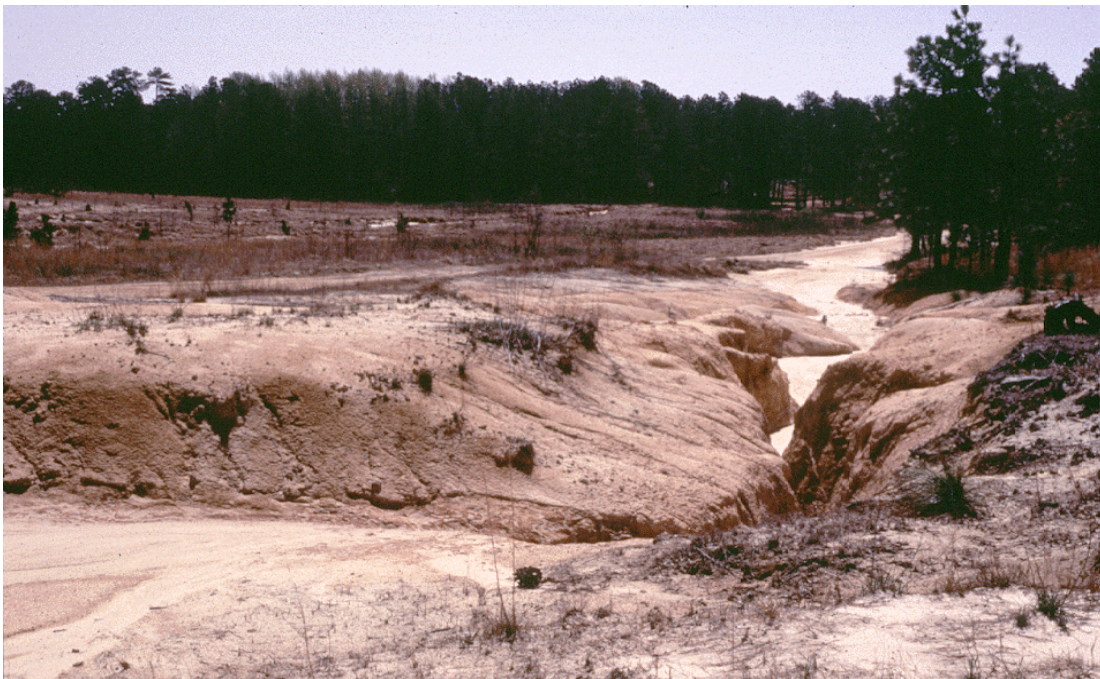
Figure C-4. Salerno DZ, southeast corner; deep and wide gullies posed safety issues for parachutists.

Land restoration and revegetation work was first performed on a 120-acre area in the southeast corner of Salerno DZ (Figure C-4). The work was completed in 1997. Following is a description of the major components of this revegetation effort as implemented in the field.

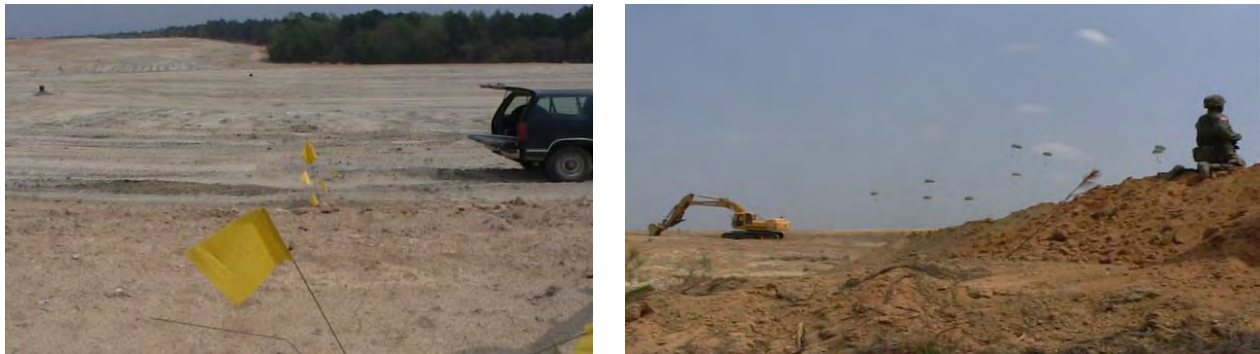
Figure C-5. Earth work including leveling, grading, and terrace construction at Holland DZ, Fort Bragg, NC.

The terraces were: a minimum 48-in. high from channel to ridge; a front slope of not less than 12 ft; front and back slope no steeper than 6:1; and a minimum 2-ft wide at the top and level at the ridge. Each terrace had each end closed or blocked with the same cross-section turned uphill until it met with existing ground contour. The lengths of these terraces were 2400, 2700, and 2860 ft, respectively. Terraces were compacted with vibratory sheepsfoot compactors or vibratory self-propelled steel drum rollers. All terraces were built in layers not to exceed 8 in.; each terrace lift was compacted to conform to at least 95% of laboratory maximum density.

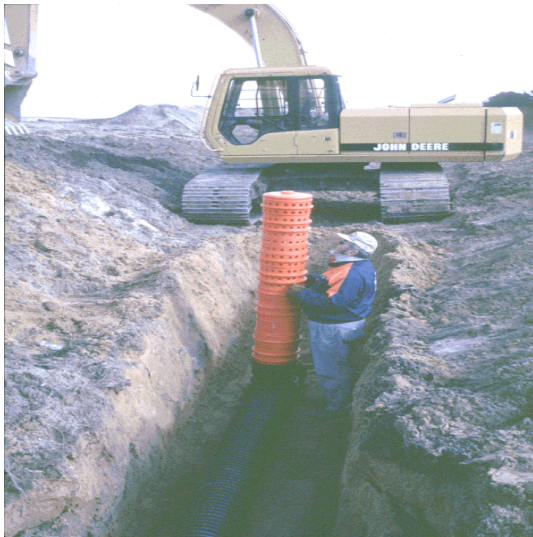
Figure C-6. Higginbottom riser installation at Normandy DZ, Fort Bragg, NC.

Higginbottom terrace inlet risers, 12 in. in diameter, were installed (Figure C-6) to direct filtered stormwater into the subsurface drains. Approximately 2 cu yd of round and washed DOT NC #57 gravel was hand-placed around each Higginbottom to filter trash and keep it from entering the subsurface drain system (Figure C-7). All stone used was circular in shape (no sharp ends) to avoid injury to Army parachutists.

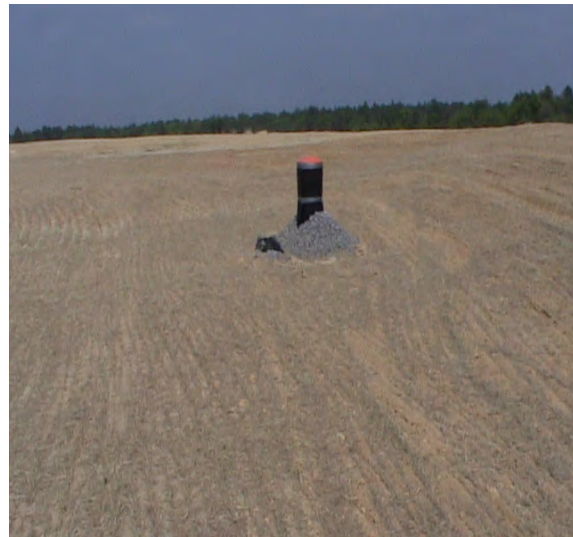
Figure C-7. Installed Higginbottom terrace inlet riser with gravel piled around it.

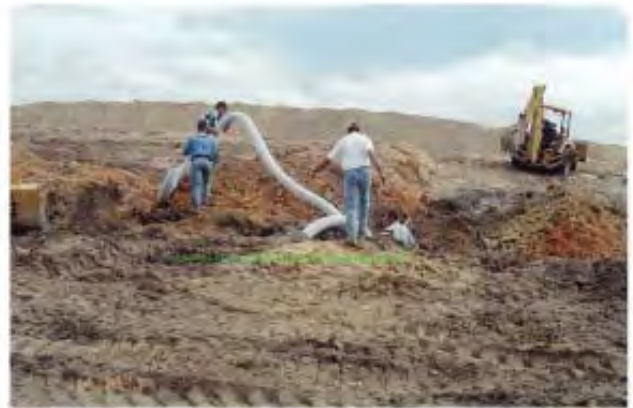
Figure C-8. Subsurface stormwater drainage system.

Nonperforated subsurface plastic conduits, with a diameter of 12 in., were installed 3-ft deep in the ground to carry the stormwater runoff from terraces onto the woodlands off the project area (Figure C-8).

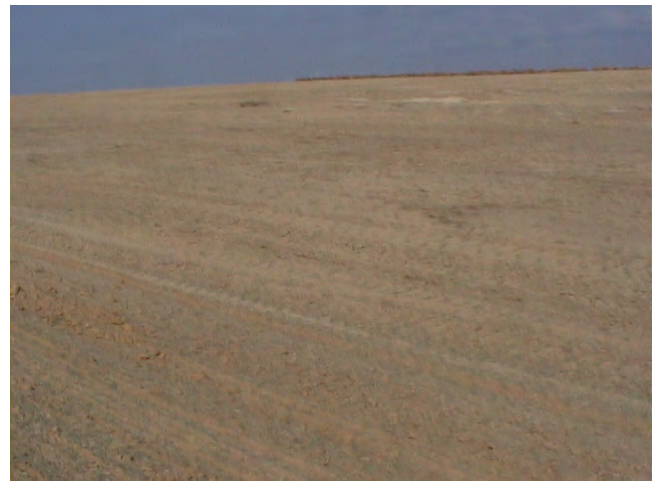
Figure C-9. Plowed area.

Before seeding, the project area was plowed and loosened to a depth no less than 4 in. (Figure C-9). Areas to be seeded were dressed to a smooth, firm surface (Figure C-10).

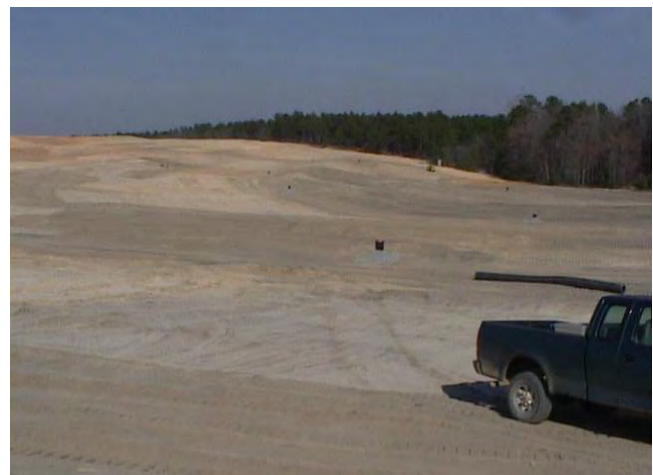
Figure C-10. Smooth, firm area to be seeded.

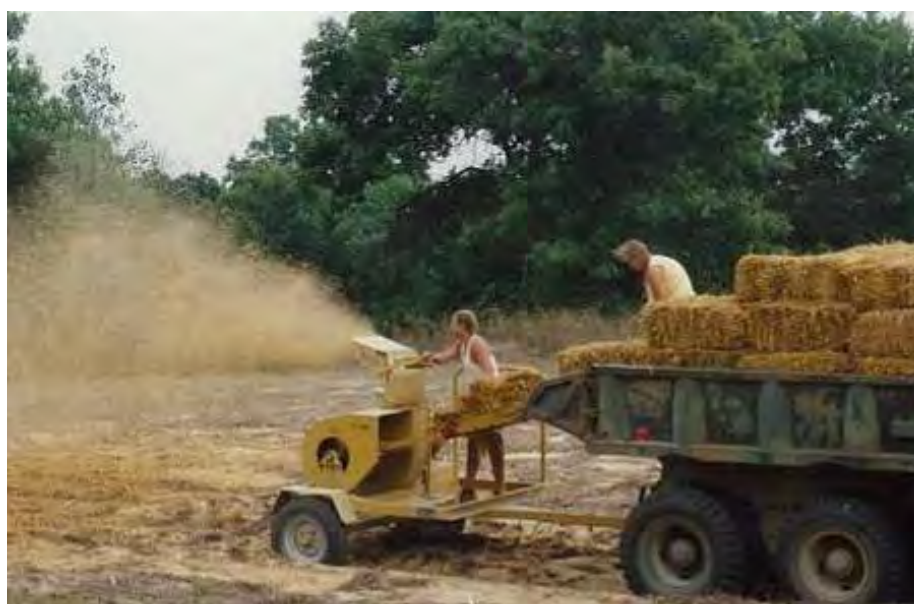
Figure C-11. Grain straw mulch applied at 4,000 lb/acre.

Grain straw mulch was applied by blow-type mulch spreader at the rate of 4,000 lb/acre (Figure C-11). Mulching was begun on the windward side of relatively flat areas, or on the upper part of a steep slope, and continued uniformly until the area was covered.

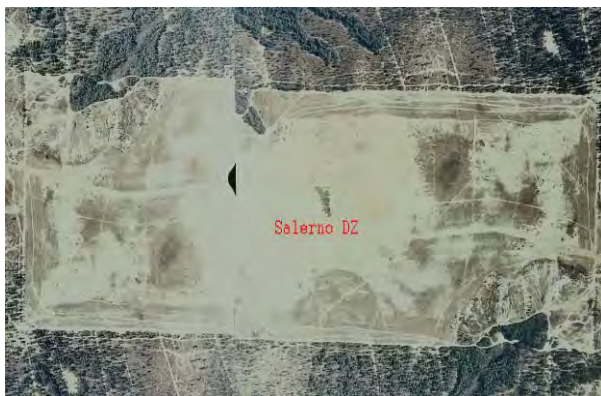
Figure C-12. Salerno DZ before restoration.

1. When the concept of seeding DZs was presented to Fort Bragg in 1995, land managers were skeptical. They had never seeded any of their 20 DZs, so the concept of seeding was a departure from past practice. Fort Bragg's main question/concern was the safety of parachutists in that a grass surface might be harder than a soft, sandy surface on legs and knees of dropping parachutists. CERL responded with a proposal to try seeding a small 120-acre area to find out the response from the real customer, the parachutists. Response from the trainers and trainees was very, very positive. The green, smooth surface was not only gentle on landing, but also provided great visuals and aesthetics (Figure C-14).

2. Through the practice of revegetation on the four major and most-used drop zones covering more than 2500 acres, it was demonstrated that the cost of restoration using vegetative measures (\$3,000 per acre) is far less than conventional methods (\$22,000 per acre) employing mission-incompatible structural controls of riprap, grassed waterways, and sediment basins that were used by the local USDA NRCS.

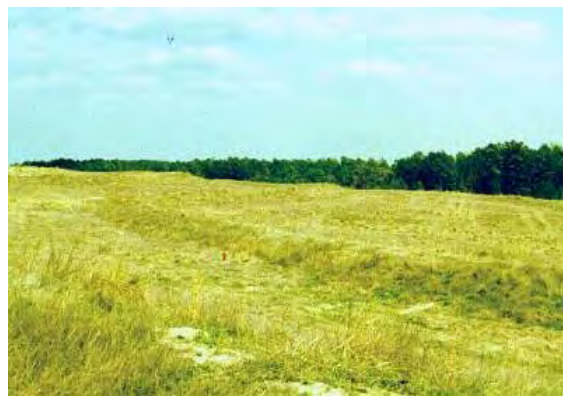
Figure C-13. Salerno DZ after restoration.

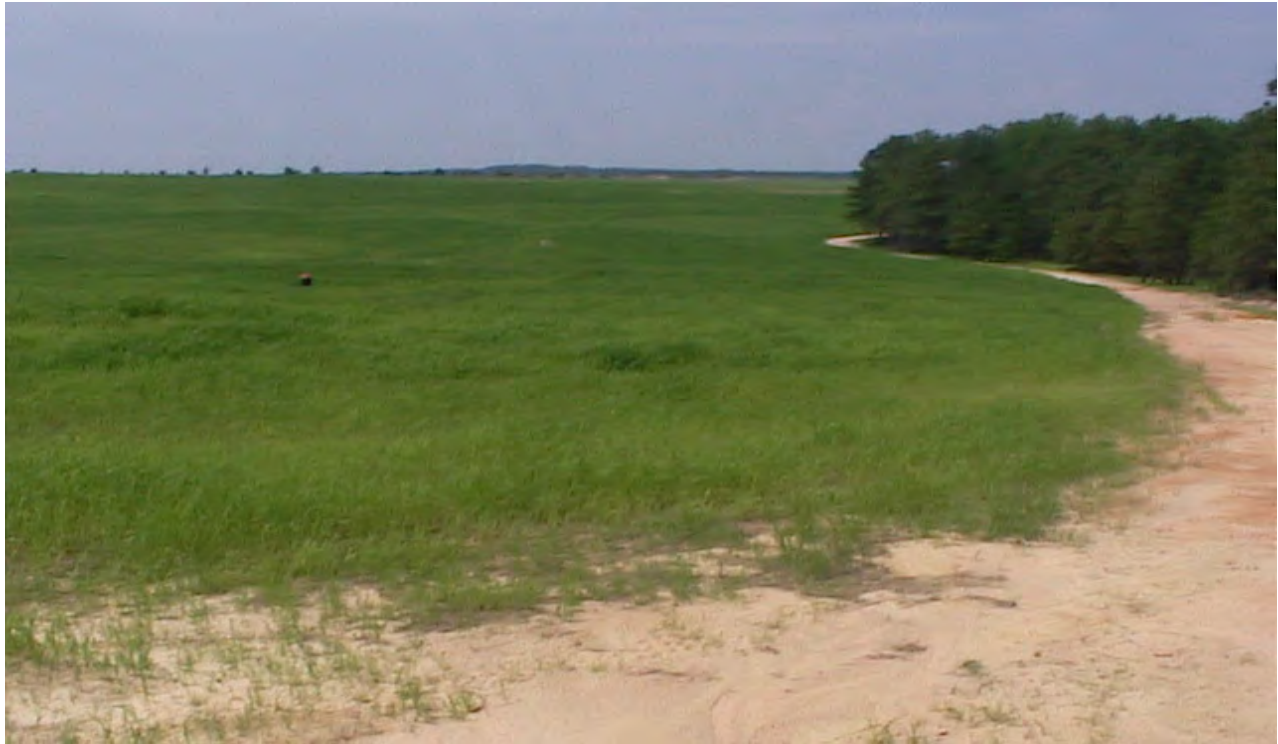
Figure C-14. Salerno DZ – Lush green vegetation established on sandy soils.

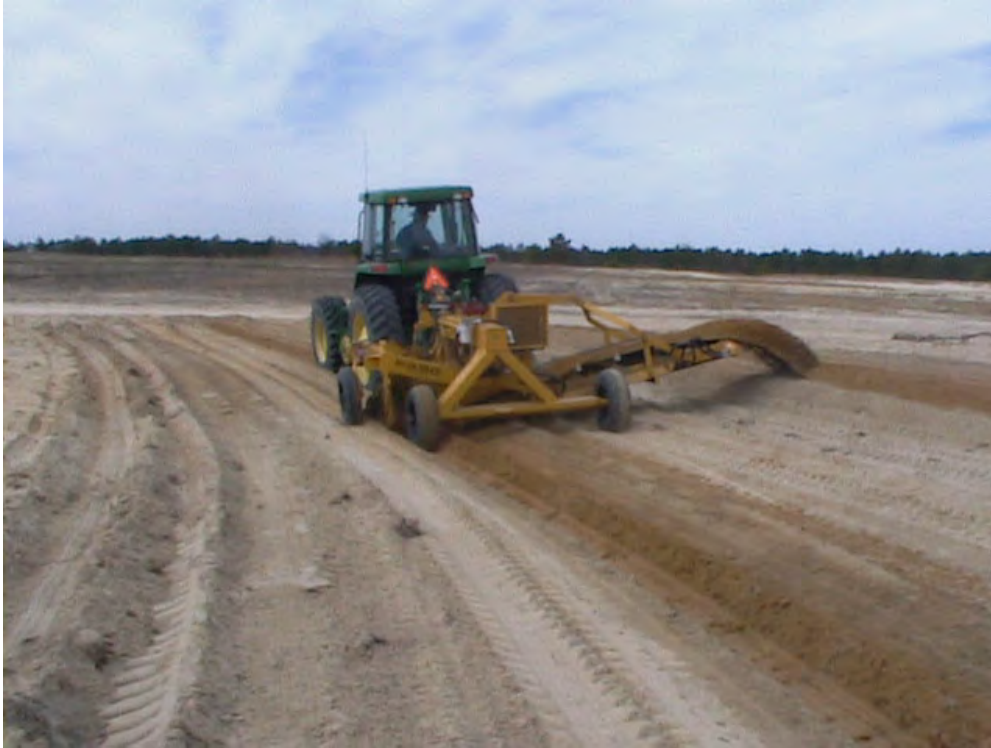
Figure C-15. Using in-house labor for terrace construction and seeding, Fort Bragg's revegetation costs have come down substantially compared with commercial contracting costs.

3. The demonstrated practice of revegetation combined with terraces and a subsurface drainage system provides advantages such as on-site stormwater harvesting, erosion/sediment control, little or no maintenance, and attractive and green aesthetics. Realizing the advantages of this demonstrated technology, and the confidence in terrace-revegetation practices, Fort Bragg purchased their own terracing machine (Figure C-15). Using in-house labor for terrace construction and seeding, their revegetation costs have come down substantially compared with those of commercial contractors.

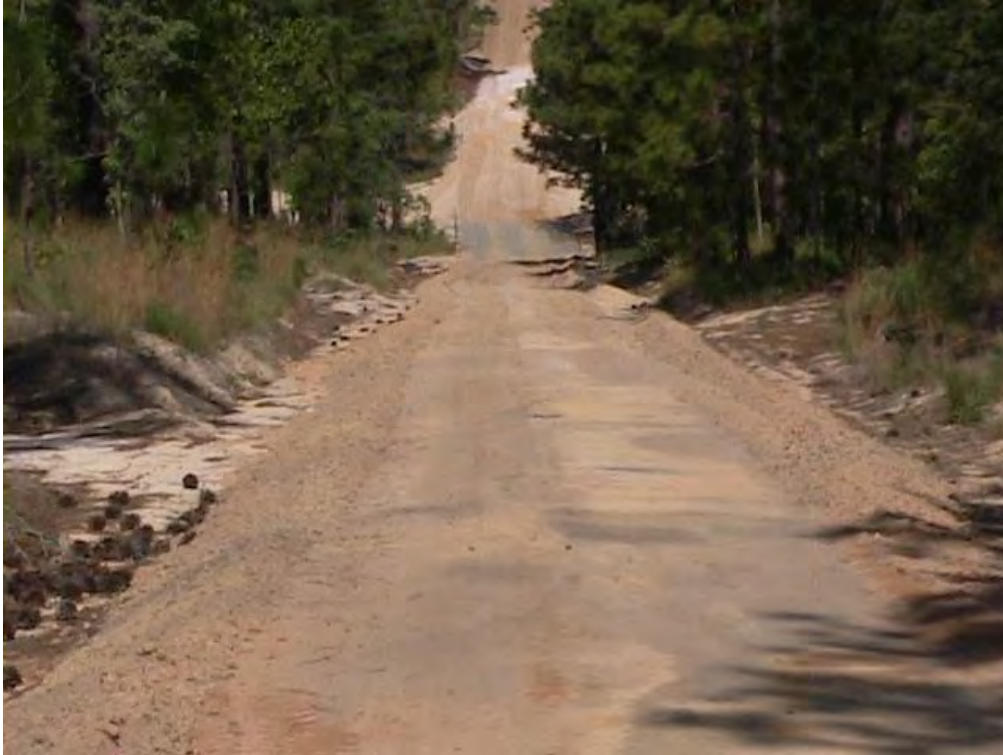
Figure C-16. Preachers Tank Trail.

1. Treatment #3 (sandy soil fill, followed by geoweb installed over geosynthetic fabric and filled with locally available crush and run gravel) was observed to be the most effective method for the stabilization of tank trails.
2. All newly constructed and upgraded tank trails must be raised a minimum of 18-24 in. above the natural ground contour.
3. Tank trails must have a center crown (Figure C-16).
4. Treatment #3 is the most expensive in initial construction costs. However, this is the preferred choice because of low or little post-construction R&M costs.

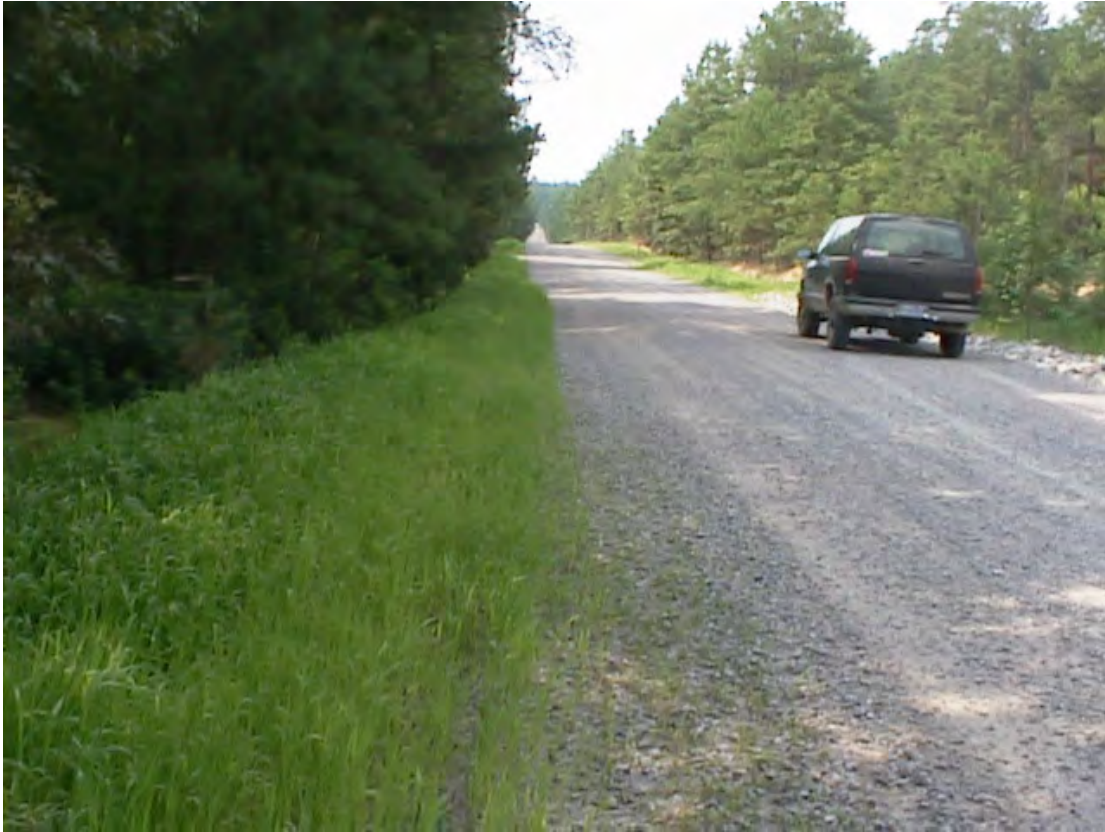
Figure C-17. Revegetated 2-mile section of McKellers Road.

9. Following successful results, a 2-mile section of McKellers Tank Trail at Fort Bragg was stabilized the next year using Treatment #4. This project was also constructed through the USACE Savannah District (Figure C-17). CERL researchers devel-

oped construction design specifications and performed all QA/QC work.

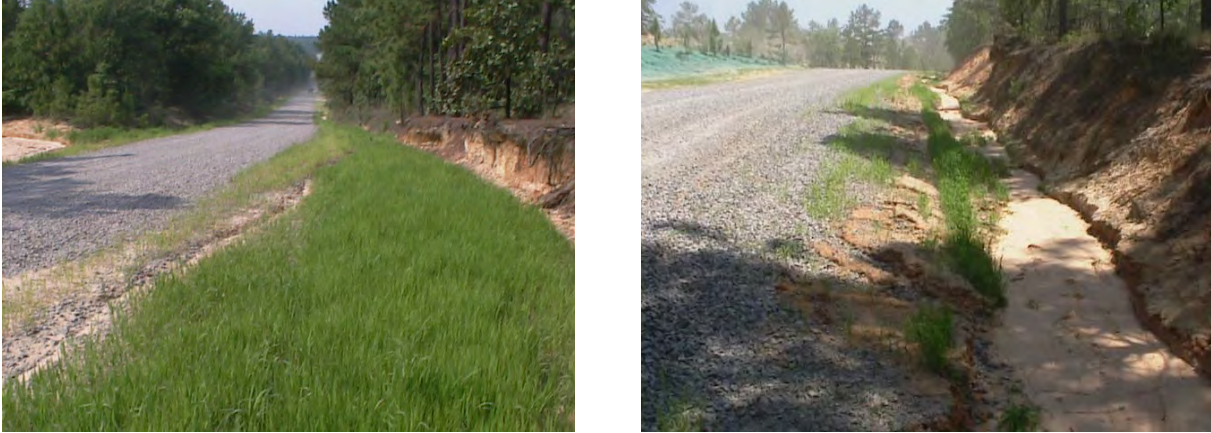
Figure C-18. McKellers Road – Adequate checkdams and in-time repairs would have prevented a complete washout.

10. Installations usually lack both financial as well as manpower resources. Most, if not all, training area stabilization efforts often fail, not because the technology was inadequate or improperly implemented. Rather, minor post-construction repairs were not performed resulting in major catastrophes such as utter project failures and NPS pollution problems.
11. Vegetation is not a panacea to all erosion problems. Because of the nature of sandy soils, steep slopes, and potential erosion problems, vegetation did not work in some of the projects at Fort Bragg.
12. As shown in Figure C-18, the failure on the right could have been avoided if immediate repairs had been made at the very start of the problem. The main reason for this wash out is that check dams were not provided to break down long, steep slopes to reduce concentrated flow velocities.

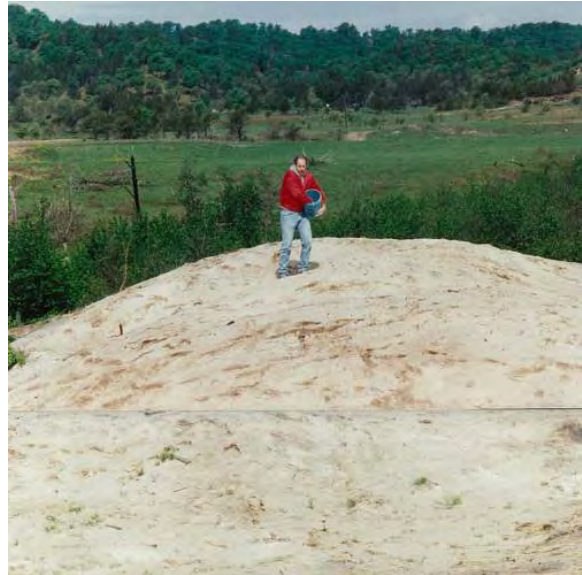
Figure D-1. Fort McCoy, WI, March 1992 before restoration.

Two sites were selected for pilot testing and evaluation. The sites were located in different areas, but had similar sandy soil characteristics. Sites were disked to loosen soil and the

seedbed was prepared by leveling and grading using conventional agricultural practices. All of the seeding operations were performed by the in-house civilian work force and were completed in early March 1992. Corn and sorghum were planted at a depth of 2 in. using a seed drill. Following corn/sorghum seeding, native perennials were again drill planted at a shallow depth of approximately 0.50 in. All seeded areas were fertilized, limed, and mulched per Turf Specifications of the USDA SCS, Monroe County, Wisconsin.

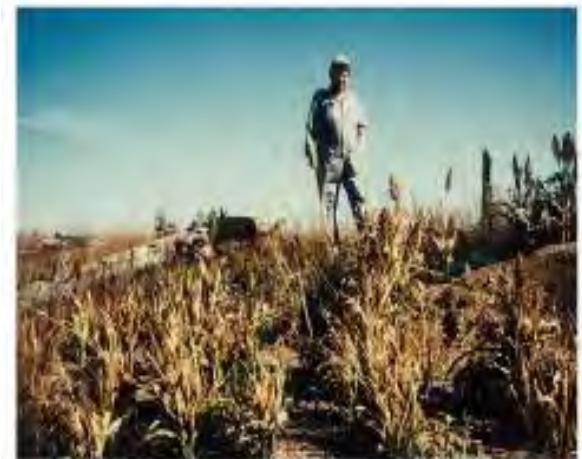
Figure D-2. Fort McCoy, WI, October 1992 after restoration.

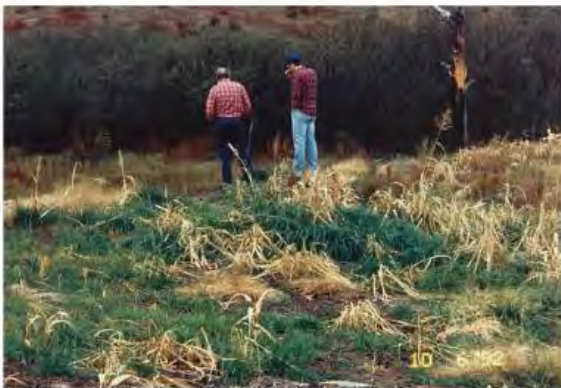
Figure D-3. A stand of corn stalks and perennial grass.

2. Pictures taken during October of the same year (Figures D-3 and D-4) show an excellent stand of nurse crops and perennials.
3. Corn cobs and sorghum heads provided a good source of food for area deer and wildlife during the winter.

4. Dead stalks of corn and sorghum proved to be a welcome source of organic matter that is always deficient in sandy soils on military training lands.

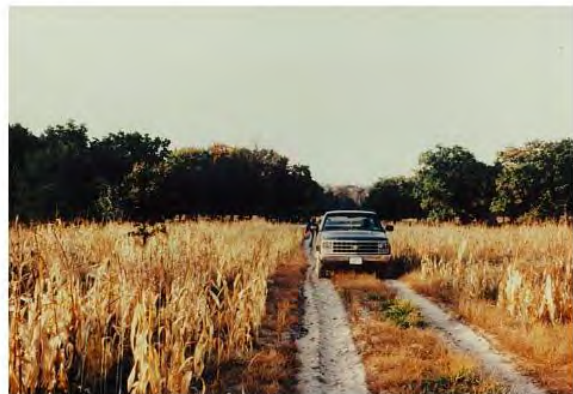
Figure D-4. Example of successful vegetation.

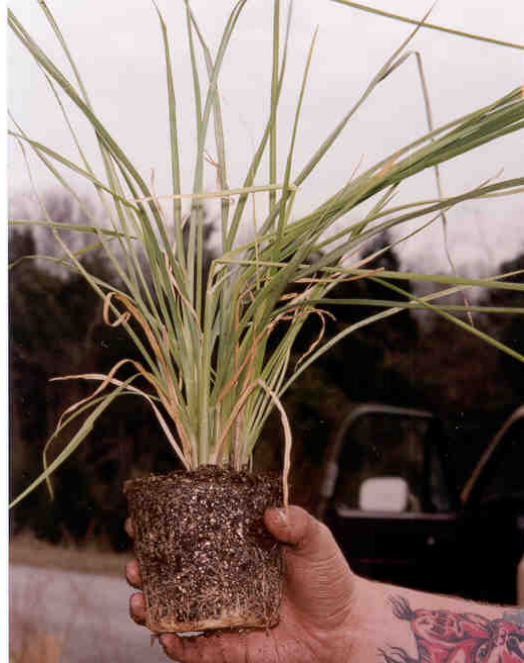
Figure E-2. Vetiver tiller.

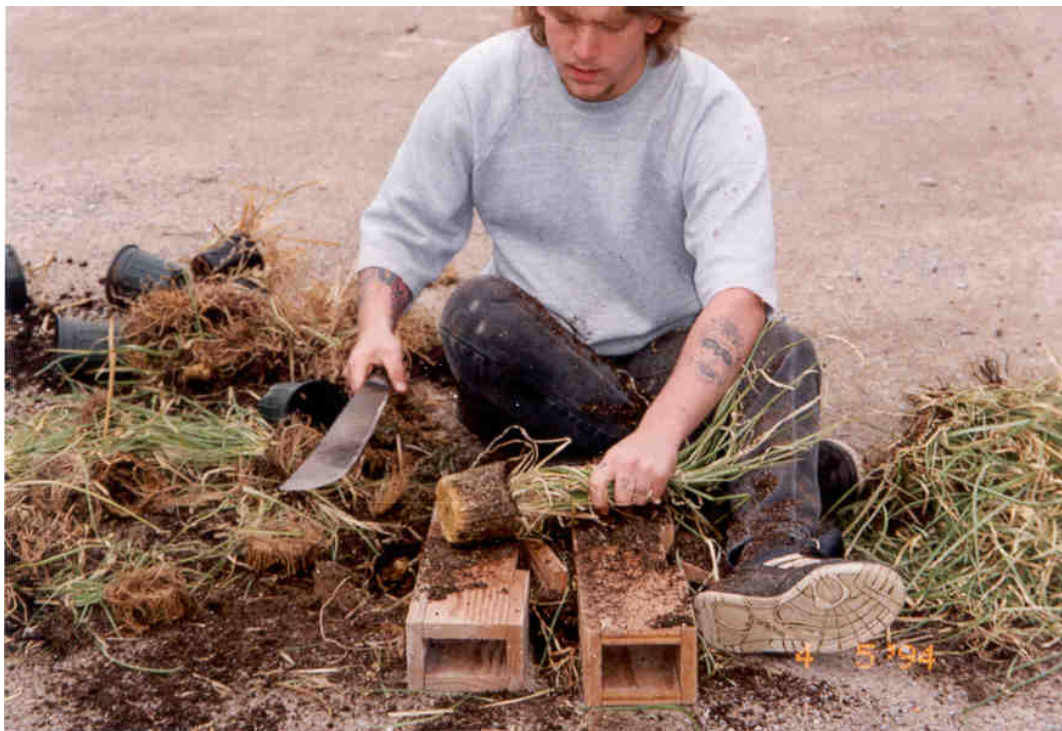
Figure E-3. Cutting lower roots off Vetiver tiller.

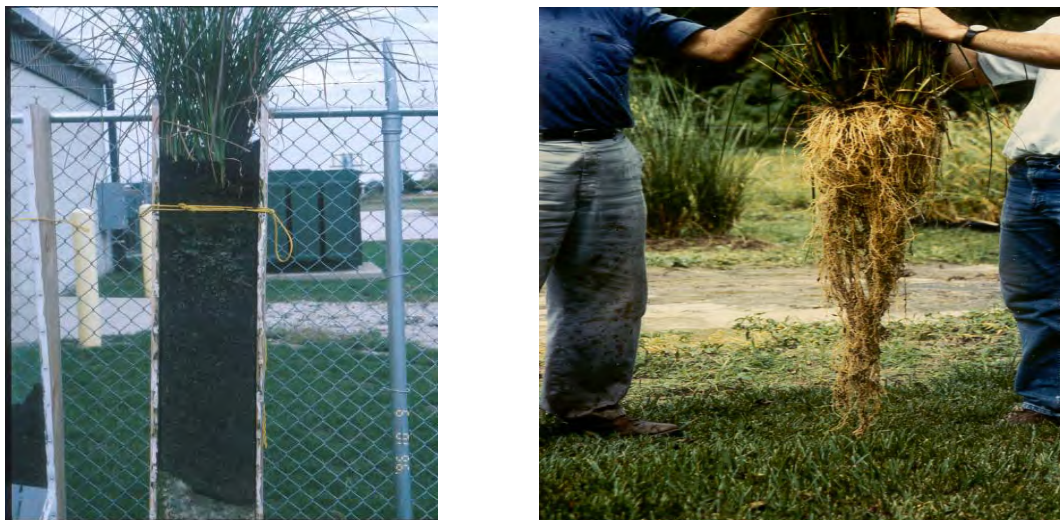
Figure E-4. Vetiver roots shown to grow in excess of 3 ft in a period of 3 months.

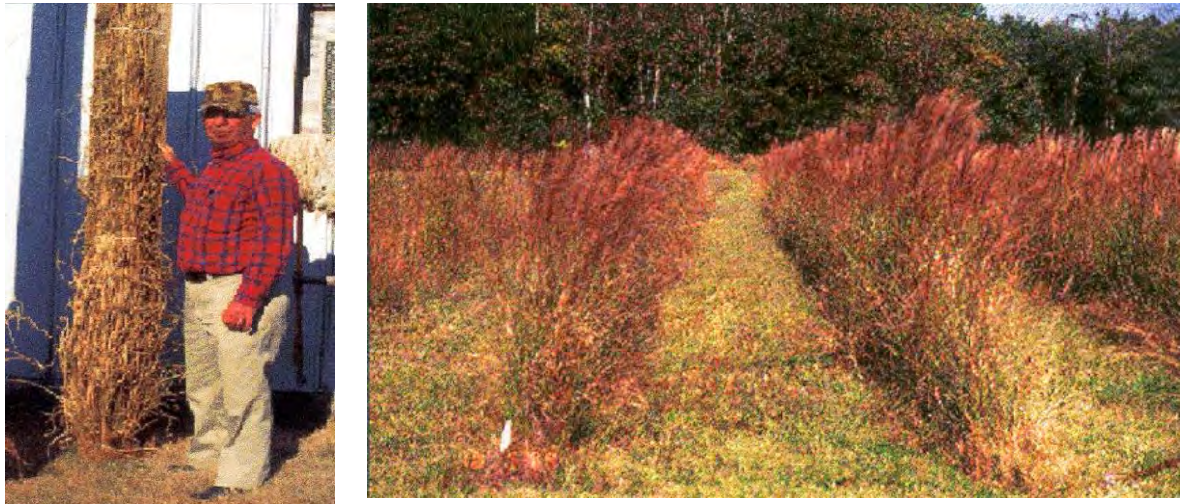
Figure E-5. Vetiver in rich soil (left) and sandy loam soil (right) at Fort Campbell, KY.

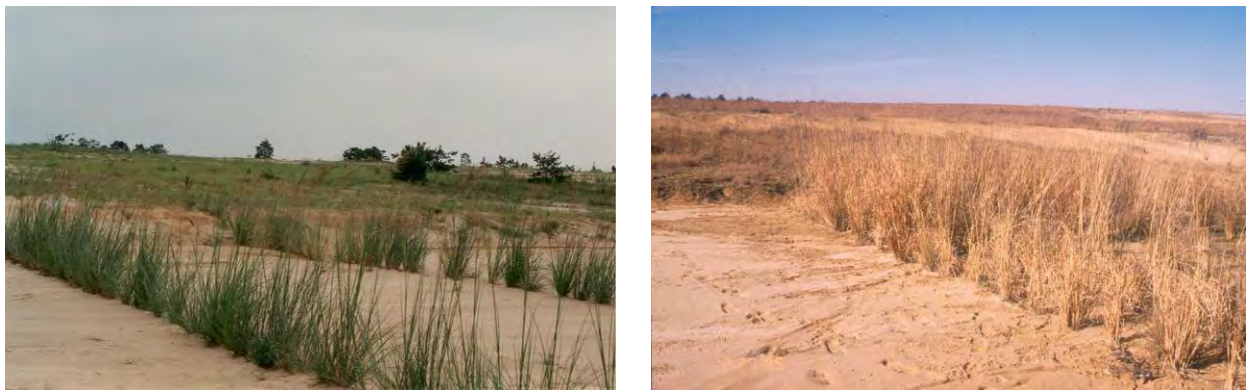
Figure E-6. India (left) and Sunshine (right) varieties of Vetiver in sandy loam at Fort Bragg, North Carolina.

Vetiver planted on sandy loam sites at Fort Campbell grew over 7-ft tall (Figure E-6) and produced profound clumps during its first year of planting. However, most of the plants did not survive the cold winter. During the few years after planting, most of the plants had died due to cold winters and the remaining few were taken over by native species, indicating the plant does not like competition.

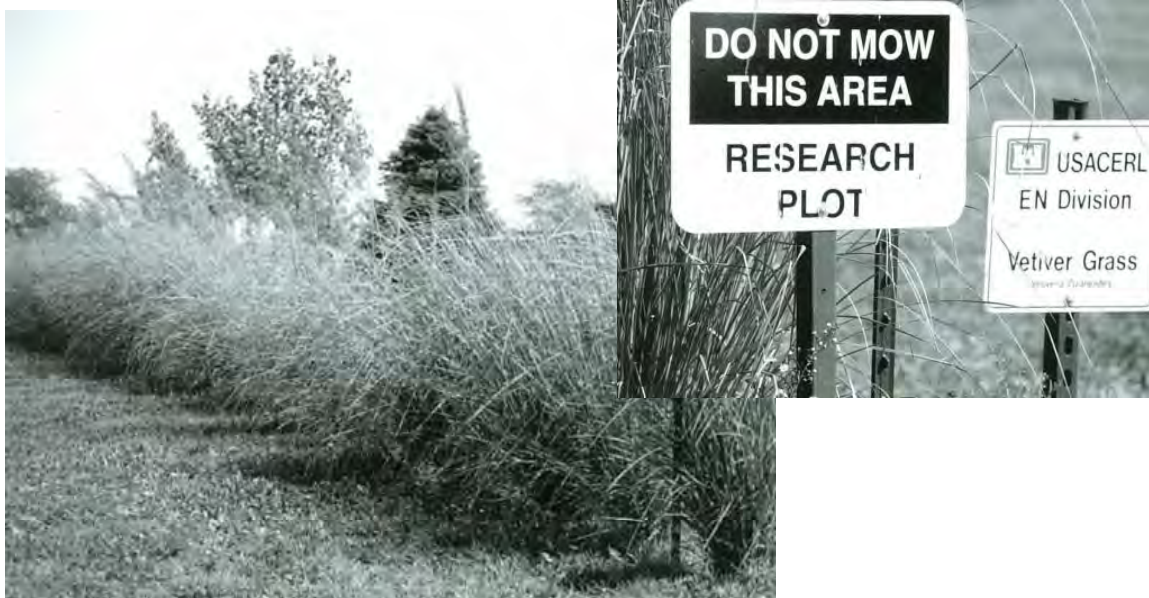
Figure E-7. Sunshine variety planted at ERDC/CERL in Champaign, Illinois.

At locations where the India variety was planted side-by-side with the Sunshine variety, results show that the India variety grows taller and produces stronger robust stems. The Sunshine variety grows shorter and produces a bushy plant structure (Figure E-7).

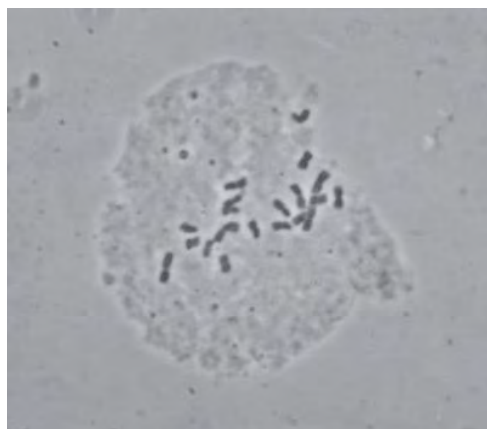
Figure E-8. Sunshine diploid chromosomes.

If Vetiver were a triploid, then it would be sterile and could be introduced on Army lands without any environmental concerns. Karyotypic (chromosome counting) testing performed at the University of Purdue, West Lafayette, Indiana, showed that both cultivars of India and Sunshine had a chromosome number of $2n = 2x = 20$ (Figure E-8). This testing confirmed that the plant is diploid and capable of producing mature seed. This finding led to a check of seed viability.

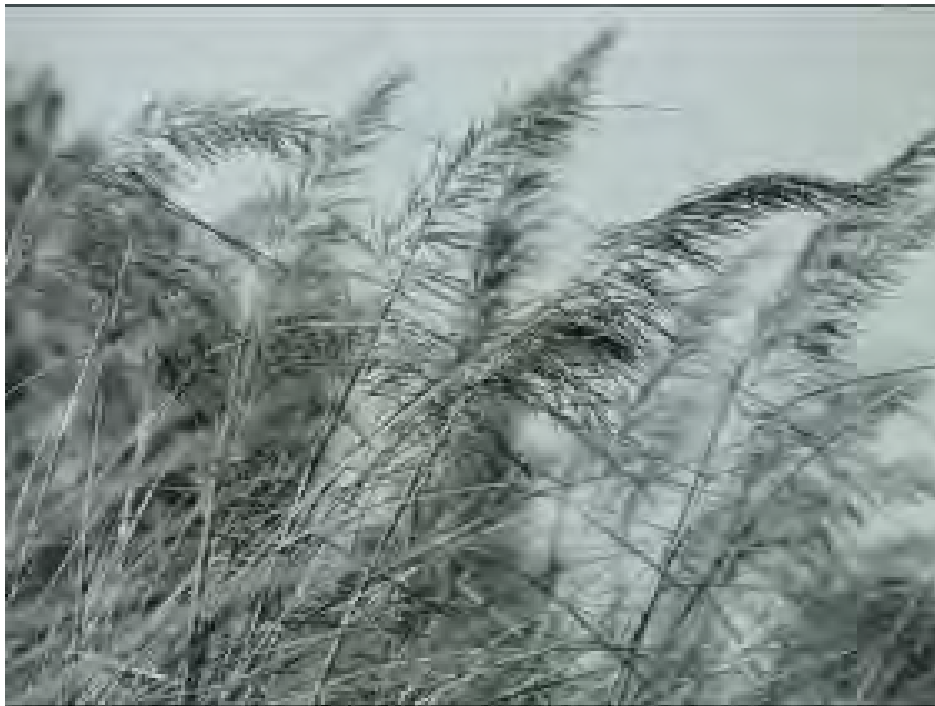
Figure E-9. Flower heads of India variety Vetiver.

Mature inflorescences were collected from both Sunshine and India varieties. The seed heads were sent to Purdue University for seed viability and germination testing. The total numbers of seeds in each inflorescence were counted and approximately 400 seeds selected for seed germination under controlled laboratory conditions. Seed numbering and germination test data are given in Figure E-10 and
