PUBLIC WORKS TECHNICAL BULLETIN 200-1-72
30 SEPTEMBER 2011

**ARMY CRITICAL AREA REVEGETATION
ESTABLISHMENT STRATEGIES (ARMY CARES)**

Public Works Technical Bulletin
No. 200-1-72

ARMY CRITICAL AREA REVEGETATION
ESTABLISHMENT STRATEGIES (ARMY CARES)

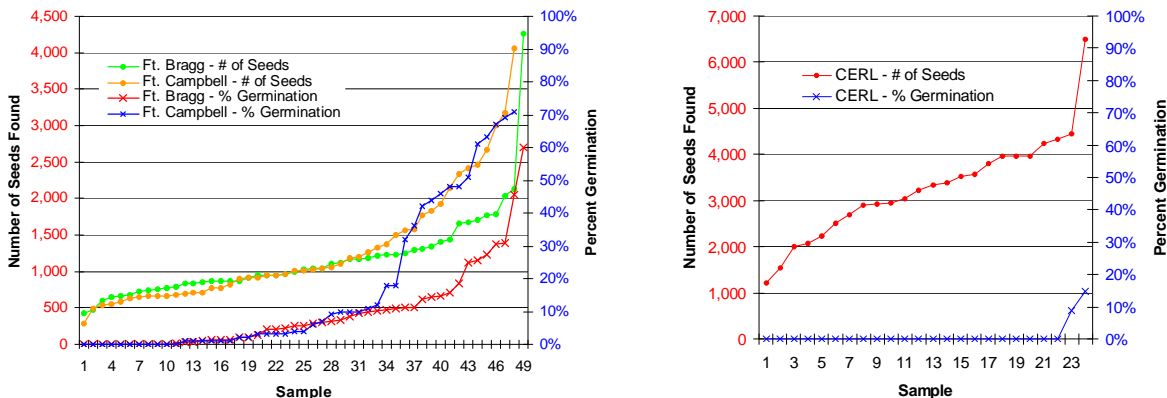
Figure E-10. Number of seeds in each inflorescence and germination results for (left) India variety and (right) Sunshine variety.

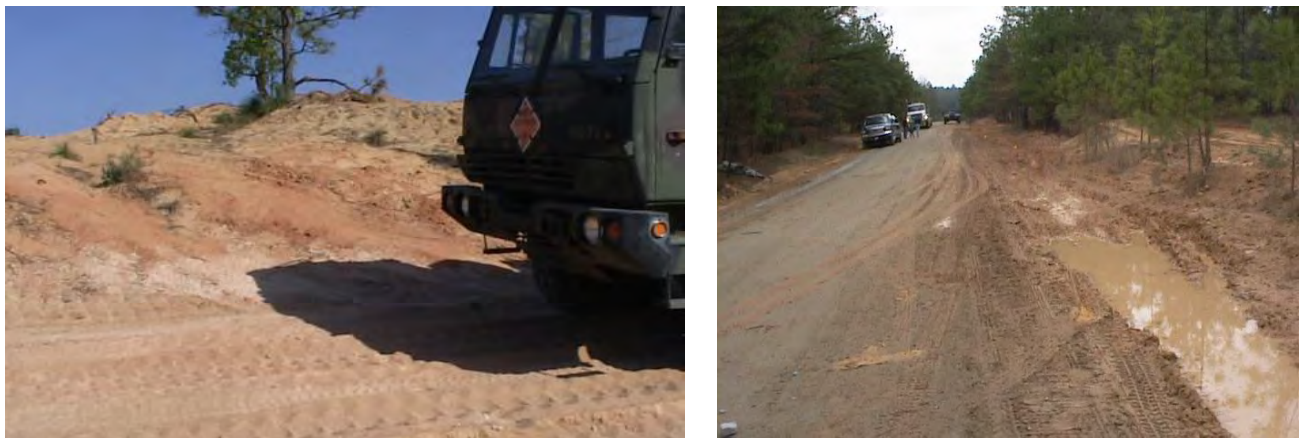
Figure F-1. Major sources of NPS pollution on Army installations are land disturbance from tracked and wheeled vehicles (left) and concentrated runoff from roads and trails (right)

Figure F-1 shows serious land disturbance from tracked and wheeled vehicular traffic at MPRC Range 63, Fort Bragg. Barren, hilly terrain would suggest huge amounts of erosion. However, all this estimated and apparent soil loss does not end up in downslope surface waters. It is true that disturbed areas contribute to sediment loading of downslope forest lands, wetlands, and streams and creeks on Army lands. However, the small open, barren areas and road shoulders of improved and unimproved roads and trails are the significant contributors of sediment and NPS pollution. This is because roads and trails are usually built on high ground. Concentrated runoff from roads and trails results in big washouts and gullies that transport large quantities of sediment and NPS downgrade.

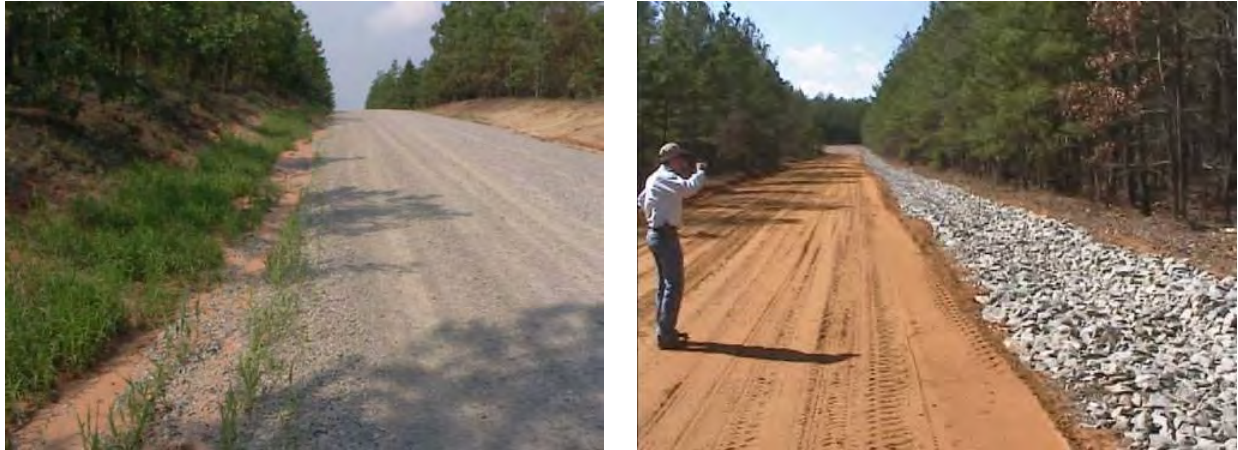
Figure F-2. Tank trail improvements to McKellers Road, Fort Bragg show Army CARES implementation that fits the particular topography, soils, and natural/native vegetation of the site.

3. Plan the development of Army CARES to fit the particular topography, soil, and natural/native vegetation of the site. Long, steep slope stabilization of sandy roads and trails by establishing vegetation may not be as effective as a riprap channel to prevent scouring and frequent R&M (Figure F-2).

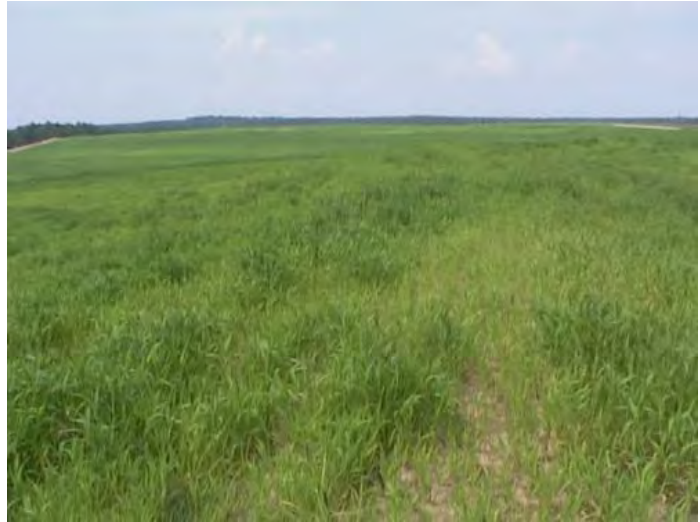
Figure F-3. Stabilize disturbed areas immediately by establishing temporary vegetation.

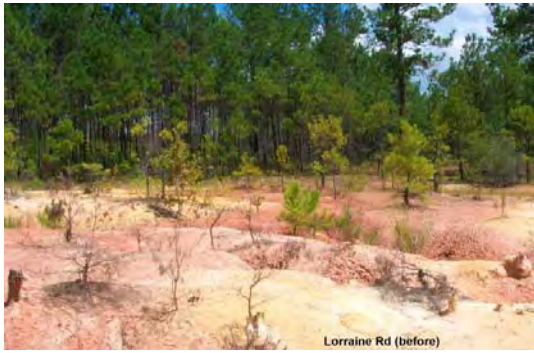
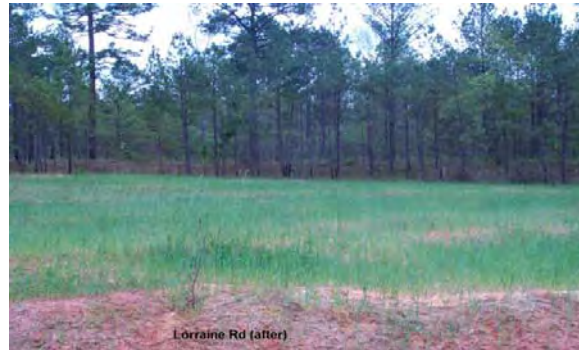
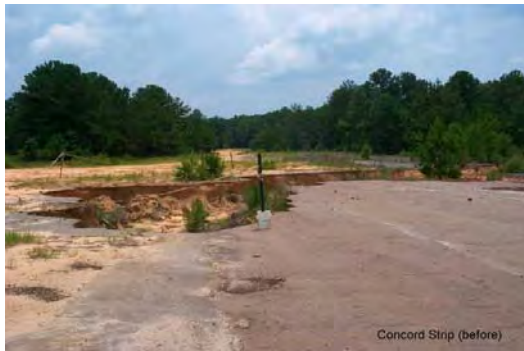
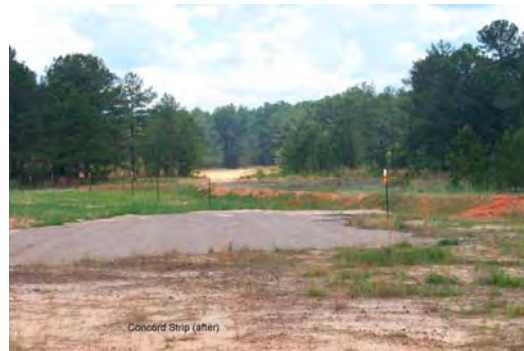
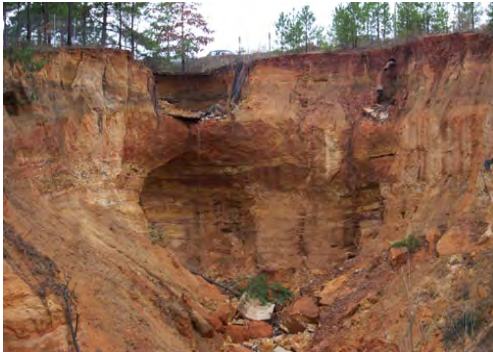
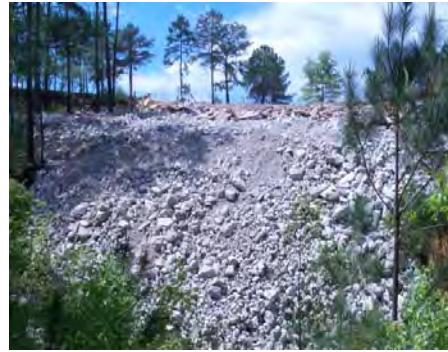
Figure F-4. Examples of delayed or deferred conservation (erosion) problems at Fort Benning that resulted in serious degradation and restoration costs: Lorraine Road, before/after (a/b); Concord strip before/after (c/f); and Kelley Hill gully, before/after (e/f).

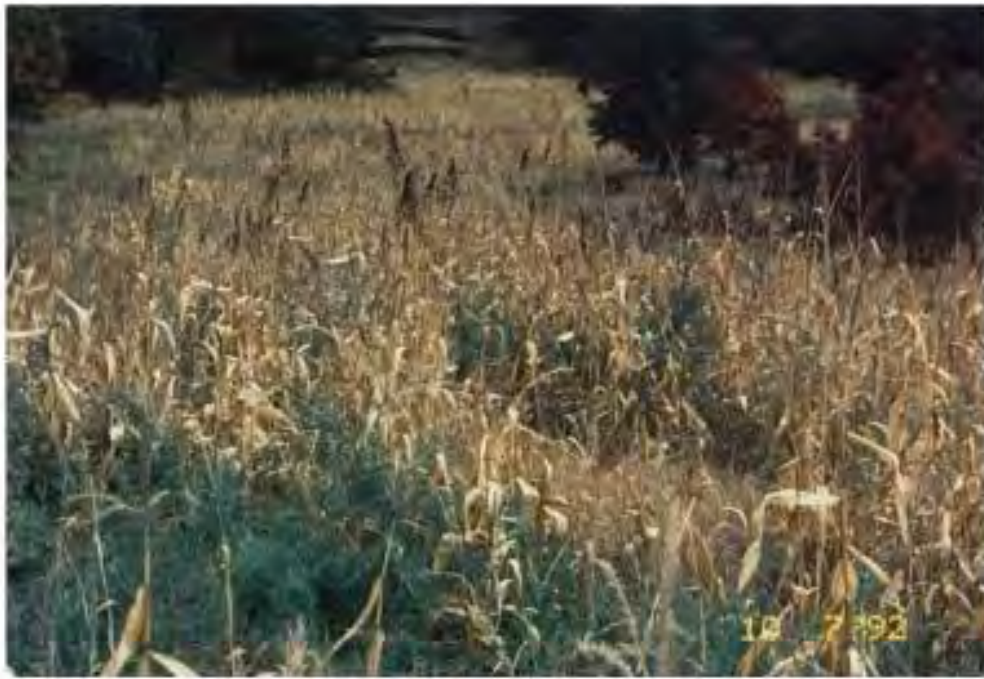
Figure F-5. For establishing perennials in difficult sandy soils, use large grain (corn, sorghum) as a nurse crop. It conserves moisture and provides microclimate.

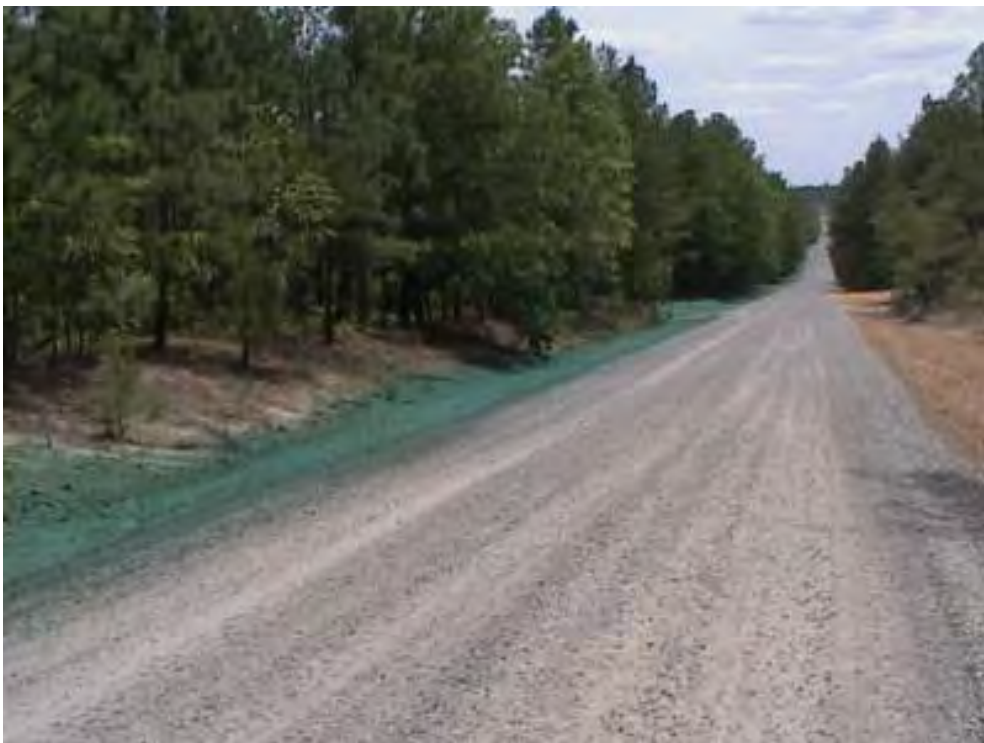
Figure F-6. Often hydroseeding may be the only Army CARES option for seeding steep slopes and narrow, long road shoulders.

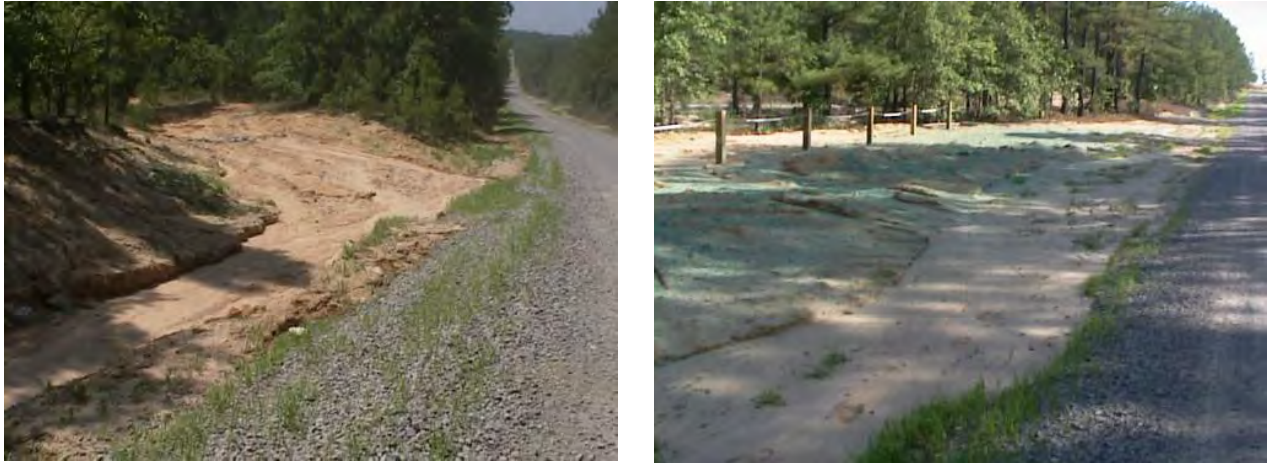
Figure F-7. In surface runoff and sediment problems, attack the source (origin, left) before implementing control measures (right) because it pays to "nip the evil in the bud."

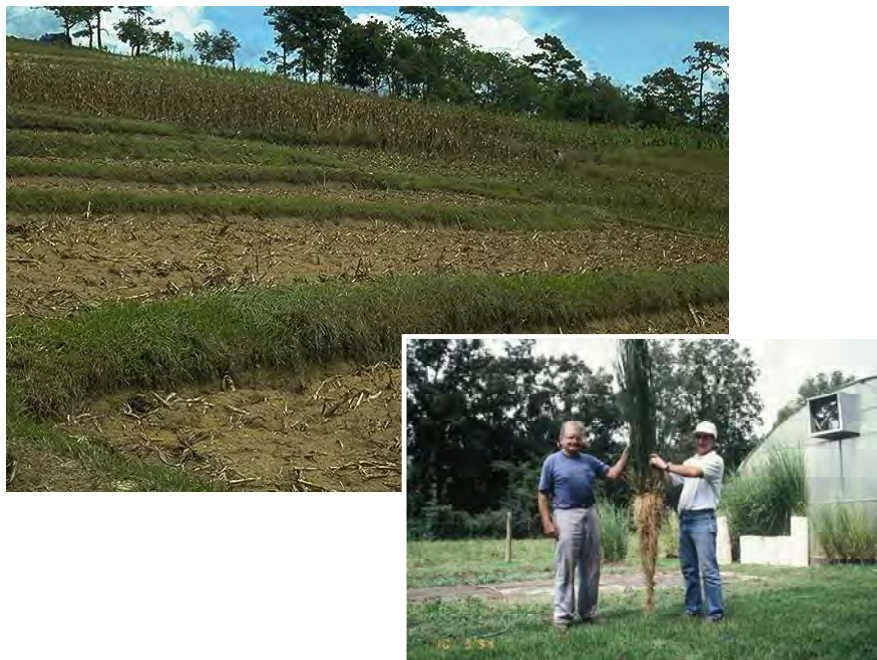
Figure F-8. Vegetative contour hedges act as bio-terraces, and are unparalleled in stormwater harvesting; they are cost-effective, self-healing, mission compatible, visually appealing, and an excellent choice for concealment islands.

Standard practices include the use of riprap or similar type check dams and sediment basins, respectively. Both of these practices are expensive and sometimes may conflict with the mission. Both objectives can be realized by establishing vegetative hedgerows, also known as contour hedges, as shown in Figures F-5 to F-8.

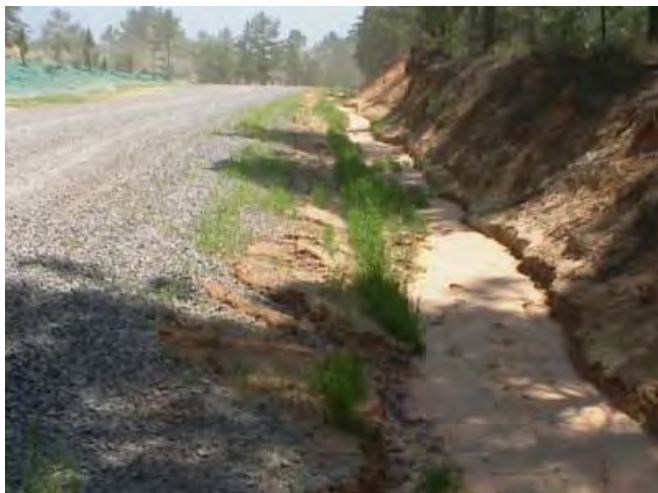
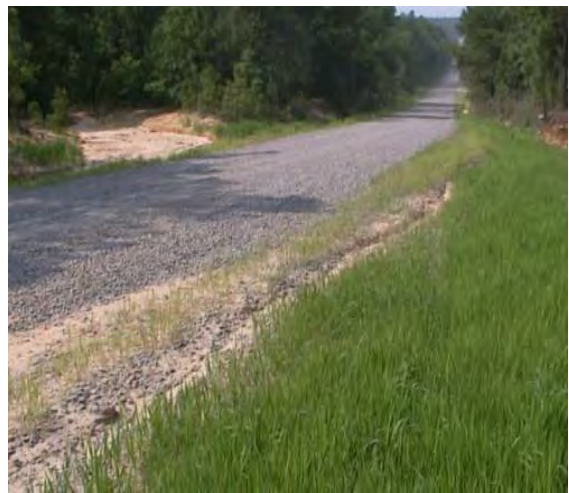
Figure F-9. Many revegetation failures can be traced to simple neglect, e.g., failure to construct check dams (left) or rill erosion (right).

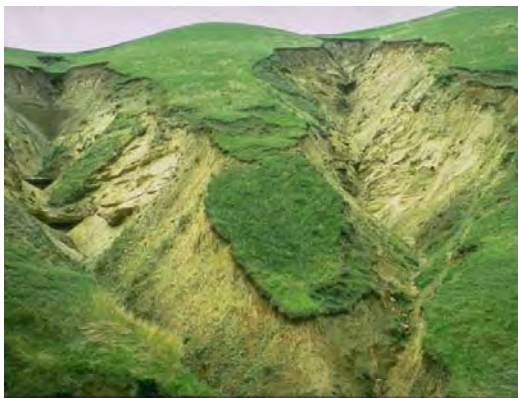
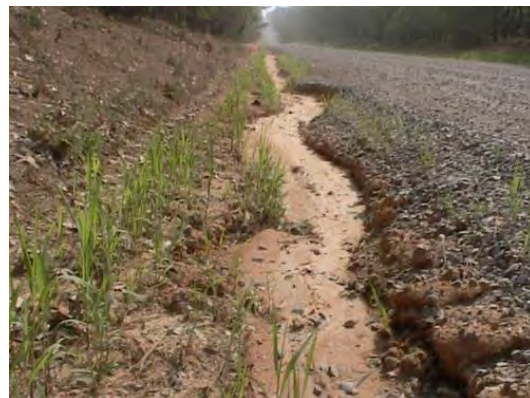
Figure F-10. Vegetative control measures are not a cure-all for all erosion problems, e.g., Fort Bragg gully erosion (left) and McKellers Road erosion, Fort Bragg (right).
