Techniques for the Seismic Rehabilitation of Existing Buildings

FEMA 547/2006 Edition

FEMA 547 – October 2006

Rutherford & Chekene (R & C) Consulting Engineers (Subconsultant) under contract with National Institute of Standards and Technology (NIST).

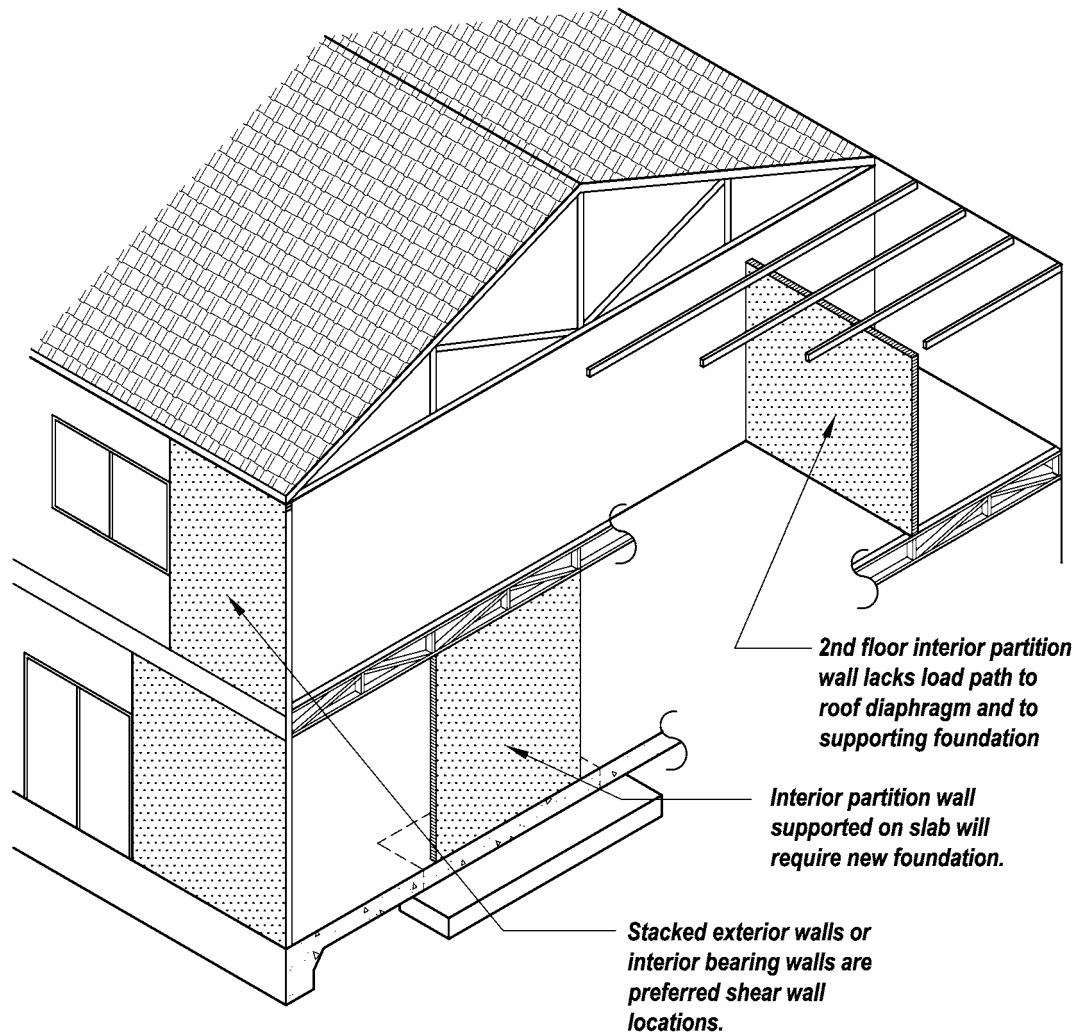
Figure 5.4.1-2: Preferred and Less Preferred Shear Wall Locations

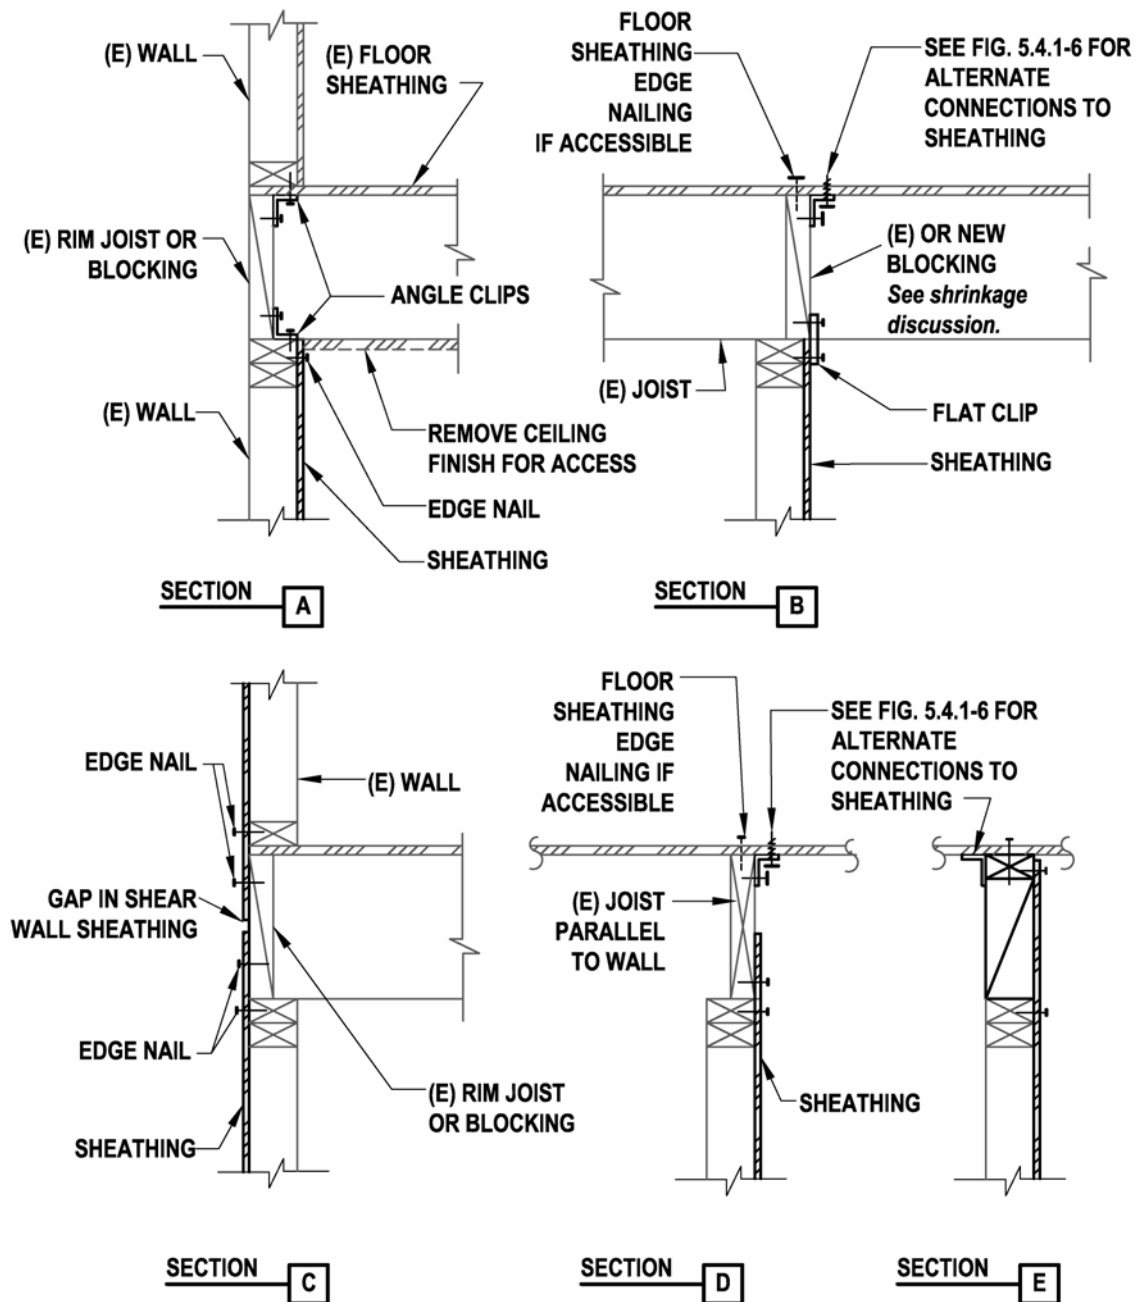
Figure 5.4.1-7: Load Path From Floor Diaphragm to Lower Story Shear Wall

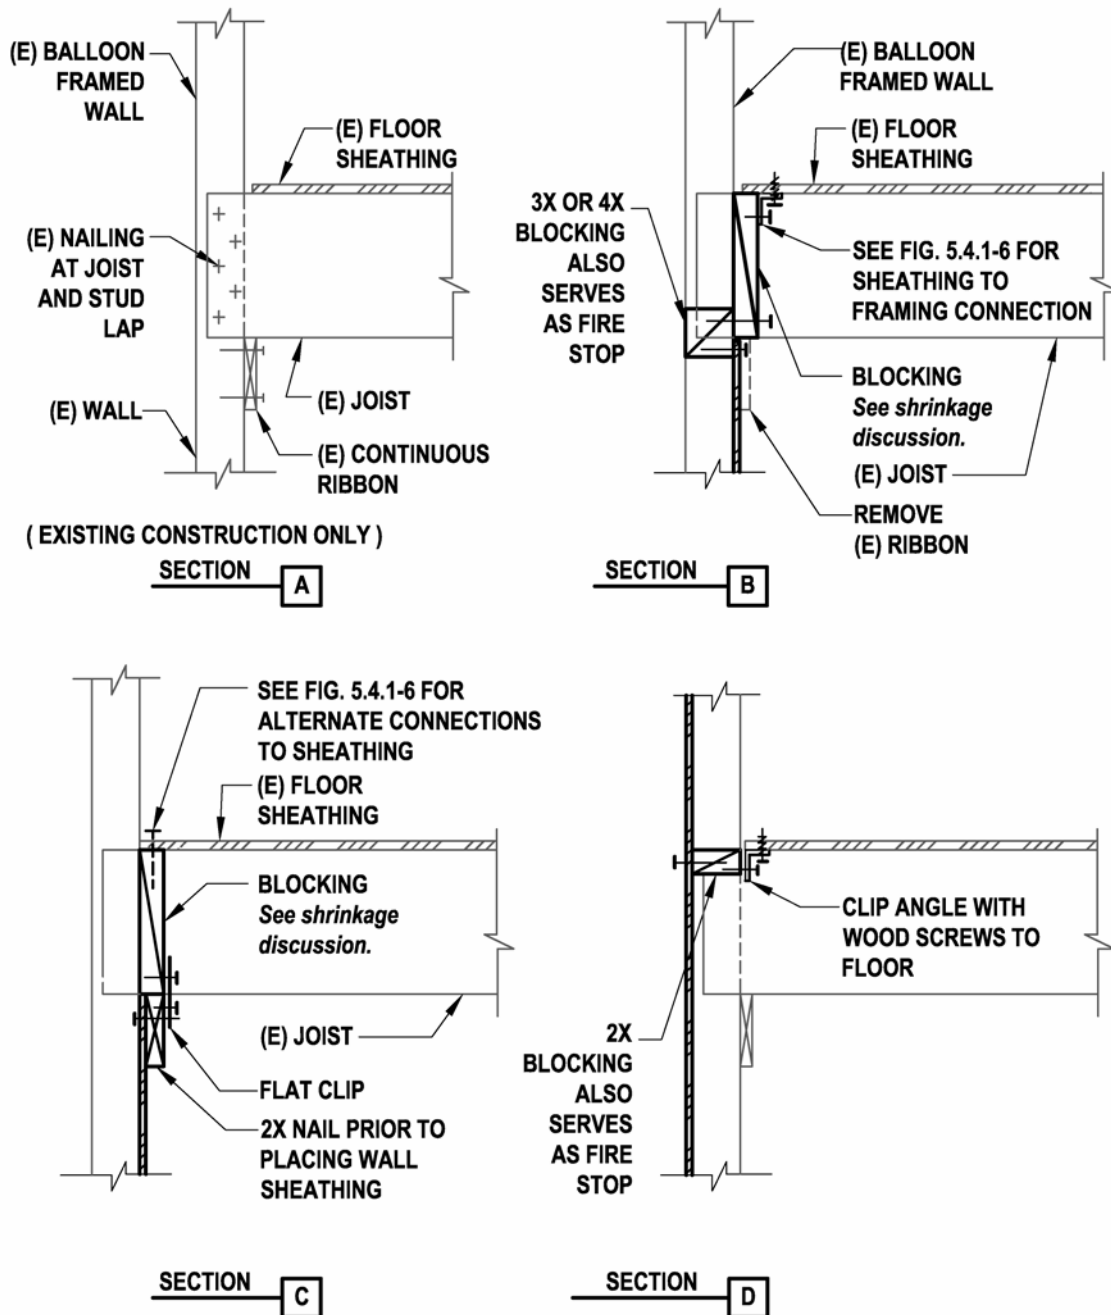
Figure 5.4.1-8: Load Path From Floor Diaphragm to Lower Story Shear Wall – Balloon Framing

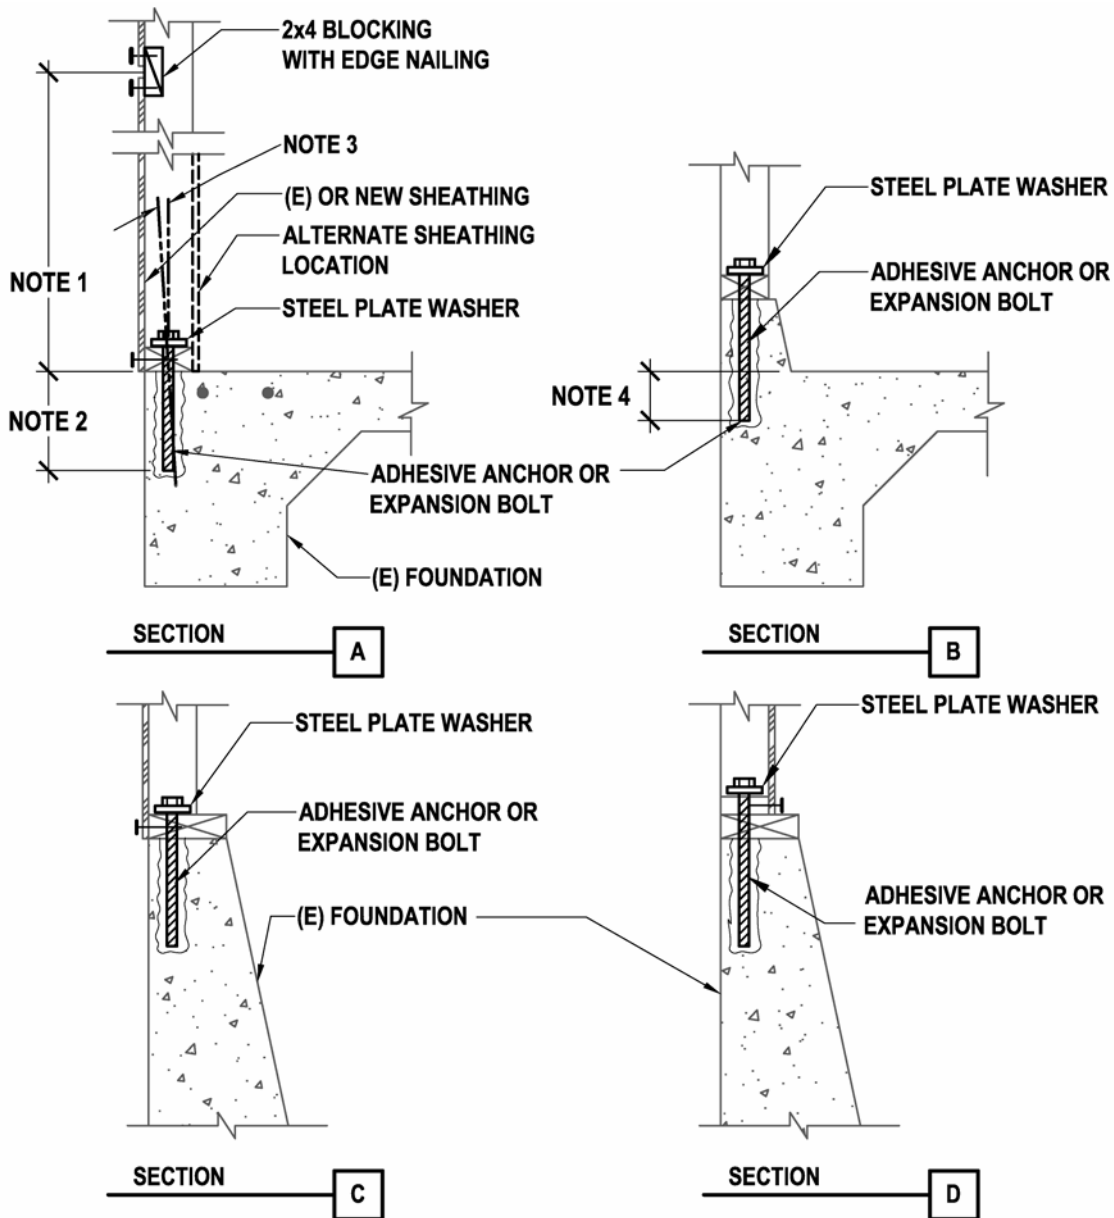
Figure 5.4.3-2: Added Anchor Bolt at Existing Partially Grouted Concrete Masonry Foundation

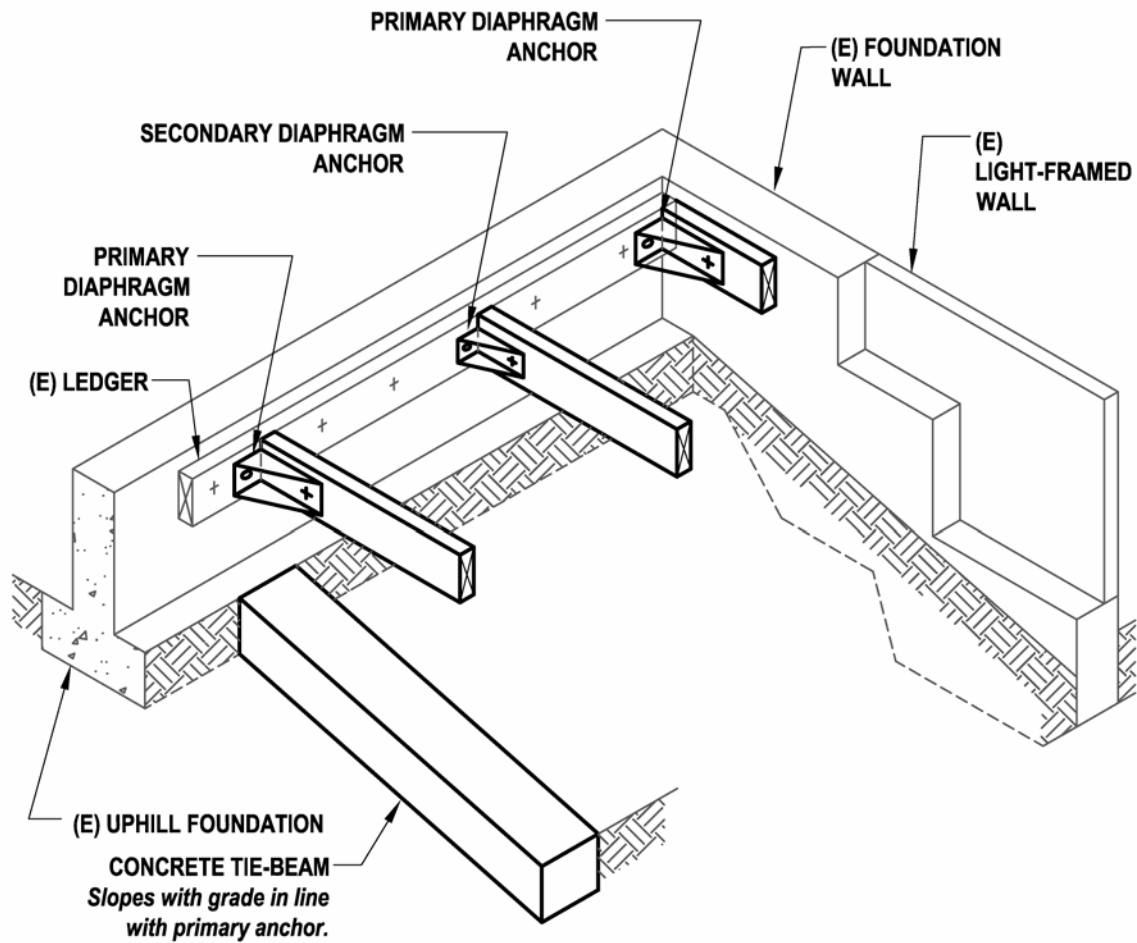
Note. Diaphragm anchor prevents existing ledger from pulling off at uphill foundation.

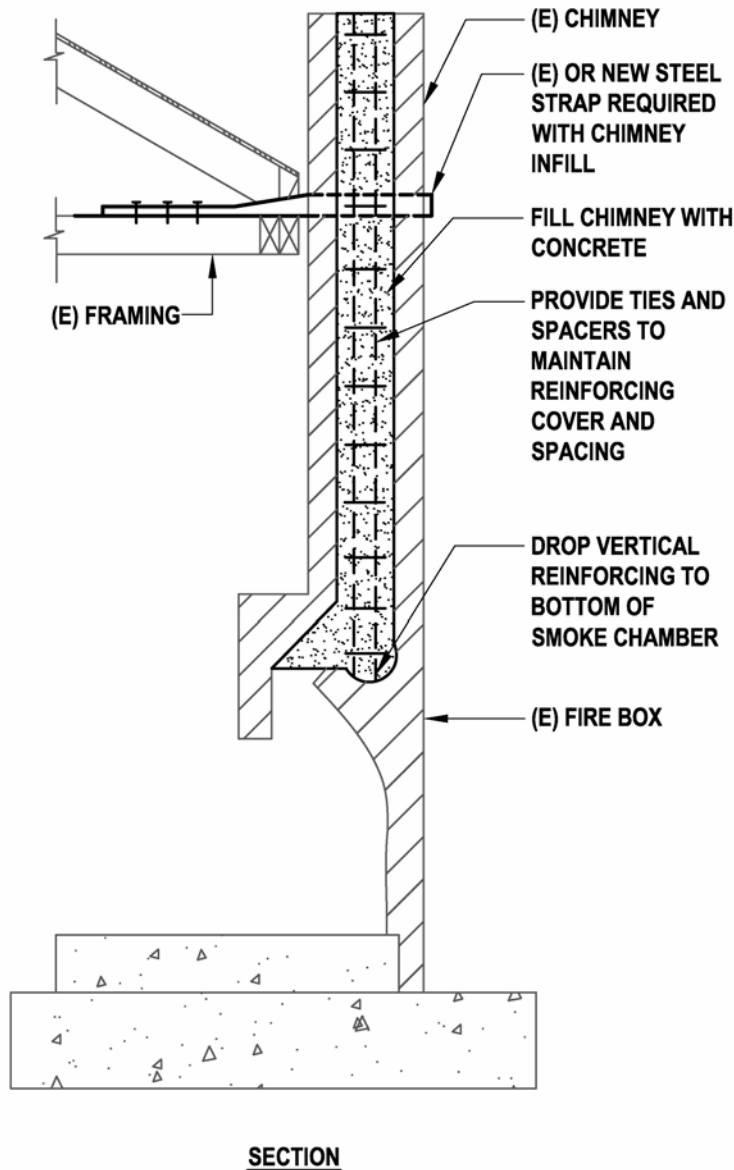
Figure 5.4.6-1: Infill and Bracing of Masonry Chimney

stiffness continuity at the commonly seen weak points (roof line and transitions in width). Filling the chimney may reduce, but is unlikely to eliminate damage. This rehabilitation measure is most often used for buildings of historical significance where there is a strong desire to maintain the current appearance. In some cases the height of very tall chimneys are reduced prior to filling with concrete. Use on chimneys already in poor condition due to deterioration or foundation movement is not recommended. Placement of grout between the flue liner and masonry is also recommended where this grout is completely missing or has significant gaps.

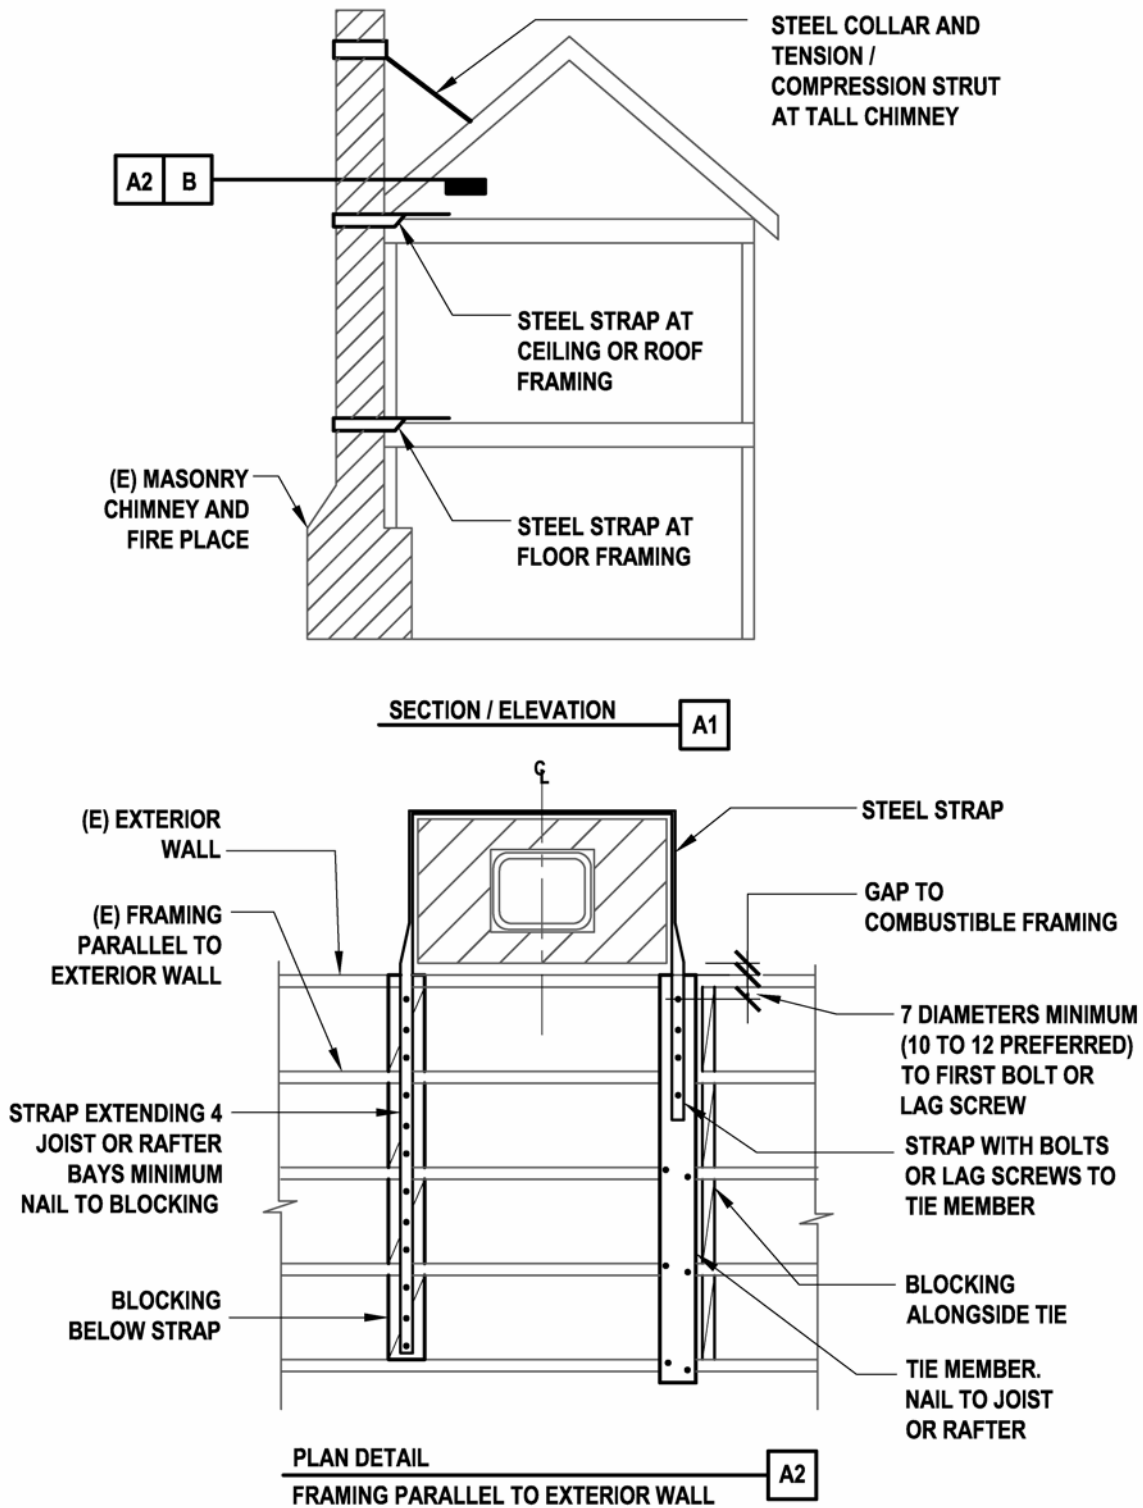
Figure 5.4.6-2A: Bracing of Masonry Chimney

Anchorage of a strap or other tie to an existing masonry chimney should be avoided where possible and otherwise approached with caution. Expansion anchors cause splitting tensile stresses that can result in cracking of the masonry. Adhesive anchors change properties under elevated temperatures that might be experienced during use of the chimney.

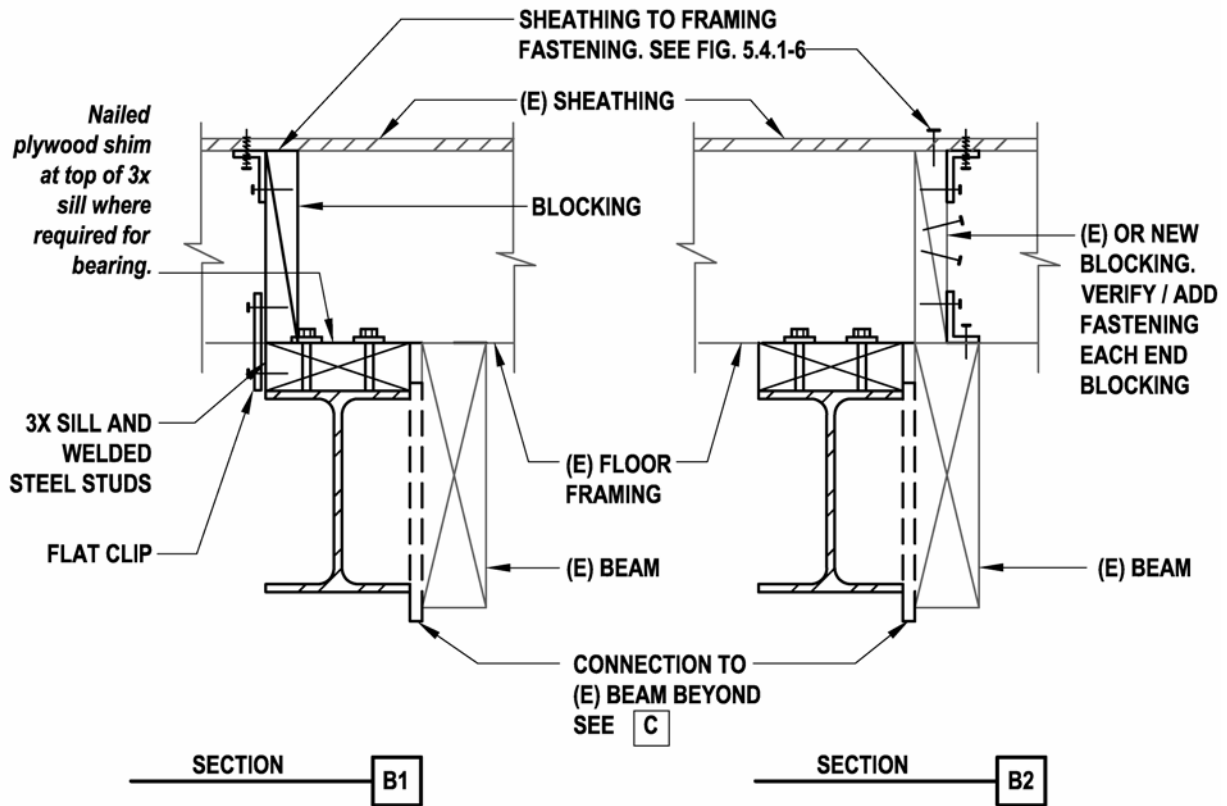
Figure 6.4.1-1B: Shear Transfer Between Moment Frame Beam and Diaphragm

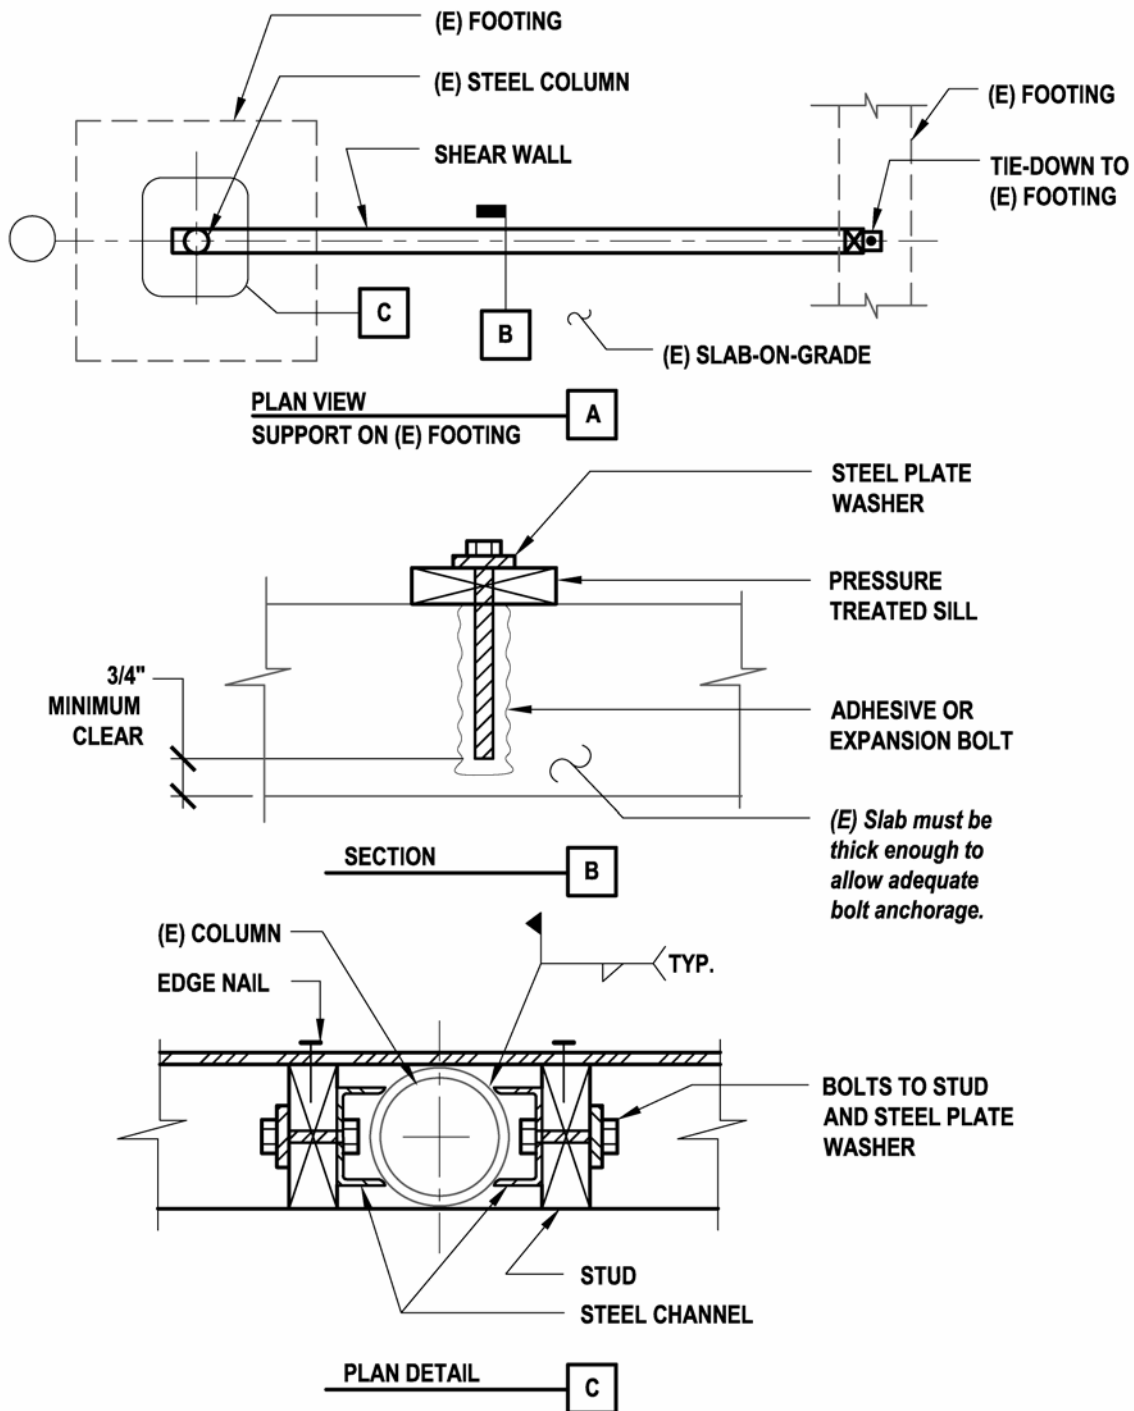
Note: This approach is only applicable where the slab-on-grade is thick enough to permit installation of anchor bolts, and where there will not be regular moisture exposure (such as garage floor). Do not use powder-driven fasteners.

Figure 6.4.2-1 shows a shear wall located so that it can use the dead load carried by a building column to resist uplift at the left hand side and an existing bearing wall foundation at the right

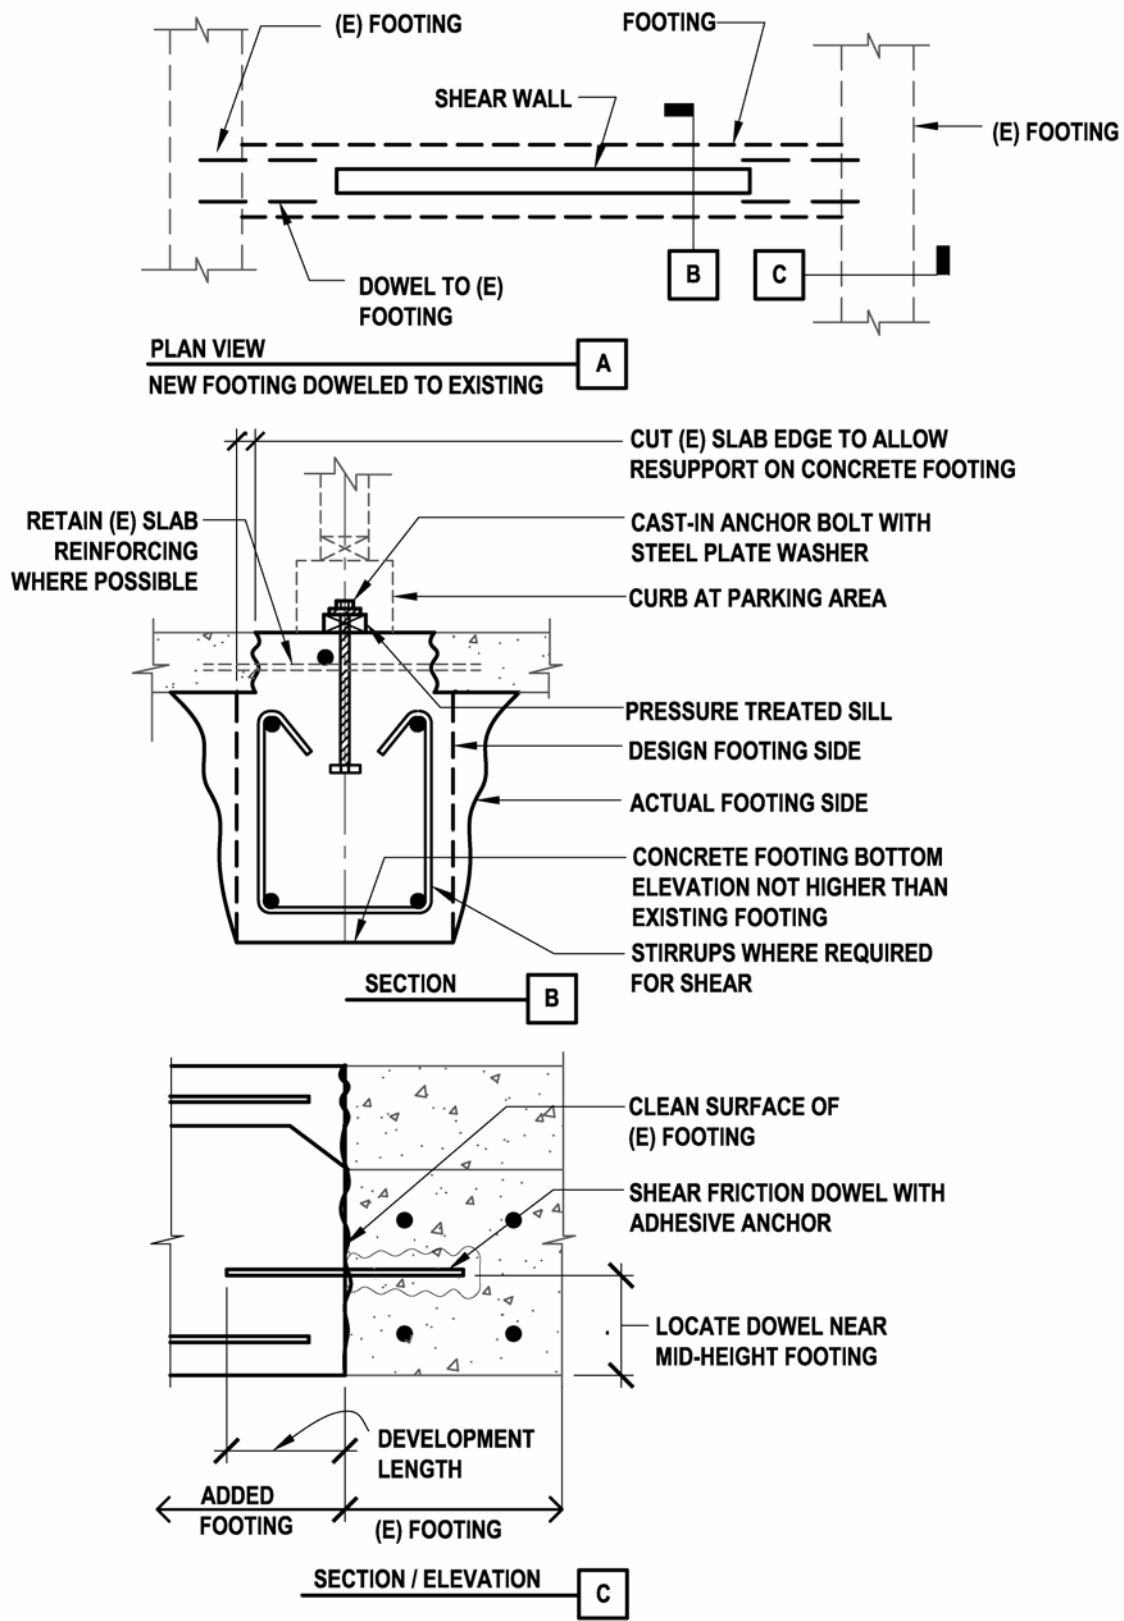
Figure 6.4.2-2: Added Shear Wall Supported by New and Existing Footings

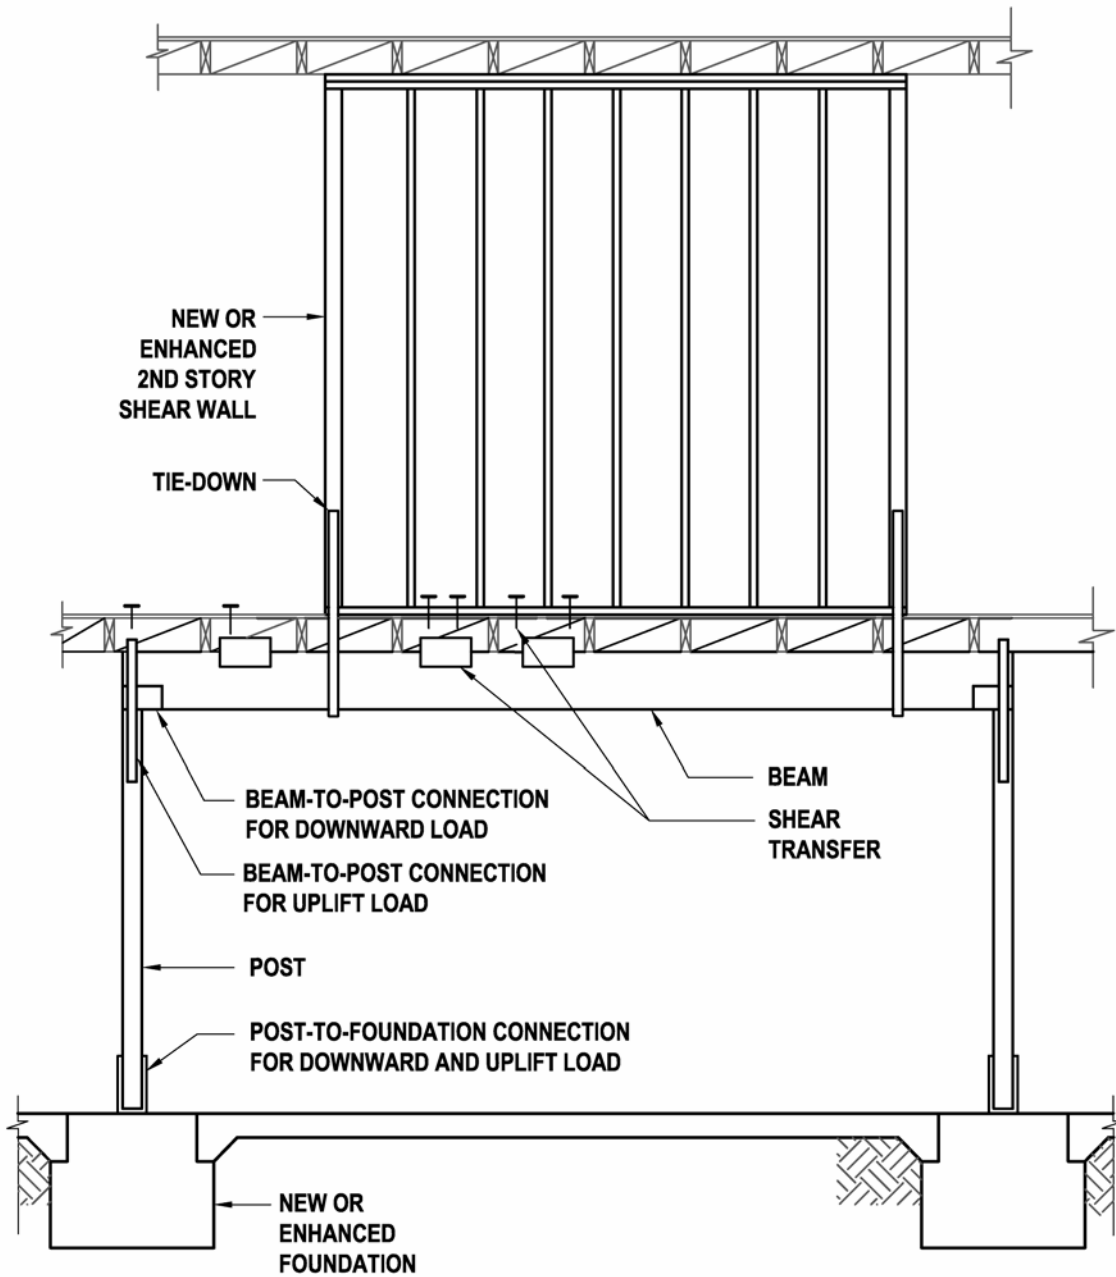
Note: Evaluation of beam, post, beam-to-post and post-to-foundation connections is for force-controlled actions; design is for over-strength load combinations.

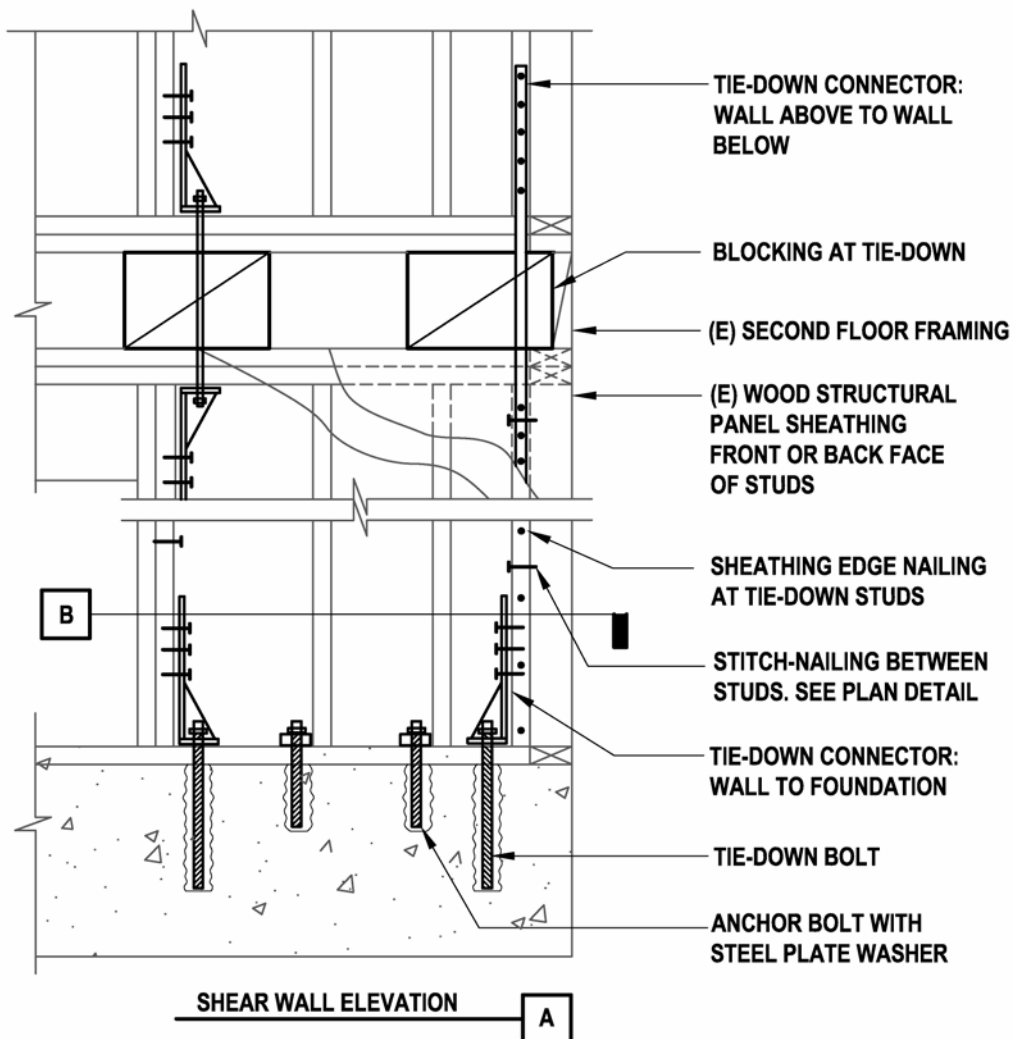
Figure 6.4.4-1A: Shear Wall Elevation with Enhanced Overturning Detailing

Figure 6.4.4-1A illustrates a shear wall elevation with commonly used tie-down connectors for a slab-on-grade condition. Figure 6.4.4-1B illustrates fastening to develop a load path between the tie-down connector and the shear wall sheathing edge nailing. For sheathing and framing conditions other than those shown, similar fastening must be provided to complete the load path.

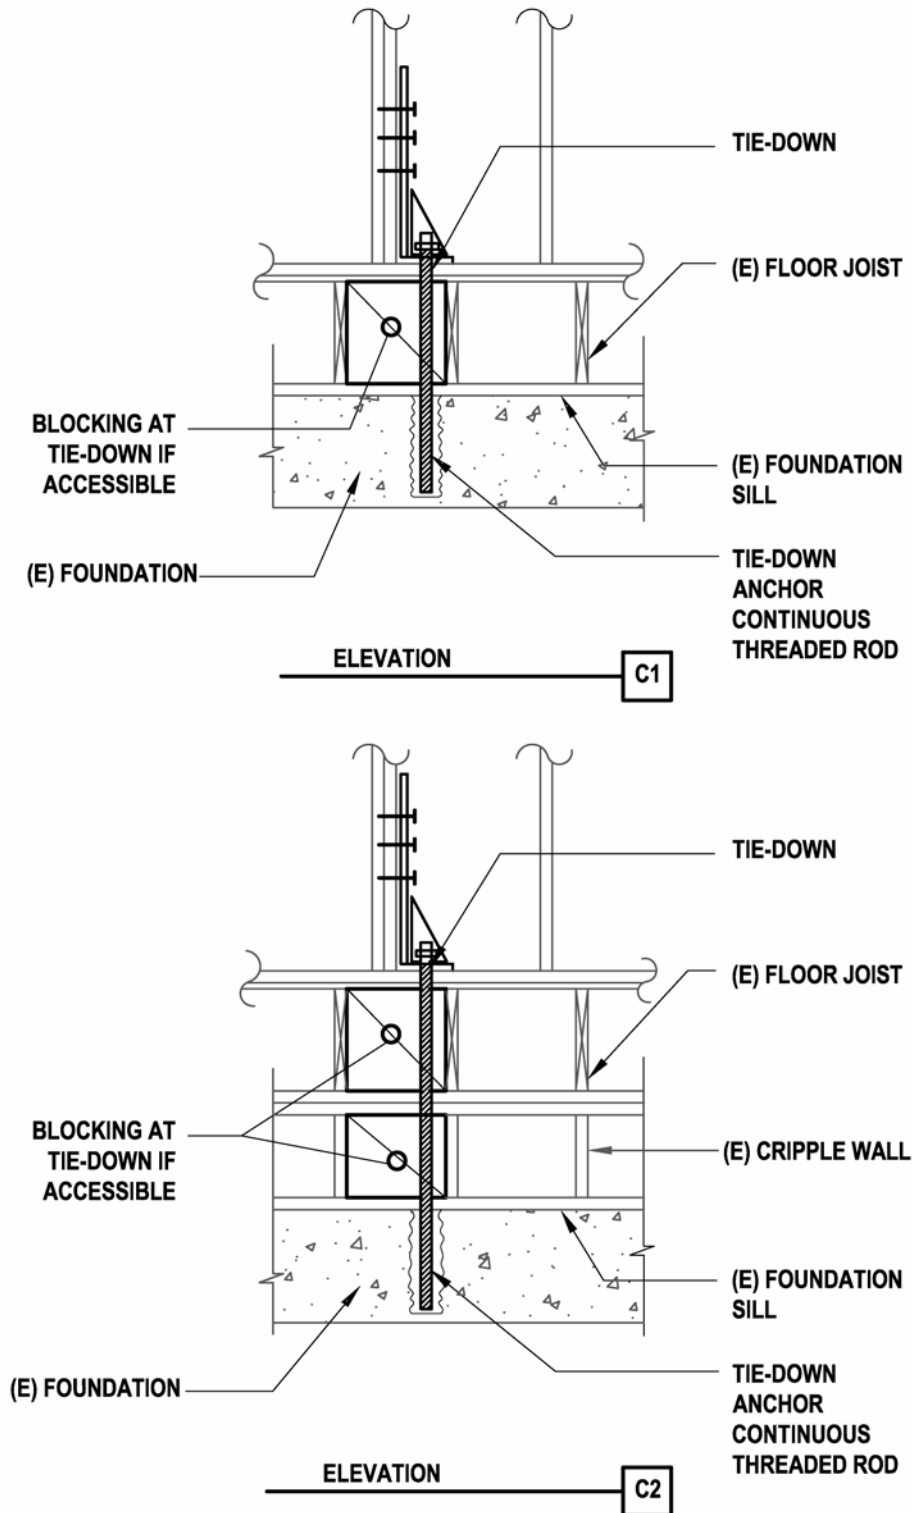
Figure 6.4.4-1C: Tie-down Details at Alternate Base Conditions

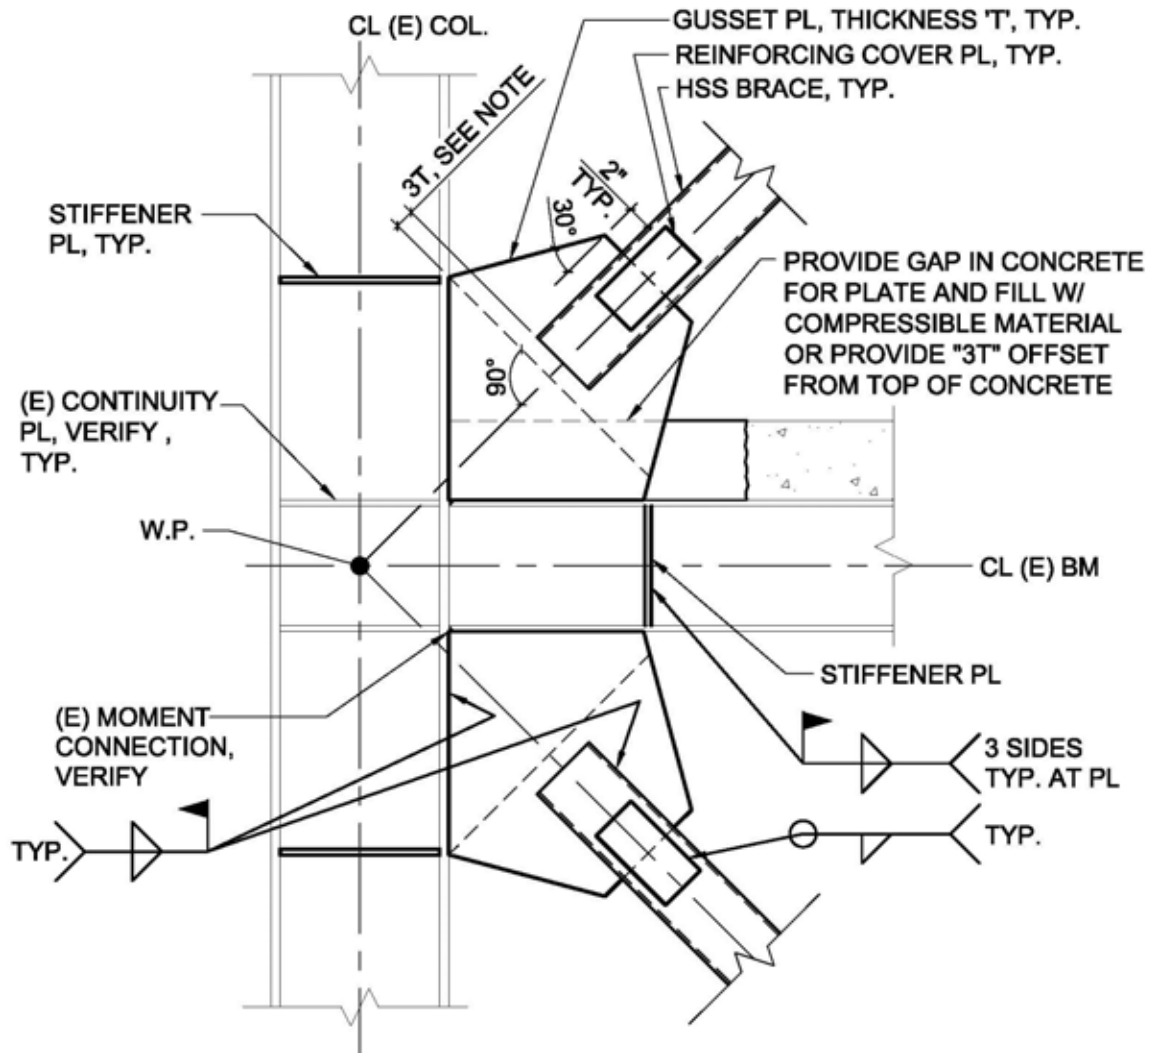
Note:
AISC recommends $2T$ to allow for restraint-free plastic rotations.
 $3T$ is shown here to accommodate overcutting of HSS slots.

Figure 8.4.1-1: HSS Brace at Existing Beam-Column Connection in SCBF

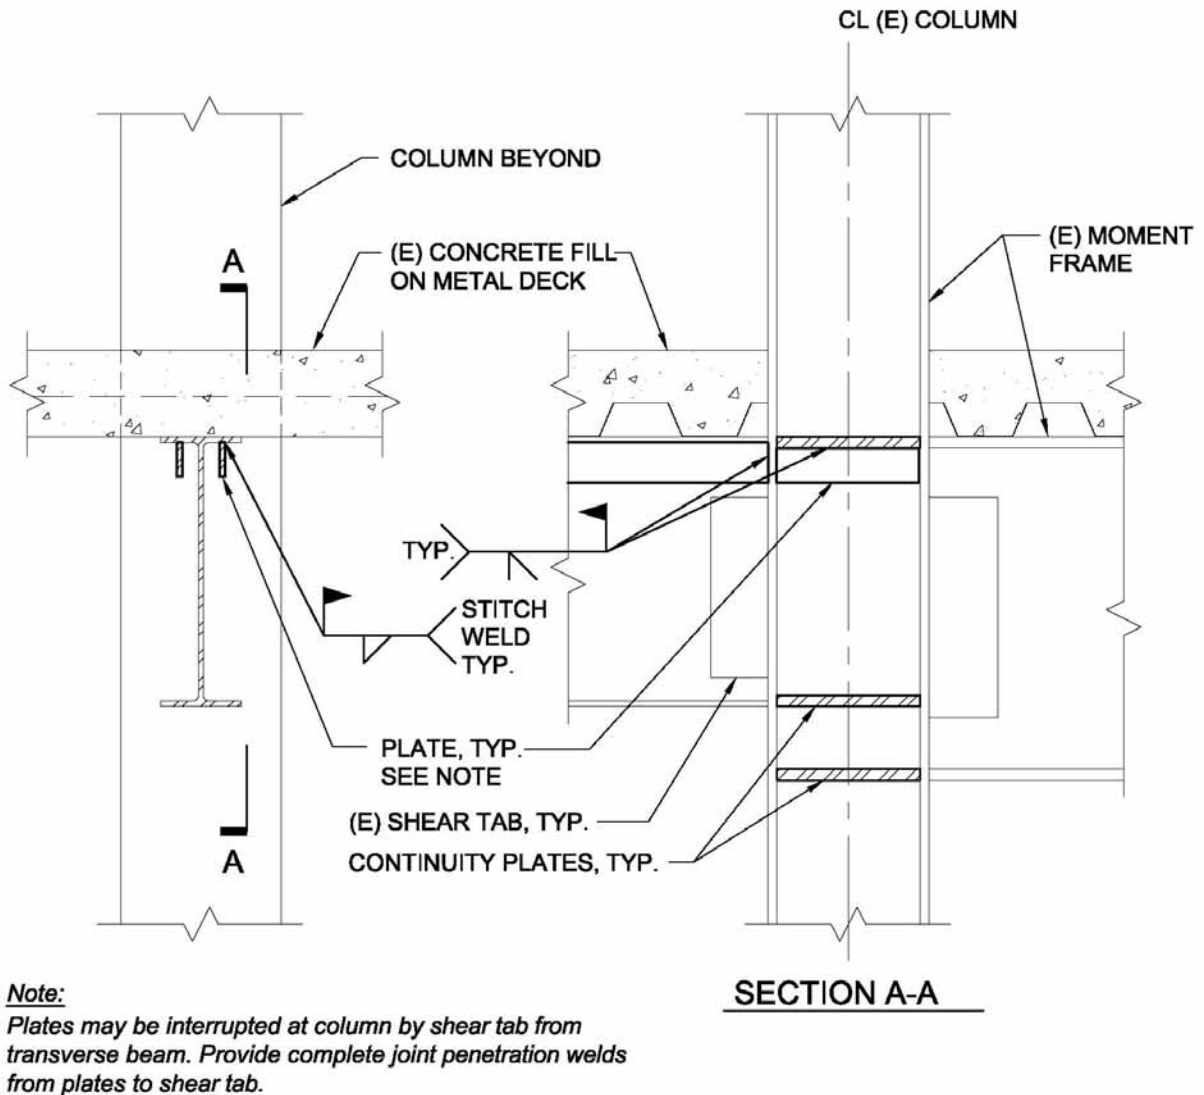
Figure 8.4.4-1: Plate Collectors at Existing Beam

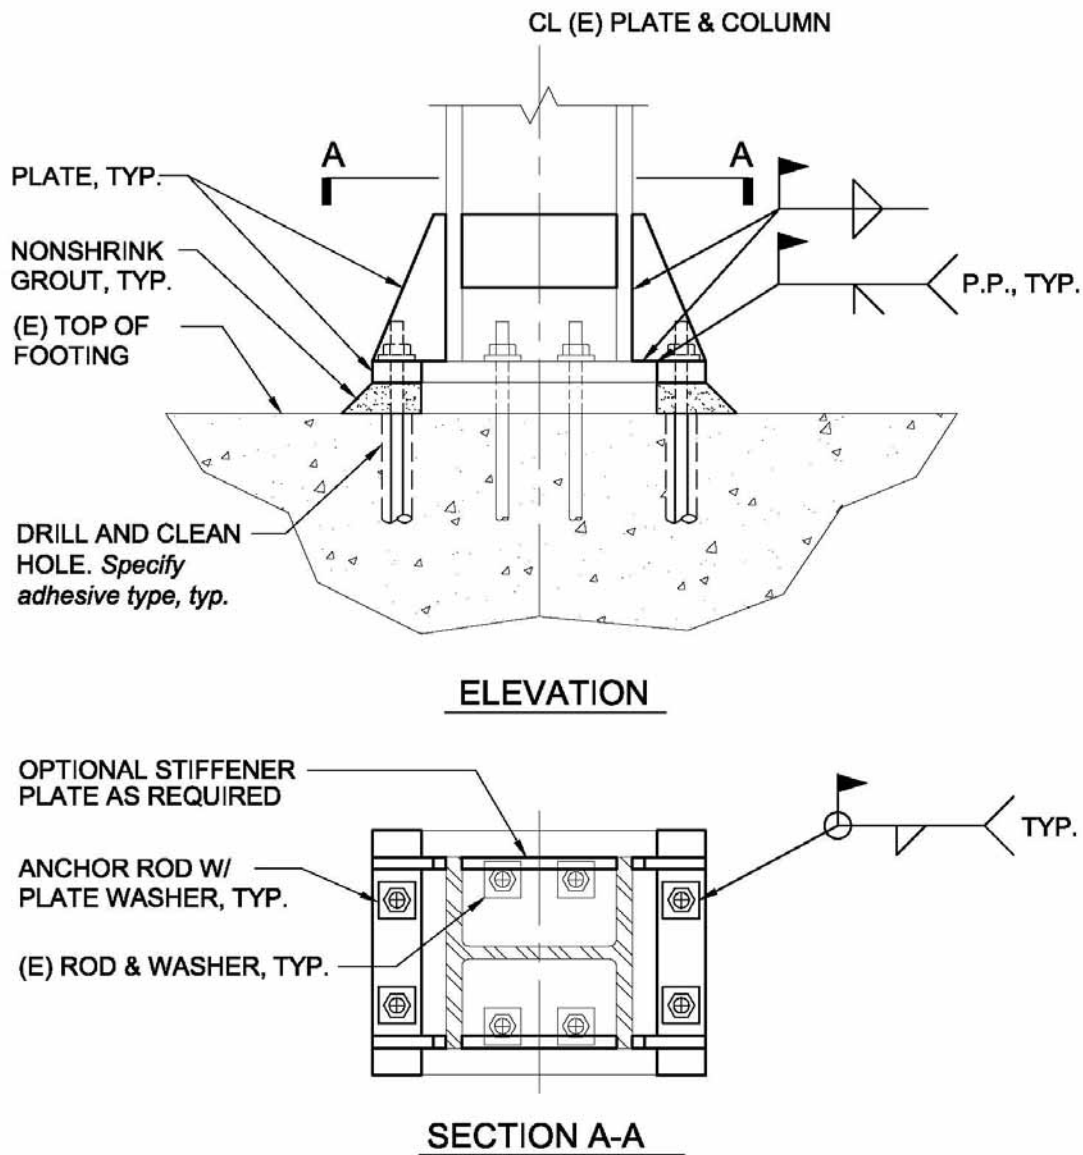
Figure 8.4.5-1: Modified Base Plate to Increase Uplift Capacity
