Techniques for the Seismic Rehabilitation of Existing Buildings

FEMA 547/2006 Edition

FEMA 547 – October 2006

Rutherford & Chekene (R & C) Consulting Engineers (Subconsultant) under contract with National Institute of Standards and Technology (NIST).

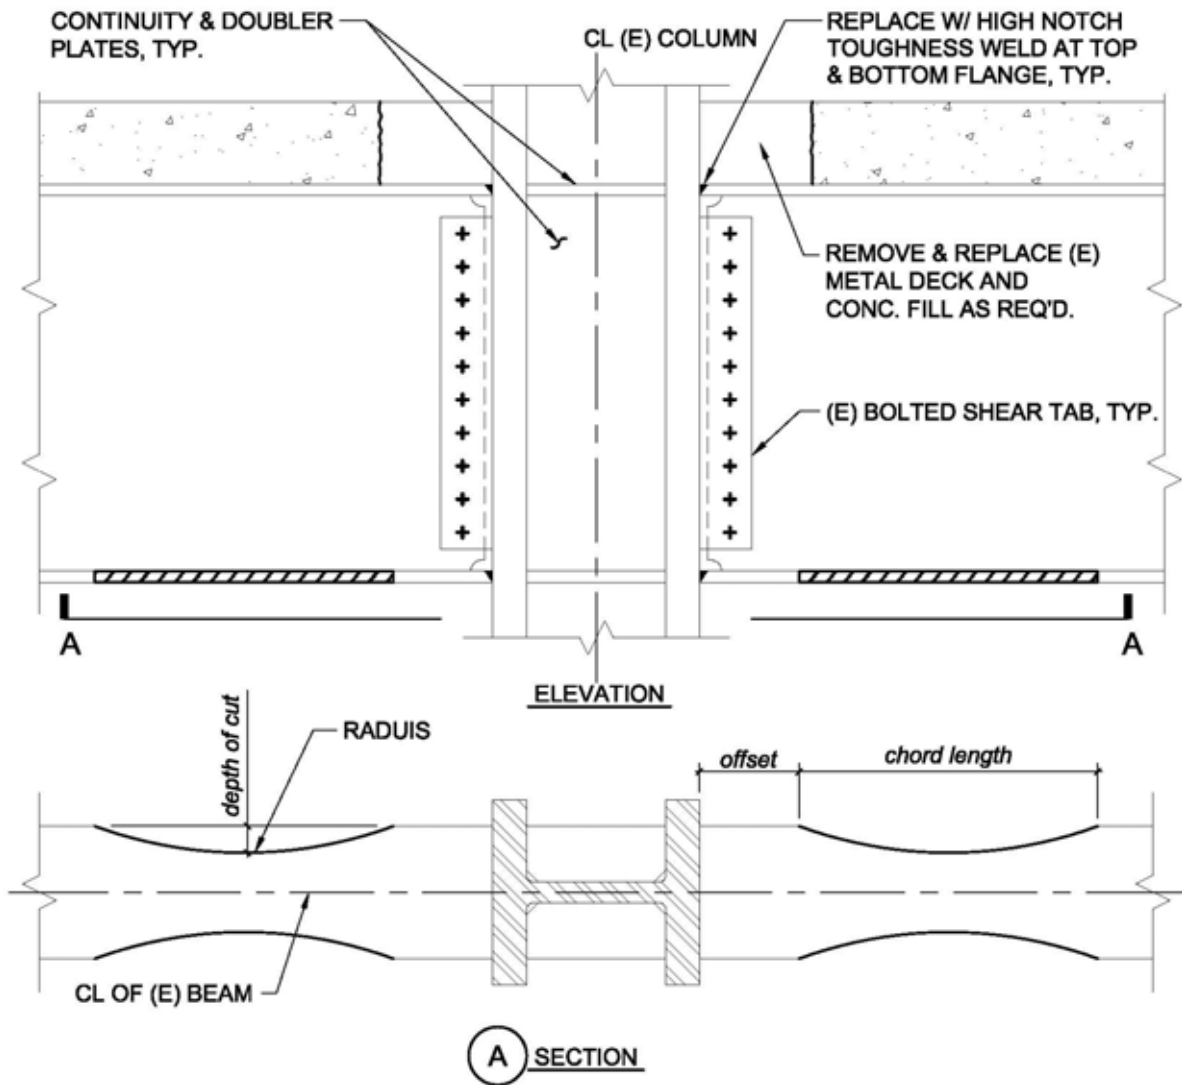
Figure 8.4.6-1: Reduced Beam Section at Bottom Flange of Existing Beam
(adapted from AISC Design Guide 12)

length of the cut should also be long enough to control the inelastic strains along the RBS. The radius of the cut is a function of its depth and the chord length. See *AISC Design Guide 12* for specific recommendations and guidelines for selecting these dimensions.

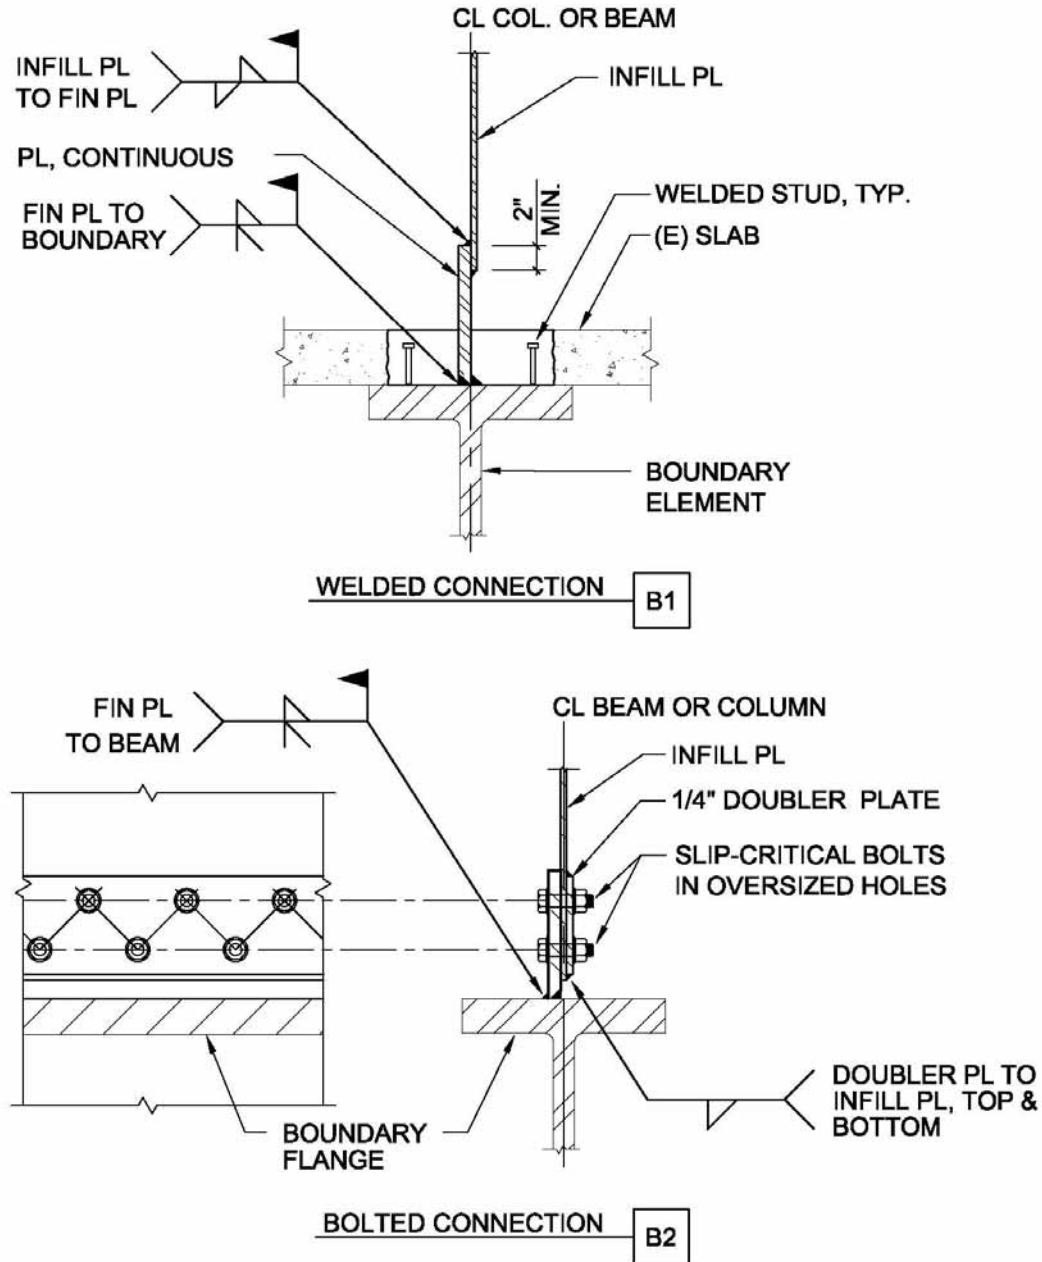
Figure 8.4.8-1B: Fin Plate Connection Options

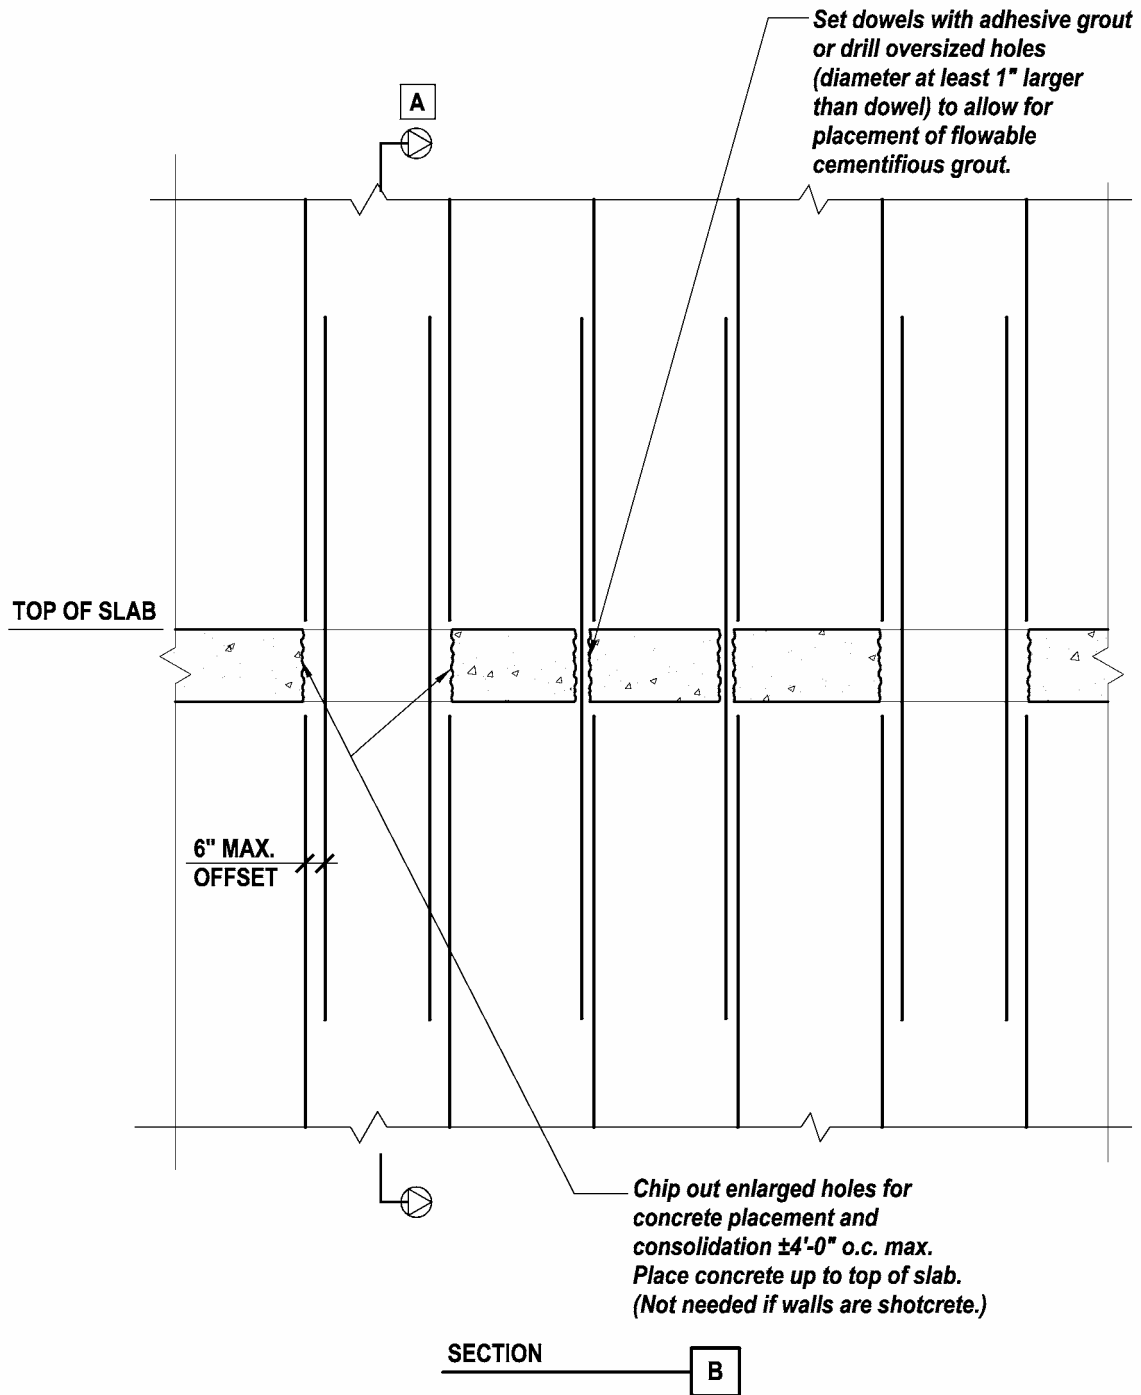
Figure 12.4.2-1B: Concrete Wall Connection to Concrete Slab – Partial Elevation View

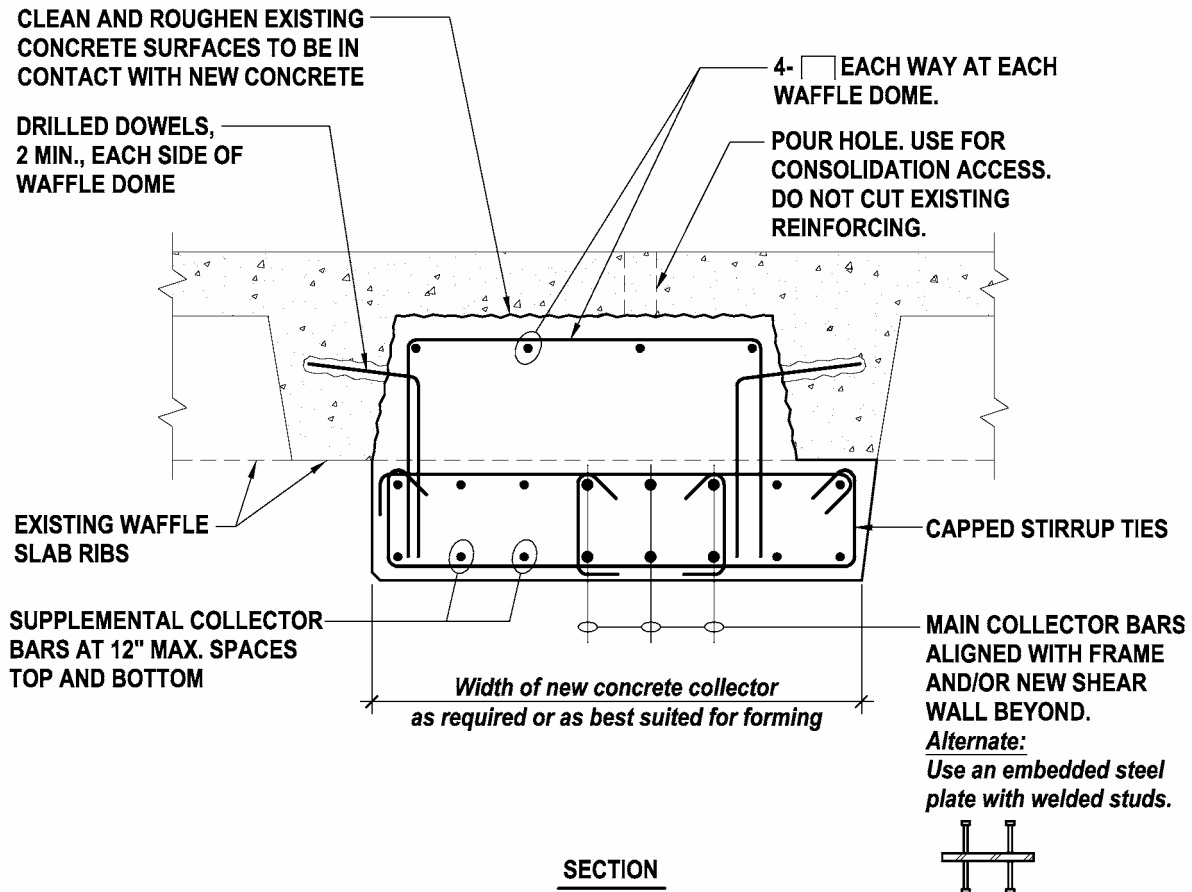
Figure 12.4.3-2: Concrete Collector at Waffle Slab

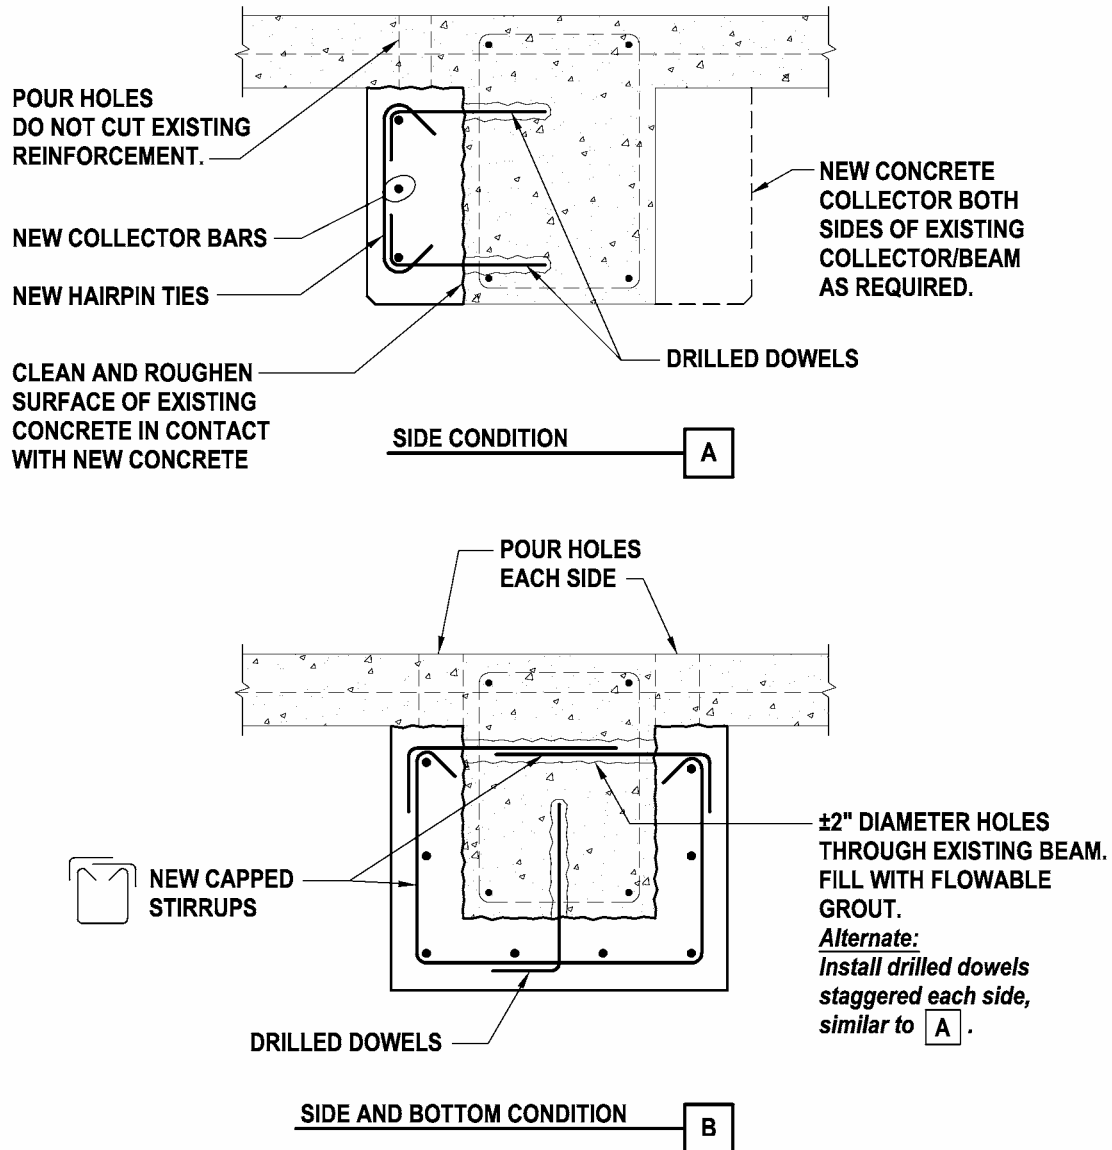
Figure 12.4.3-3: Concrete Collector at Existing Beam

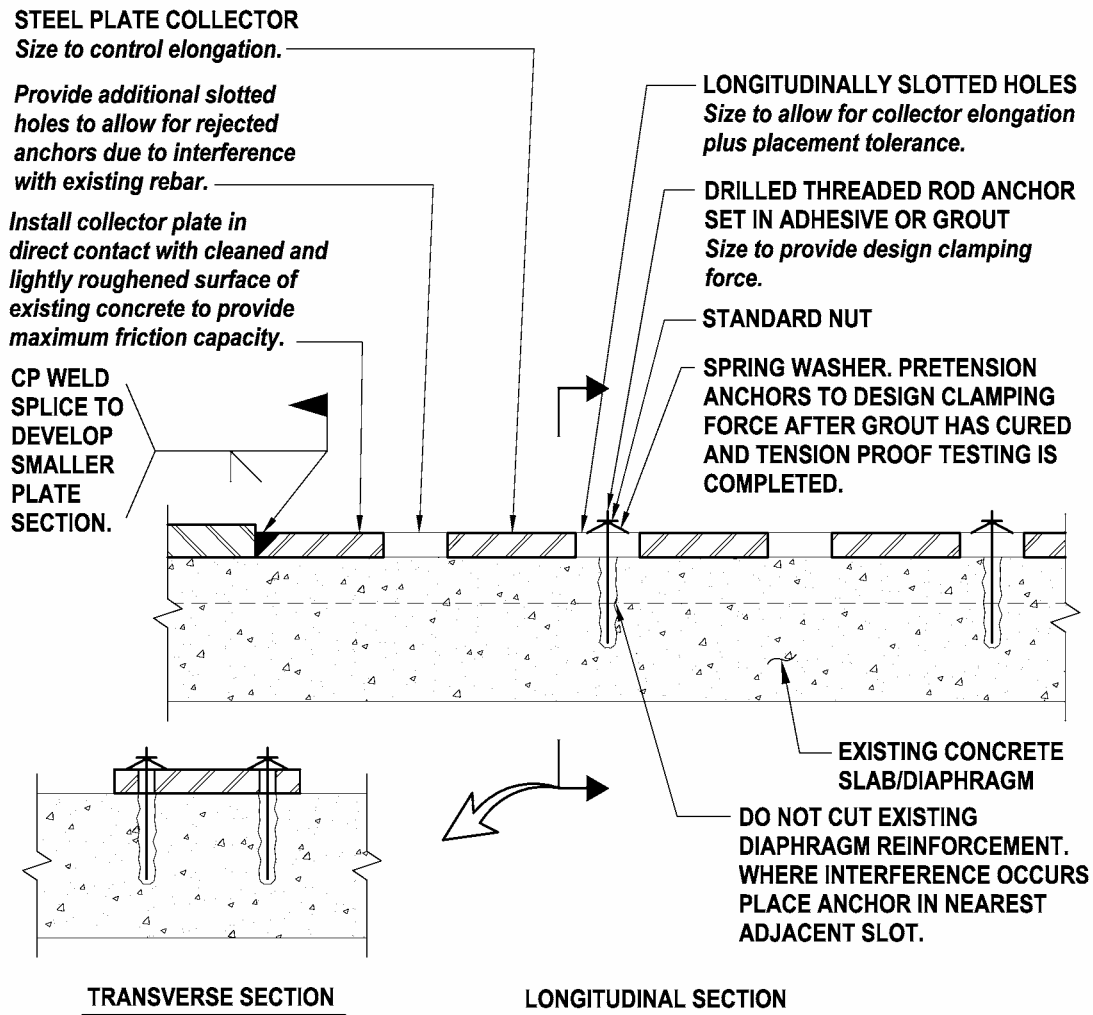
Figure 12.4.3-4: Steel Plate Collector

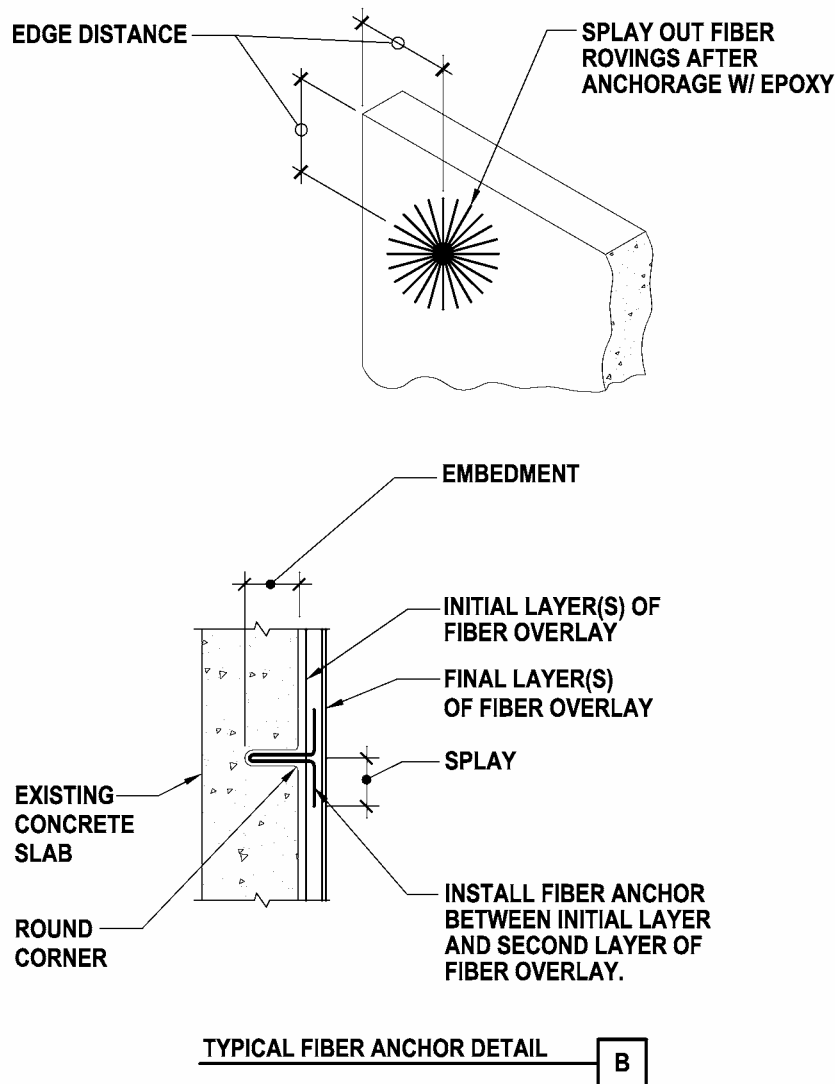
Figure 13.4.1-1B: Fiber Anchor Details

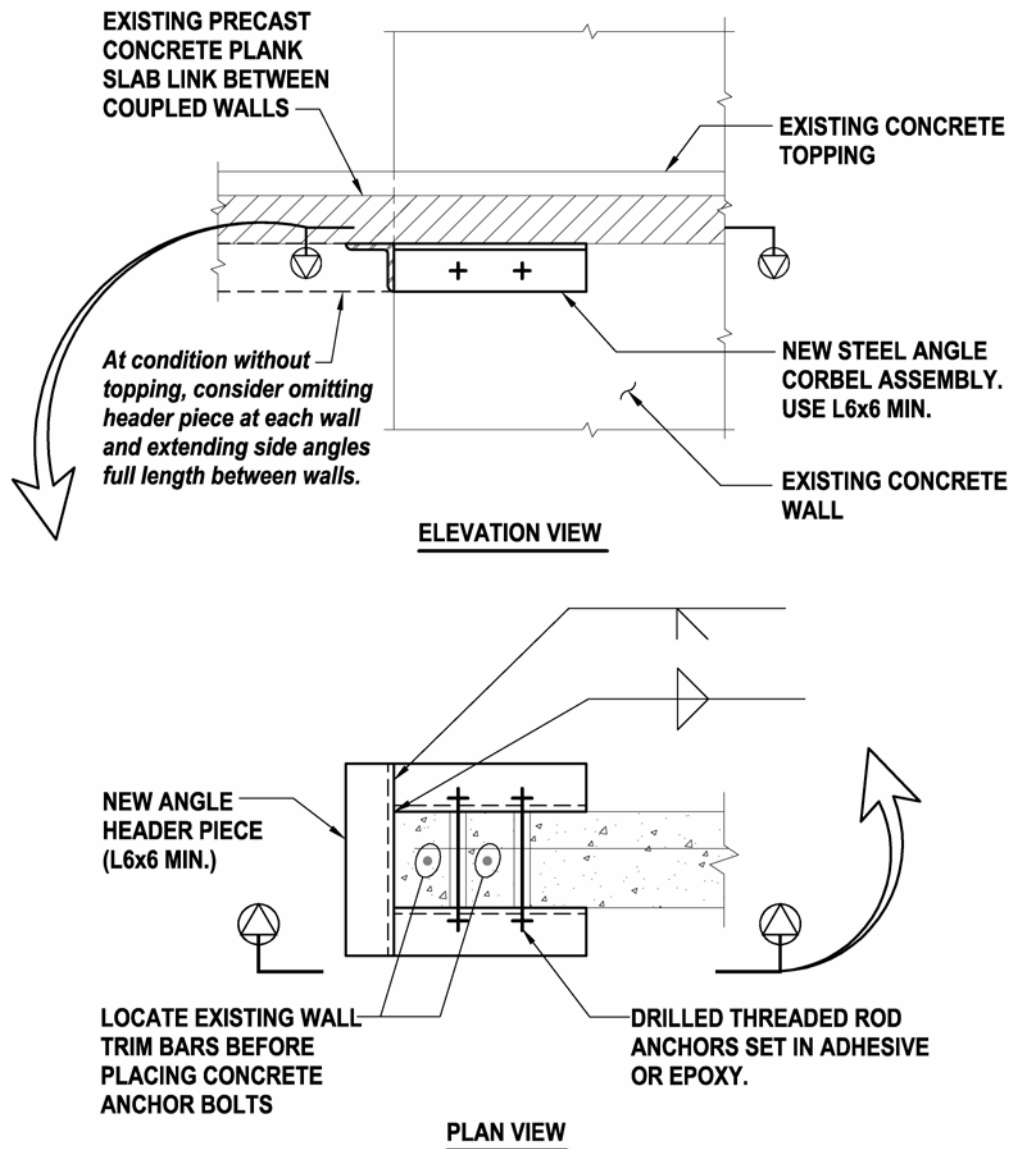
Figure 13.4.2-1: Typical Corbel at Linking Slab

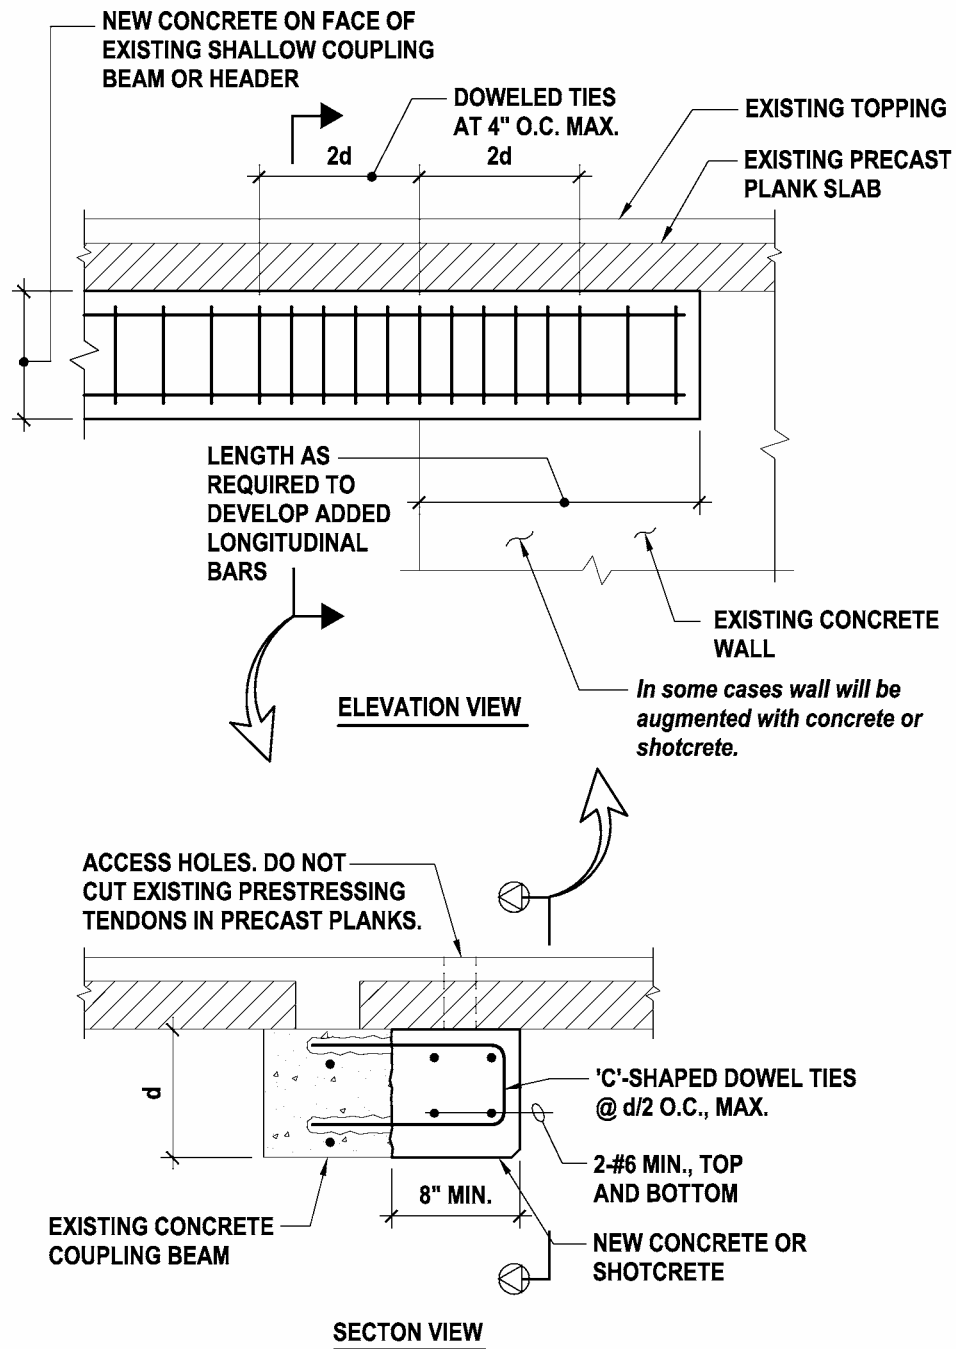
Figure 13.4.2-2: Typical Strengthening of Shallow Coupling Beam

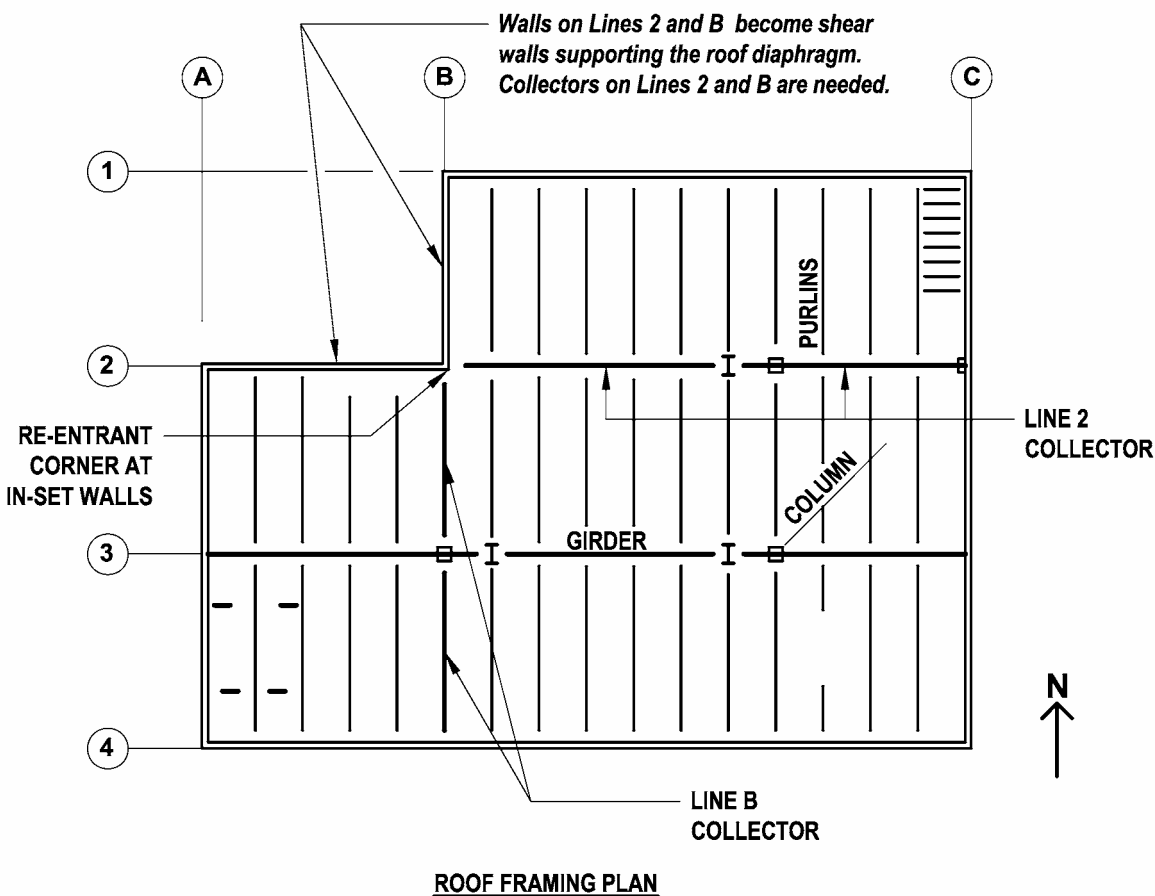
Figure 16.3-1: Plan of PC1 Building with Re-entrant Corner at In-Set Panels

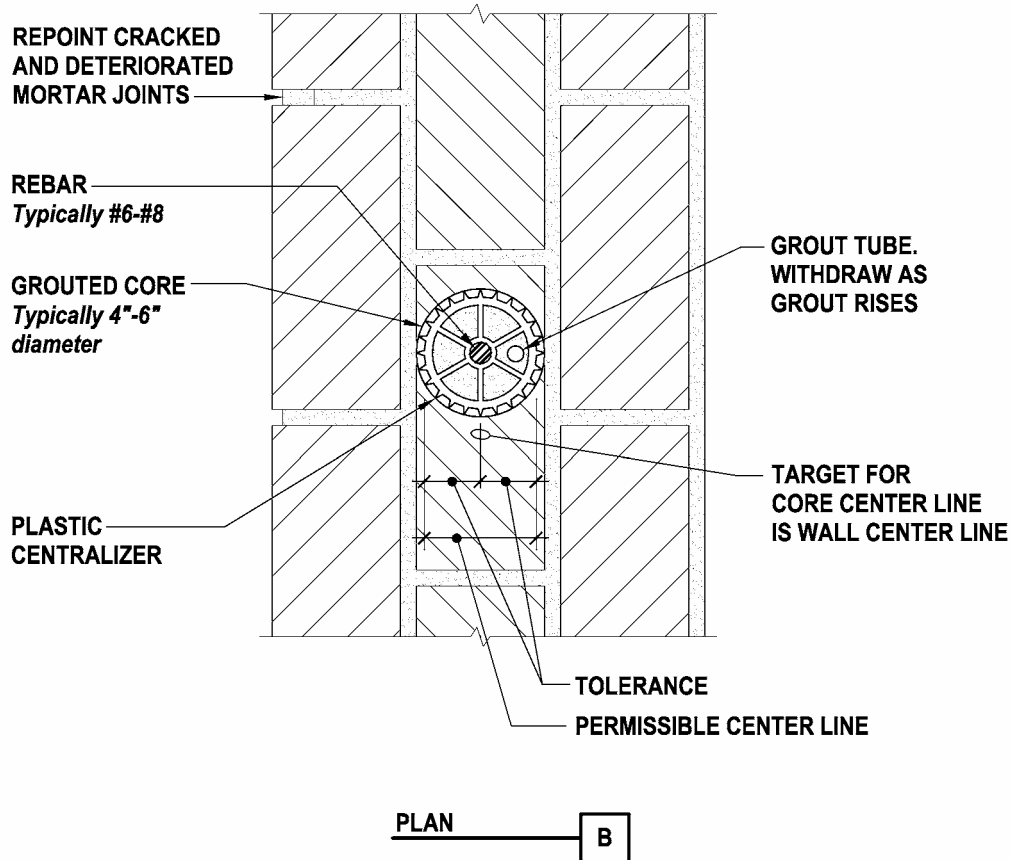
Figure 21.4.4-1B: Plan Detail of Reinforced Core in Masonry Wall

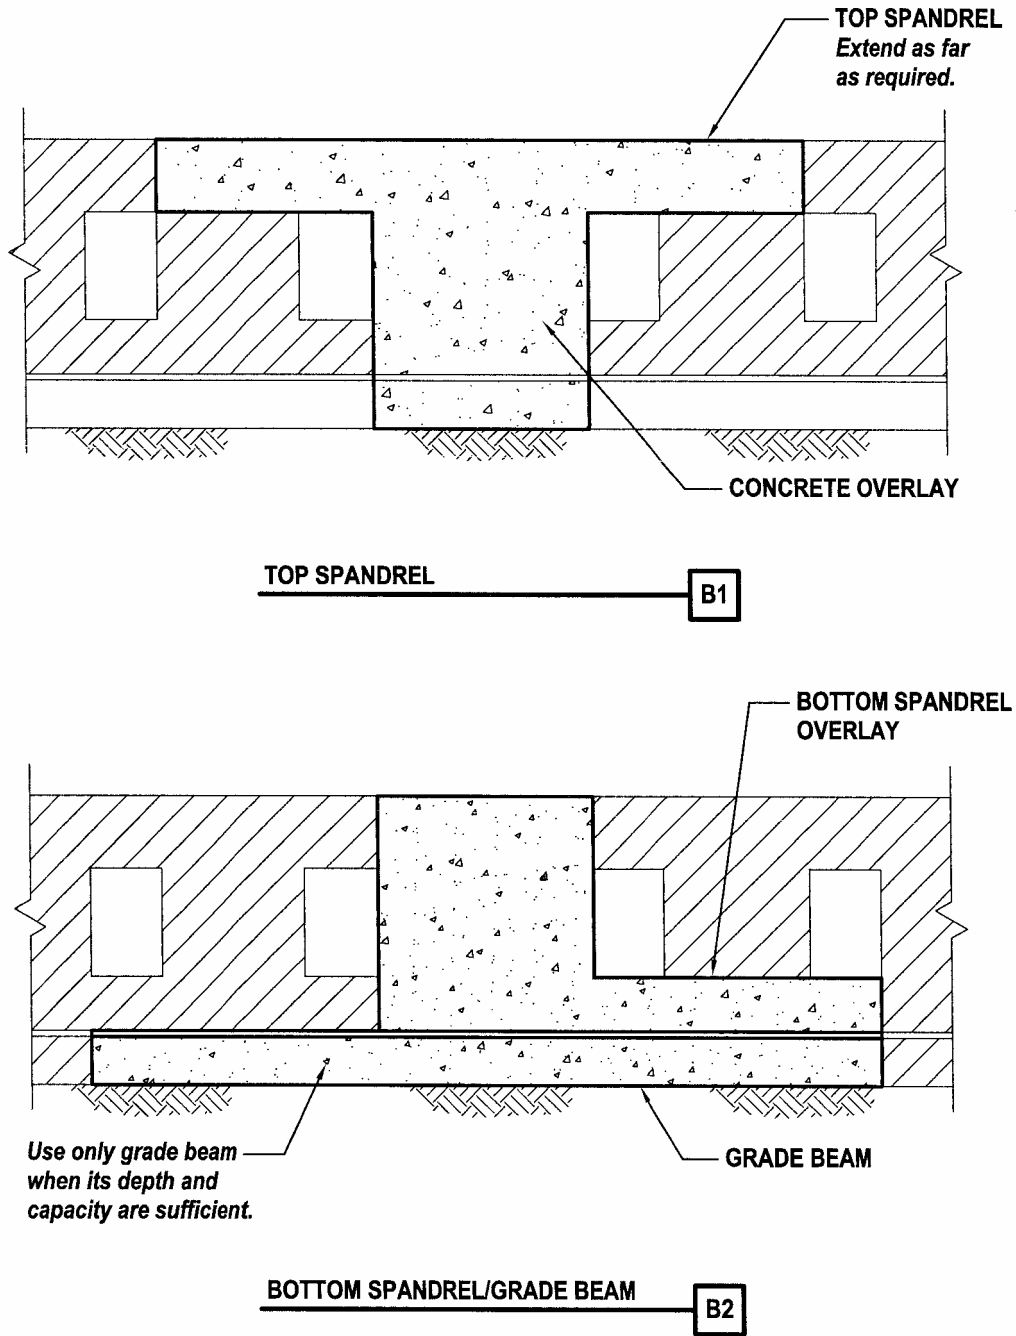
Figure 21.4.5-2B: Alternatives to Distribute Overturning Loads in Concrete Overlay

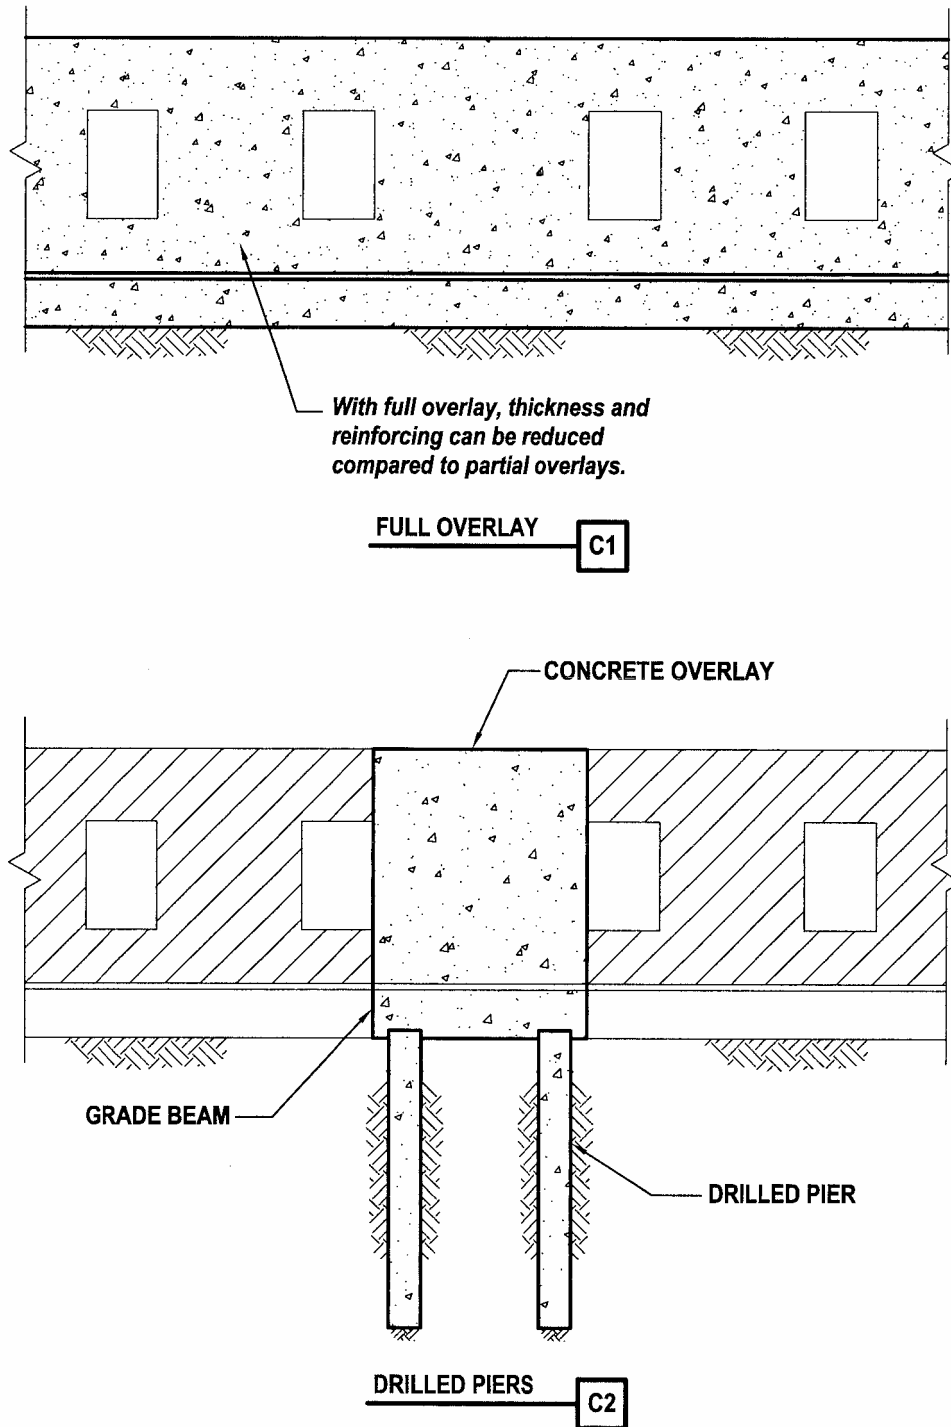
Figure 21.4.5-2C: Alternatives to Distribute Overturning Loads in Concrete Overlay

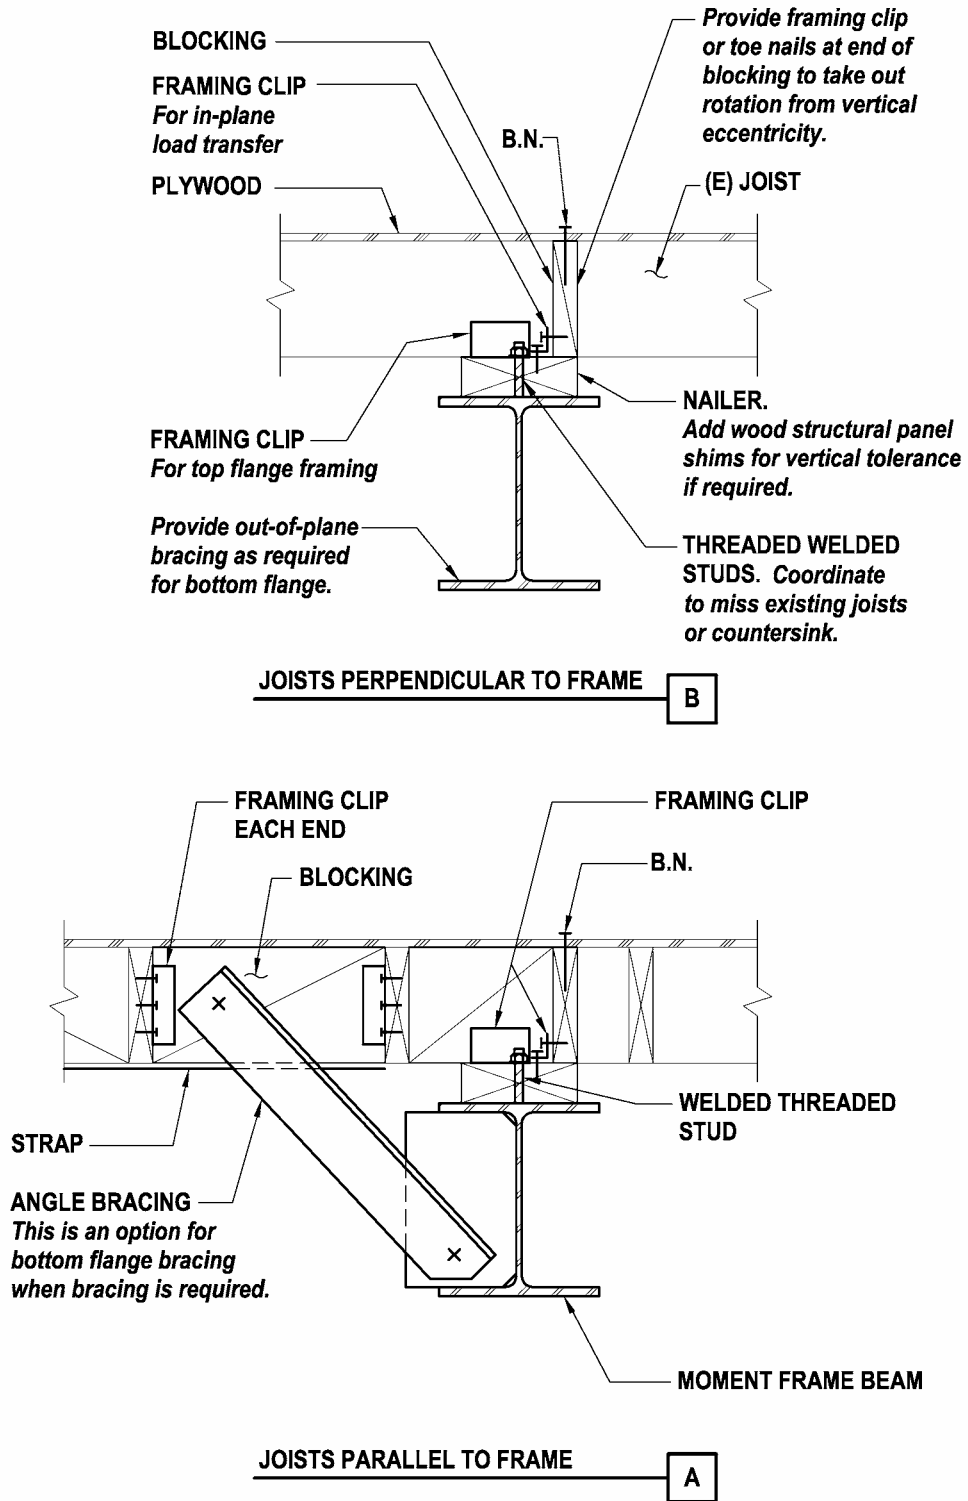
Figure 21.4.9-2: New Interior Steel Moment Frame to an Existing Wood Floor

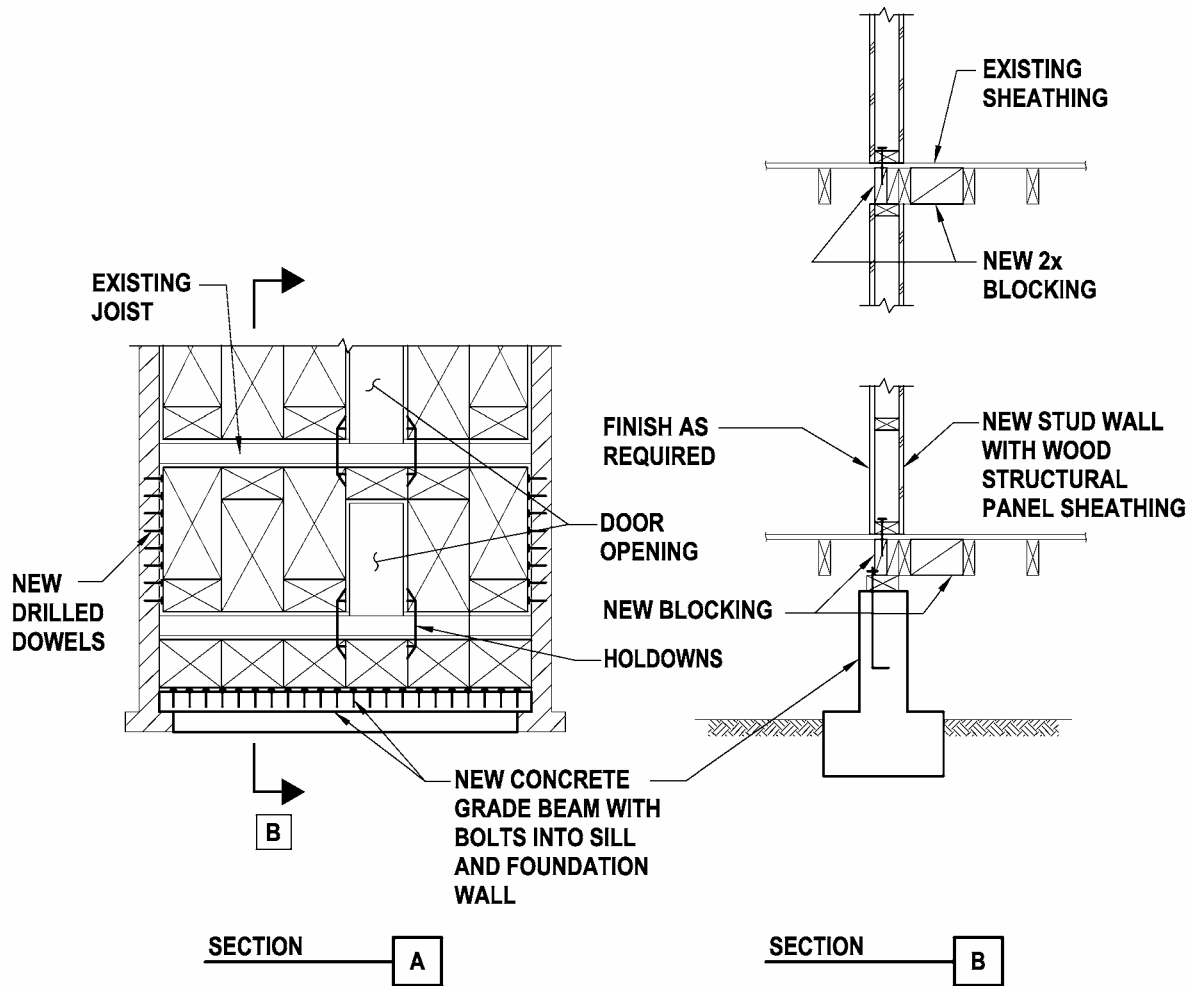
Figure 21.4.10-2: Add New Crosswalls

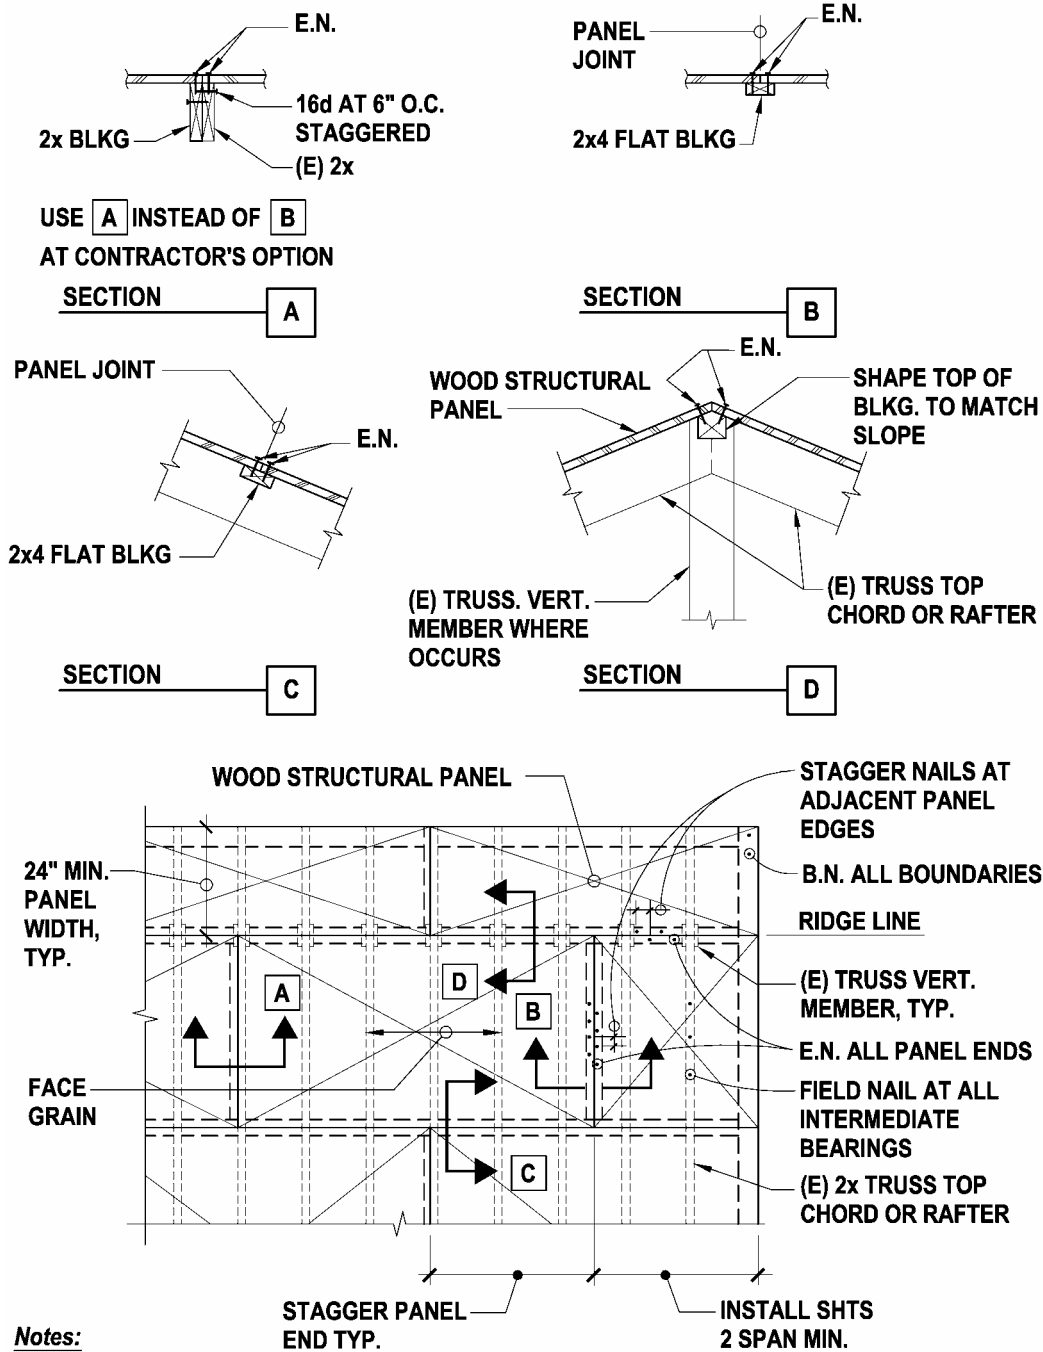
Figure 22.2.1-1: Remove and Replace Existing Wood Sheathing with Wood Structural Panel at a Roof

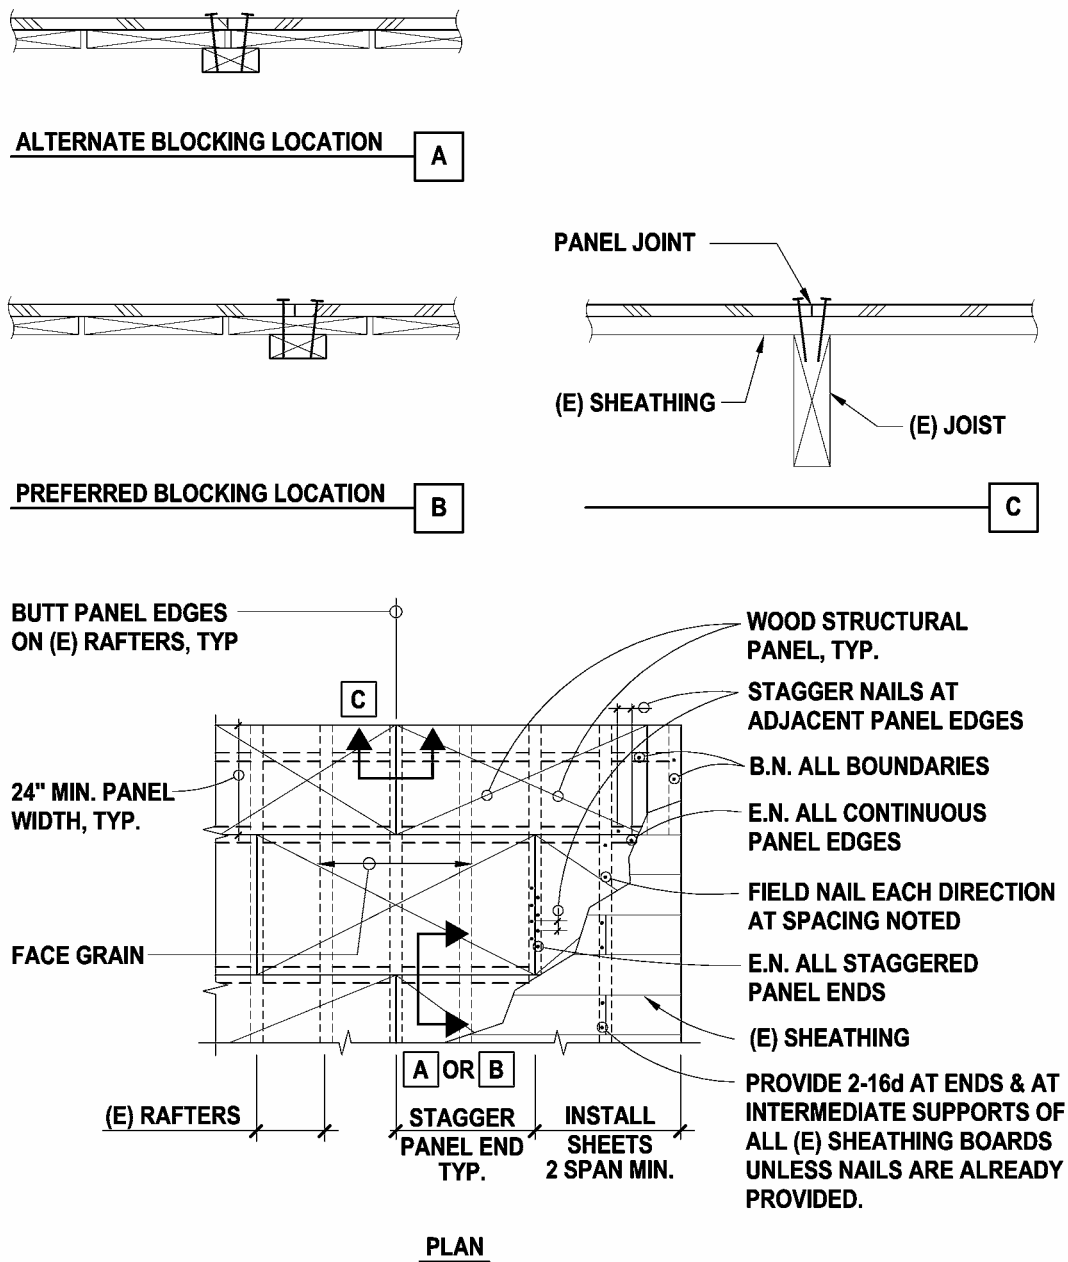
Figure 22.2.1-2: Wood Panel Overlay with Blocking Over Existing Sheathing

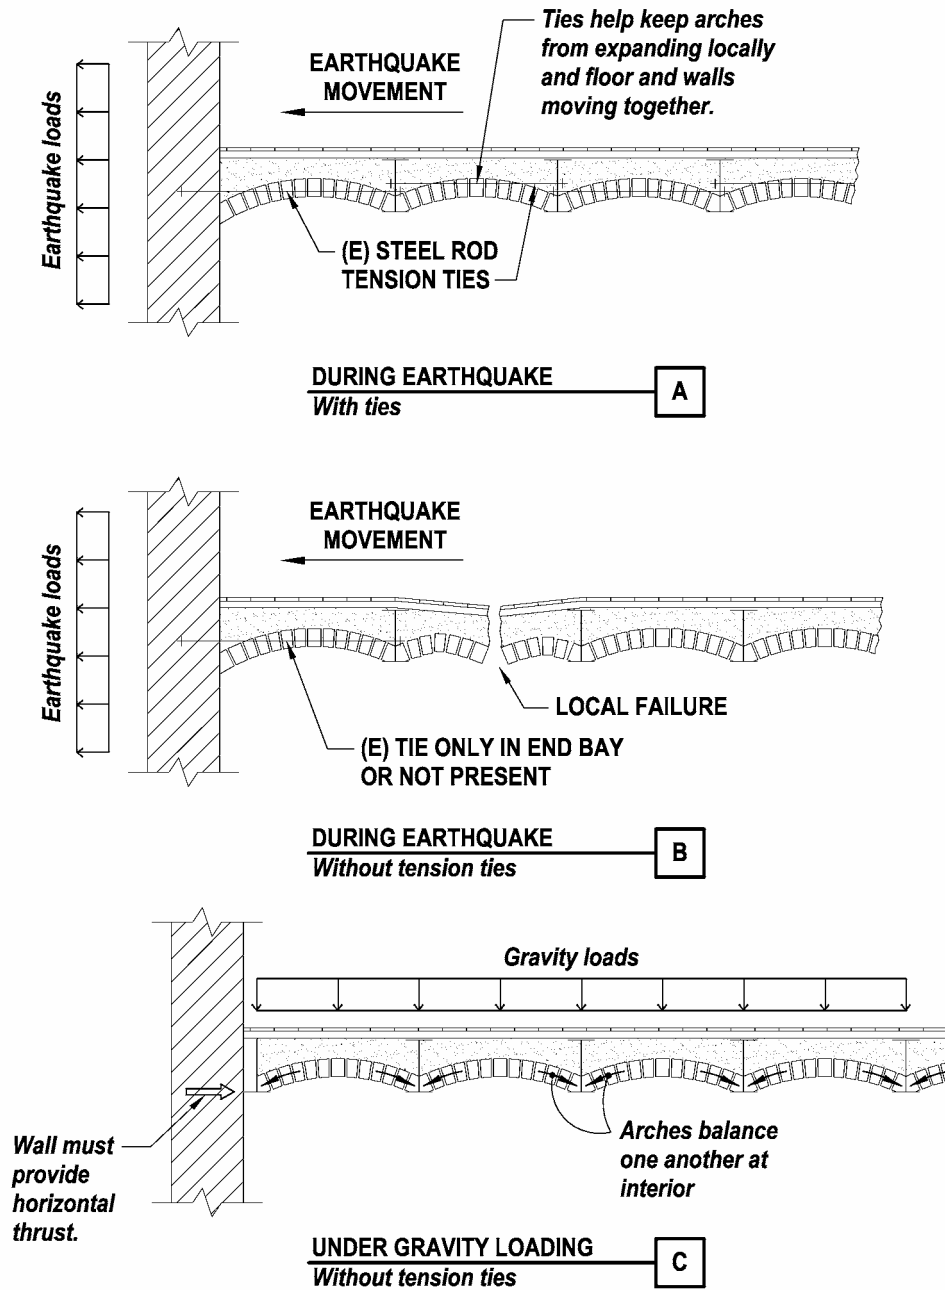
Figure 22.2.8-1: Failure Scenarios for Masonry Flat Arch Floors
