Techniques for the Seismic Rehabilitation of Existing Buildings

FEMA 547/2006 Edition

FEMA 547 – October 2006

Rutherford & Chekene (R & C) Consulting Engineers (Subconsultant) under contract with National Institute of Standards and Technology (NIST).

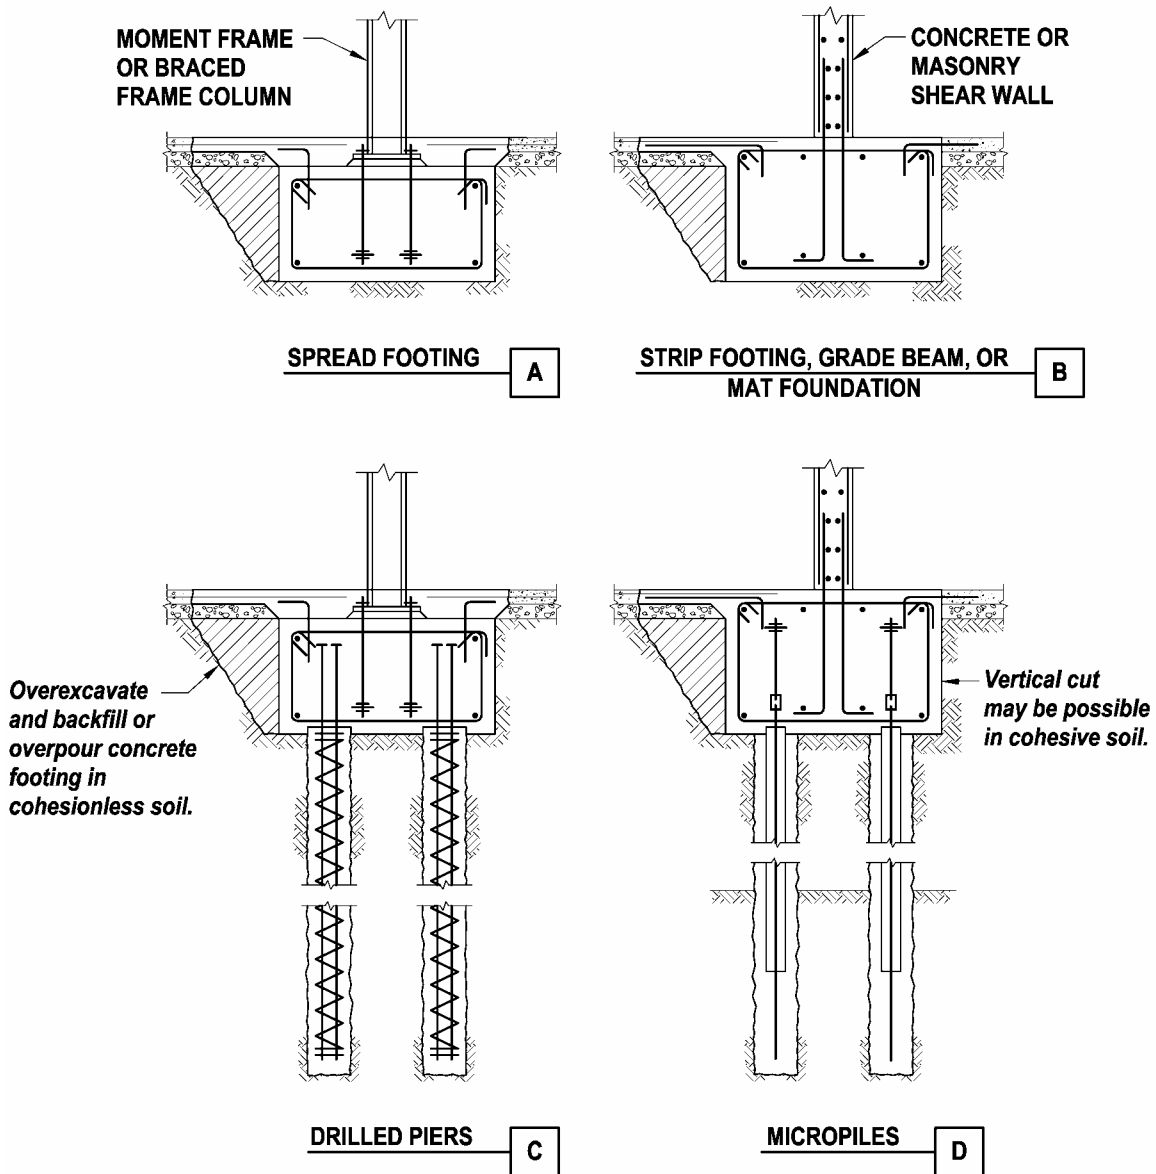
Figure 23.6.1-1: Types of New Foundations Commonly Used in Seismic Rehabilitation

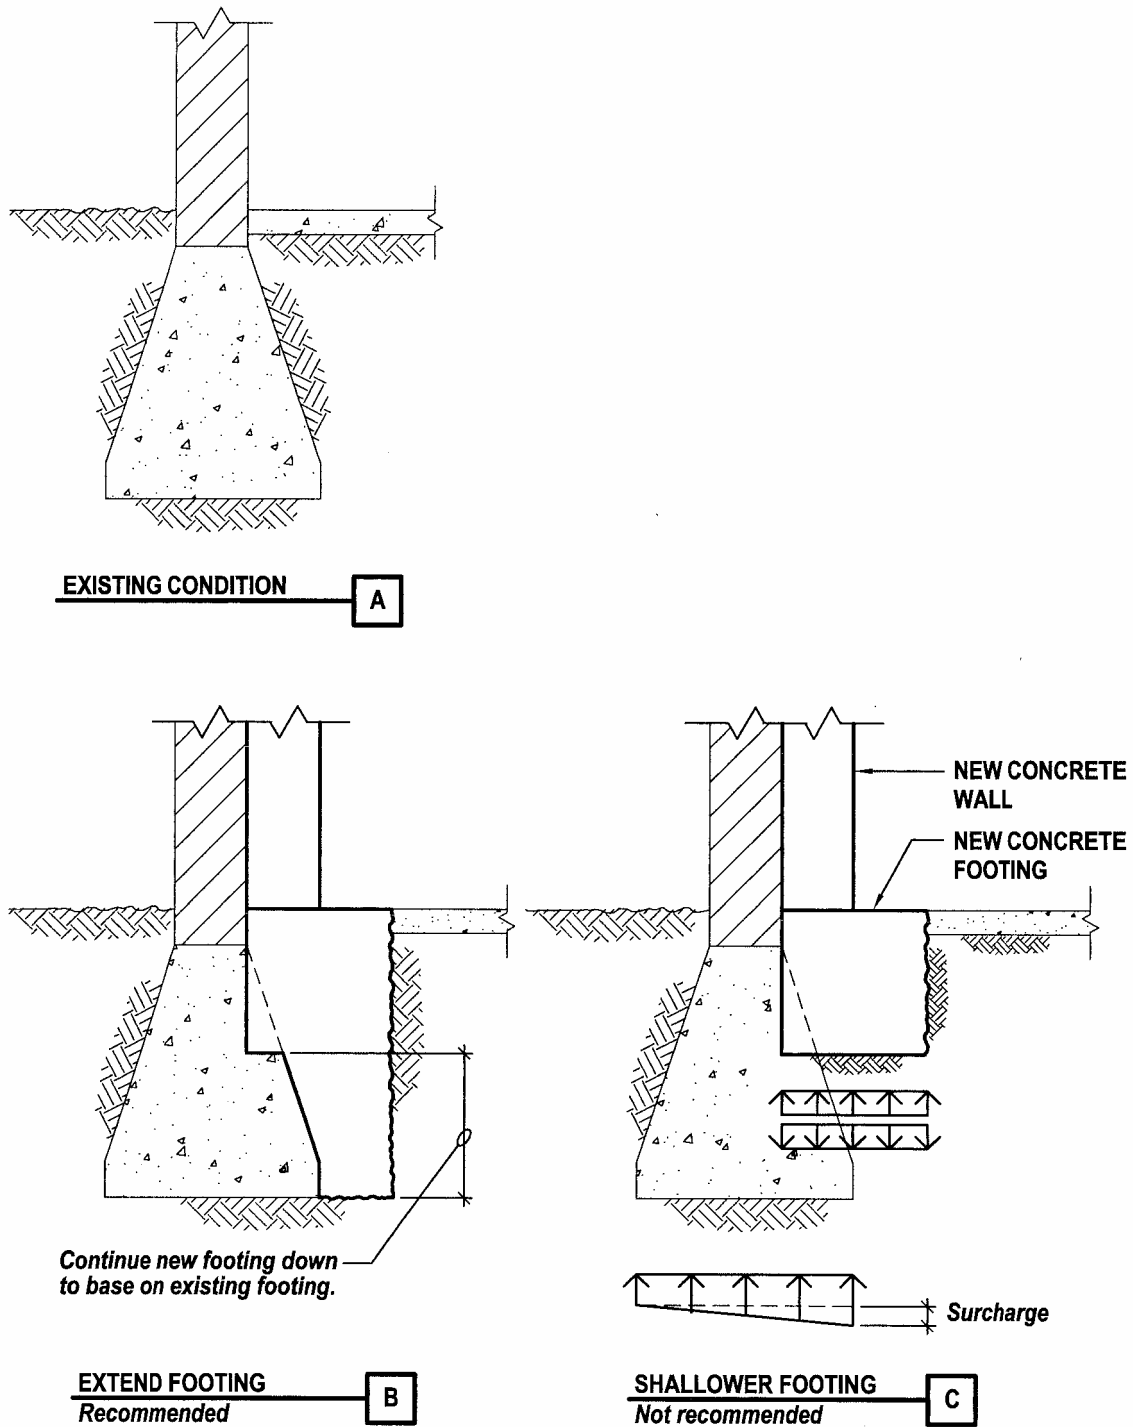
Figure 23.6.2-3: New Shallow Footing Does Not Need to be as Deep as Existing Shallow Footing

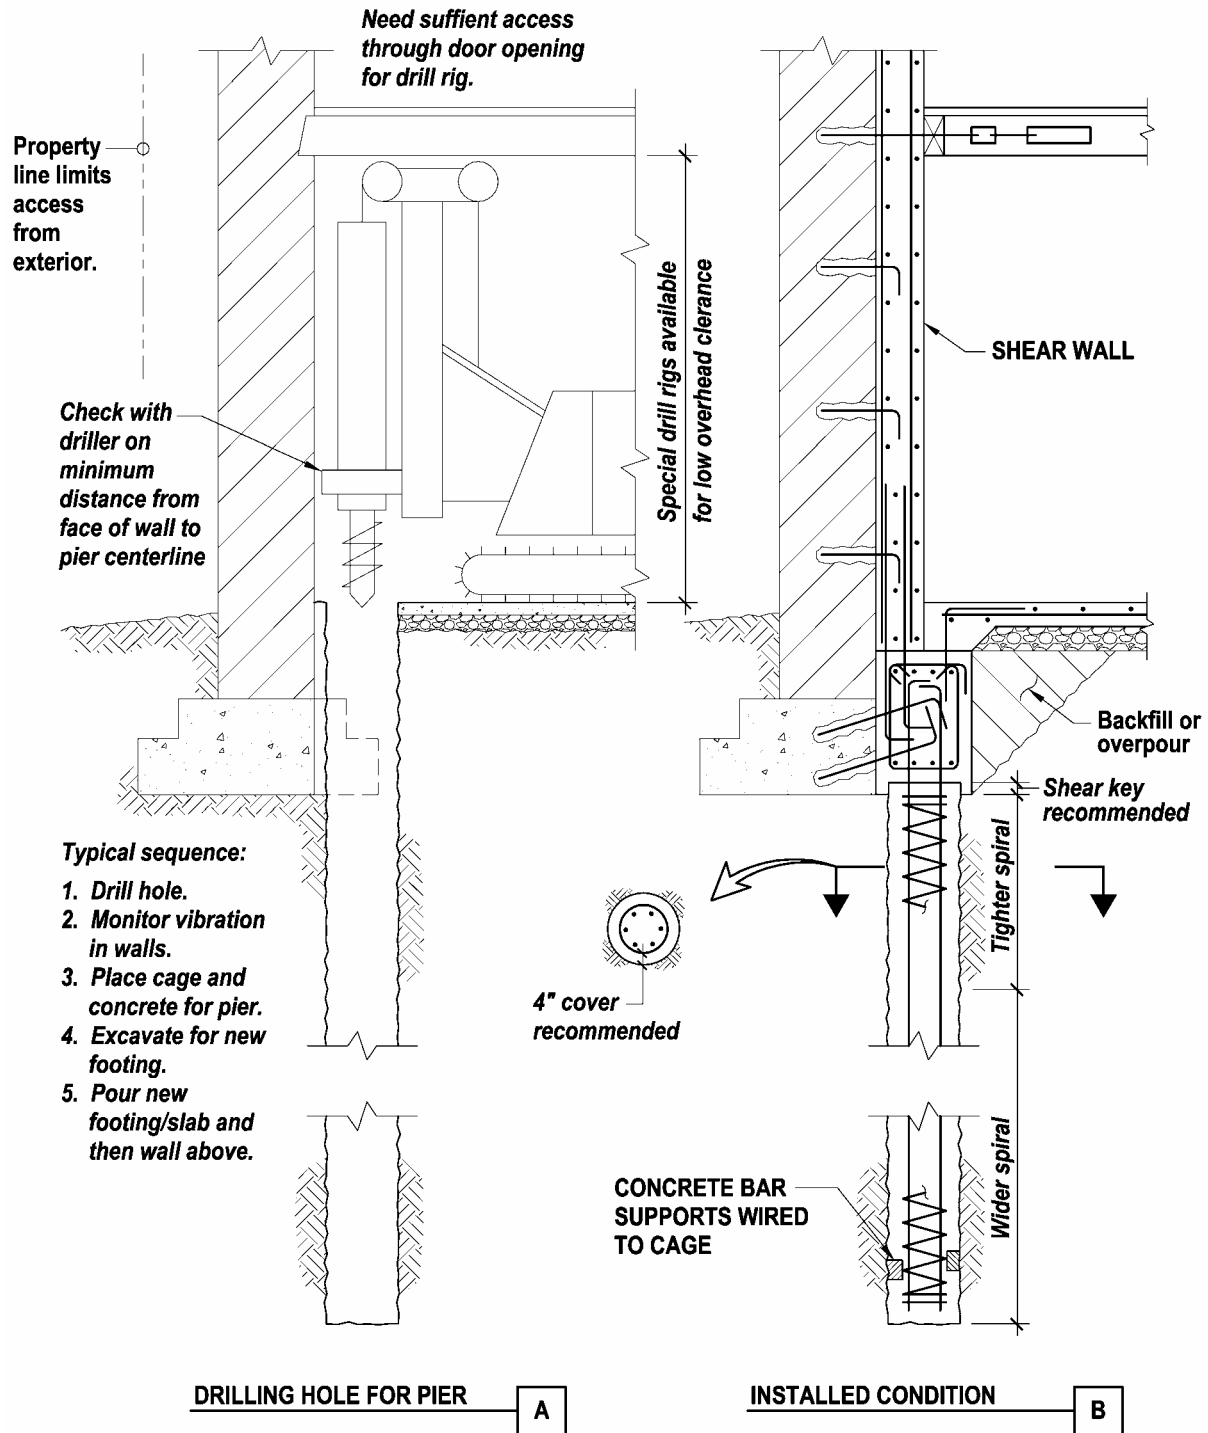
Figure 23.6.4-1: New Drilled Pier Next to Existing Strip Foundation

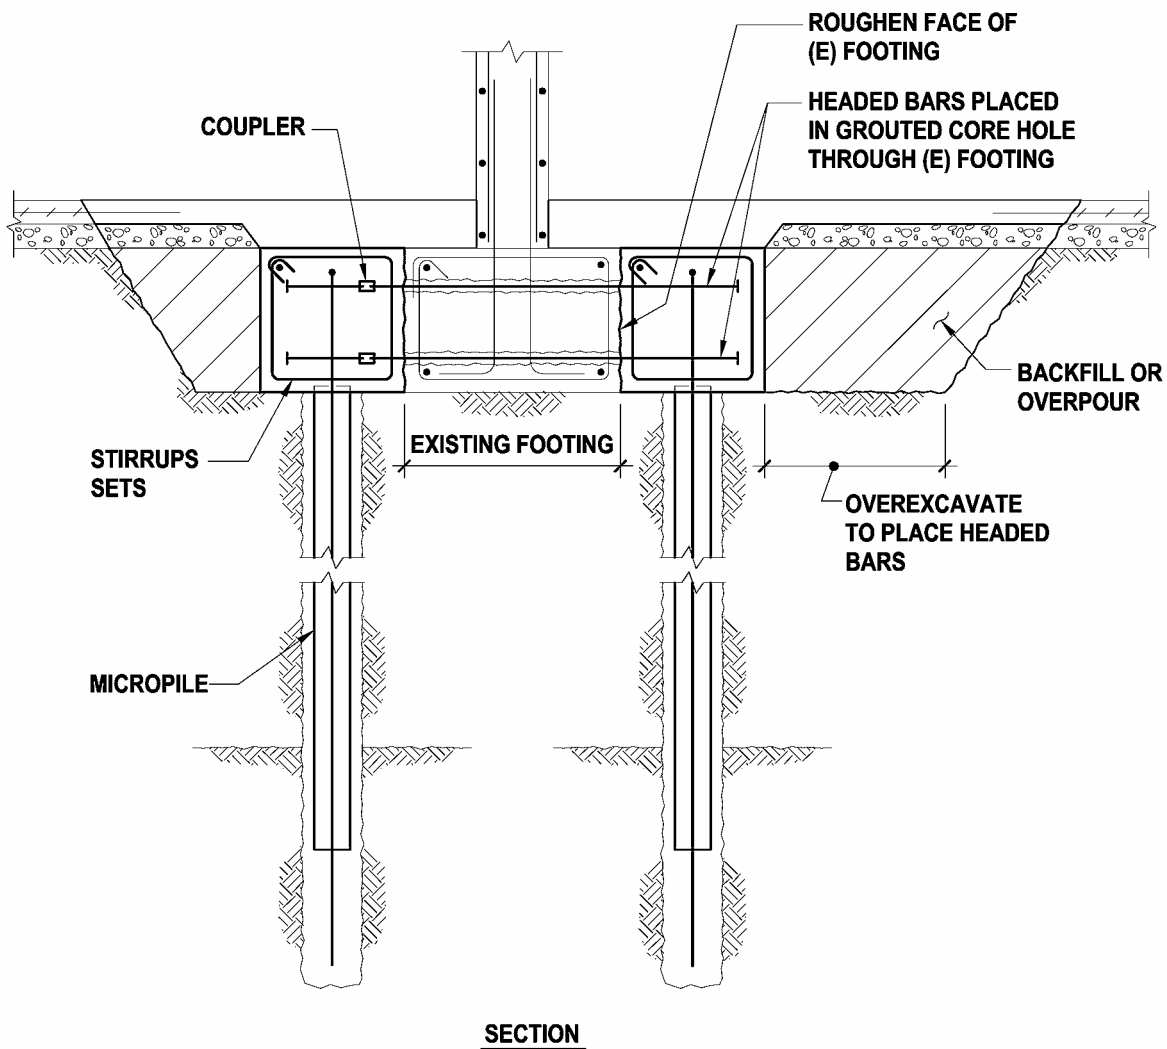
Figure 23.7.2.-1: Micropile Enhancement to Existing Strip Footing

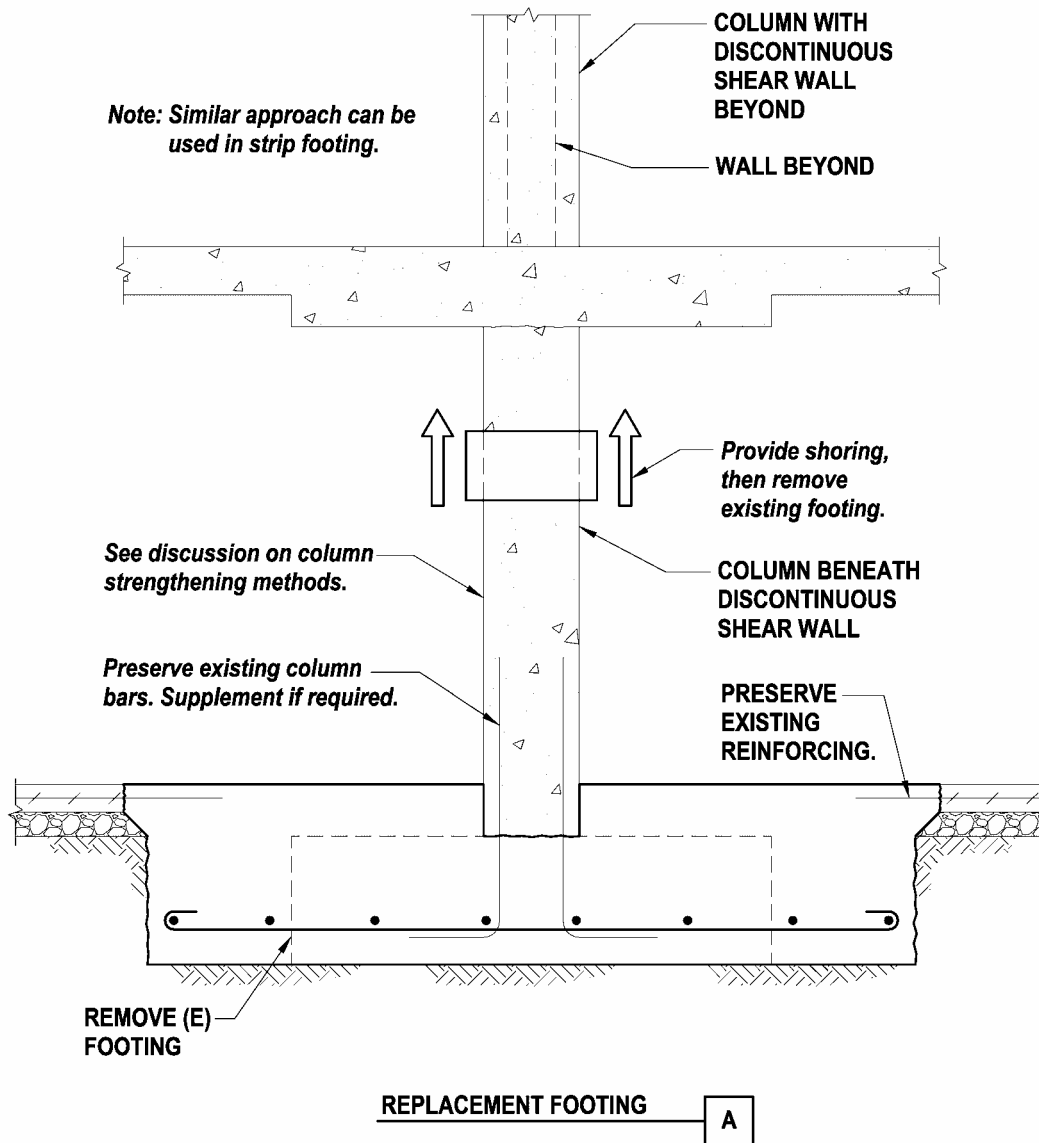
Figure 23.7.3-2: Replace Existing Spread Footing

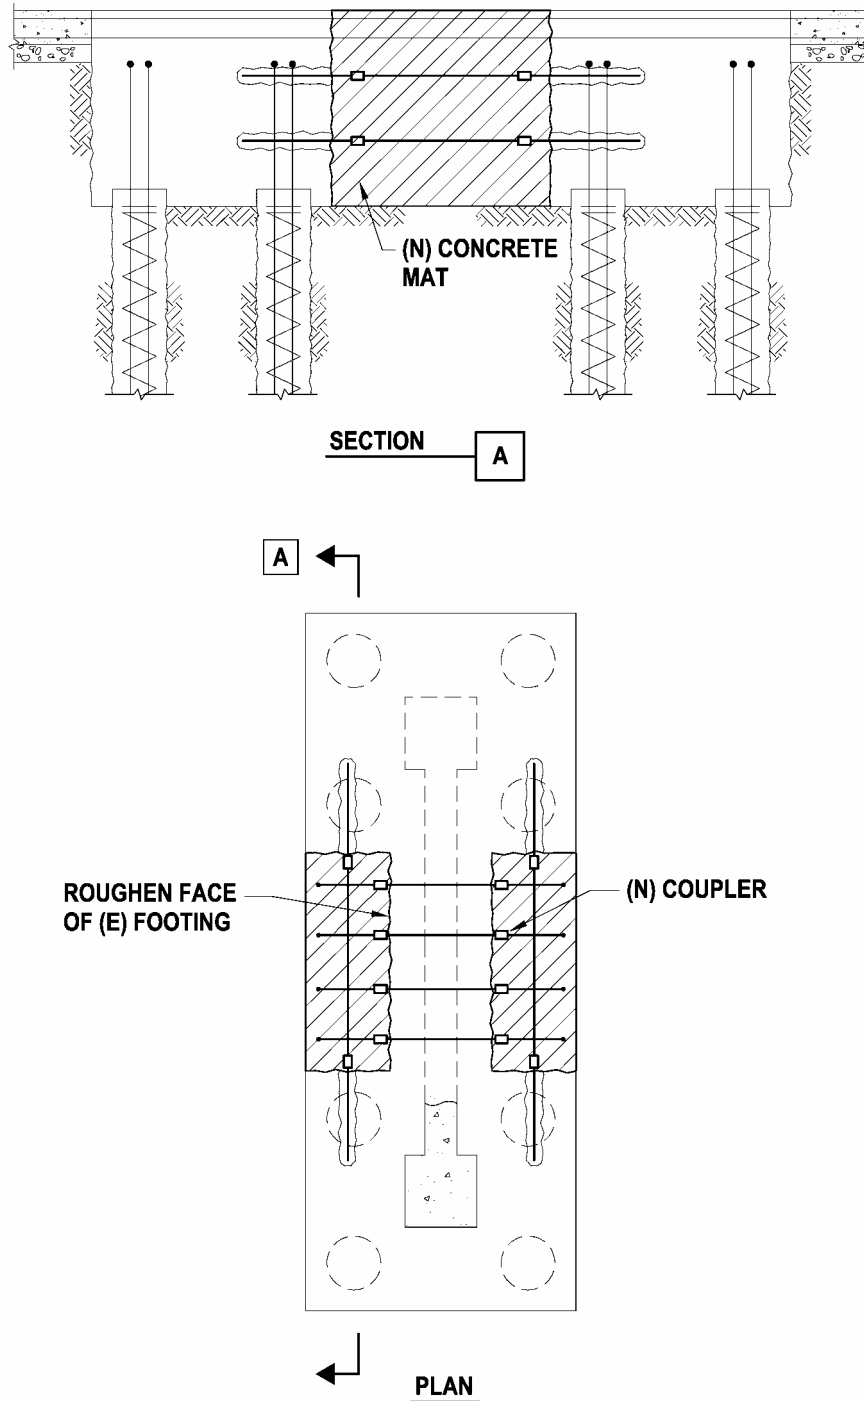
Figure 23.8.2-1: New Mat Foundation Between Existing Drilled Piers

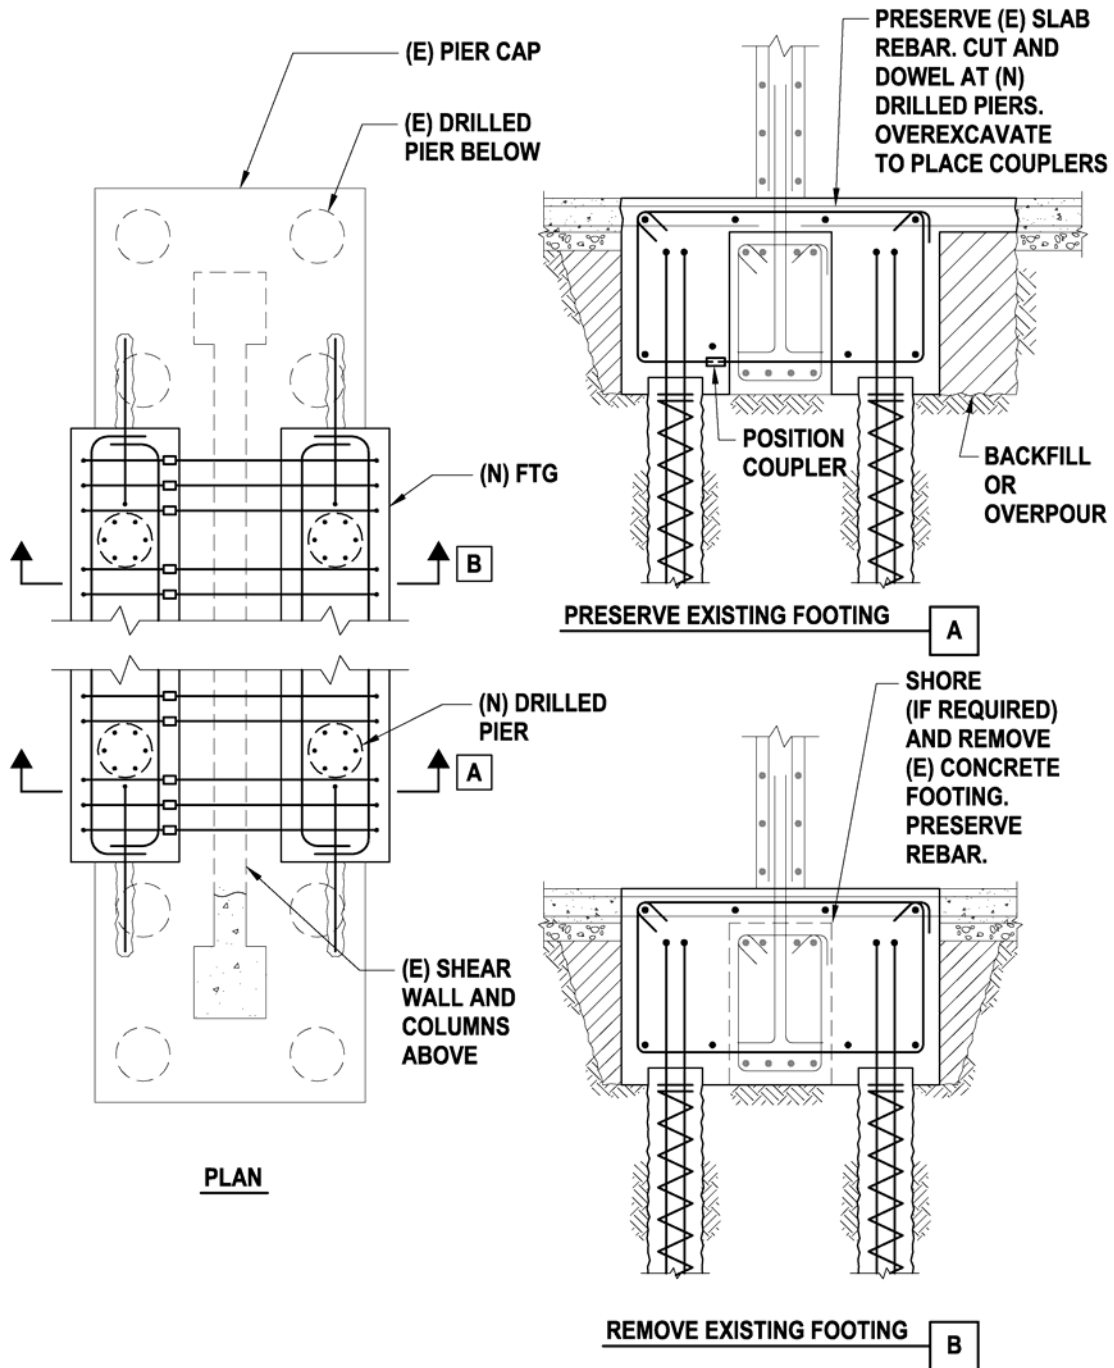
Figure 23.8.3.-1: Adding Drilled Piers to an Existing Drilled Pier Foundation

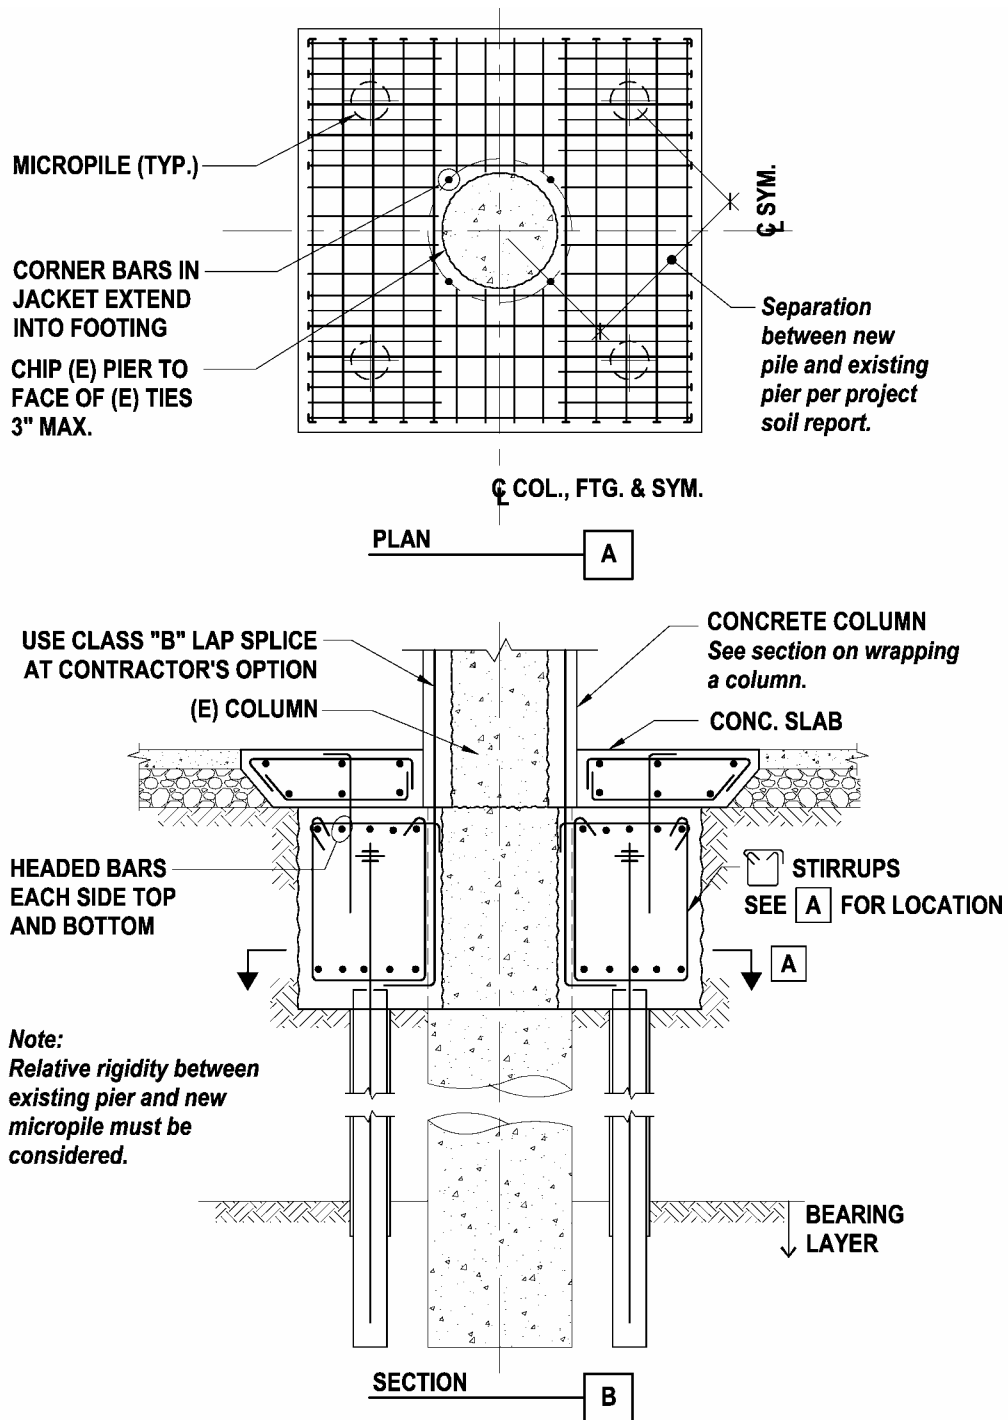
Figure 23.8.4.-1: Micropile Enhancement of an Existing Drilled Pier Footing

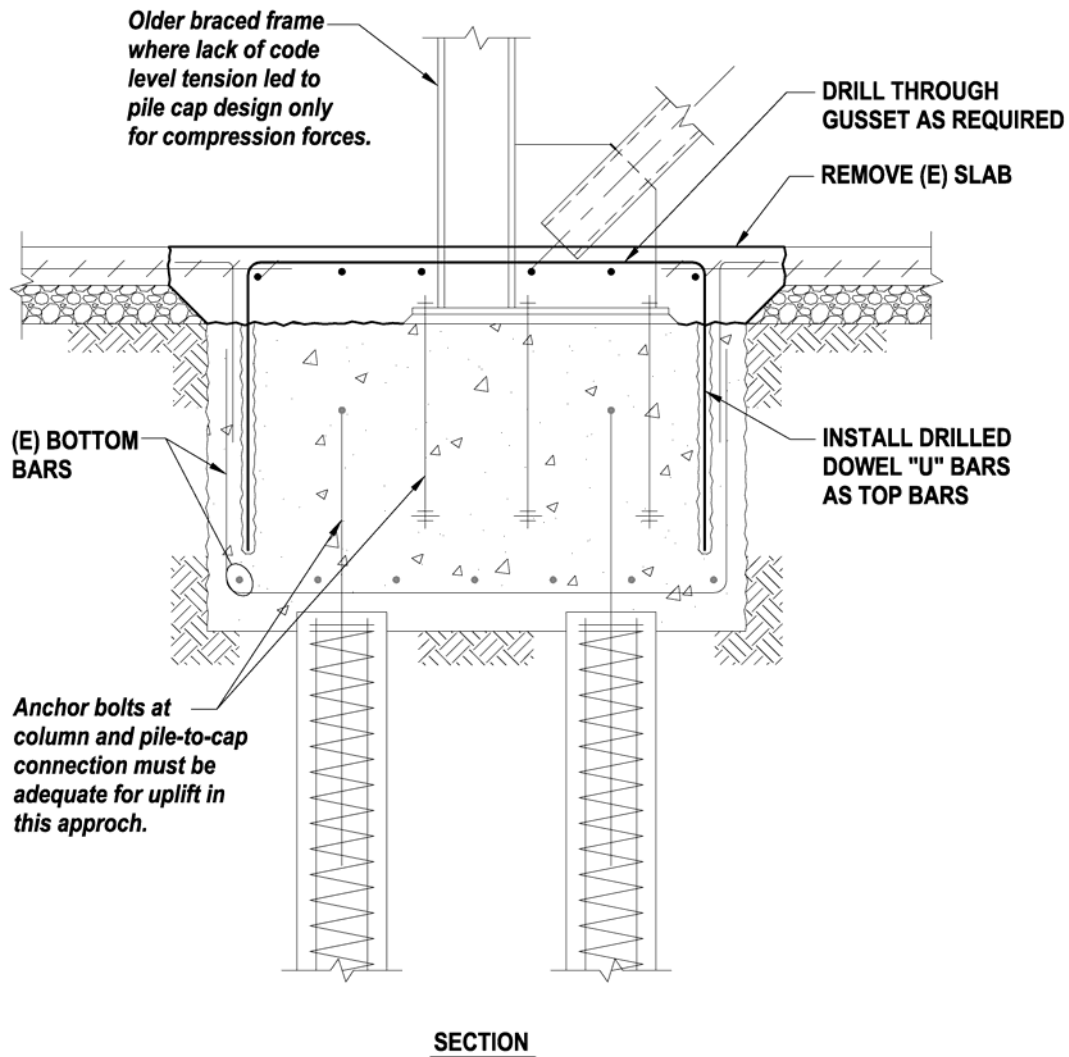
Figure 23.8.5-1: Adding Top Bars to an Existing Pile Cap

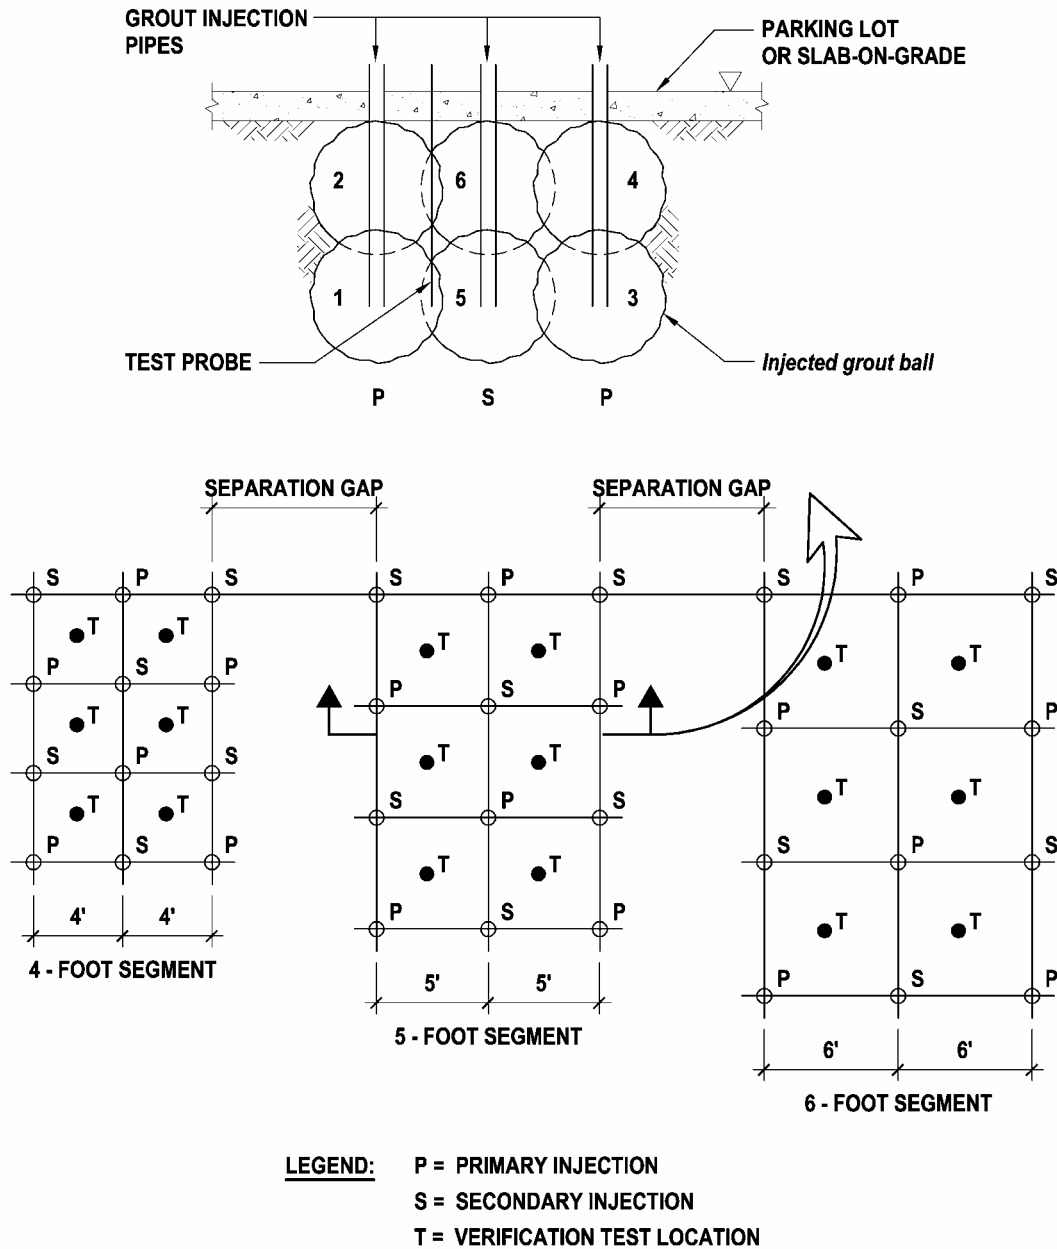
Figure 23.9.2-1: Compaction Grouting Under Existing Shallow Foundations – Pilot Test Program

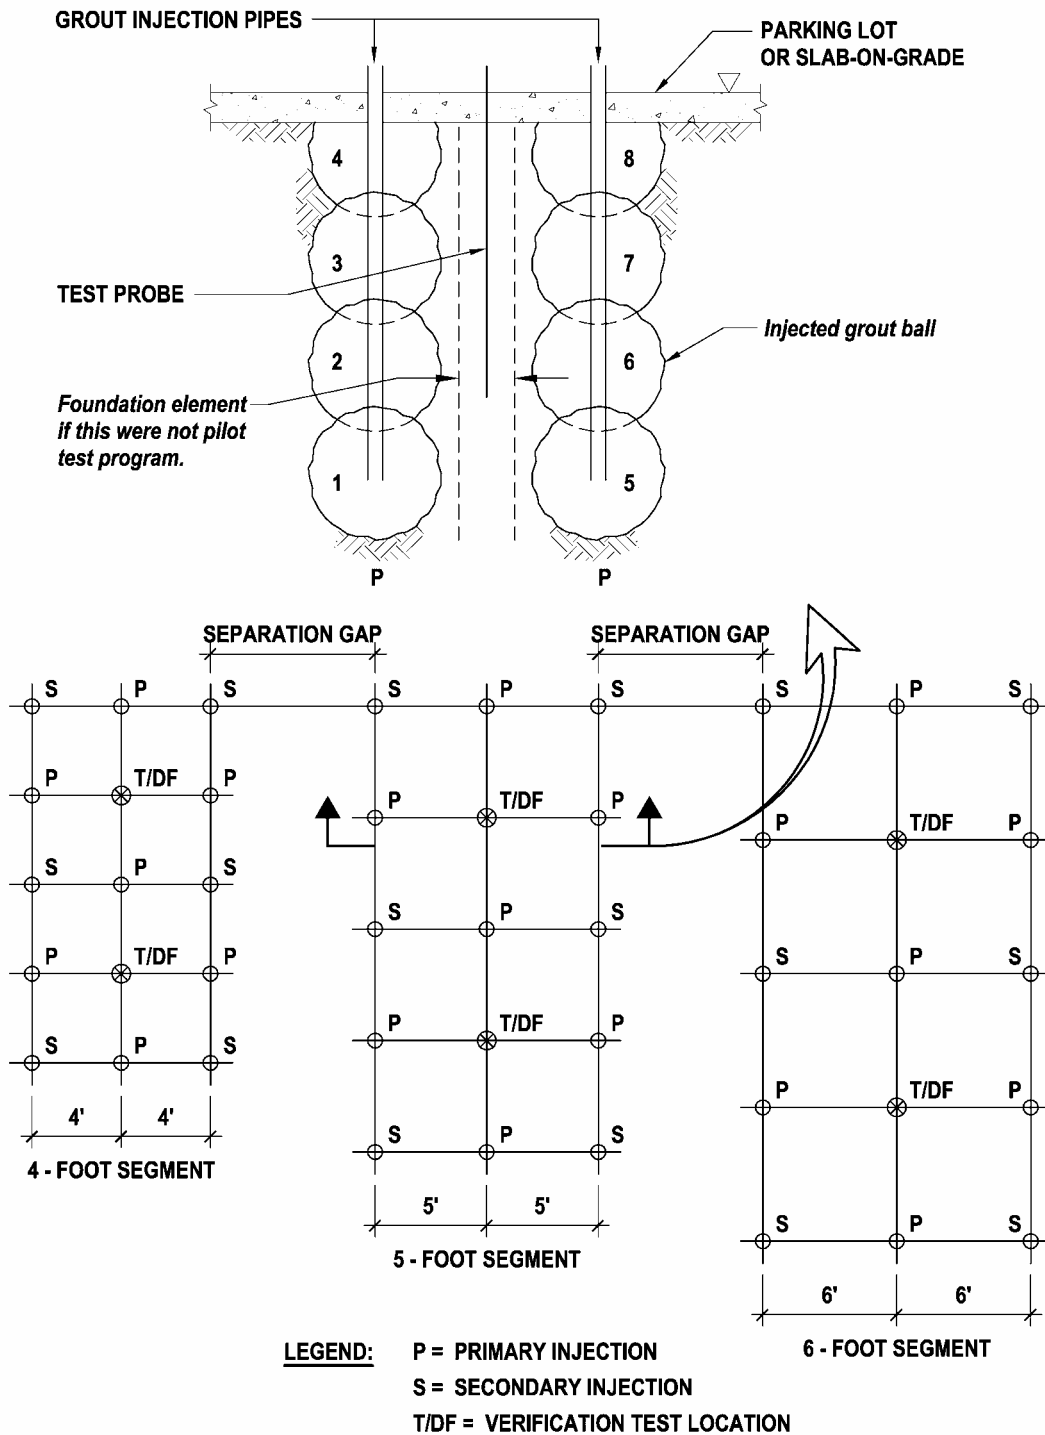
Figure 23.9.2-2: Compaction Grouting Under Existing Deep Foundations – Pilot Test Program

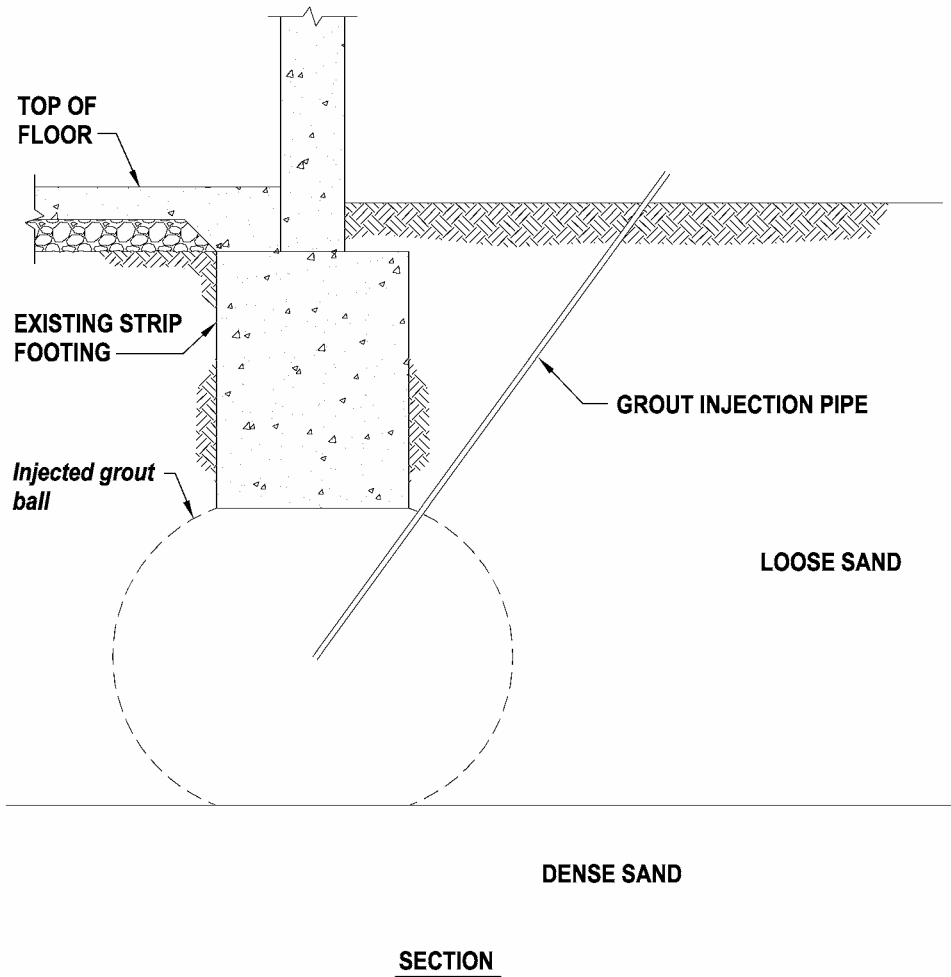
Figure 23.9.3-1: Permeation Grouting of Loose Sand Under Existing Shallow Foundation

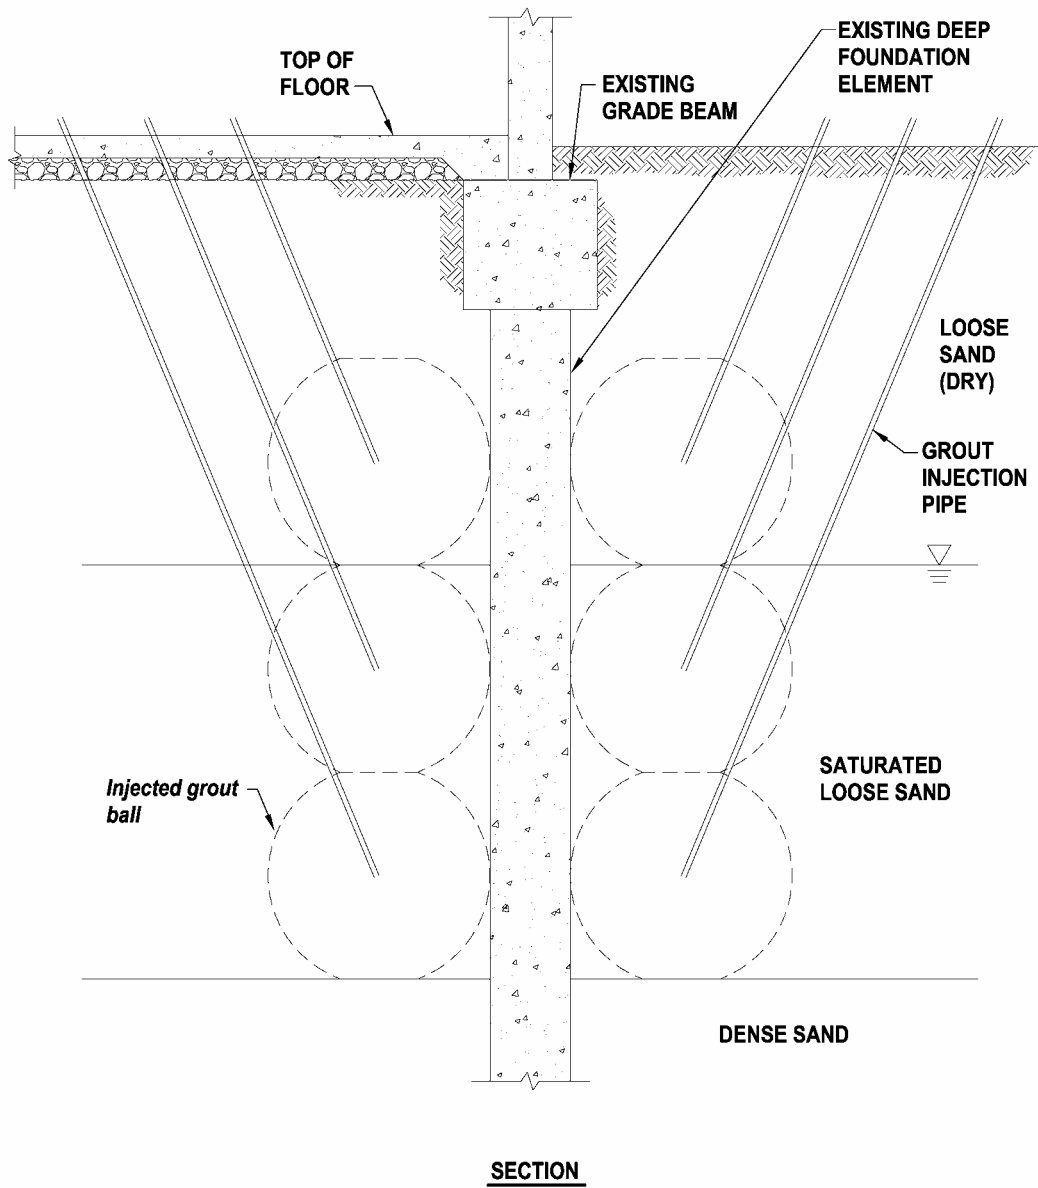
Figure 23.9.3-3: Permeation Grouting of Liquefiable Layer Around Existing Deep Foundation

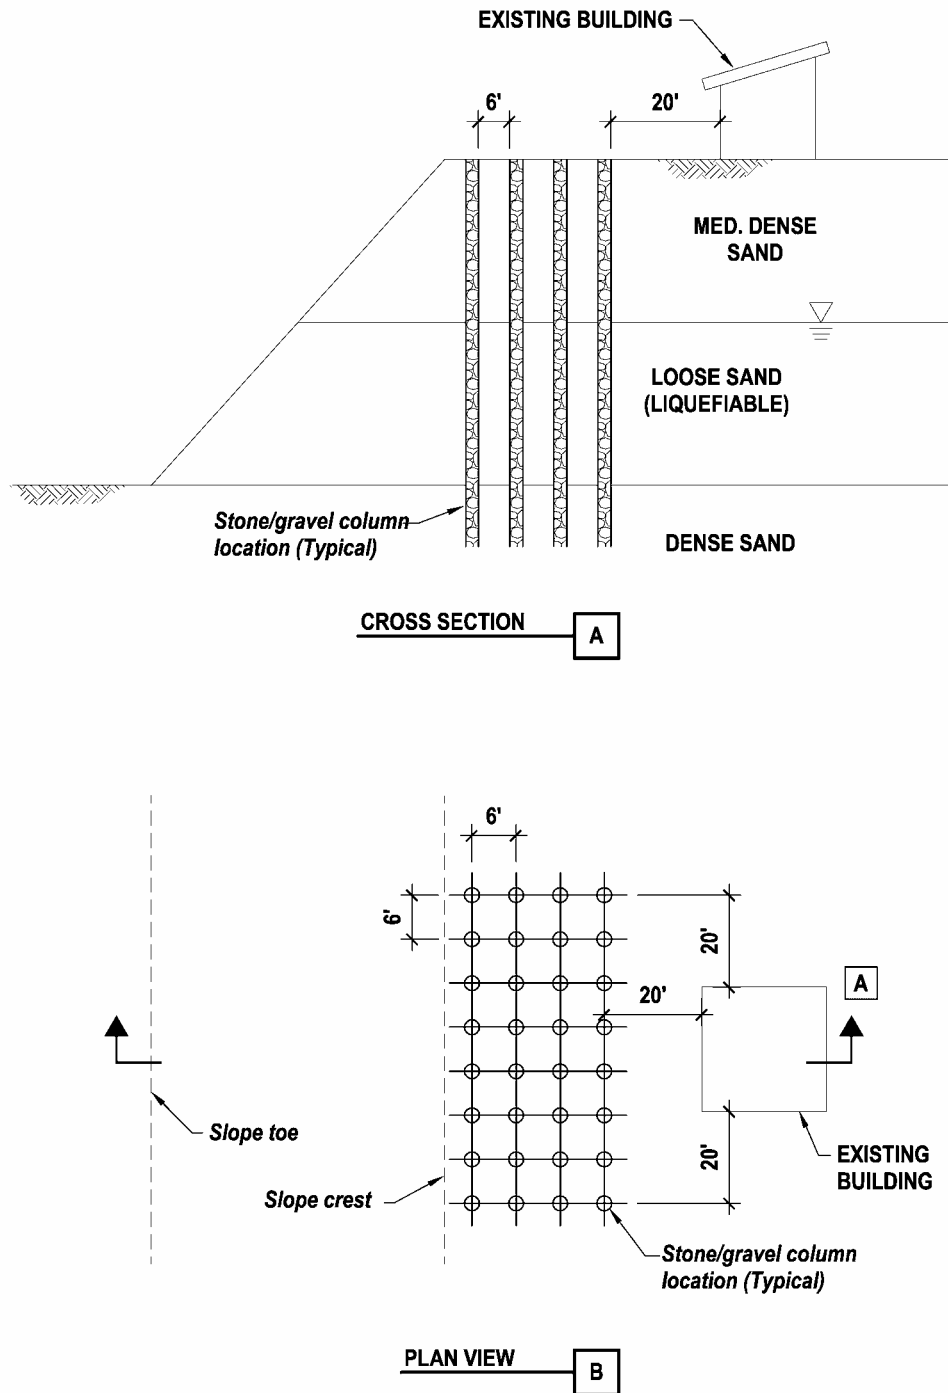
Figure 23.10.3-2: Mitigation Measure for Lateral Spreading – Stone/Gravel Column

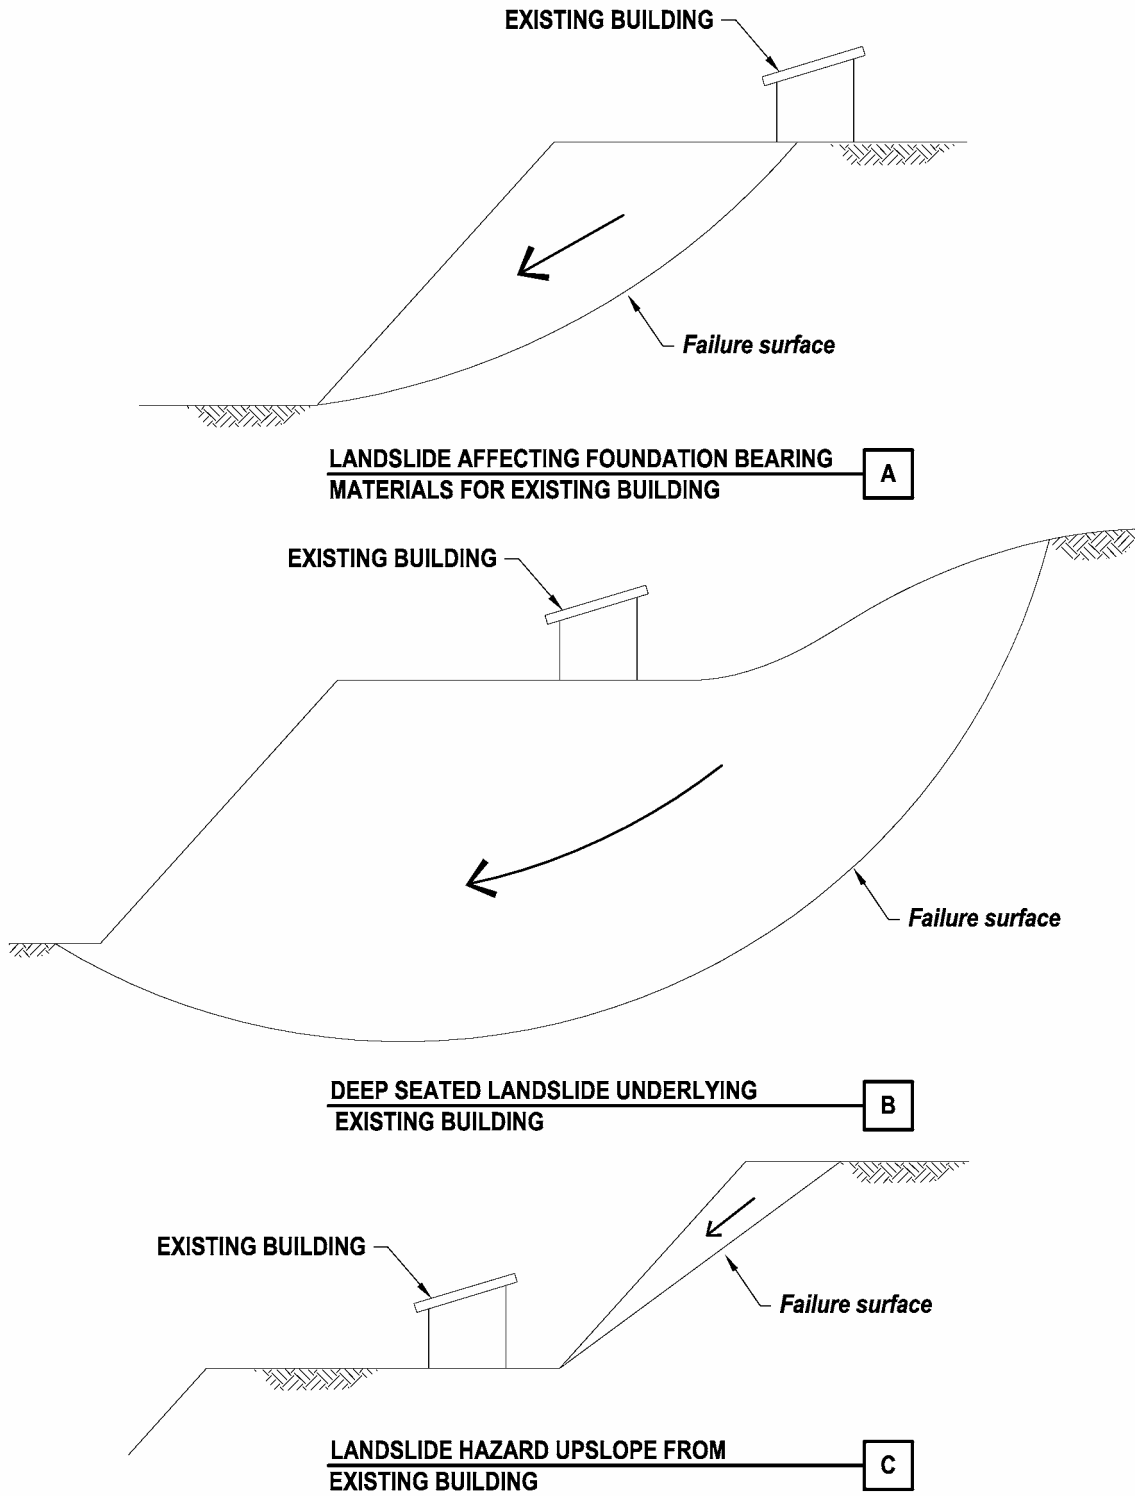
Figure 23.10.4-1: Landslide Hazards

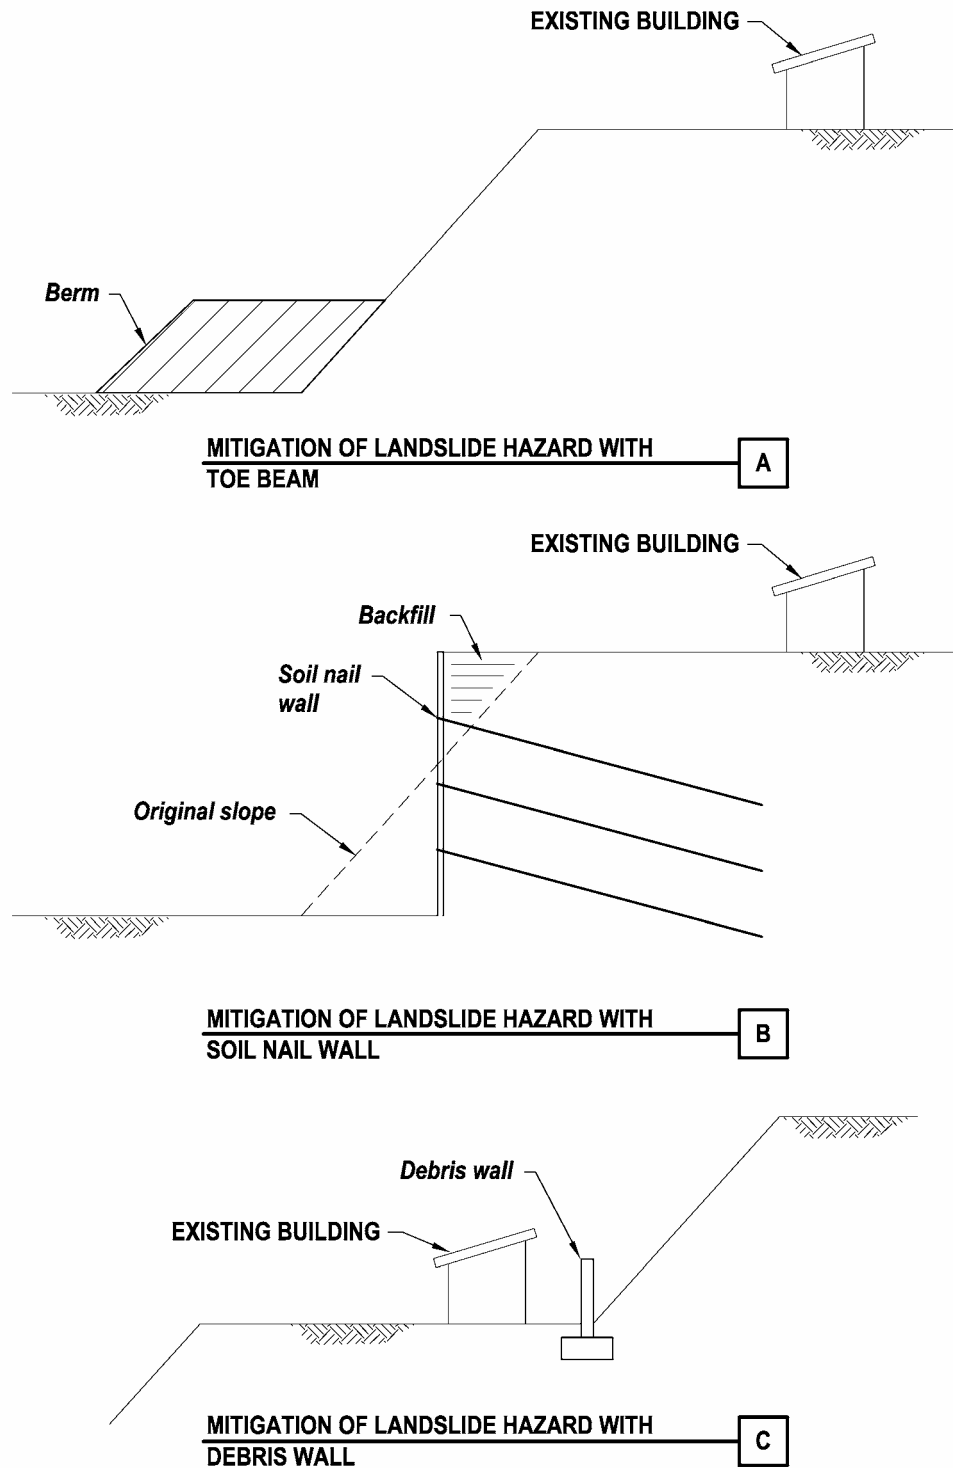
Figure 23.10.4-2: Mitigation of Landslide Hazards
