Techniques for the Seismic Rehabilitation of Existing Buildings

FEMA 547/2006 Edition

FEMA 547 – October 2006

Rutherford & Chekene (R & C) Consulting Engineers (Subconsultant) under contract with National Institute of Standards and Technology (NIST).

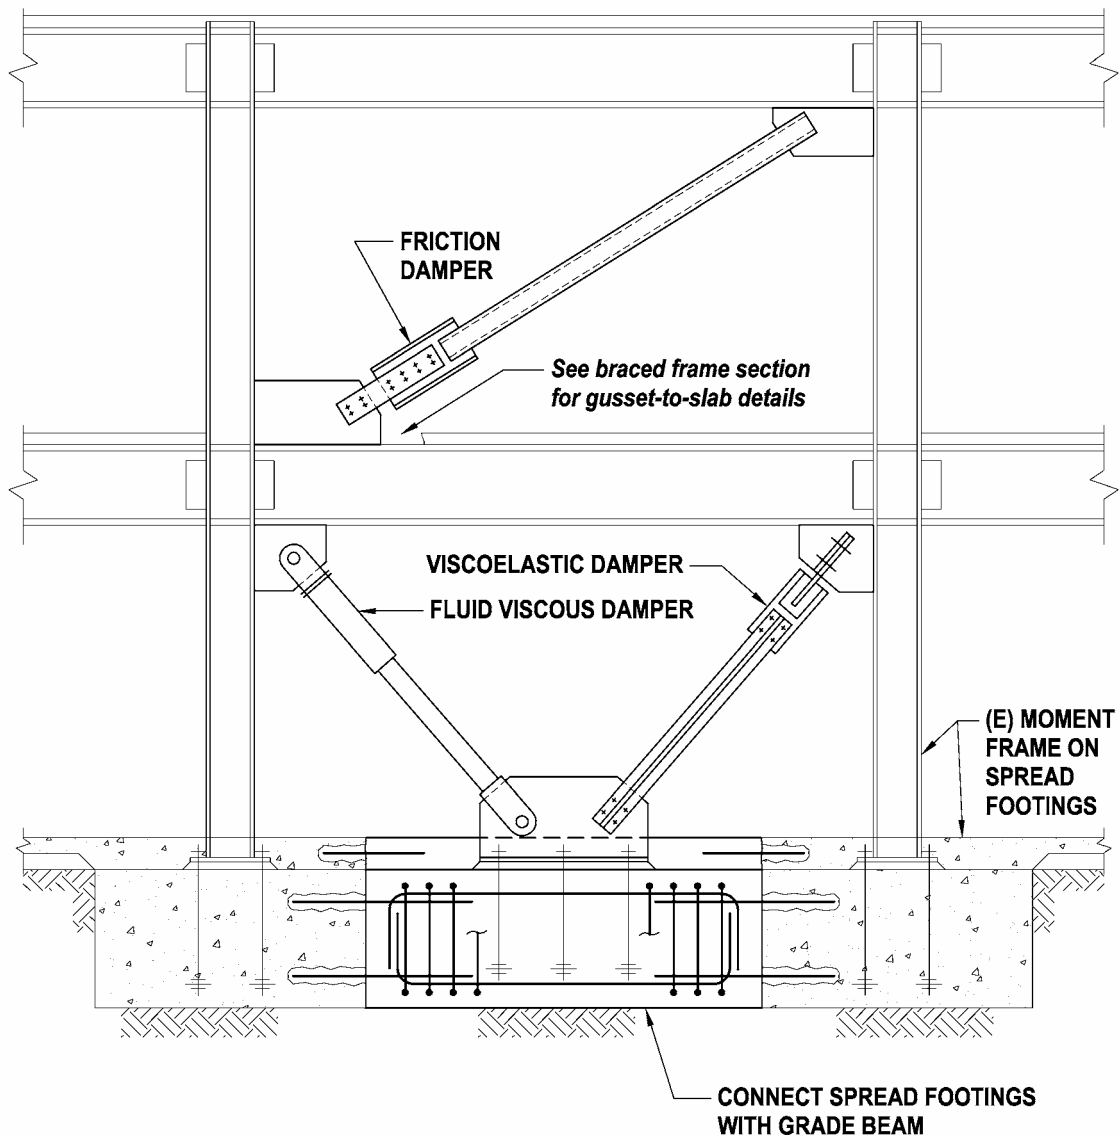
Figure 24.4-1: Damper Alternatives for Rehabilitating an Existing Moment Frame

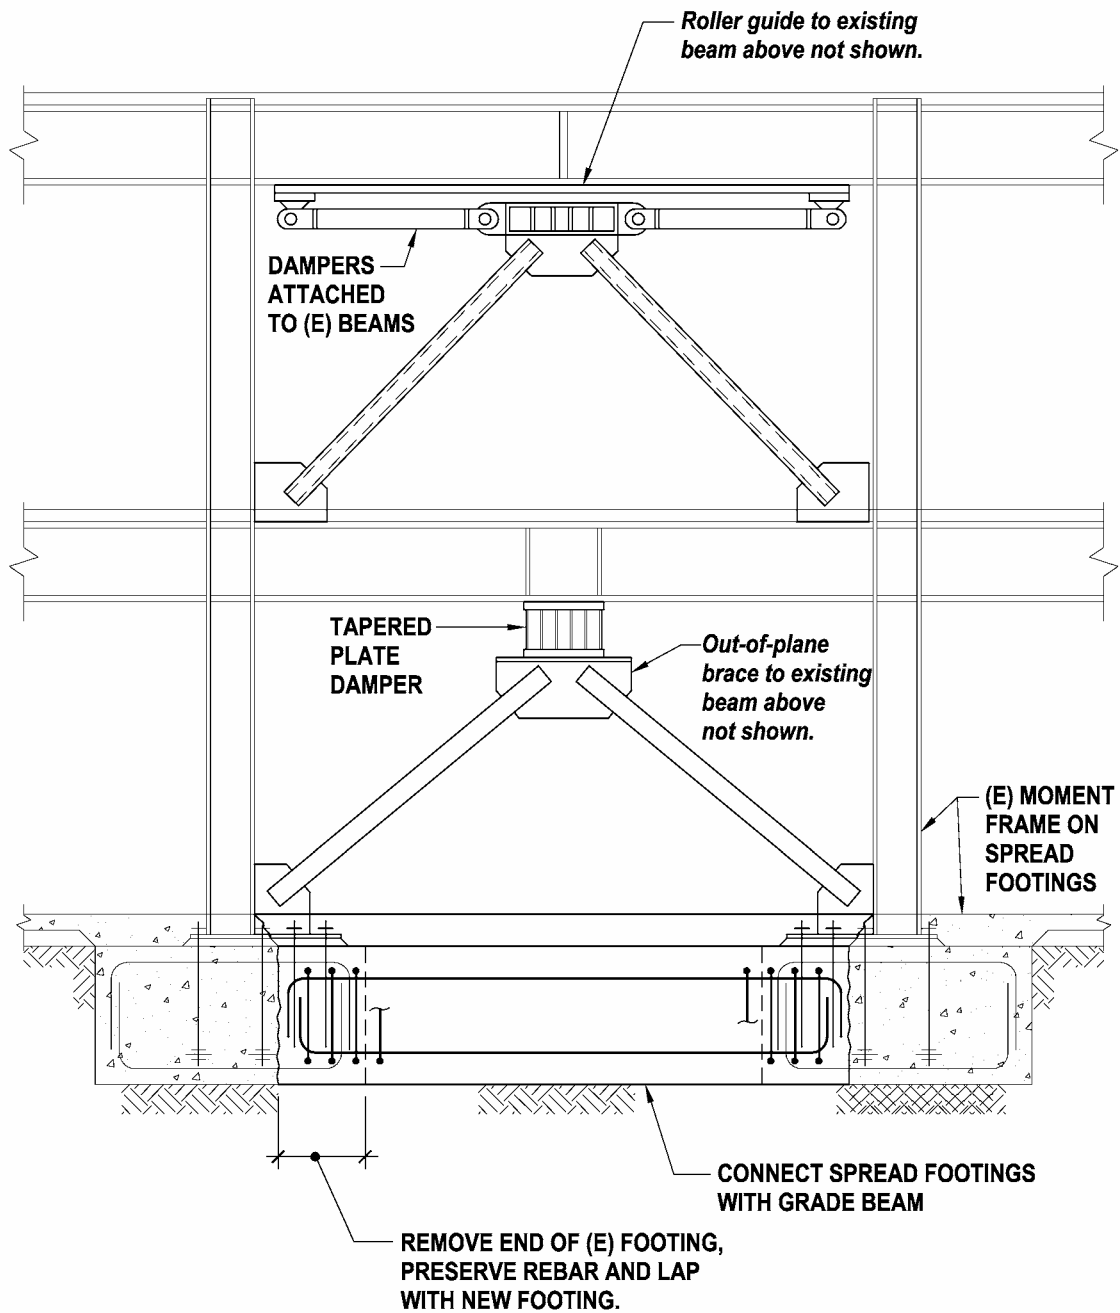
Figure 24.4-2: Additional Damper Alternatives for Rehabilitating an Existing Moment Frame
