**PUBLIC WORKS TECHNICAL BULLETIN 200-1-16
7 JANUARY 2002**

**INNOVATIVE USES OF RECYCLED TANK TRACKS FOR
EROSION CONTROL**

INNOVATIVE USES OF RECYCLED TANK TRACKS FOR
EROSION CONTROL

Recycling DRMO Materials for Erosion Control

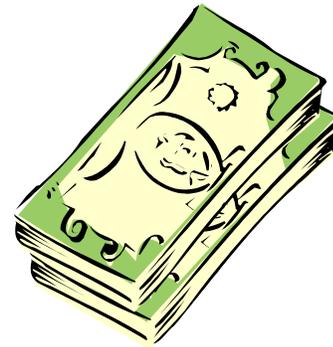
How much money is being spent to repair trouble spots? The City of Colorado Springs was installing gravel and/or asphalt twice annually at a road shoulder in the Pike's Peak

area along an asphalt road that was continually being eroded by runoff during storm events. The crew of four or five took a full 8-hour day for the work. By current (2002) costs, each maintenance action would cost about \$2300. By using tank tracks to harden the site, no further maintenance has been needed since Spring 1998.

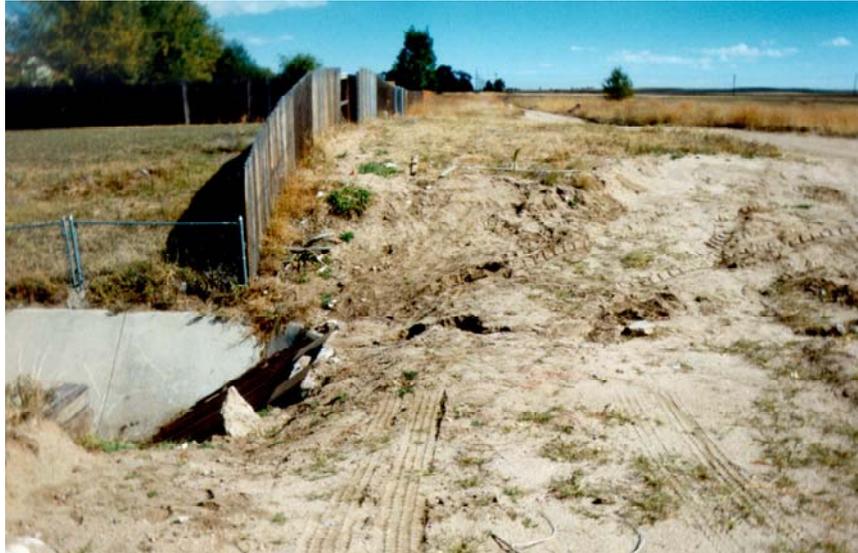
(1) Culverts: Armoring of inlet at City of Colorado Springs site. Figure 1 shows an unstable inlet that needed periodic maintenance to ensure the concrete was not being undercut by high intensity storm events.

Figure 1. Unstable culvert inlet.

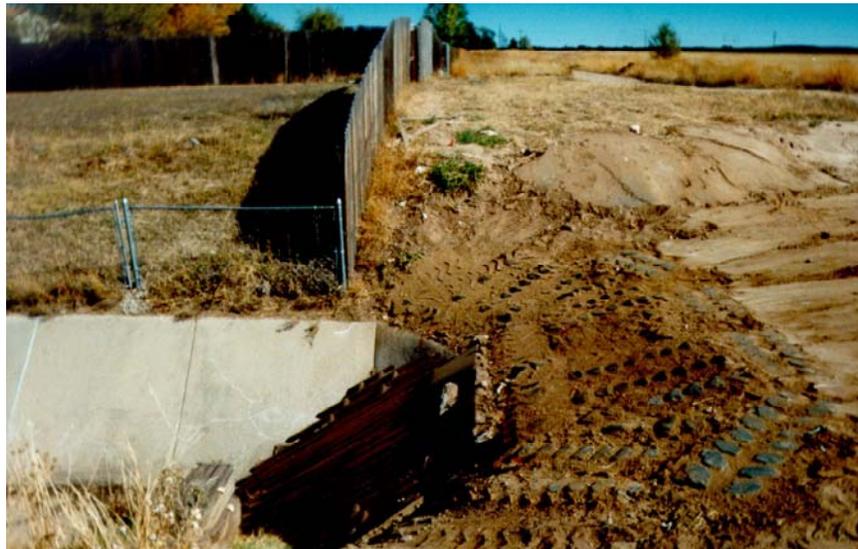
Figure 2 is the same culvert after using tank tracks to harden the inlet. This project was concluded in 1998 and has not required any further maintenance.

Figure 2. Stabilized culvert inlet.

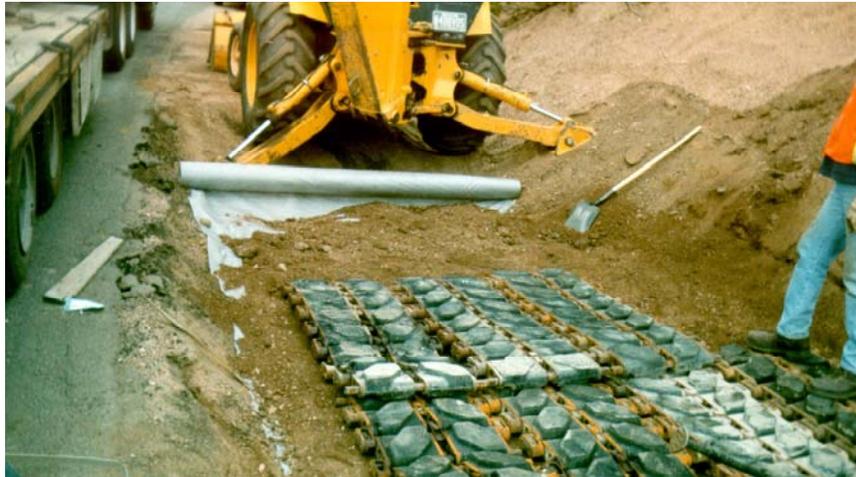
- a. The City first excavated the drainage channel to grade and laid geotextile down as the base for laying the tracks (Figure 3).

Figure 3. A drainage channel lined with geotextile and tank tracks.

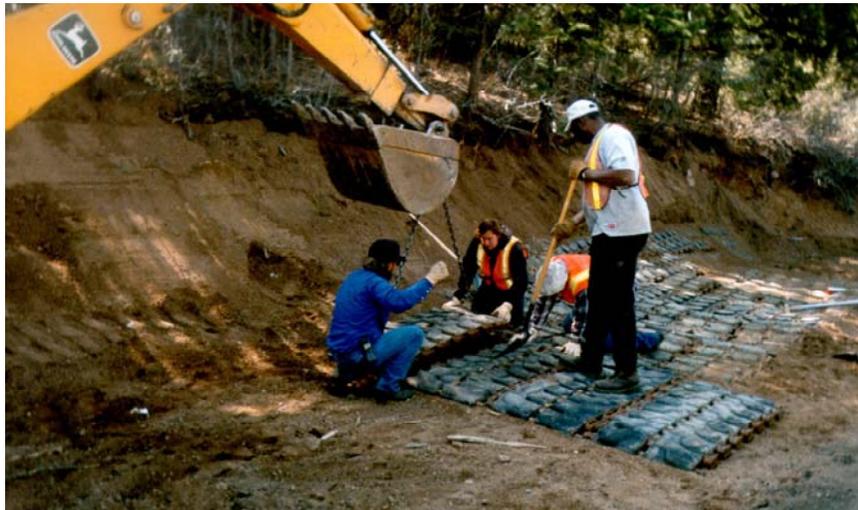
- b. Workers then were able to direct the tracks into place using as few as three people. Figure 4 shows how the tracks are laid in a stairstep fashion.

Figure 4. Tracks laid in a stairstep fashion.

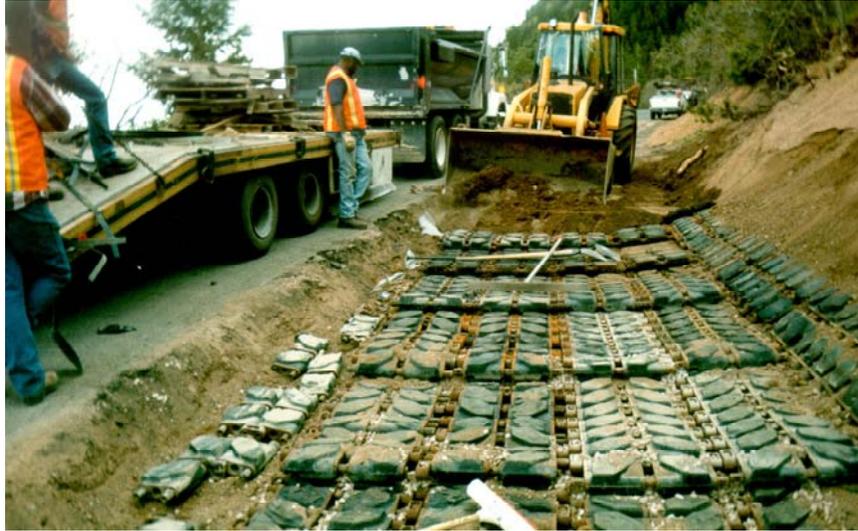
c. The tracks are toed under the adjacent roadway so as to interlock at the road/drainage channel interface (Figure 5). Asphalt will be used to anchor the tracks into place under the water flow line. This will allow the water to run over the tracks and road surface and prevent gullying.

Figure 5. Tracks toed under the adjacent roadway.

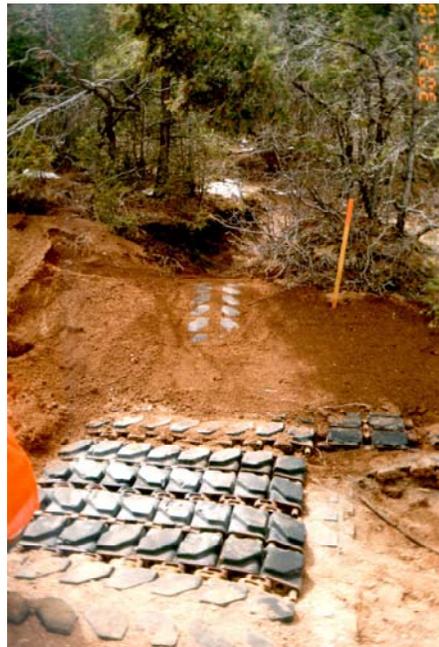
d. Natural inlets were lined (Figure 6) to direct water into the main drainage channel. The channel sides are also armored. The tracks are toed into the soil profile and under the waterflow line.

Figure 6. Tank tracks lining a natural inlet.

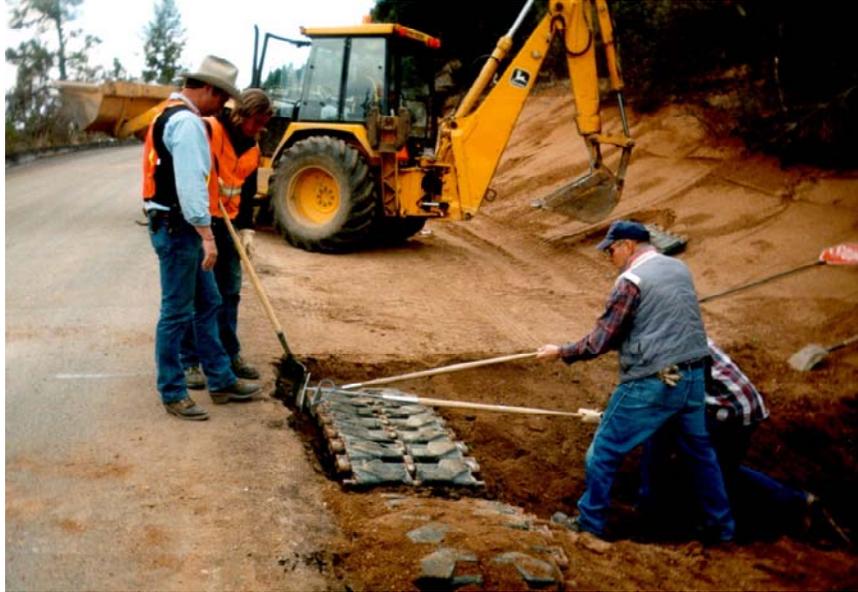
e. Tracks laid at the road/drainage channel interface were toed into the soil profile under the water flowline and later partially covered with asphalt (Figure 7).

Figure 7. Tracks toed into the soil profile under the waterflow line.

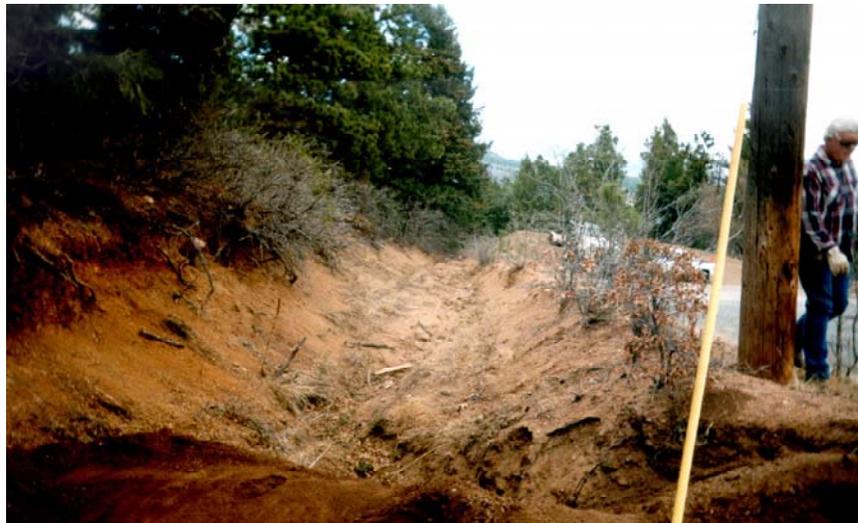
f. Figure 8 shows a spot downstream from the project site. Notice the utility pole being slowly scoured away by erosive forces.

Figure 8. Erosion and scouring downstream from the project site.

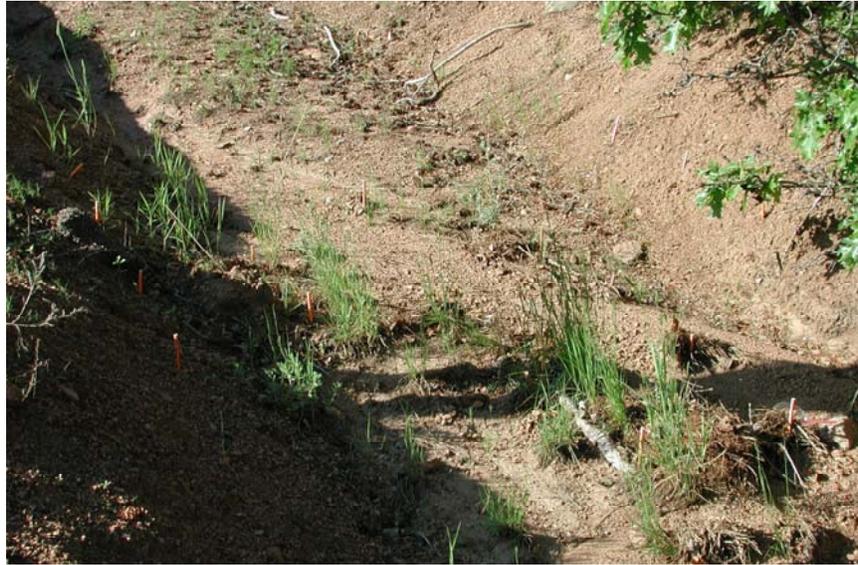
g. Figure 9 shows the same general downstream area 2 years after the project was completed. Vegetation is establishing slowly, but most is washed away during rain events.

Figure 9. Vegetation is slow to establish downstream from the project site.

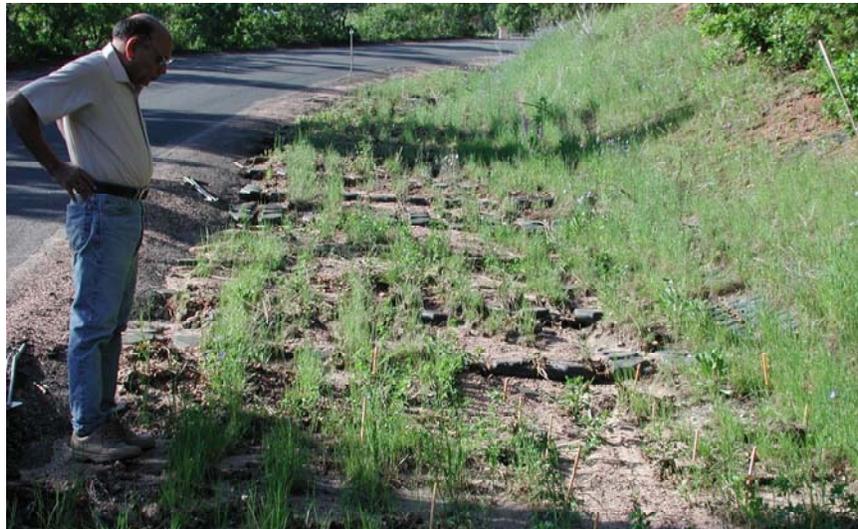
h. Figure 10 shows the upstream area 2 years after the tracks were laid for the project. Vegetation is establishing well and no further maintenance is needed. An erosion study was conducted to compare erosion rates between the tracked area and untracked area. Erosion was significantly higher in the untracked area, whereas the tracked area had significant levels of deposition occurring (Appendix B). At this point, the tracks can still be seen to some degree.

Figure 10. The project area 2 years after tank tracks were placed.

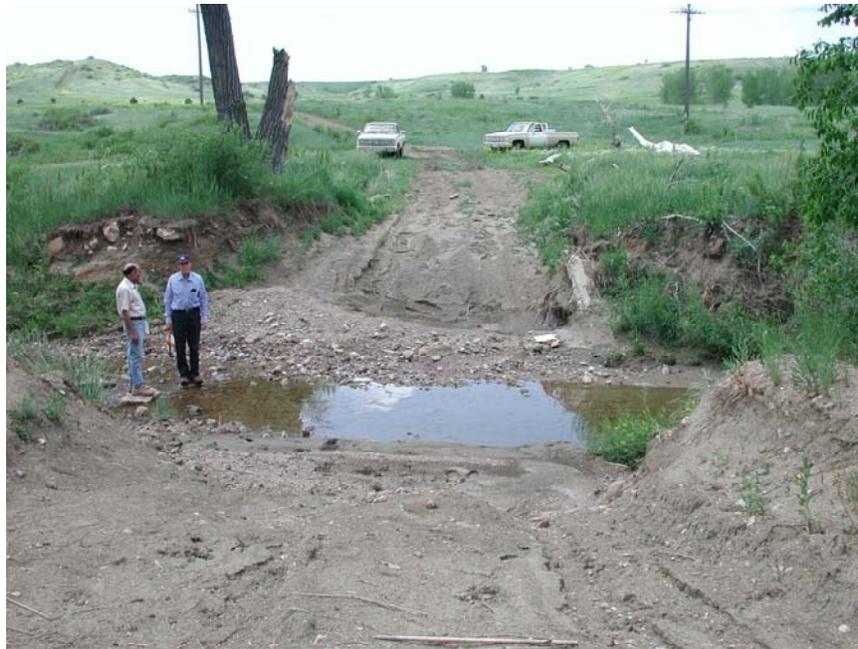
a. Figure 11 shows the crossing as it was before implementing a hardened streamcrossing. A professional engineer from the Engineer Research and Development Center (ERDC) surveyed and flagged the site, developed the specifications, and wrote the Statement of Work to hire the contractor. BMPs were followed to ensure erosion was kept to a minimum while the work was being performed.

Figure 11. Heavily trafficked tank trail crossing before hardening.

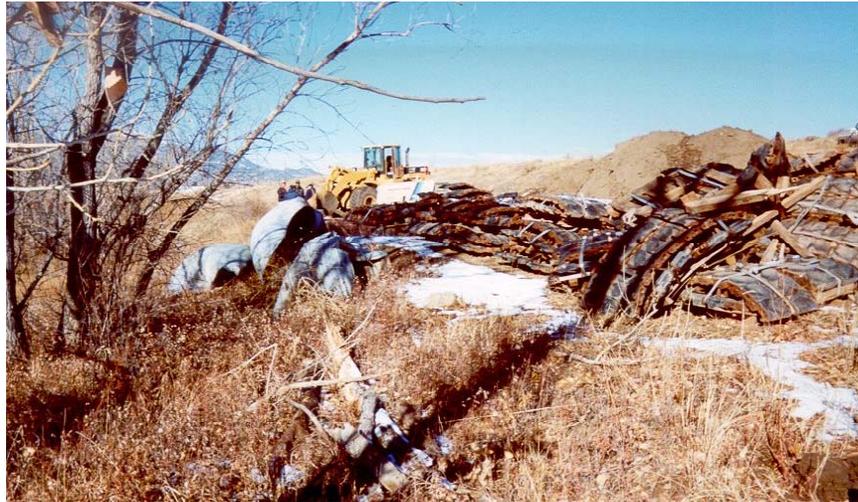
b. Unserviceable tank tracks from the DRMO yard were hauled to the project site (Figure 12). Each individual pallet held four lengths of track. Each track was 4 feet long and approximately 400 pounds. To complete the streamcrossing, the staff used 68 pallets of track to form a 20-foot x 100-foot mat that spanned the stream.

Figure 12. Tank tracks awaiting placement.

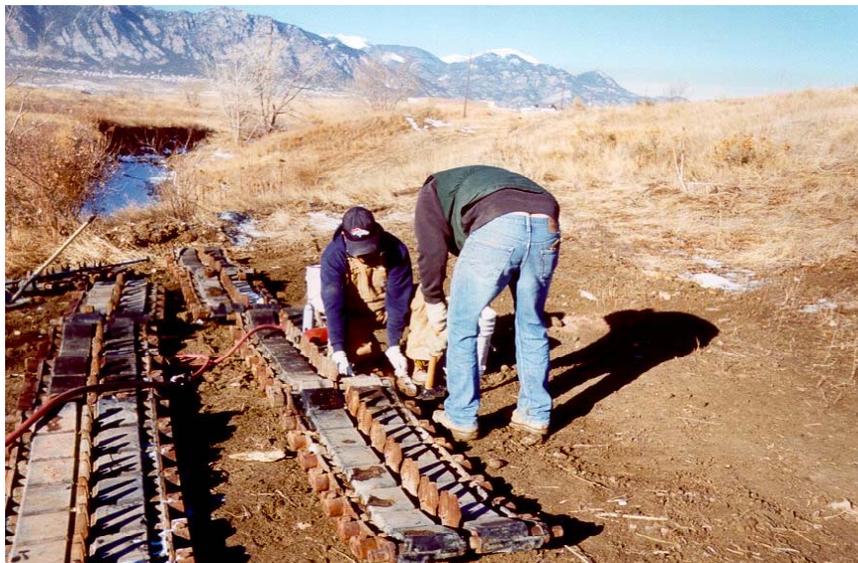
c. The track was lined up in 20-foot sections and connected end to end using spare parts from other tracks (Figure 13). Multipurpose lubricant spray was used to help ease the connectors onto the end shanks of the tracks. Preparing and laying the tracks requires intensive labor. To assemble 44 strips of 20-ft track, it took three FTE 3 days to accomplish; 72 to 80 manhours are needed to assemble a project of this magnitude.

Figure 13. Preparing the track for placement.

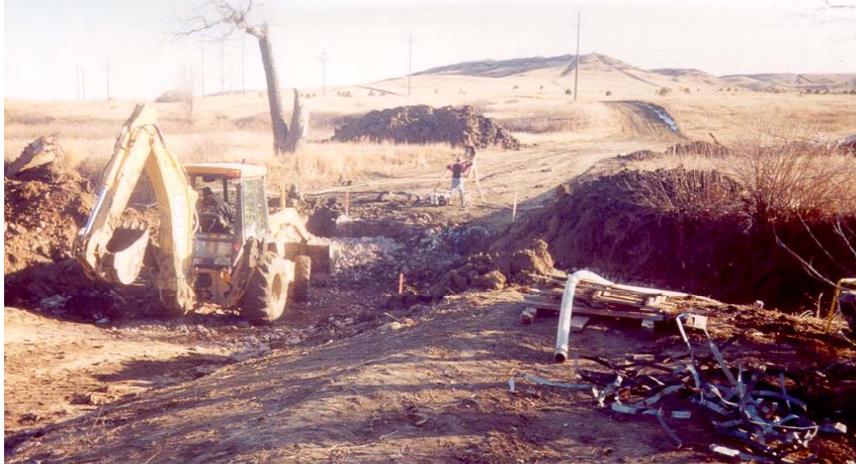
d. While the workers were assembling the tracks upslope, excavation, grading, contouring, and filling were being carried out at the crossing (Figure 14). Stream water was diverted from the project area using two pumps.

Figure 14. Earthmoving at the crossing.

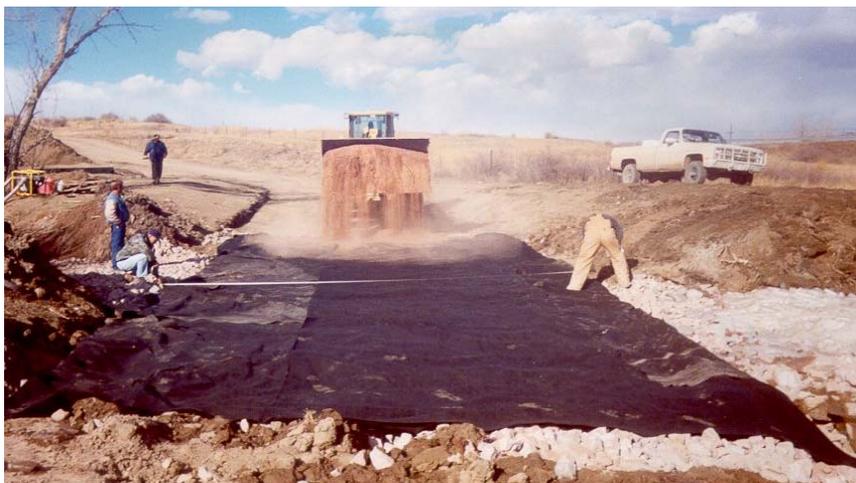
e. The crossing was filled with the following layers starting at the bottom of the stream channel (Figure 15):

1. Base = 6 inches compact fill
2. Nonwoven geotextile
3. 24 inches of riprap (d50: 6 to 12 inches)
4. 8 inches compacted gravel
5. 4-inch tank track mat (1 layer thickness of tracks)
6. 6 inches of gravel (ABC 3-1/4-inch stone with fines)

Figure 15. The bottom layers of the project.

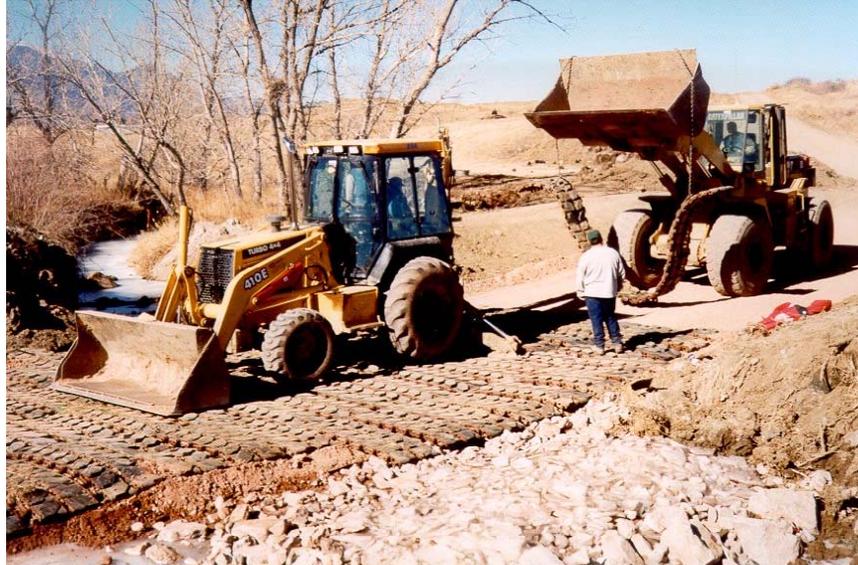
f. Tracks were laid (Figure 16) using a cable, backhoe, toploader, and one worker to guide the placement.

Figure 16. Placing the tracks.

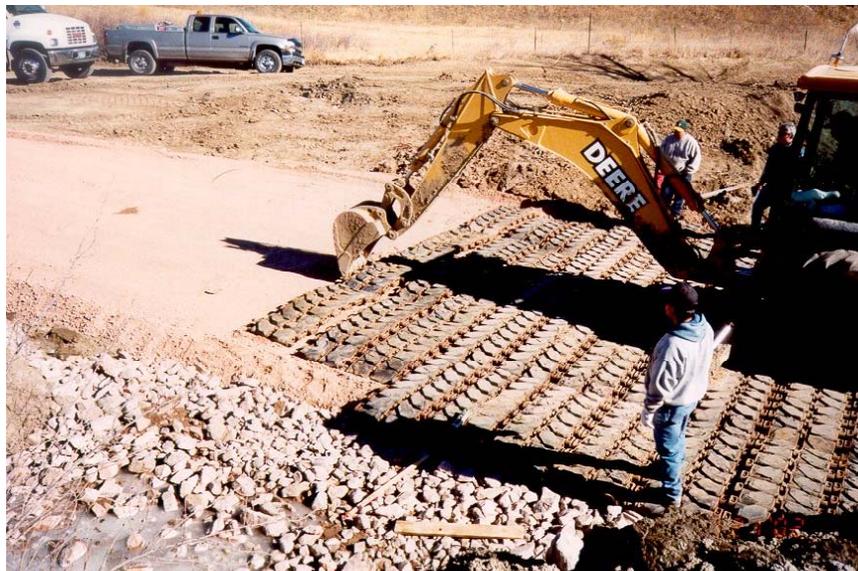
g. The backhoe operator was then able to move the track into the final position on the ground (Figure 17).

Figure 17. Moving the tank tracks into final position.

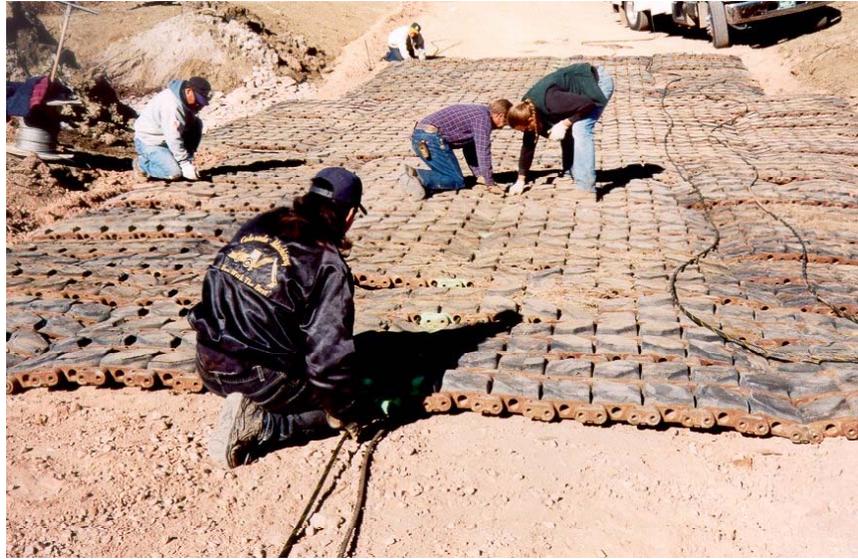
h. Rust-resistant stainless steel cable (1/2 to 5/8 inches) was used to string together the mat into a cohesive unit (Figure 18). Approximately 1,100 feet of cable was used to string the tracks. Of that total, over 750 feet of cable and 100 clamps were salvaged from the DRMO yard and other units on Fort Carson. Stream flows may be able to dislodge a single 400-pound section of track. Stringing the tracks together creates a unit weighing more than 88,000 pounds and provides a backup system if one string fails.

Figure 18. Using cables to string the tracks together.

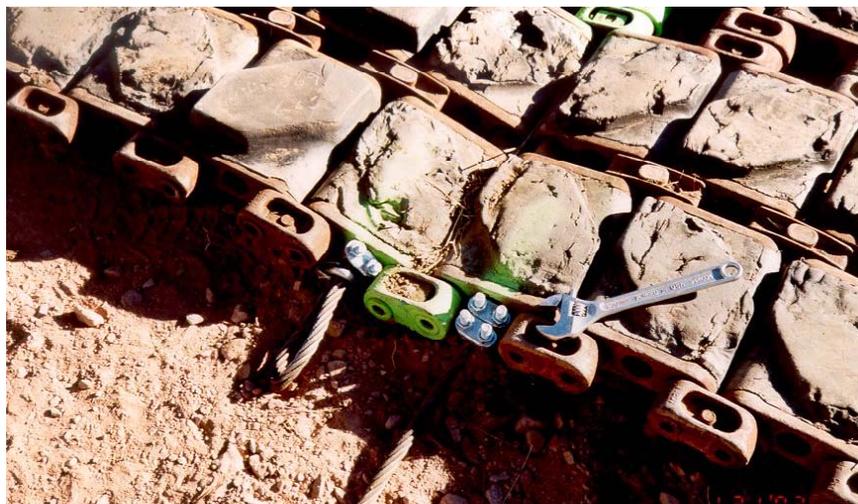
i. Cables were secured on either side by clamps (Figure 19). Insertion points were staggered to offset potential loads.

Figure 19. Using clamps to secure the cables.

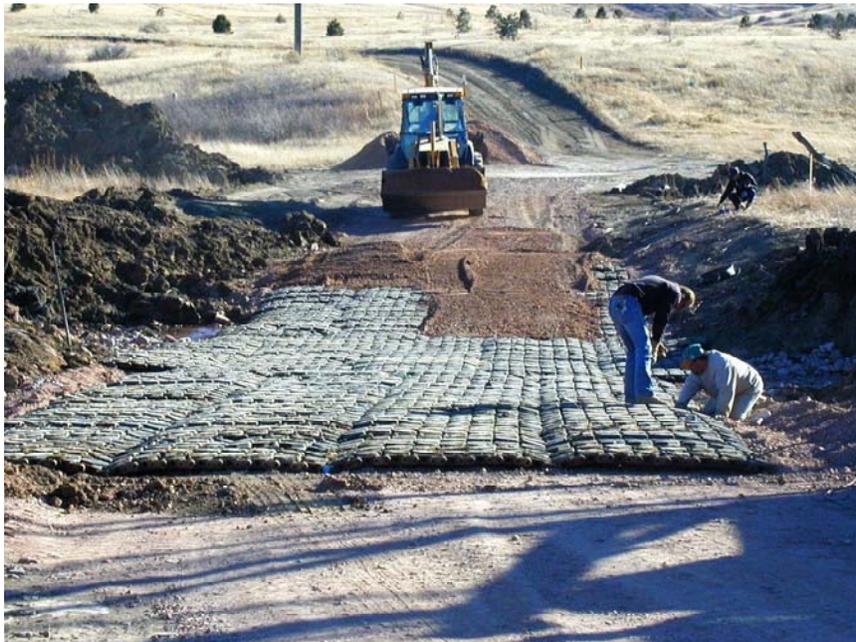
j. A layer of gravel was applied to finish the project (Figure 20). The final project costs were as follows:

Figure 20. A layer of gravel covers the final project.

1. Materials (including silt fence, fabric, riprap, fill, gravel, cable, and seed):	\$11,200
2. Labor:	\$25,972
Total:	\$37,172

The final cost was \$18.58/ square foot.

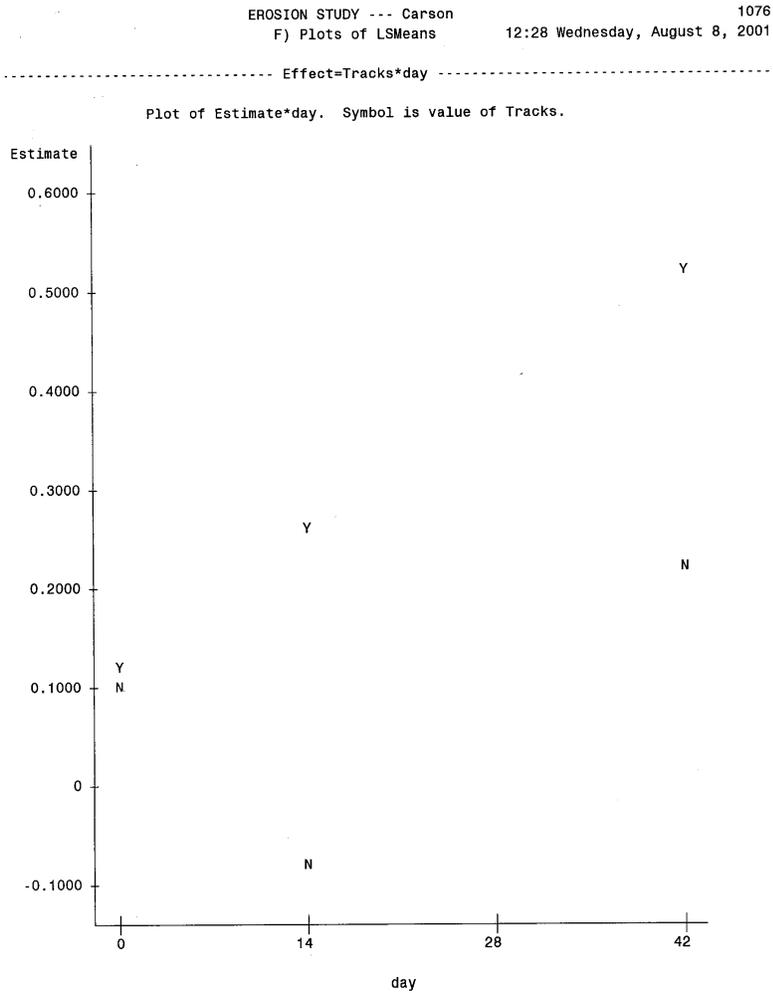
The results for Fort Carson showed a "TRACKS*DAY" interaction significant at the .05 level ($.05 < p < .001$). Figure B1 illustrates the least-squares means for this interaction. Note the pattern over time is different for the cases with vs. without tracks (Y and N, respectively), with the difference measure increasing monotonically. TRACKS = "Yes" at DAY = 42 suggests that the only significant erosion was in the tracked treatments. The differences between tracked and non-tracked treatments were not significant at any single point of measurement.

Over time for both the Fort Carson and Colorado Springs sites, significance did occur. The tracks at Fort Carson that were applied against the contour and without geotextile resulted in a contribution to erosion. The tracks placed at Colorado Springs contributed to deposition, not erosion. This is a result of proper placement and the use of geotextile, which prevented undercutting.

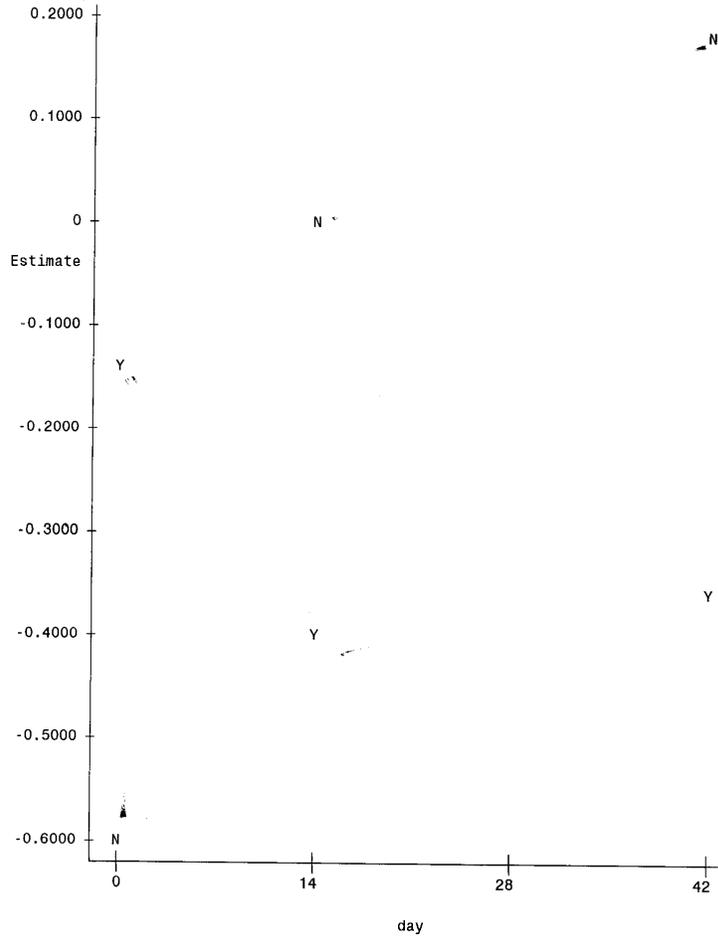
----- Effect=Tracks*day -----

The results for Colorado Springs also showed a "TRACKS*DAY" interaction significant at the .05 level ($.05 < p < .001$). Figure B2 illustrates this interaction. The values are negative at day 0, significantly so for the nontracked treatment, indicating some deposition, as opposed to erosion. In the tracked treatment, deposition increases over time, while in the nontracked treatment the deposition is reversed (eroded) over time. The differences between tracked and nontracked treatments were not significant at any single point of measurement.

Plot of Estimate*day. Symbol is value of Tracks.
