**FAC 1114 Runway, Unsurfaced**

# Unpaved Runway Sustainment Funding

25 Aug 2011

To provide information and considerations related to  
sustainment of Unpaved Runways

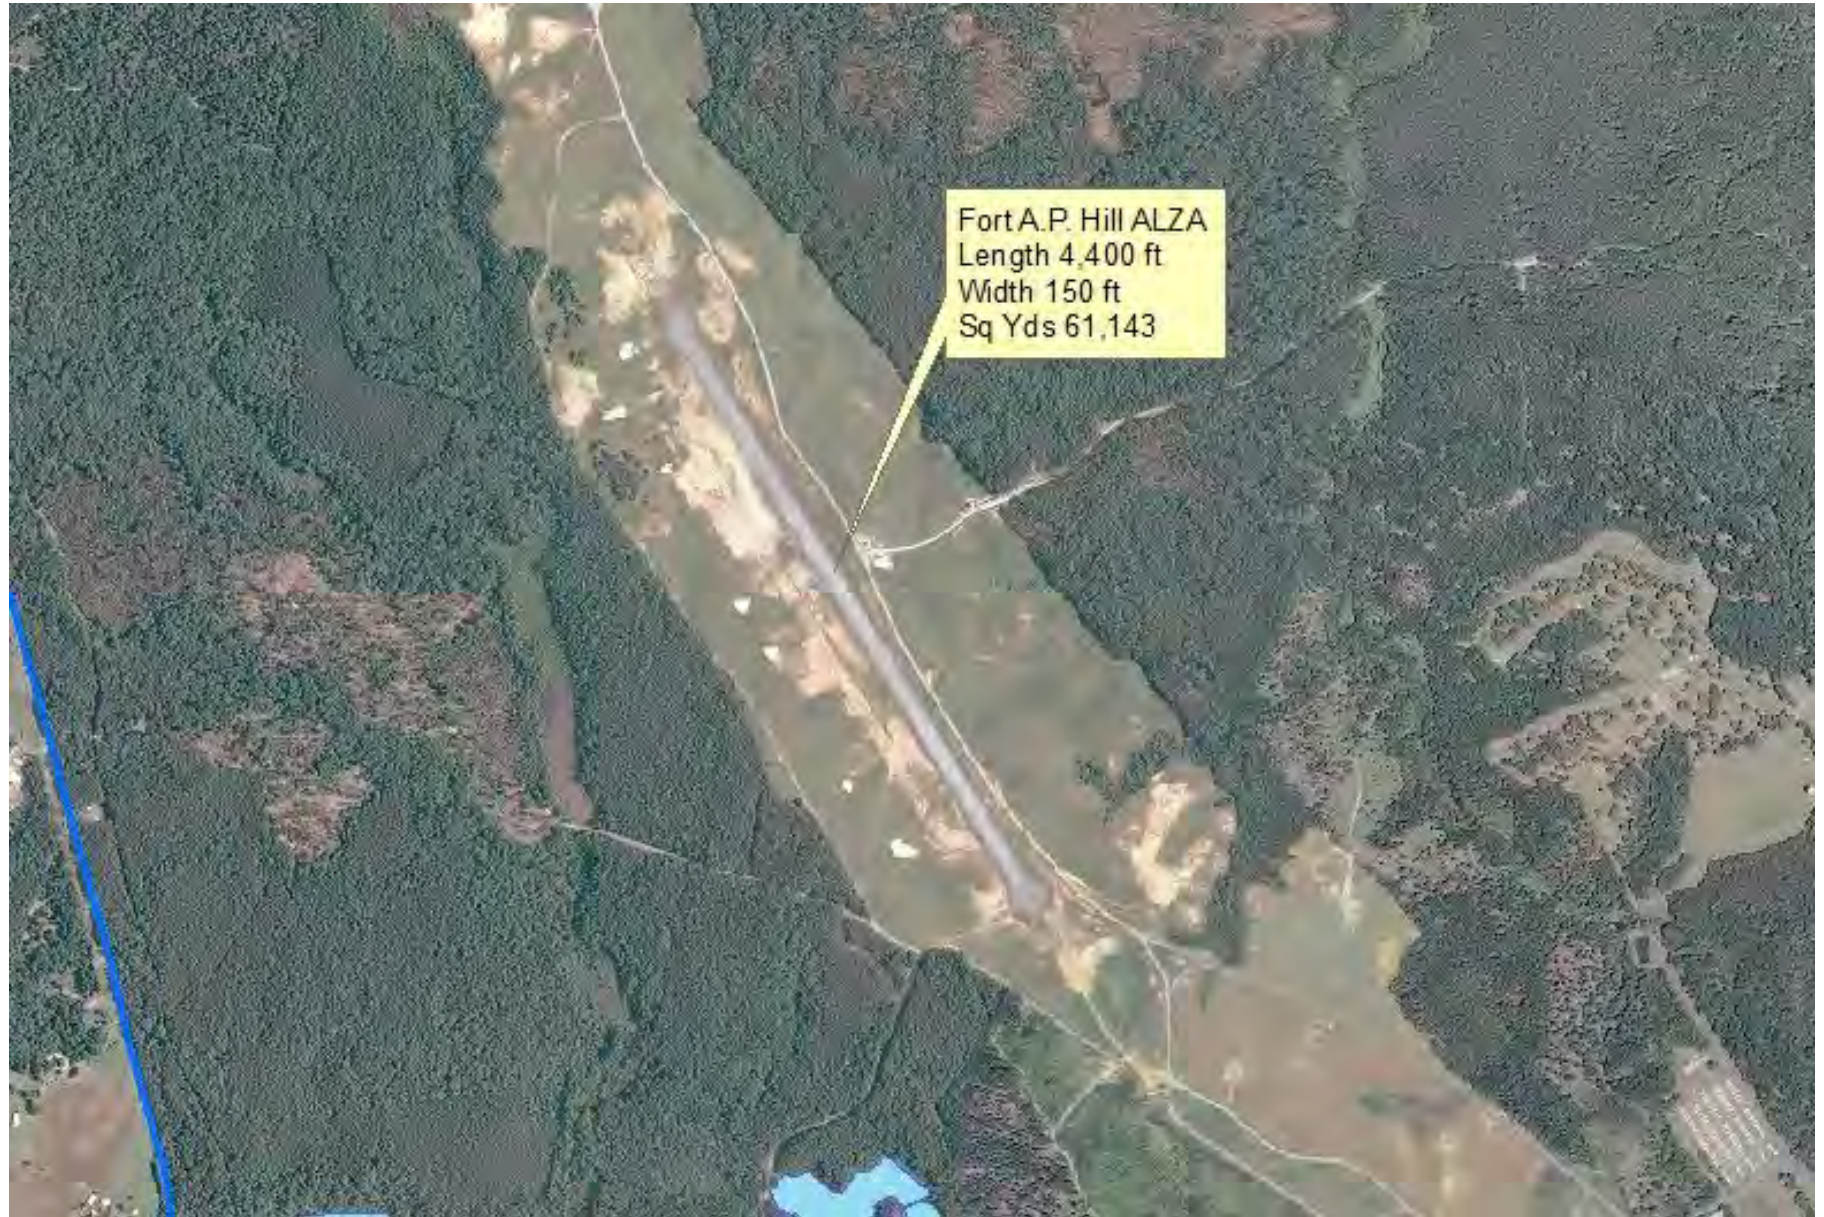
# FAPH ALZA RPID 272037 – FCC 11111

- FAPH ALZA C130, C17, Twin Otter, DHC-4
  - 4400 Ln ft stone surface
- FAPH AF1- Casa 212, 235, Twin Otter
  - Grass strip
- FAPH PENDER AF- Twin Otter
  - Grass strip
- FAPH COOKE AF- Current ops rotary wing only
  - Grass strip

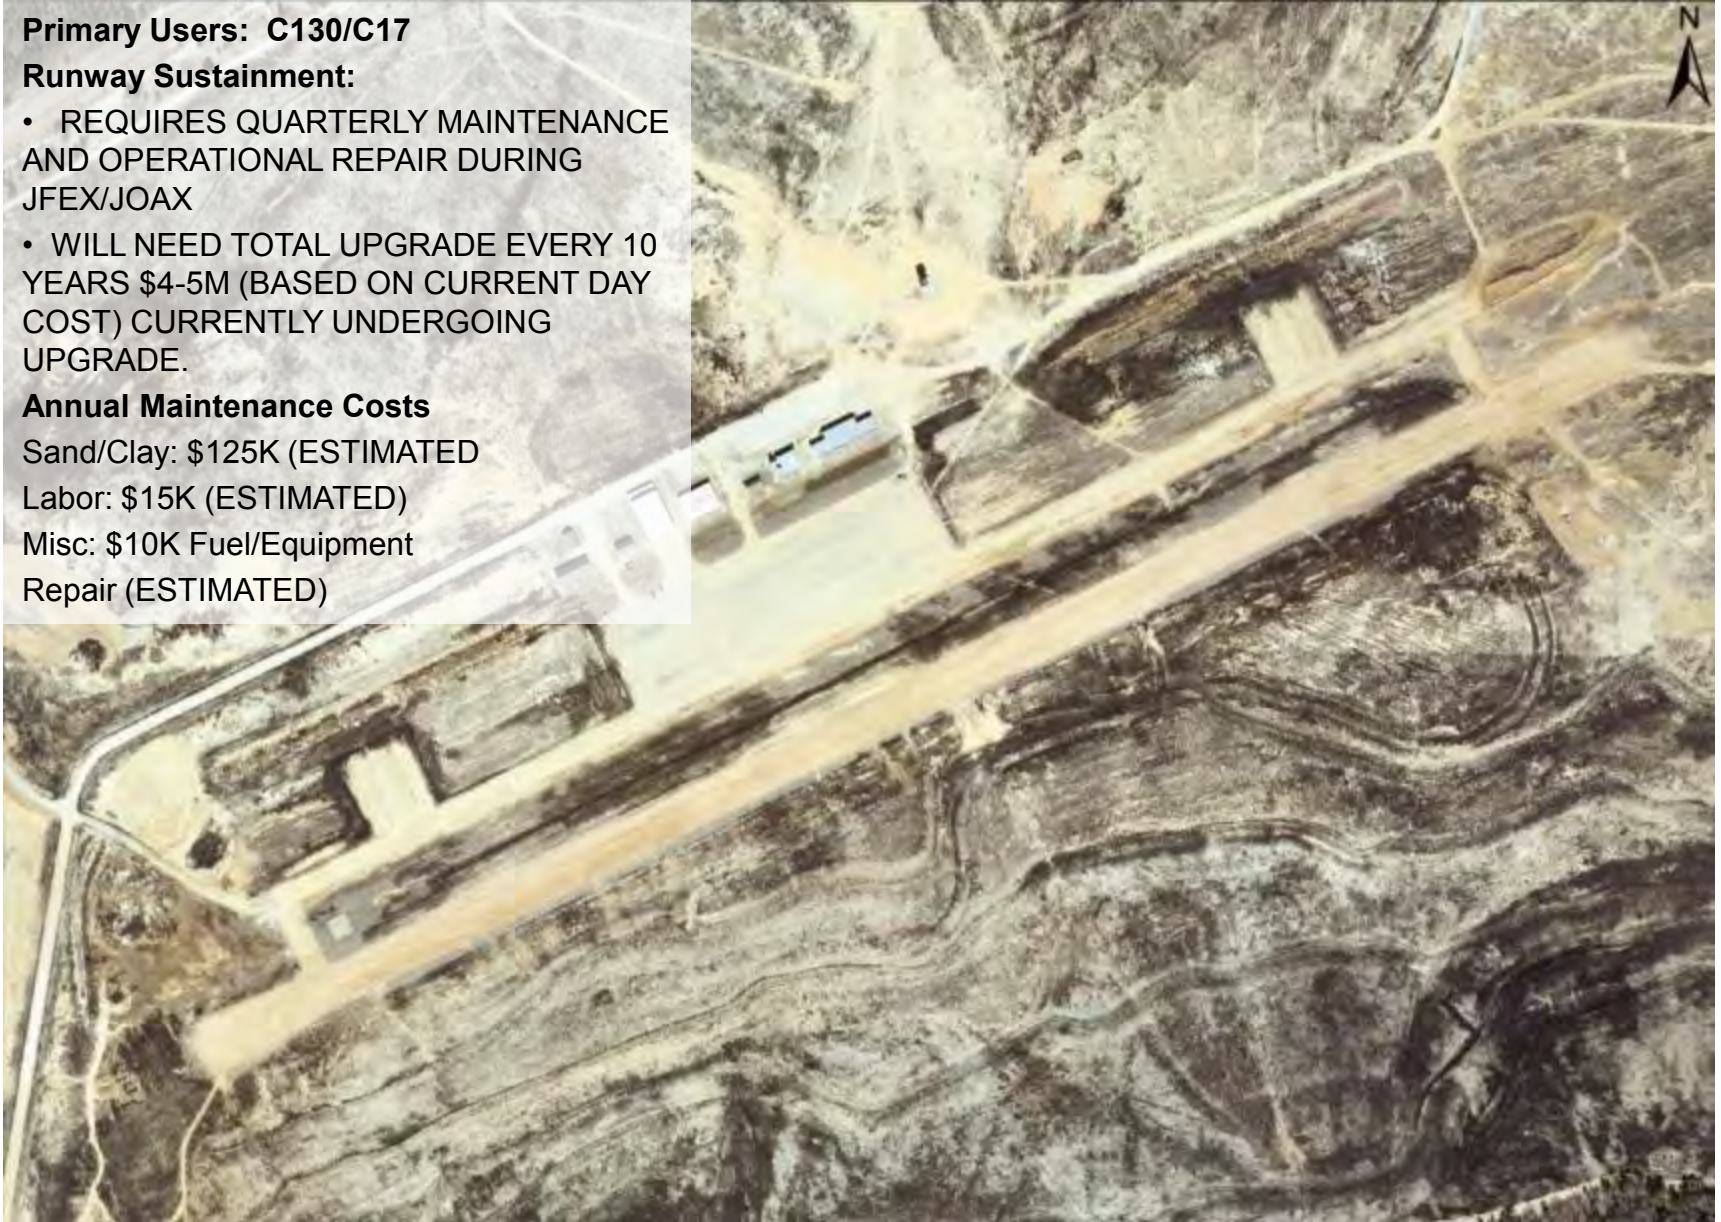
# Holland Overview

**Primary Users: C130/C17**

- REQUIRES QUARTERLY MAINTENANCE AND OPERATIONAL REPAIR DURING JFEX/JOAX
- WILL NEED TOTAL UPGRADE EVERY 10 YEARS \$4-5M (BASED ON CURRENT DAY COST) CURRENTLY UNDERGOING UPGRADE.

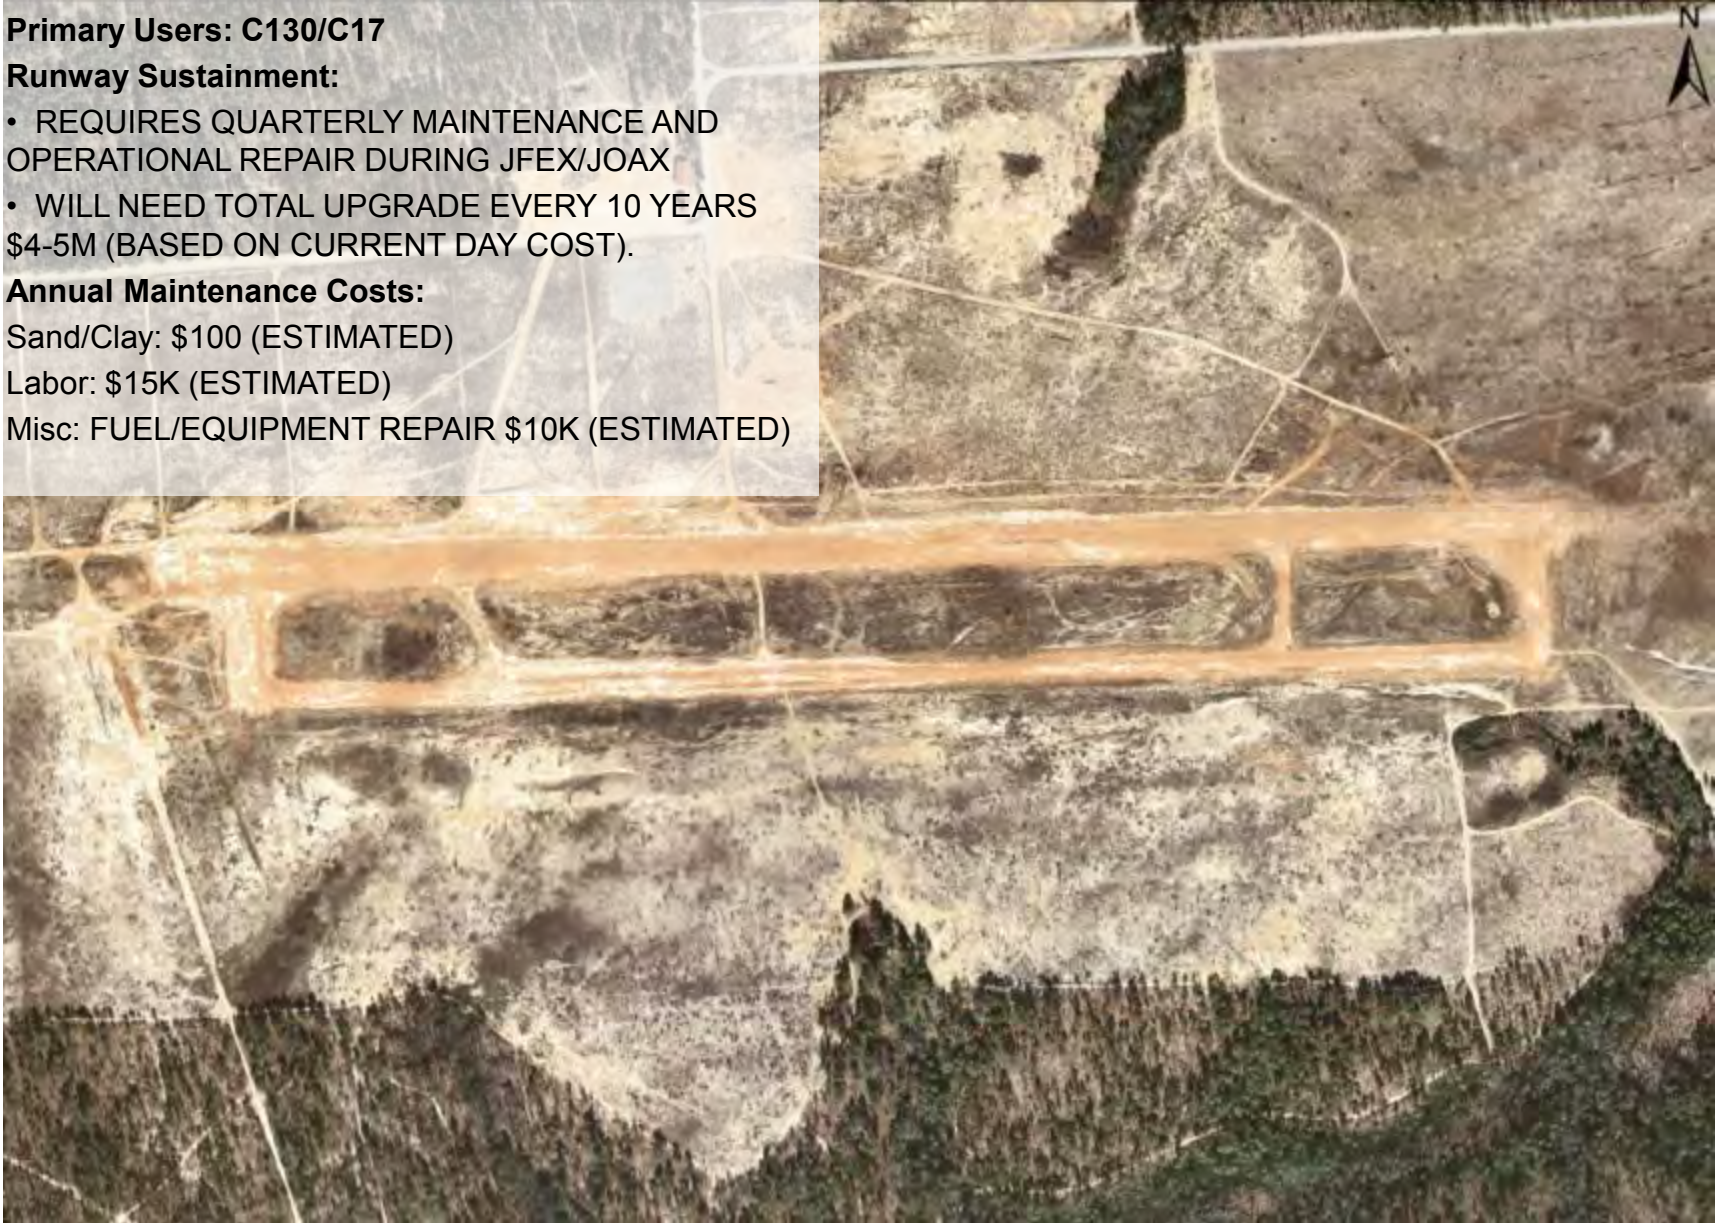
# Rhine Luzon Overview

**Primary Users: C130/C17**

- REQUIRES QUARTERLY MAINTENANCE AND OPERATIONAL REPAIR DURING JFEX/JOAX
- WILL NEED TOTAL UPGRADE EVERY 10 YEARS \$4-5M (BASED ON CURRENT DAY COST).
