## WINDOW SILL AT BRICK VENEER

GENERIC CONDITION

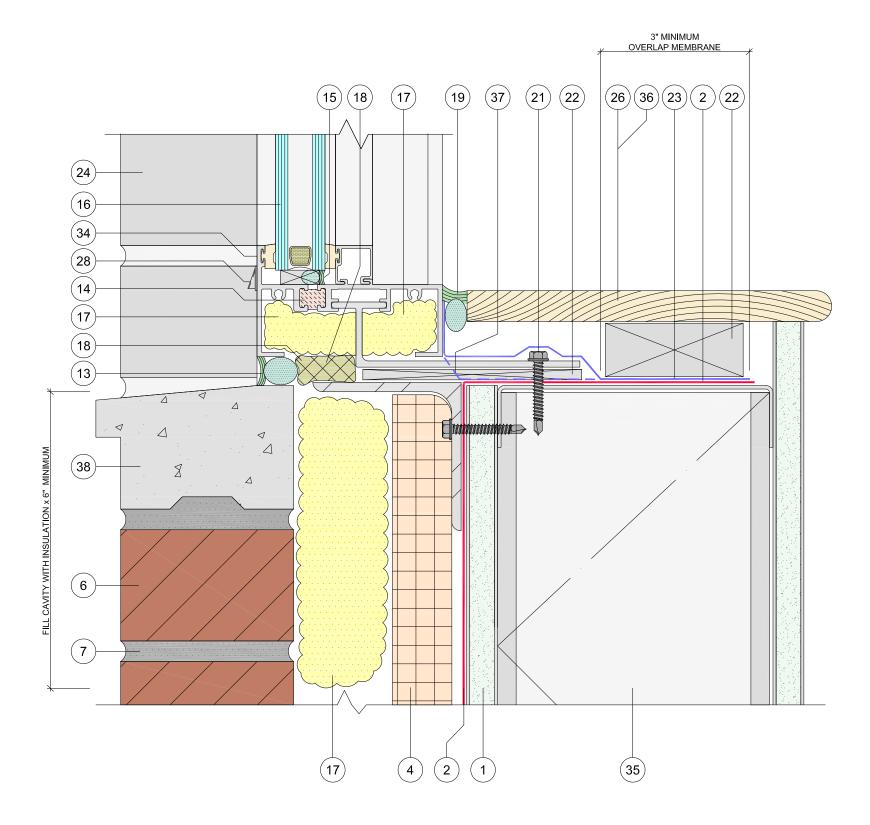
- 1. EXTERIOR SHEATHING
- 2. AIR AND VAPOR BARRIER MEMBRANE, WRAP INTO OPENING
- 4. RIGID INSULATION (WITHOUT VOIDS)
- 6. FACE BRICK
- 7. MORTAR
- 13. SEALANT AND BACKER ROD

- 14. THERMAL BREAK
- 15. HEEL BEAD OF SEALANT TO PROVIDE AIR TIGHTNESS (SNAP-IN GLAZING BEAD LEAKS AIR) CONTINUOUS AT ALL FOUR SIDES OF GLASS
- 16. HIGH PERFORMANCE INSULATING GLASS UNIT (TRIPLE GLAZED INSULATED UNIT WILL IMPROVE ENERGY PERFORMANCE)

- 17. SPRAY POLYURETHANE FOAM TO IMPROVE THERMAL PERFORMANCE
- 18. MINERAL WOOL
- 19. SEALANT AND BACKER ROD
  (VERIFY COMPATIBILITY WITH ELASTOMERIC FLASHING)

- 21. WINDOW ANCHOR CLIP AND FASTENER (SIZE AND SPACING AS REQUIRED)
- 22. BLOCKING AS REQUIRED
- 23. ELASTOMERIC FLASHING (EXTRUDED SILICONE SET IN SILICONE SEALANT OR SELF-ADHERING MEMBRANE FLASHING) (VERIFY COMPATIBILITY WITH AIR AND VAPOR BARRIER), 3" MINIMUM OVERLAP AT MEMBRANE JOINTS

- 24. BRICK AT JAMB BEYOND
- 26. STOOL
- 28. HOODED WEEP FOR GLAZING CAVITY
- 34. ALUMINUM WINDOW
- 35. STUD CAVITY (NO INSULATION)
- 36. REMOVABLE TRIM HERE TO FACILITATE FUTURE WINDOW REPLACEMENT

- 37. LINE OF ELASTOMERIC FLASHING BETWEEN ANCHOR CLIPS
- 38. MASONRY SILL
